Release Notification and Corrective Action

☐ Initial Report ☒ Final Report

Name of Company: XTO Energy, Inc.	Contact: Dudley McMinn
Address: 200 N. Lorraine St., Ste. 800, Midland, TX 79701	Telephone No.: (432) 682-8873
Facility Name: Grimes Lease Pit #3 (Windmill Oil)	Facility Type: Emergency Pit

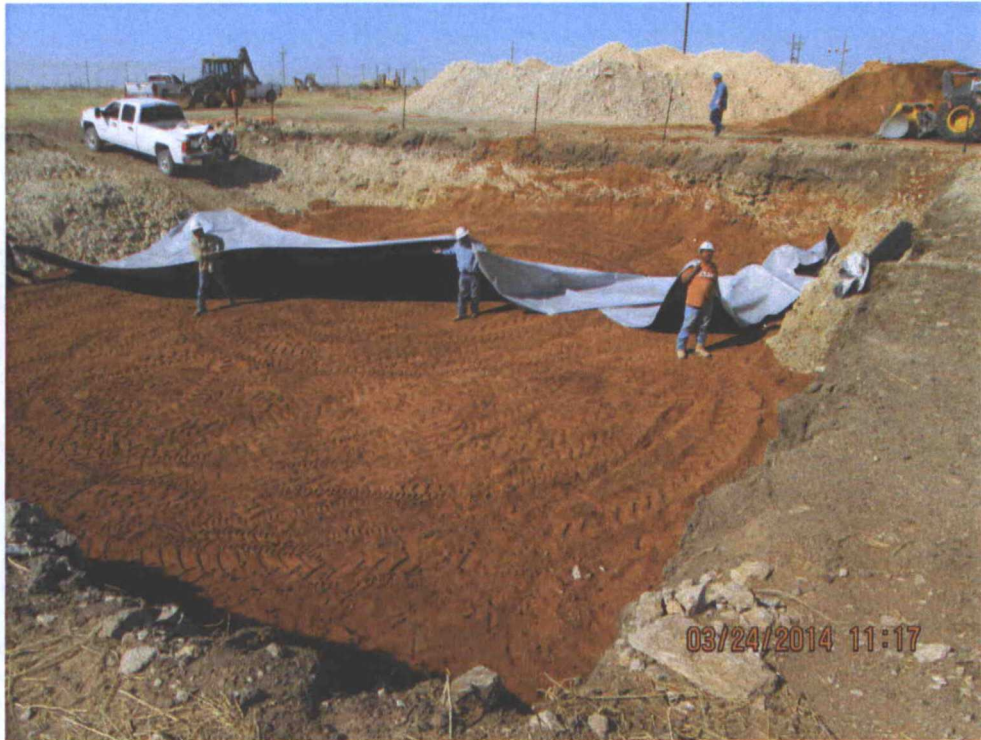
Pit #3 Liner Installation Viewing Southwest, March 24, 2014

Describe Area Affected and Cleanup Action Taken.* Lateral and vertical extent of contamination was delineated and Initial C-141 approved by OCD District I on January 30, 2014. Cleanup action was completed including excavating soil between approximately 8 and 10 feet below ground surface (bgs) for disposal a OCD approved facility, Jay Dan Landfarm, installing 20 mil polyethylene liner, with padding soil above/below liner, filling with caliche to between 3 and 4 feet bgs and remainder of excavation with topsoil. Surface reclamation will be according to plan approved by OCD Santa Fe on October 22, 2013.

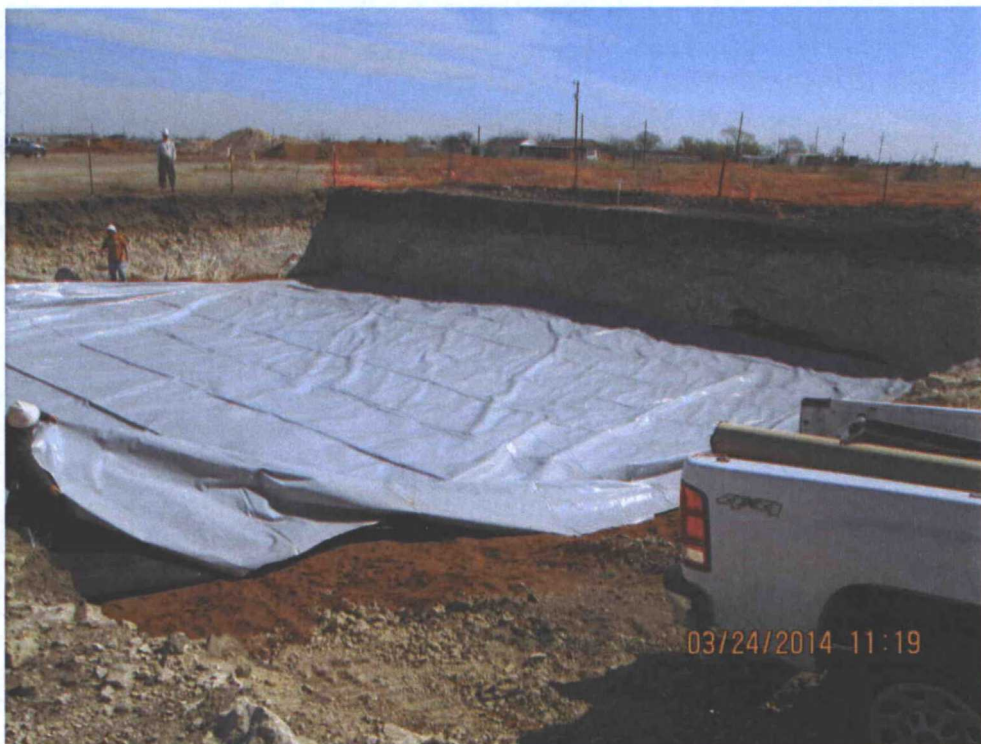
Pit #3 Liner Installation Viewing Northeast, March 24, 2014

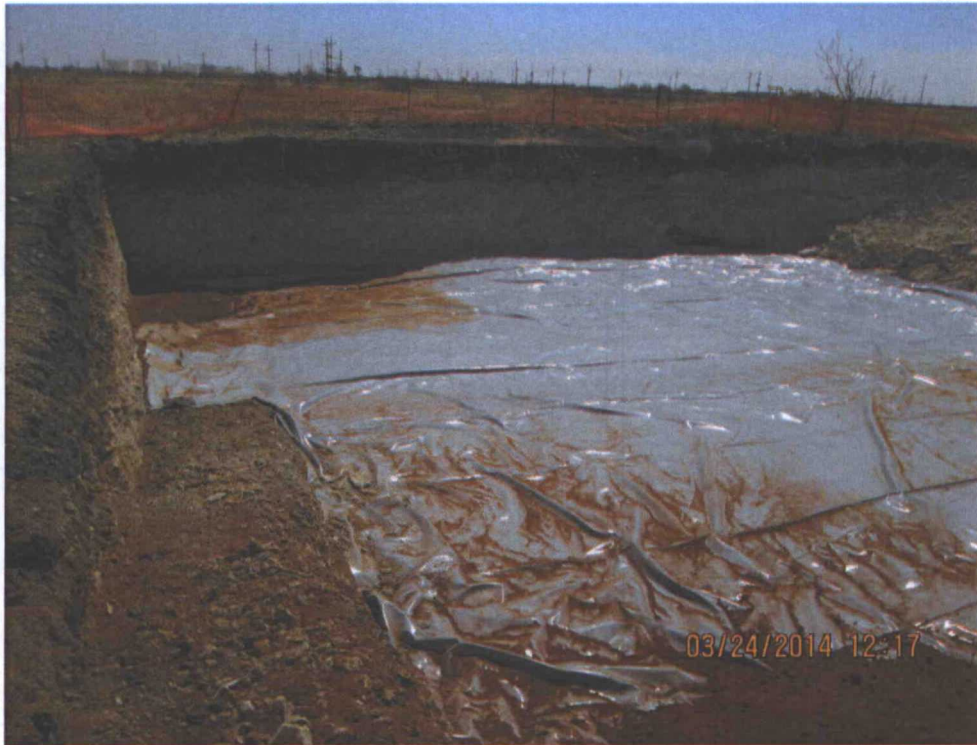
Pit #3 Liner Installation Viewing East, March 24, 2014

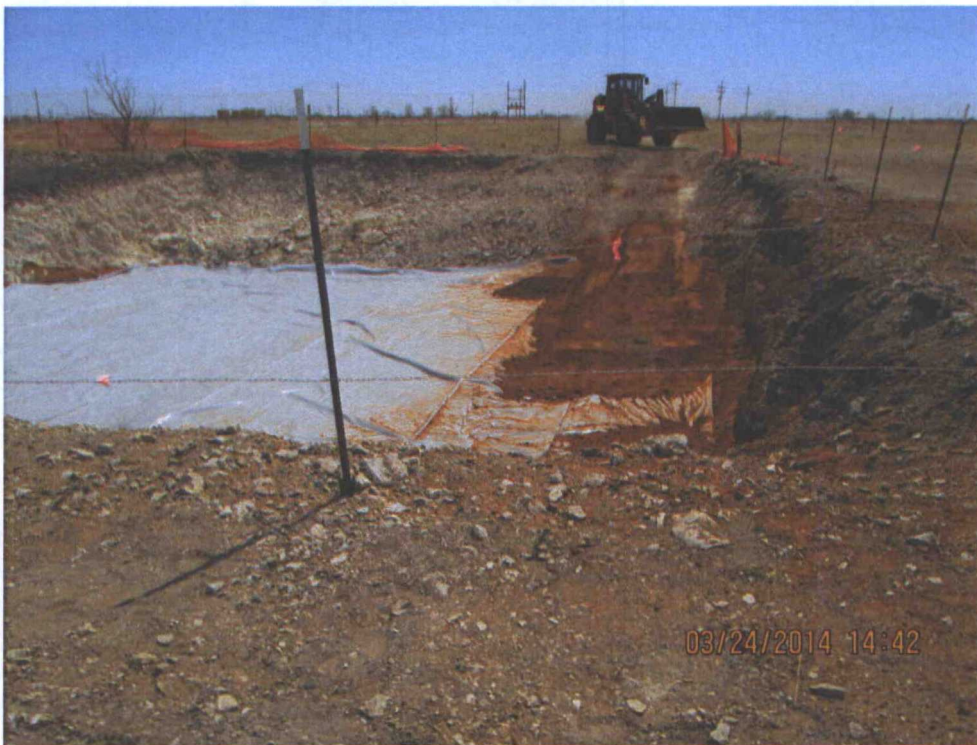
Pit #3 Covering Liner Viewing South, March 24, 2014
