Release Notification and Corrective Action

Closure Report

Site Name:	Eva E Blinebry Federal #19	RECEIVED
Company:	Oxy Permian Ltd.	
Legal Description:	U/L H, Section 34, T23S, R37E	
County:	Lea County, NM	
GPS Coordinates:	N 32.26382° W 103.141730°

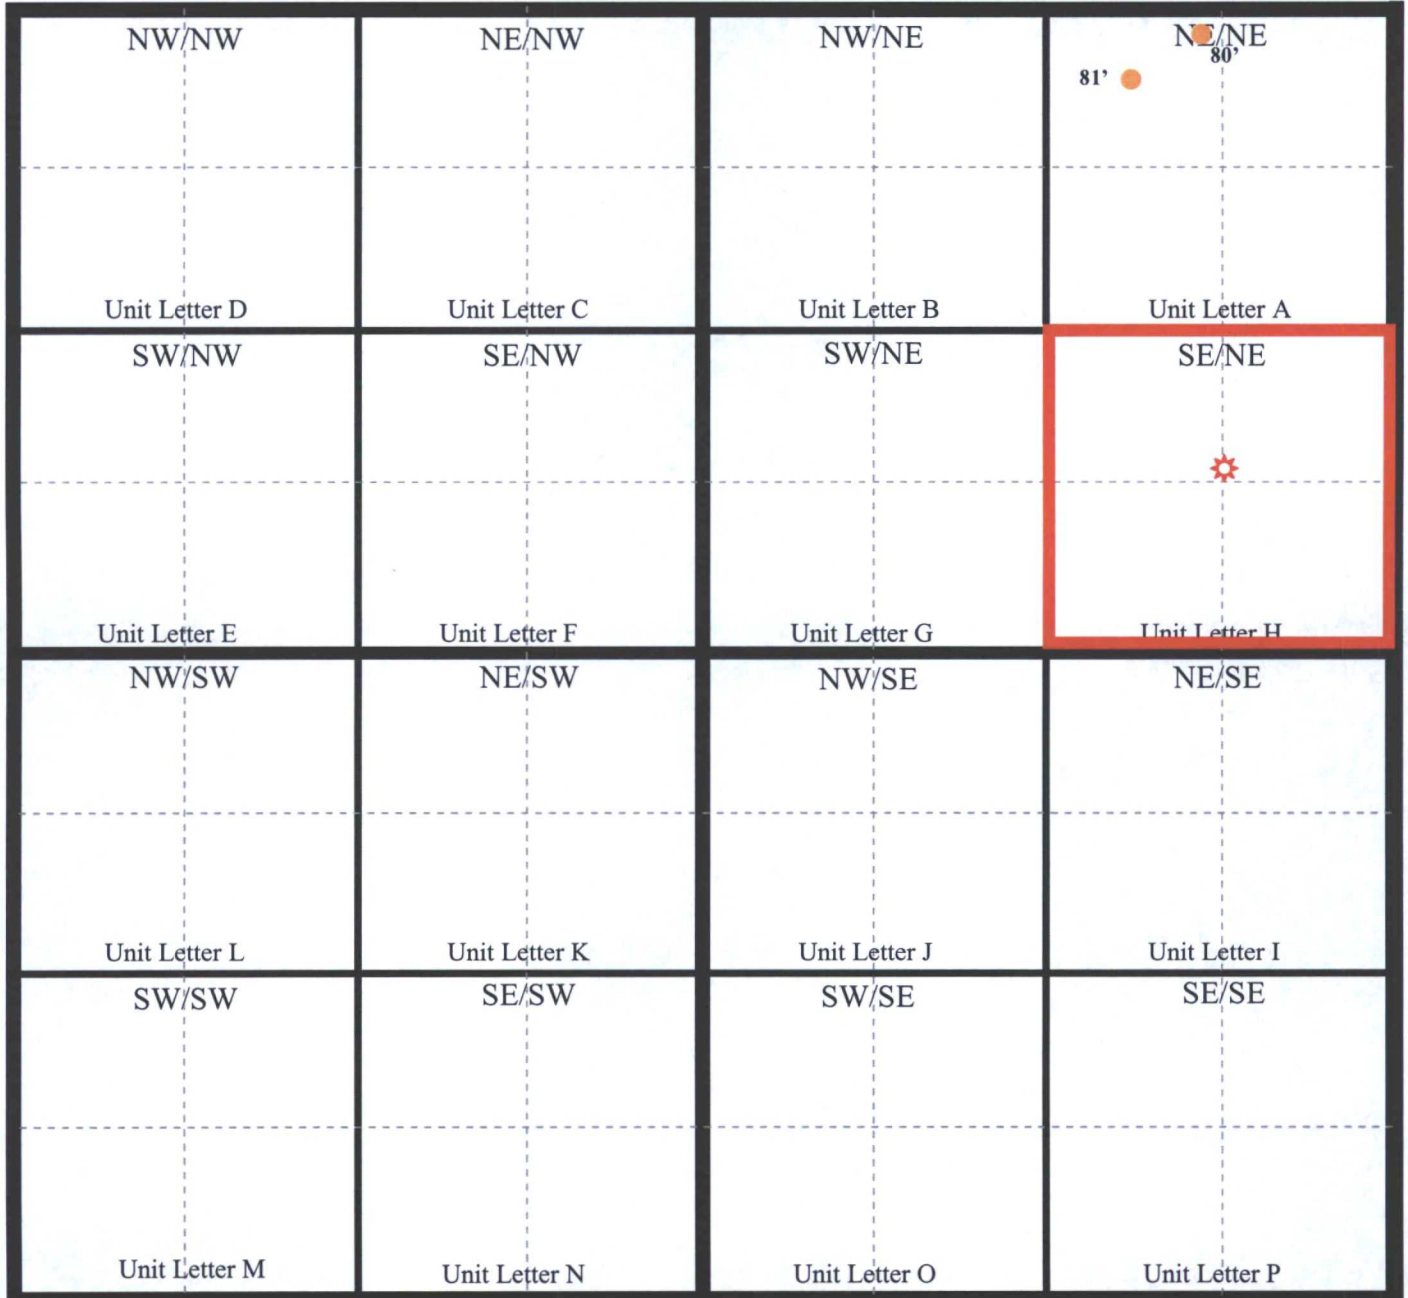
Trend Map 80'

Oxy, Eva E. Blinbry Federal #19 Battery

County Lea County Unit Letter H Section 34 Township 23S Range 37E
