SOUTHERN UNION GAS COMPANY

Environmental Site Summary

Project Name: Drip Tank #61-62 (NMOCD 1RP#-1818)

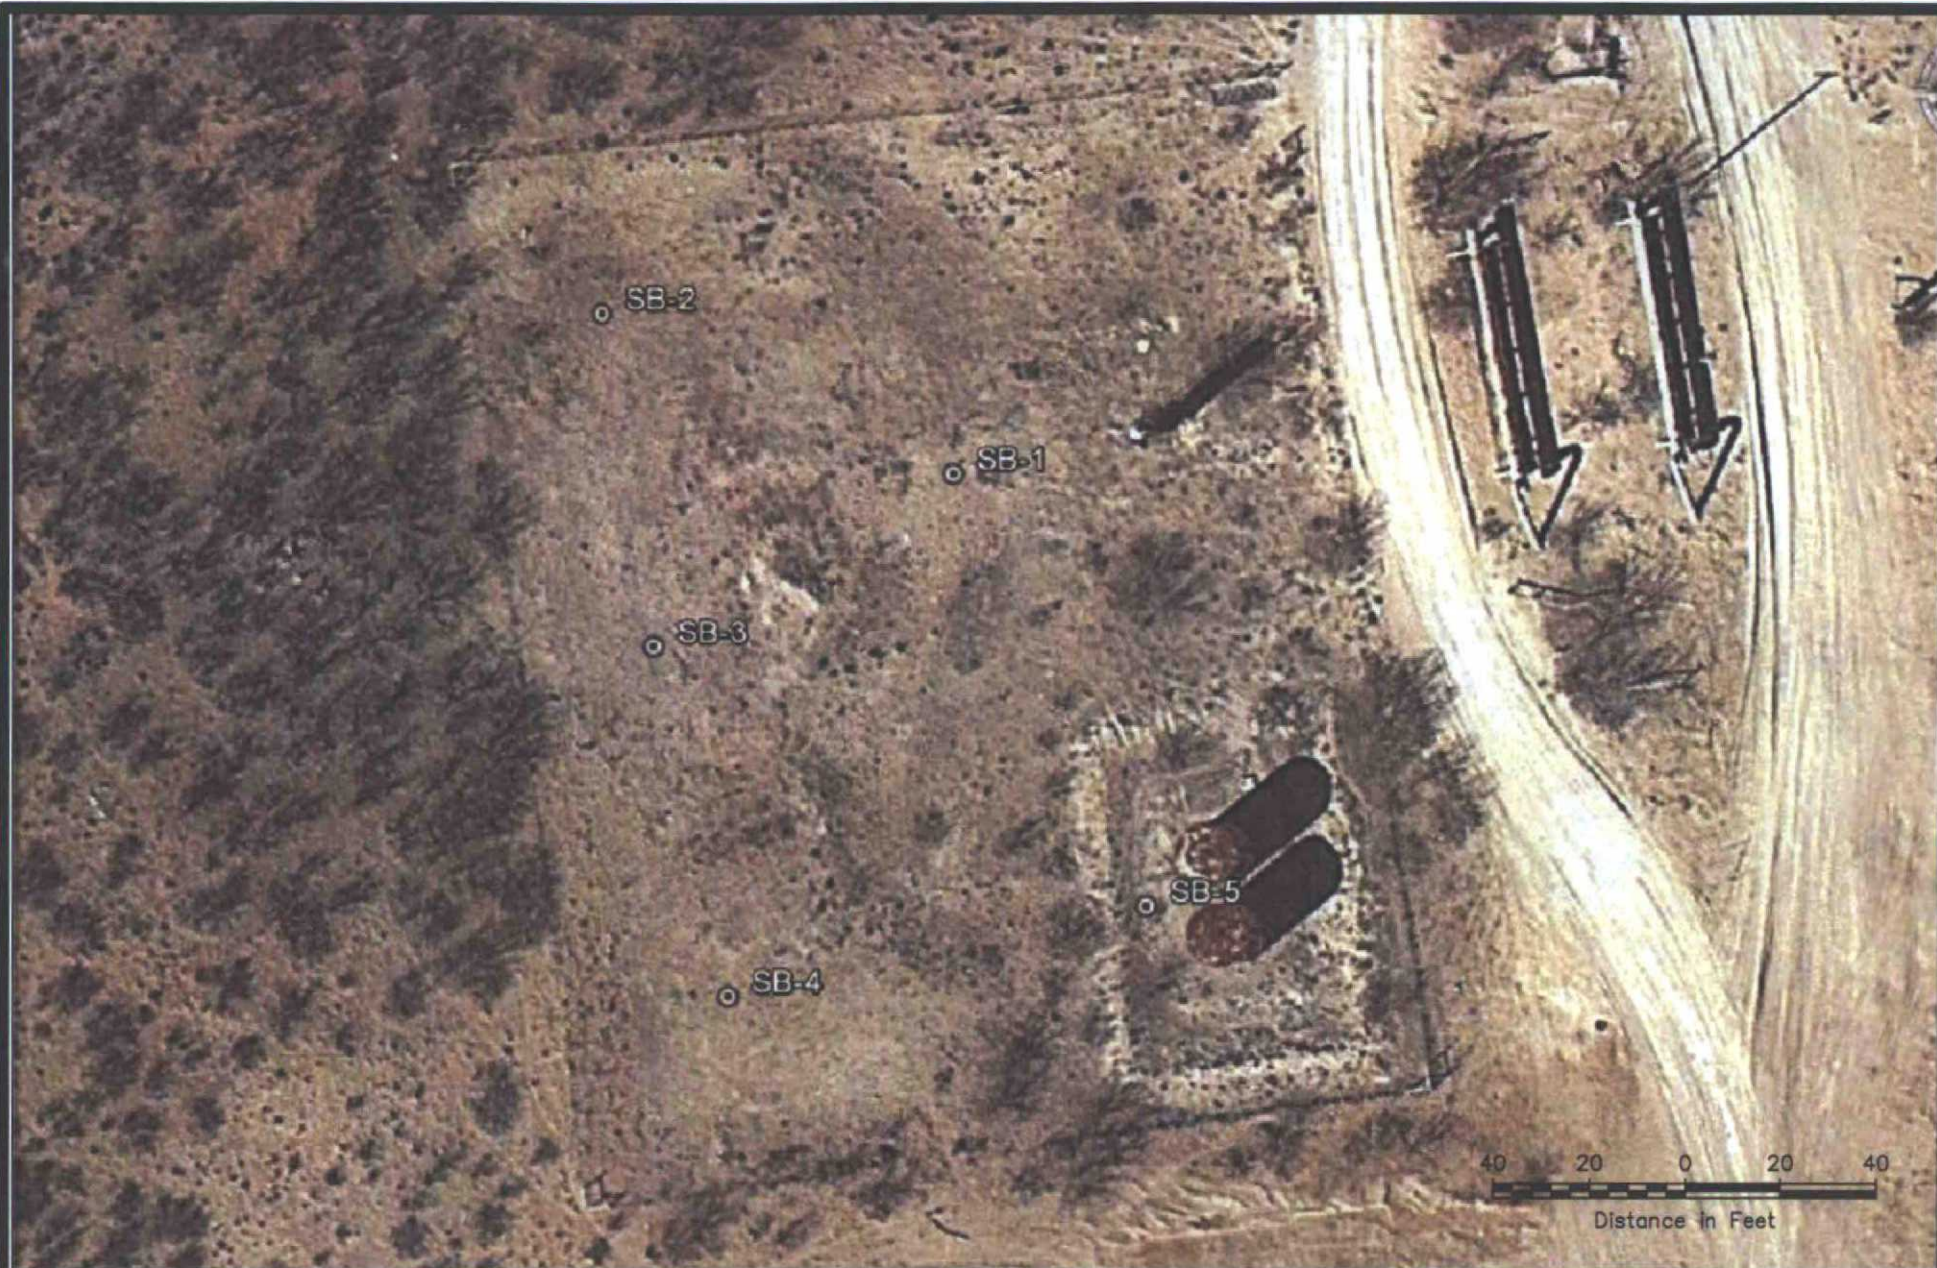
Figure 2
Proposed Soil Boring Location Map
Southern Union Gas Services
Drip Tank #61-62
NMOCD Ref RP-1818
Lea County, New Mexico

<u>~32.353394</u>	<u>N</u>	<u>~103.256439</u>	<u>W</u>
<u>~32.353493</u>	<u>N</u>	<u>~103.256689</u>	<u>W</u>
<u>~32.353291</u>	<u>N</u>	<u>~103.256654</u>	<u>W</u>
<u>~32.353079</u>	<u>N</u>	<u>~103.256602</u>	<u>W</u>
<u>~32.353132</u>	<u>N</u>	<u>~103.256303</u>	<u>W</u>

<u>SB-1 (Center of Former BGT location)</u>
<u>SB-2 (Northern margin of inferred Historical Pit)</u>
<u>SB-3 (Center of inferred Historical Pit)</u>
<u>SB-4 (Southern margin of inferred Historical Pit)</u>
<u>SB-5 (Adjacent to above ground tanks)</u>

Proposed Soil Boring/Monitor Well Locations:
