Release Notification and Corrective Action

NABI805844987

Name of Company Marathon Oil Permian LLC <i>372098</i>	Contact Callie Karrigan
Address 2423 Bonita St, Carlsbad NM 88220	Telephone No. 405-202-1028 (cell) 575-297-0956 (office)
Facility Name: Aid State 2	Facility Type Oil and gas production facilities

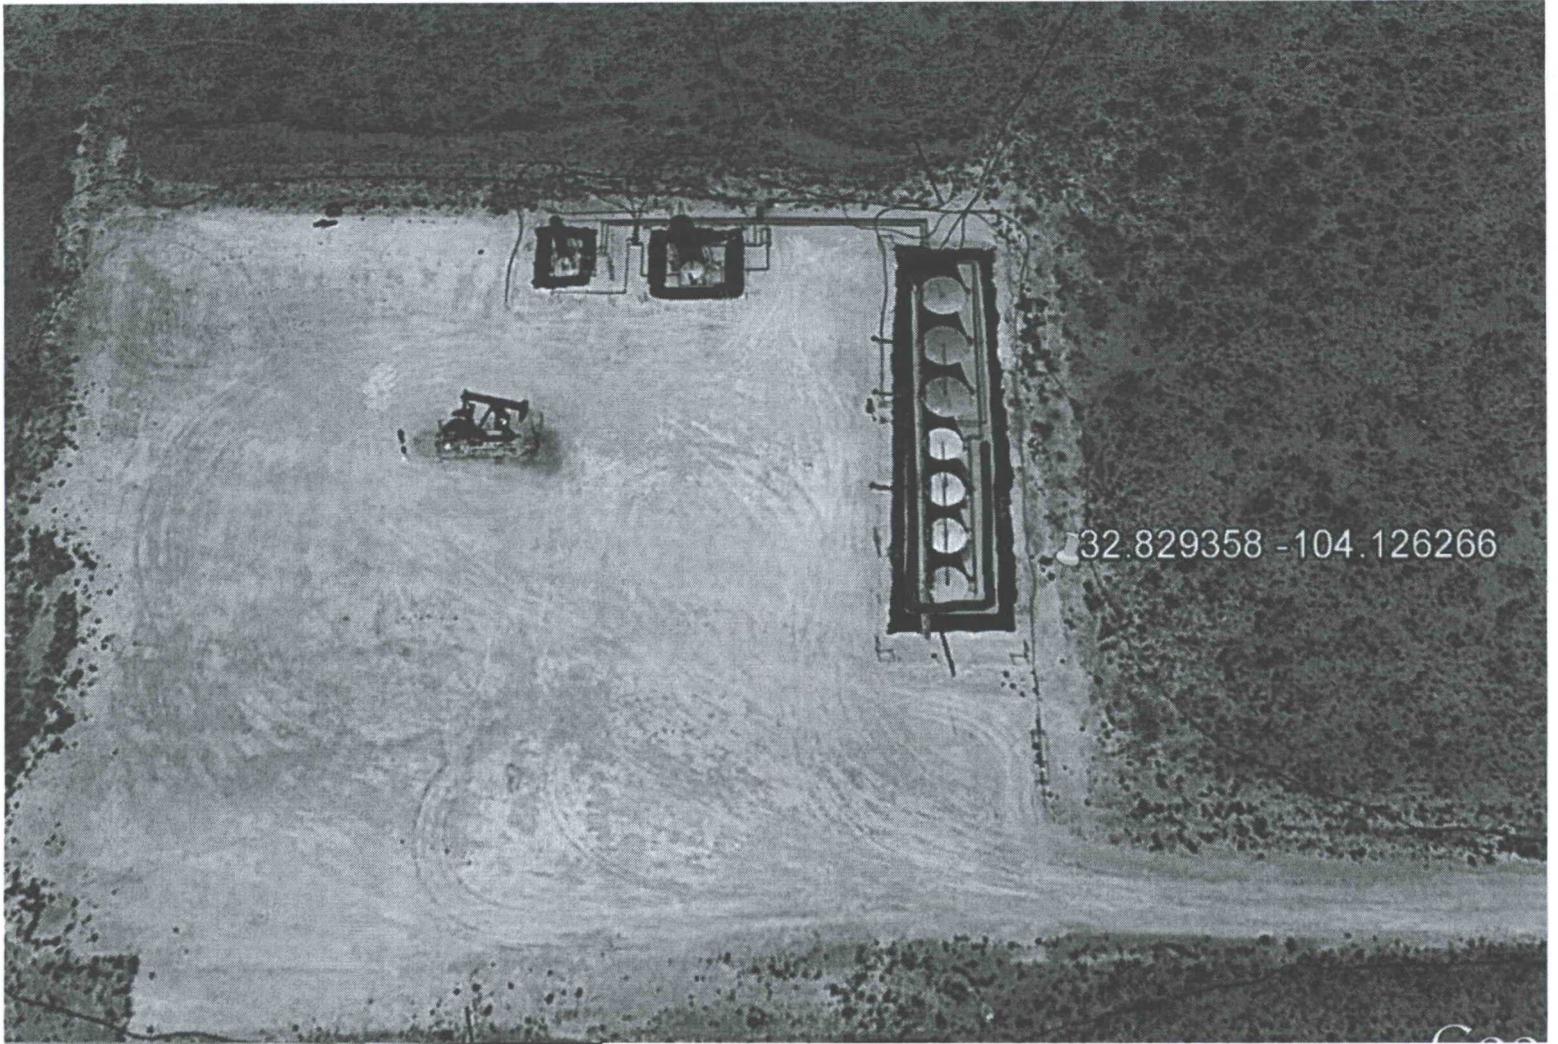
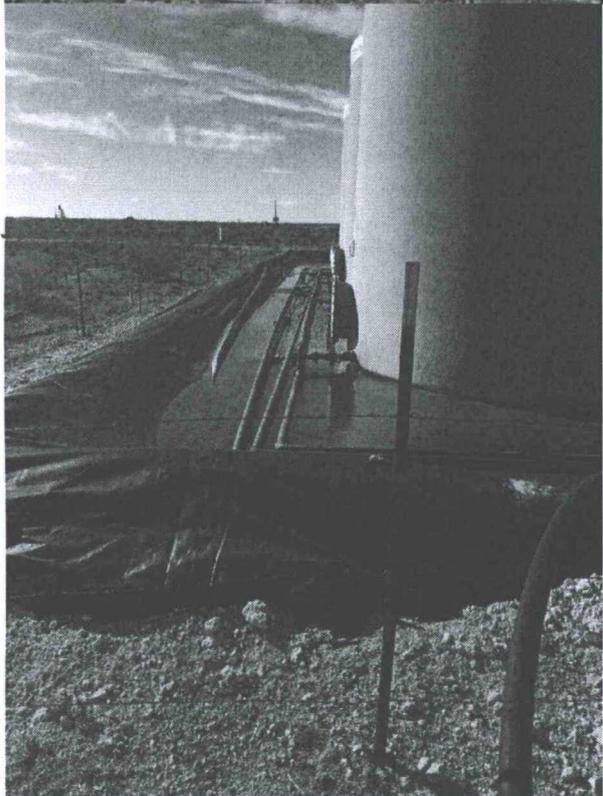
I wanted to let you know we had a release at the Aid State 2 reported by the operator at approximately 10:01 am. The Operator arrived onsite and observed standing fluids in tank containment due to a leak in the Victaulic coupling on the transfer pump. Approximately 15 bbls produced water was released into lined tank containment. A vac truck was dispatched immediately to recover standing fluids. The well is shut-in pending repairs scheduled for tomorrow morning.
