Pit, Below-Grade Tank, or  
Proposed Alternative Method Permit or Closure Plan Application

BELOW-GRADE TANK CLOSURE PLAN

**PUMP CANYON WATER<sup>+</sup>**

**API No. PLA02123109**

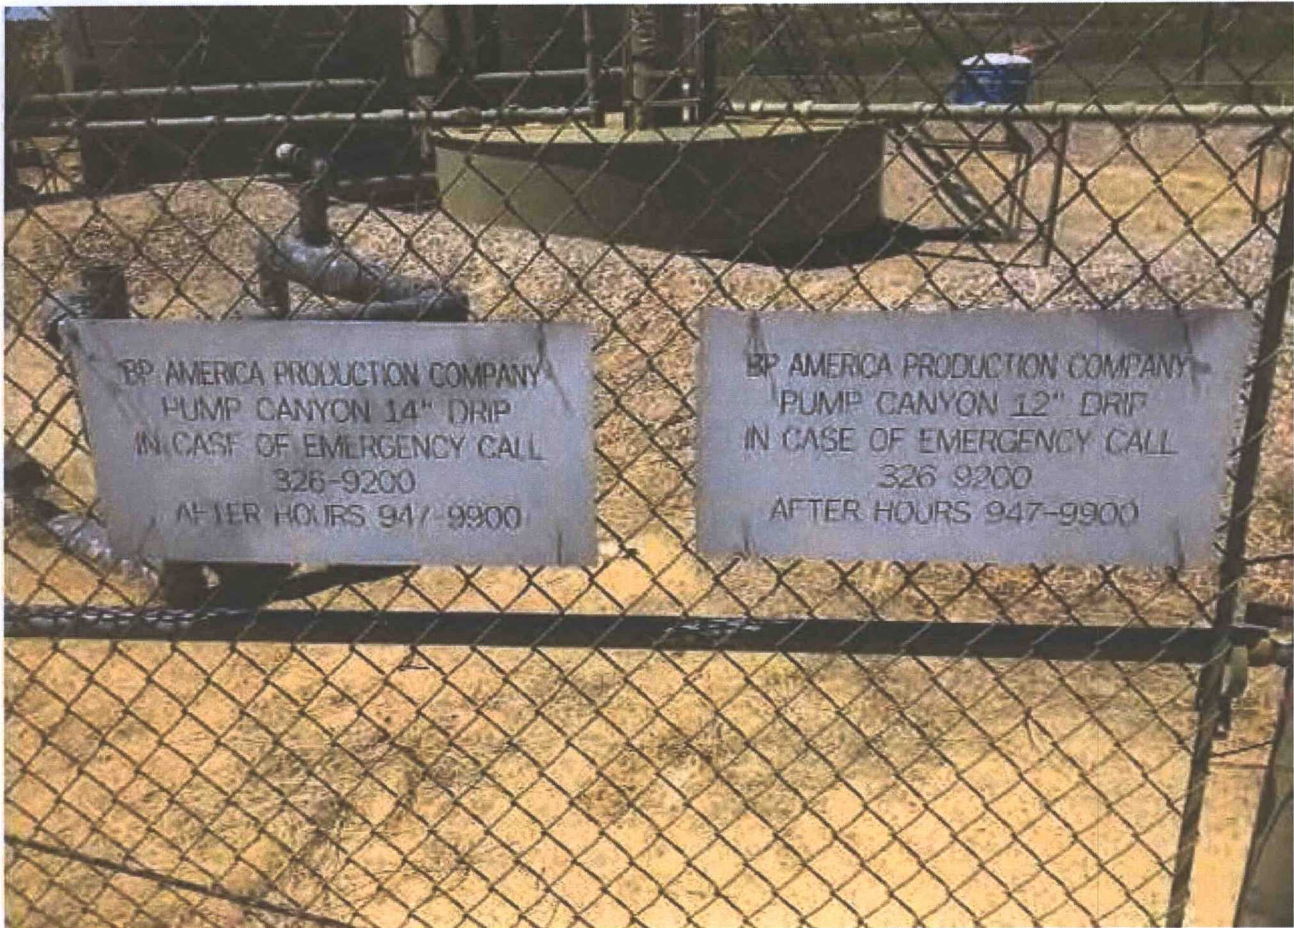
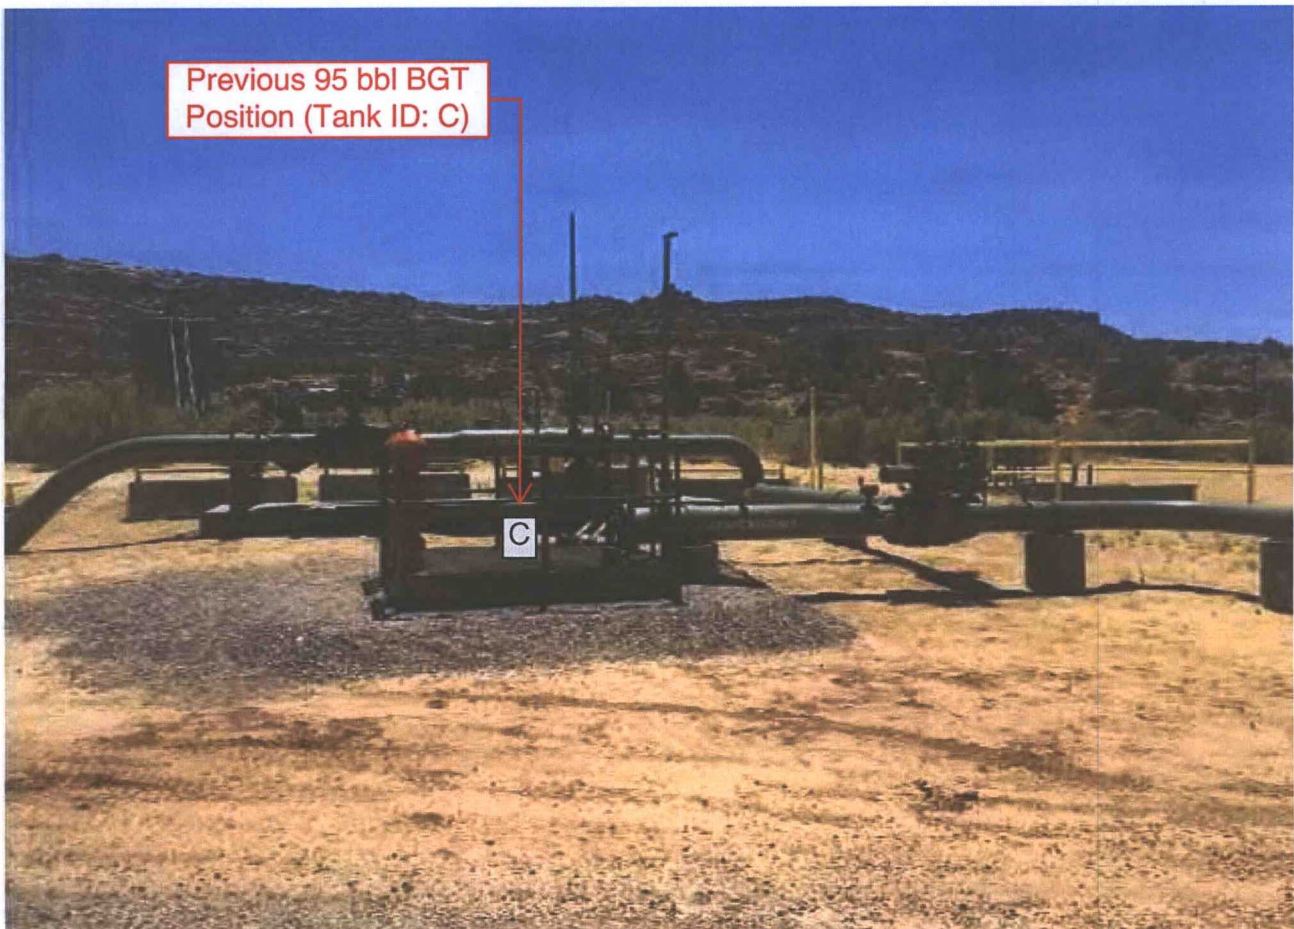
Previous 95 bbl BGT  
Position (Tank ID: C)

**The area has been backfilled and a shallow low profile above-grade tank set atop BGT location. The location will be reclaimed once the well is plugged and abandoned.**
