**Release Notification and Corrective Action**

Name of Company	Rice Operating	Contact	Tony Grieco
Address	122 W. Taylor St.	Telephone No.	(505) 393-9174
Facility Name	Justis Teague #2 EOL	Facility Type	Salt Water Gathering System

RP# 1562

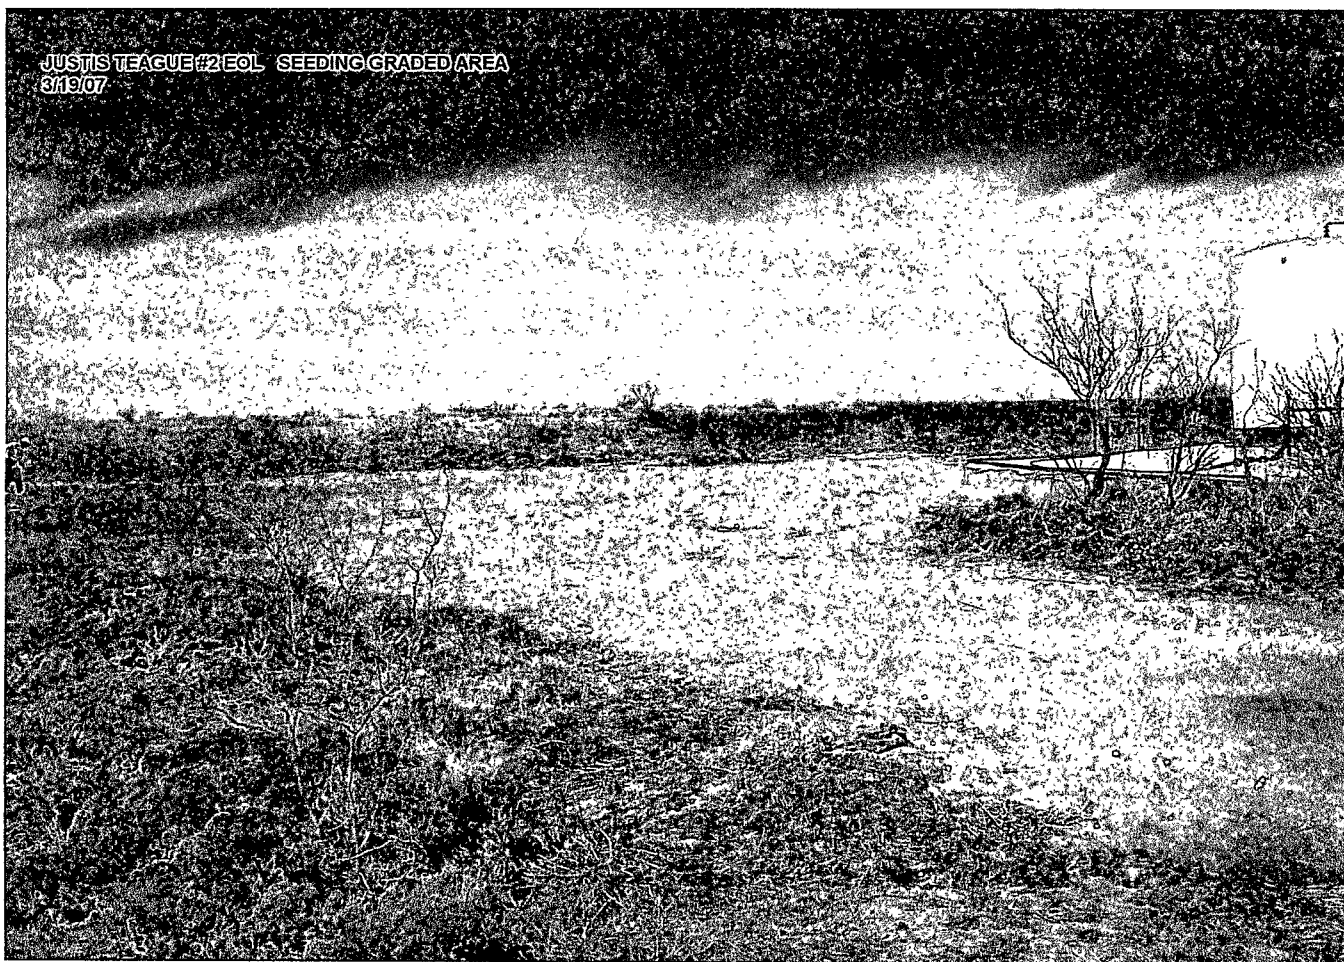
JUSTIS TEAGUE #2 EOL SEEDING GRADED AREA  
3/19/07

Area consists of pasture and pipeline right of way. A water truck was called to the location and removed approximately 5 BBLS of standing water. Groundwater is approximately 88 ft. The affected area was initially scraped to a depth of 4 inches (144 yds of material were removed and disposed), and assessment samples taken on the surface, with a hand auger and backhoe. The impacted area was later excavated to 2-3 ft bgs ( an additional 180 yds removed), and the impacted soil was hauled to the Sundance disposal facility. Clean soil (336 yds) was imported to replace the excavated material, and the site was seeded with a blend of native vegetation.

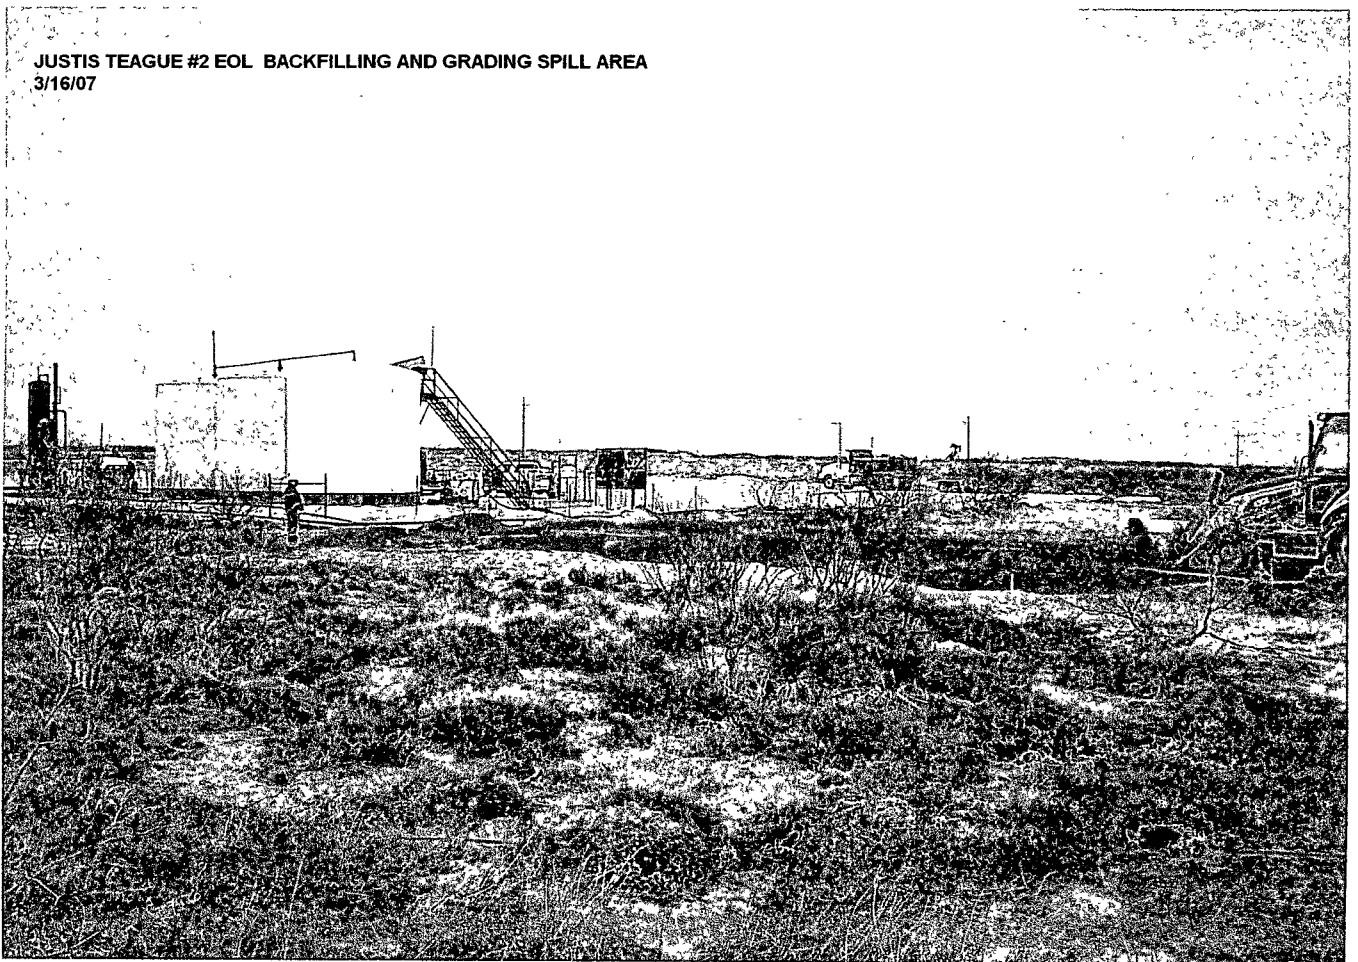
# Justis Teague #2 EOL Leak

UL D Sec 2 T 24 S R 37 E GW 88ft

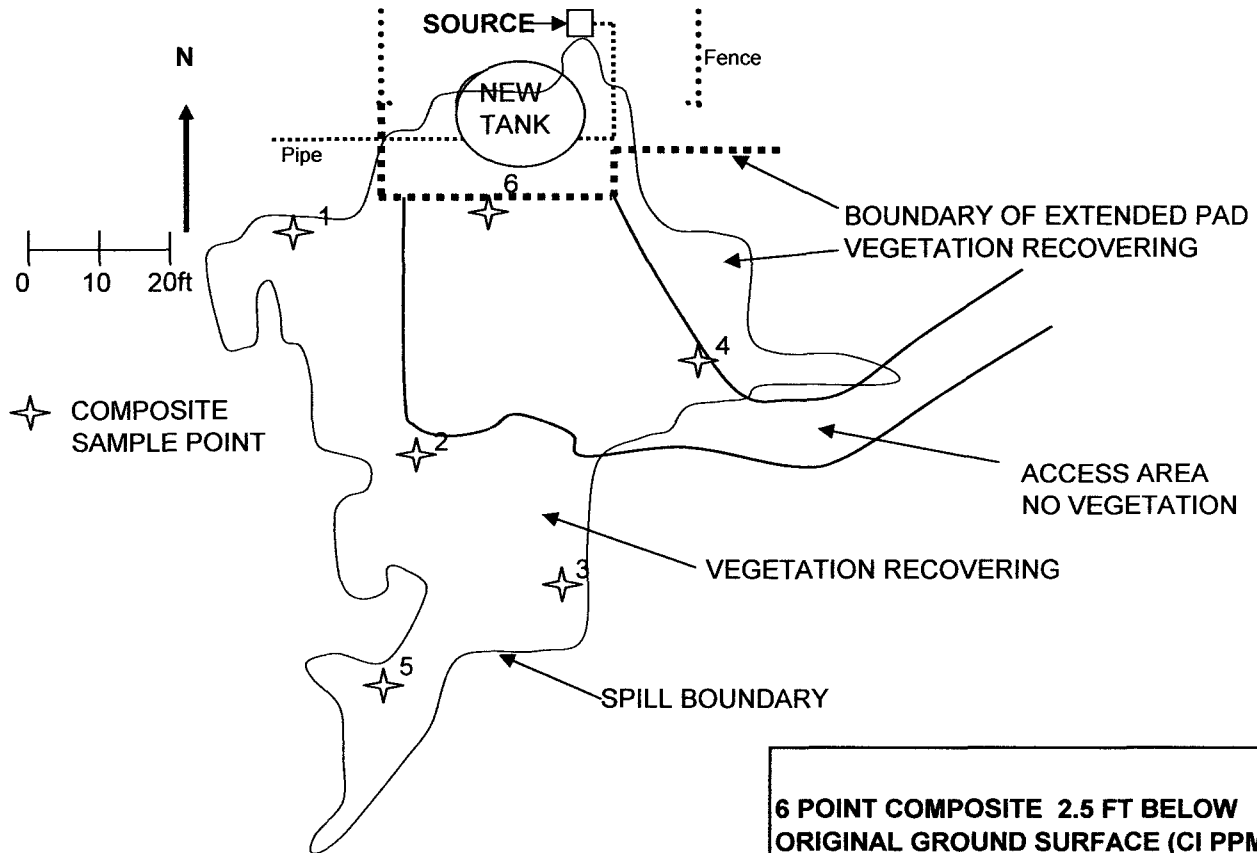
BACKGROUND 200ft SOUTH OF SOURCE @ 6 IN 117 PPM
