Release Notification and Corrective Action

Name of Company: Targa Midstream Services L P	Contact: James Lingnau 505.394.2534, Chuck Tolsma 505.631.6026
Address: PO Box 1909 Eunice, NM 88231	Telephone No. (505) 394-2534
Facility Name: Eunice Gathering System	Facility Type

Type of Release: Gas and Produced Liquids	Volume of Release: Unknown	Volume Recovered: None
Source of Release: 6" Pipeline Failure	Date and Hour of Occurrence: Unknown	Date and Hour of Discovery Unknown
Was Immediate Notice Given? <input type="checkbox"/> Yes <input checked="" type="checkbox"/> No <input type="checkbox"/> Not Required	If YES, To Whom?	
By Whom?	Date and Hour	
Was a Watercourse Reached? <input type="checkbox"/> Yes <input checked="" type="checkbox"/> No	If YES, Volume Impacting the Watercourse

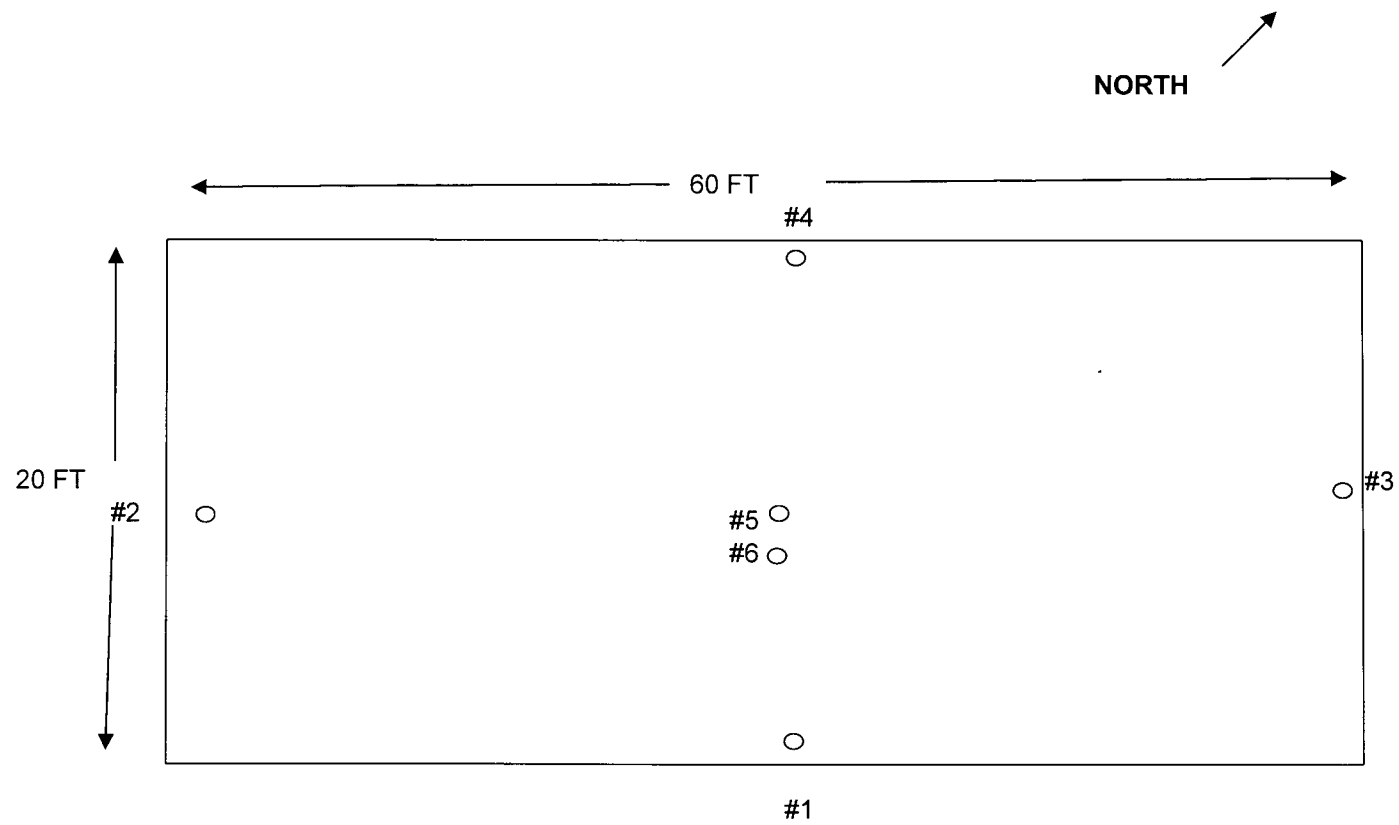
DECK ESTATE BOWLES

SAMPLE DATE	SAMPLE I.D.	SOIL STATUS	TPH GRO	TPH DRO	CHLORIDE
11/18/2008	#1 South Wall	In Situ	<10	<10	<16
11/18/2008	#2 West Wall	In Situ	<10	<10	16
11/18/2008	#3 East Wall	In Situ	<10	<10	<16
11/18/2008	#4 North Wall	In Situ	<10	<10	48
11/18/2008	#5 Bottom	Excavated	19.5	163	<16
12/15/2008	#6 Bottom	In Situ	<10	<10	64

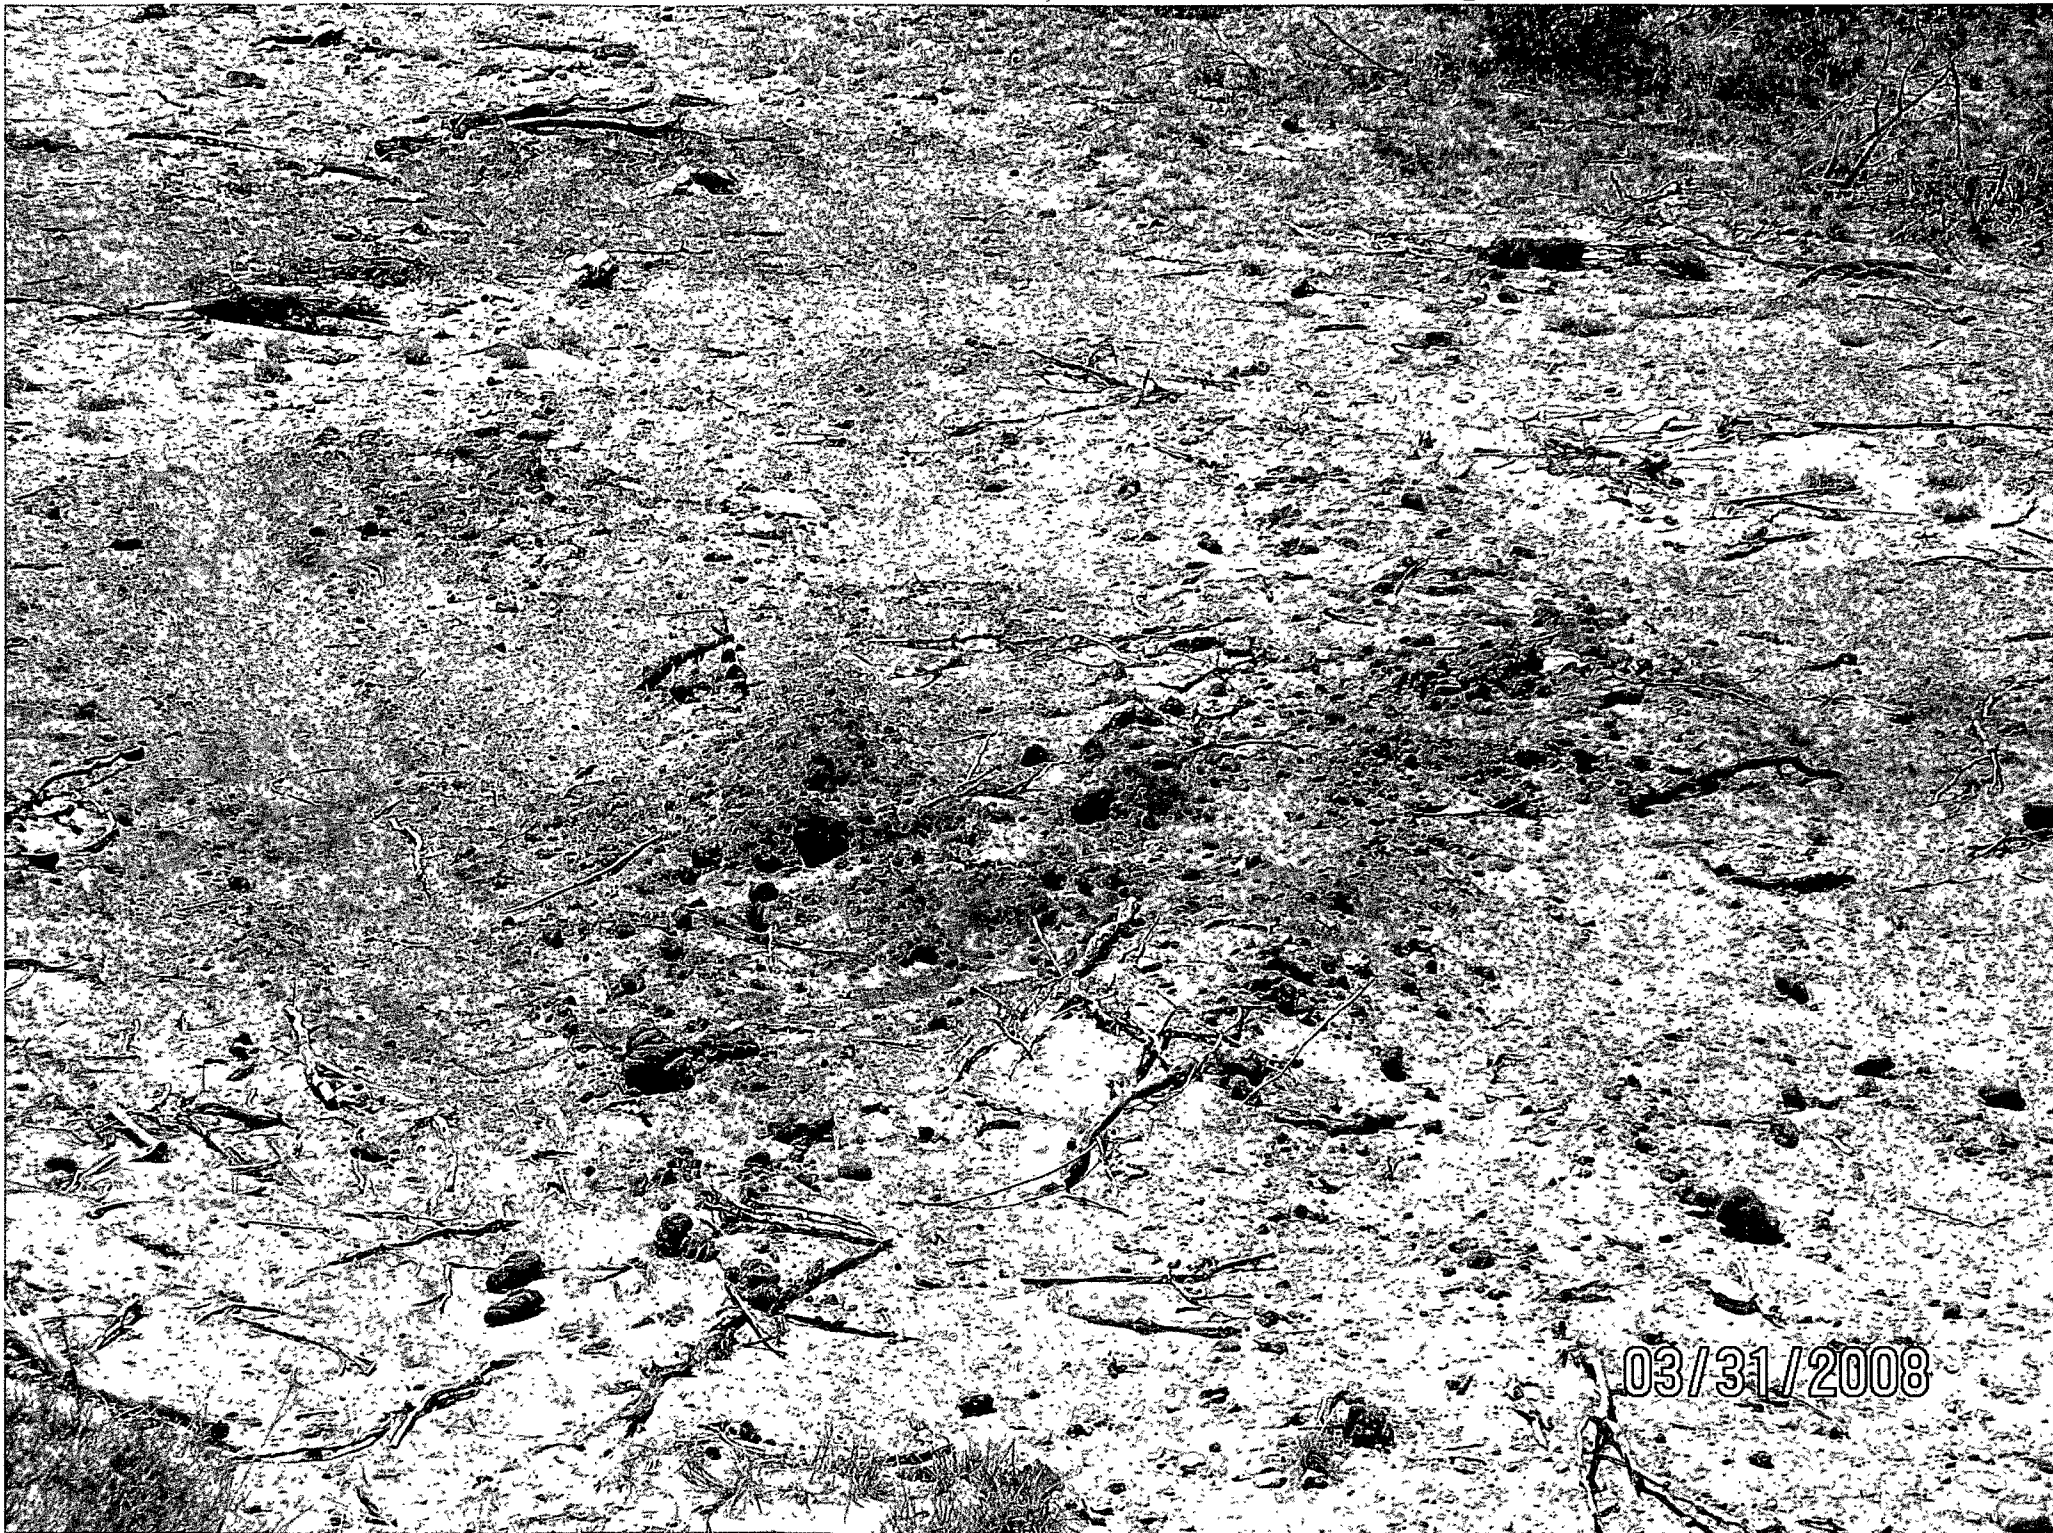
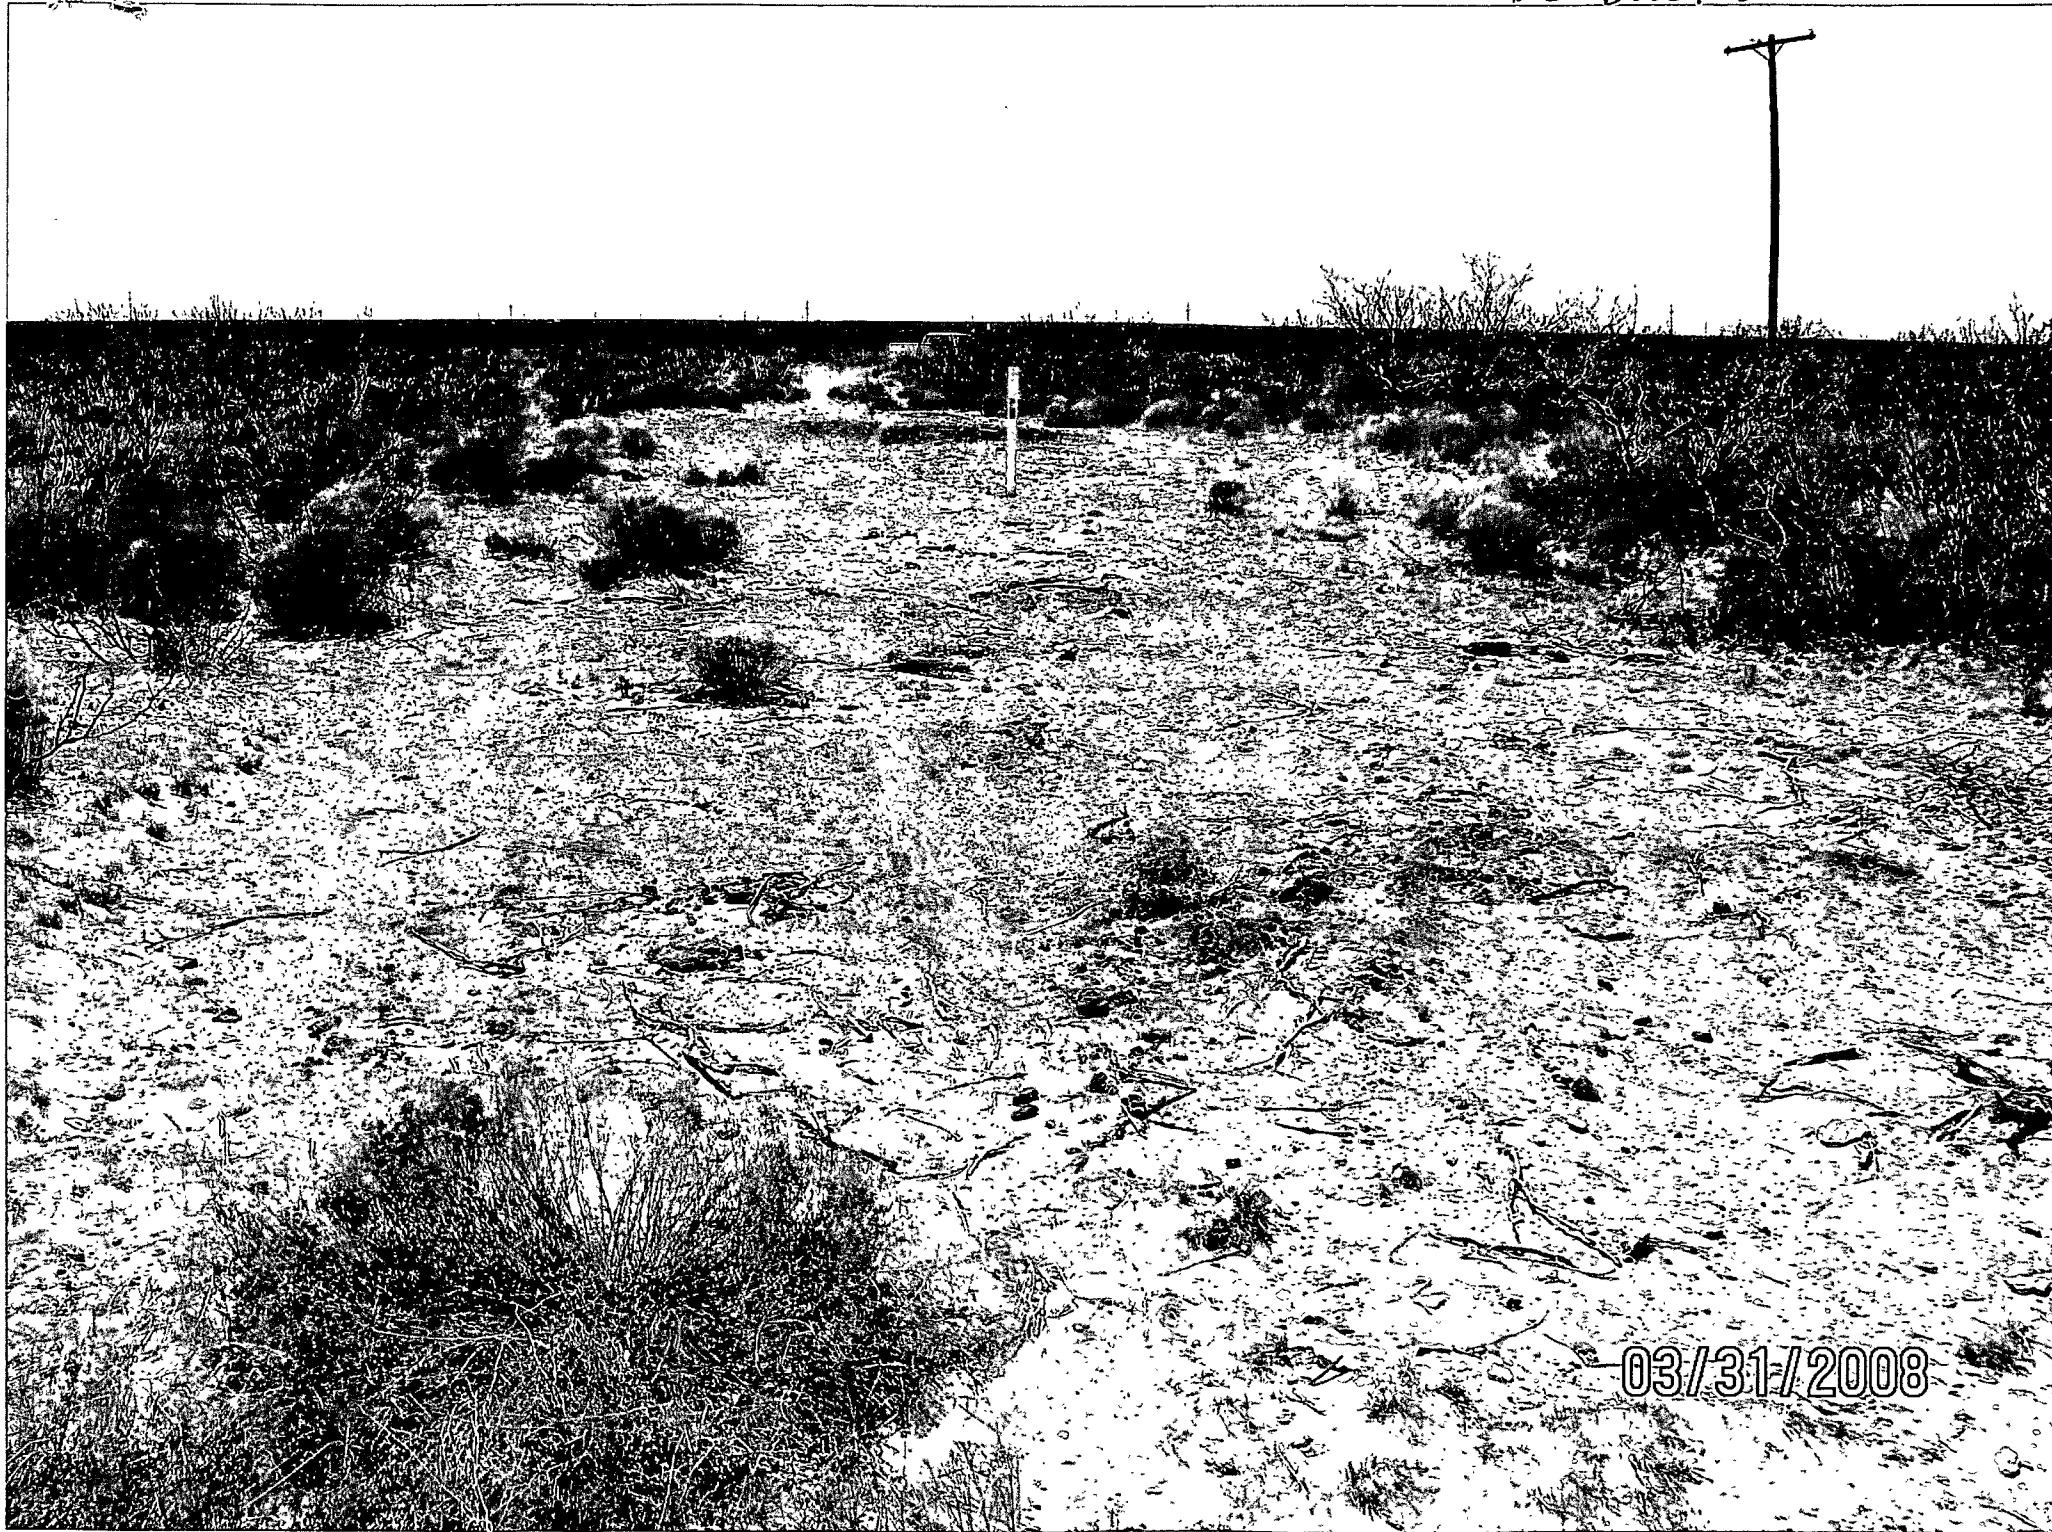
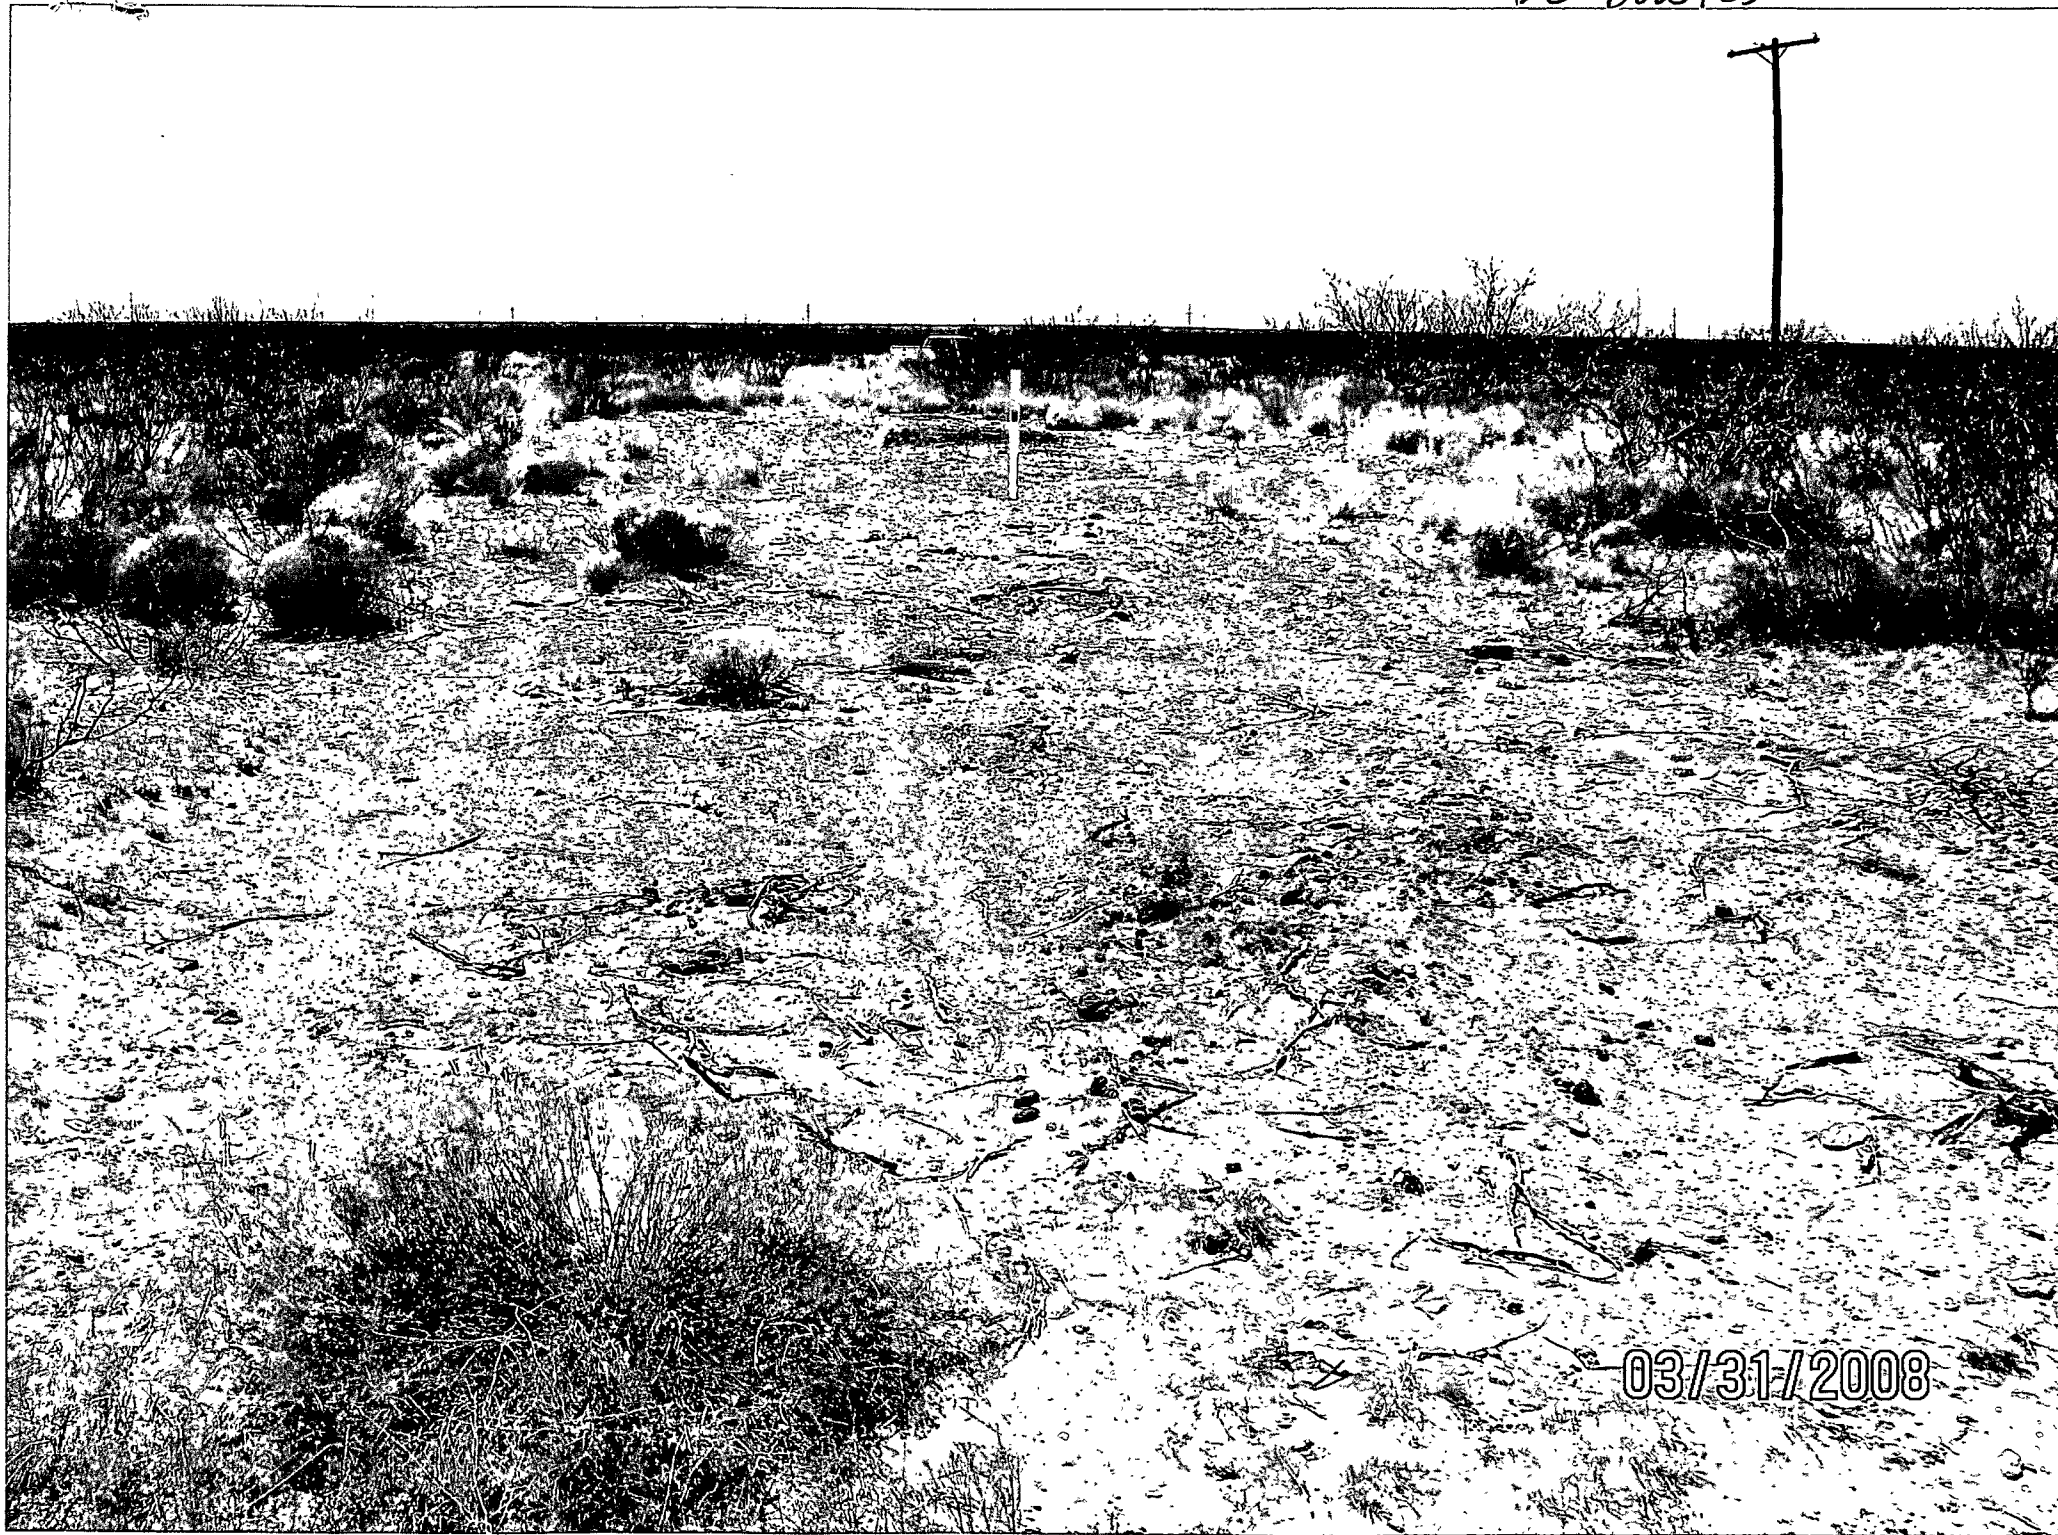
DE Bowles

A Six inch gathering line had a leak and released gas and any produced liquids that were lying in the line. Line was repaired and possibly contaminated soil used for backfill. The line has since been taken out of service.

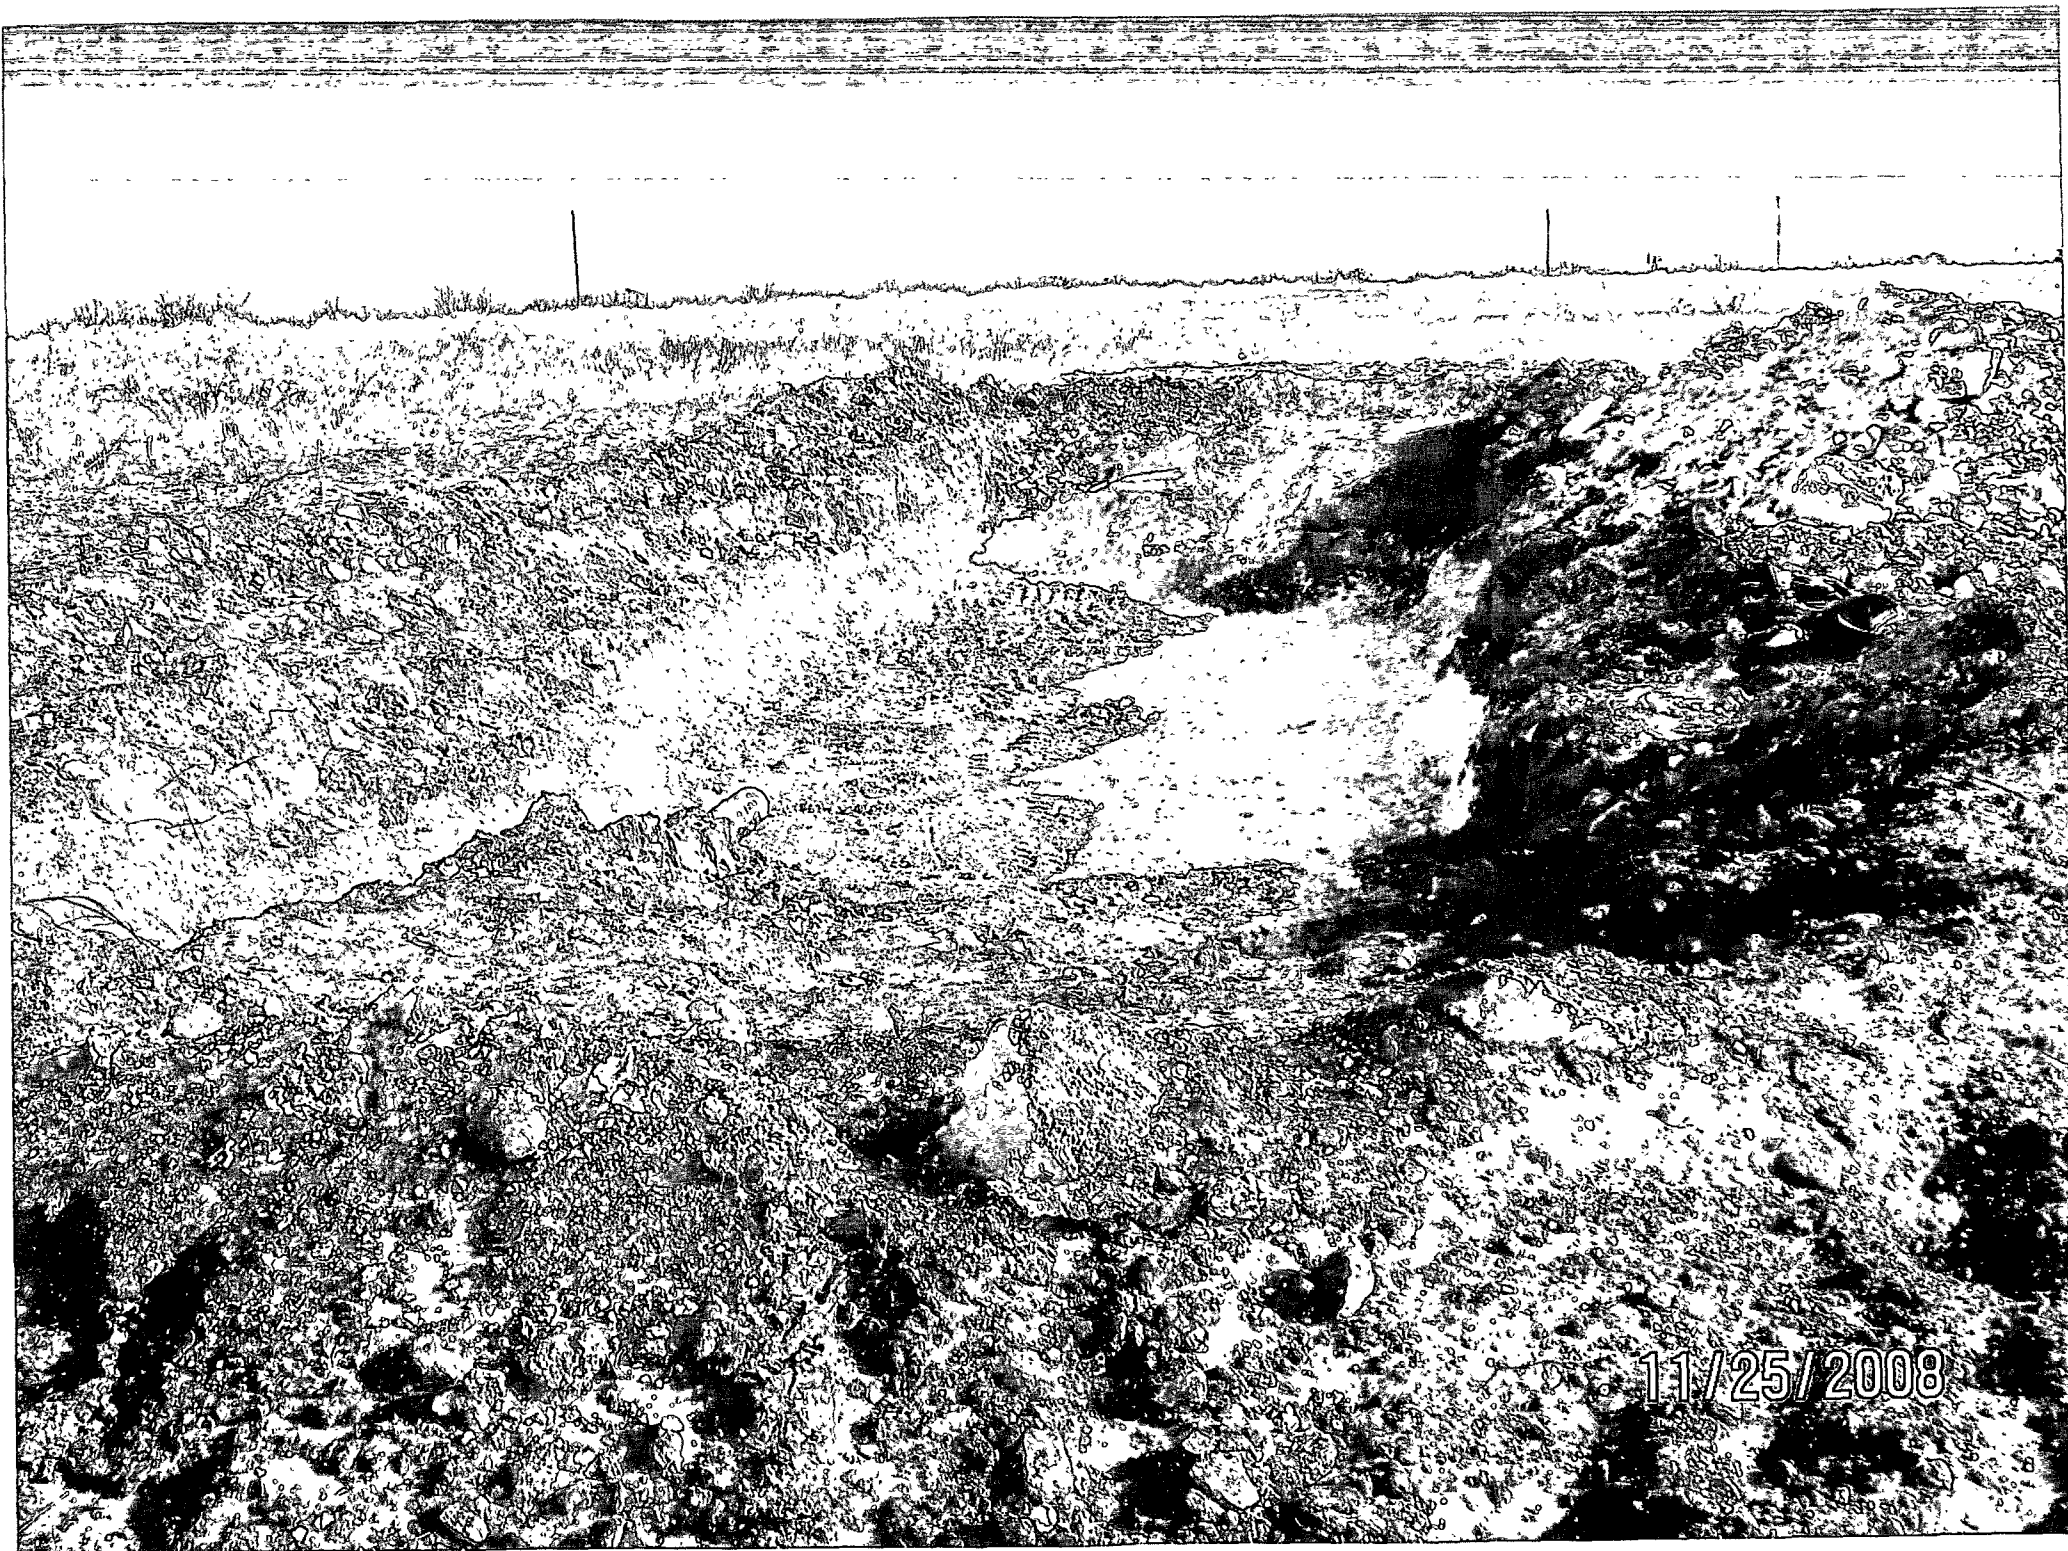
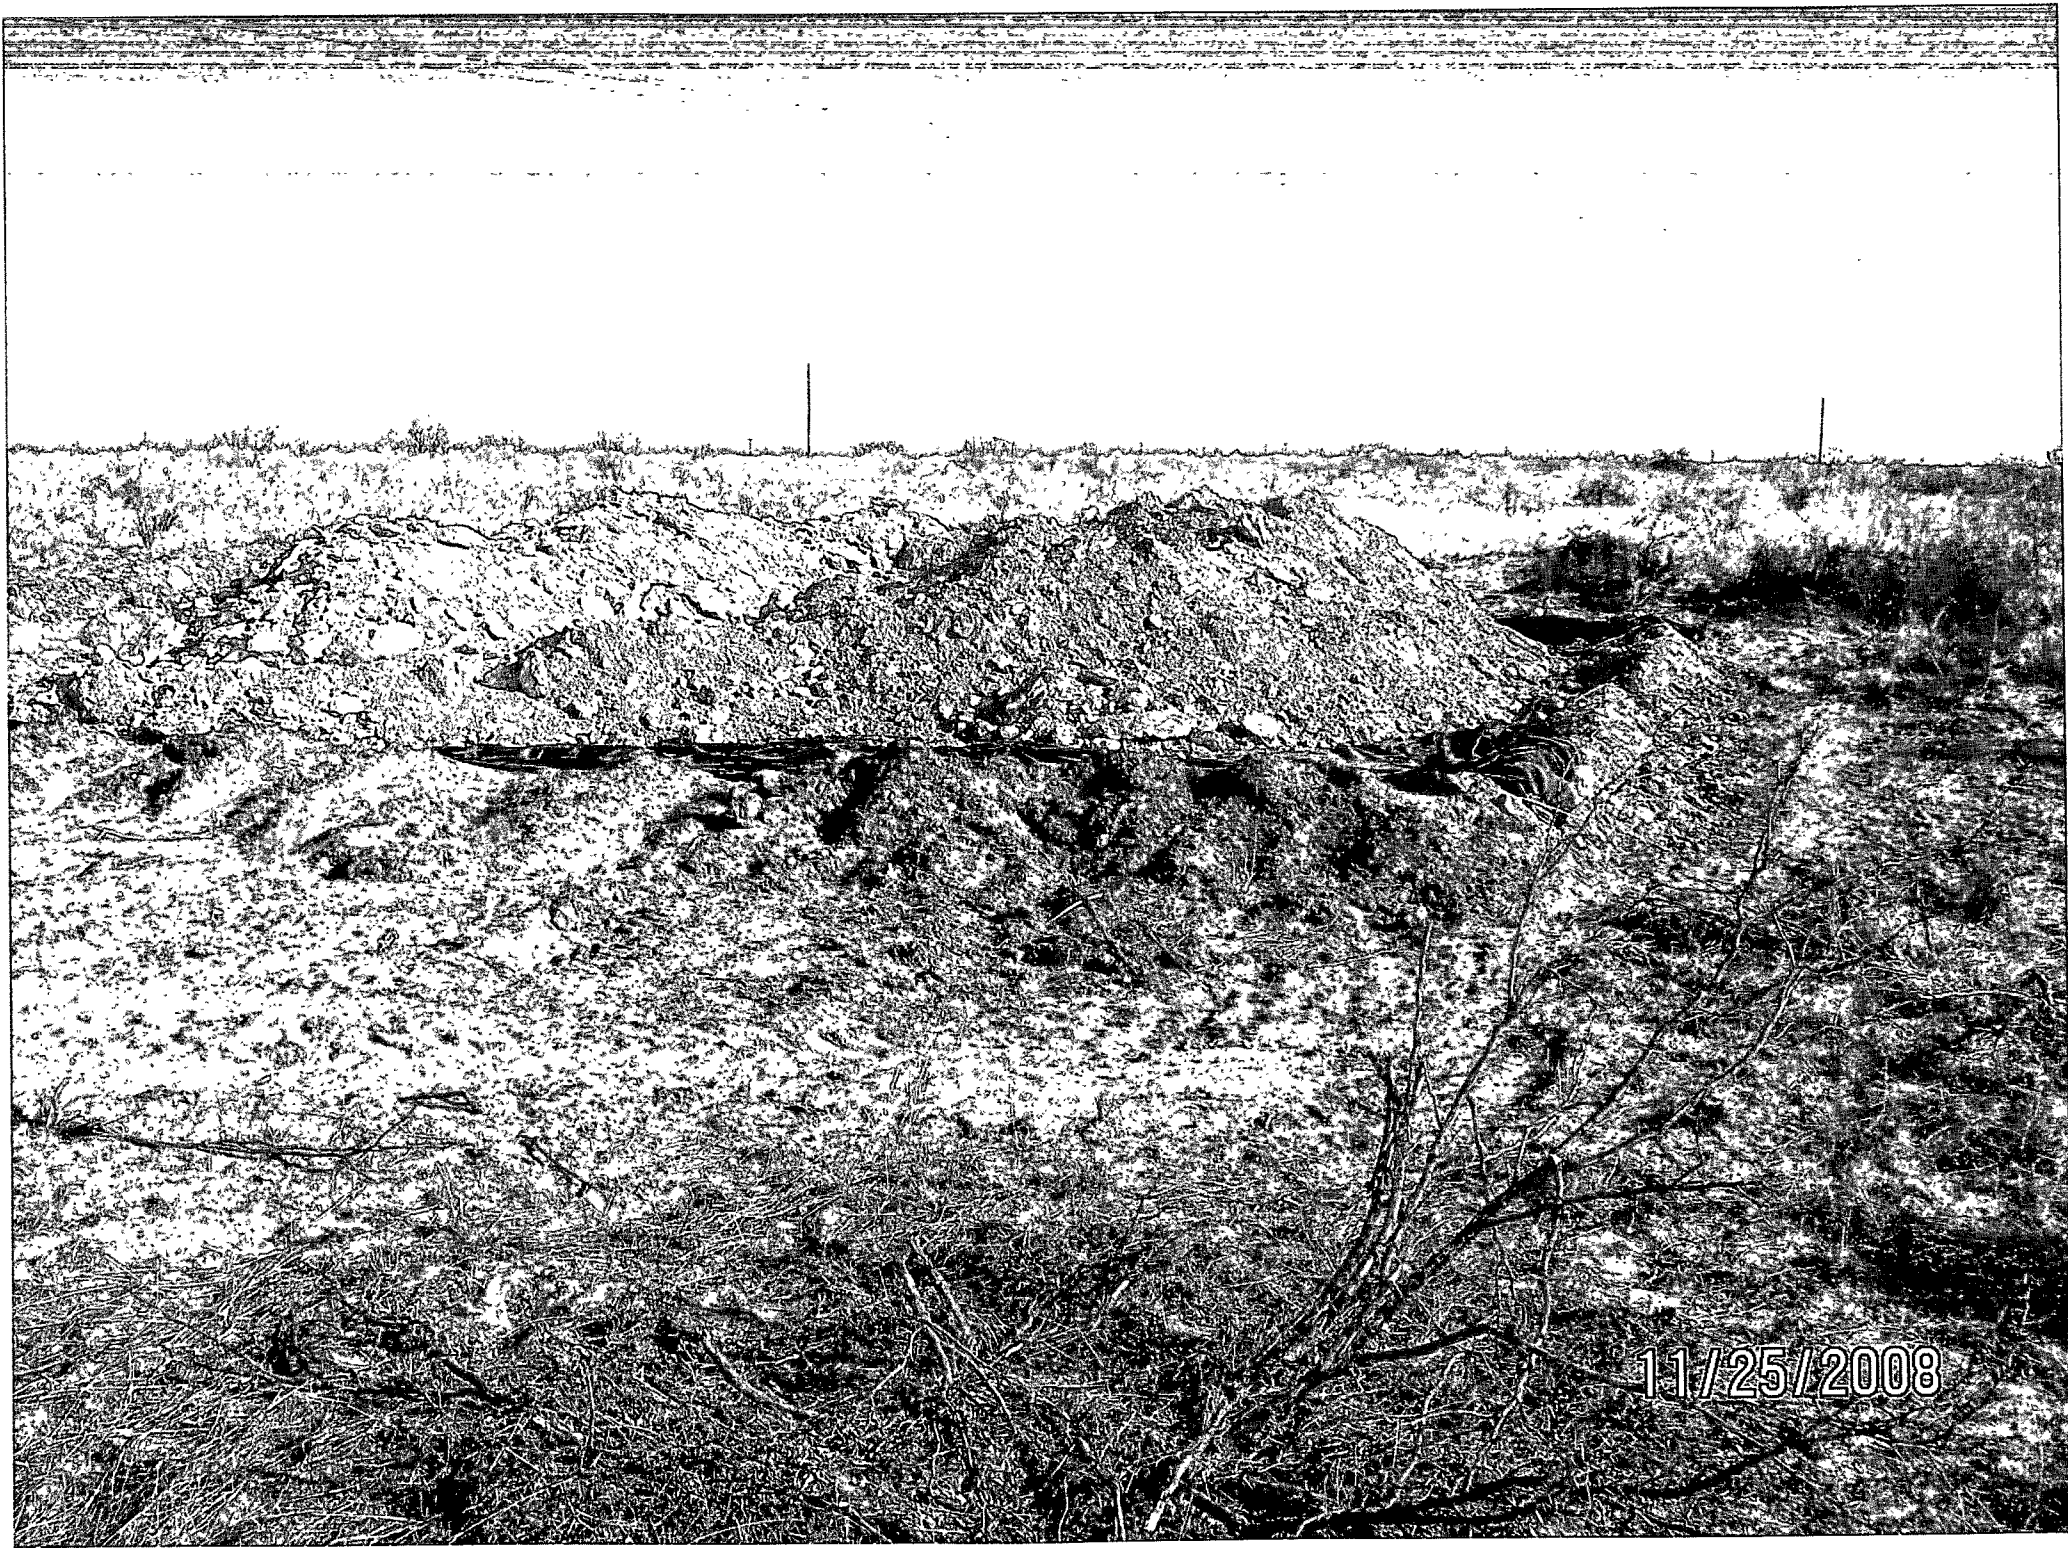
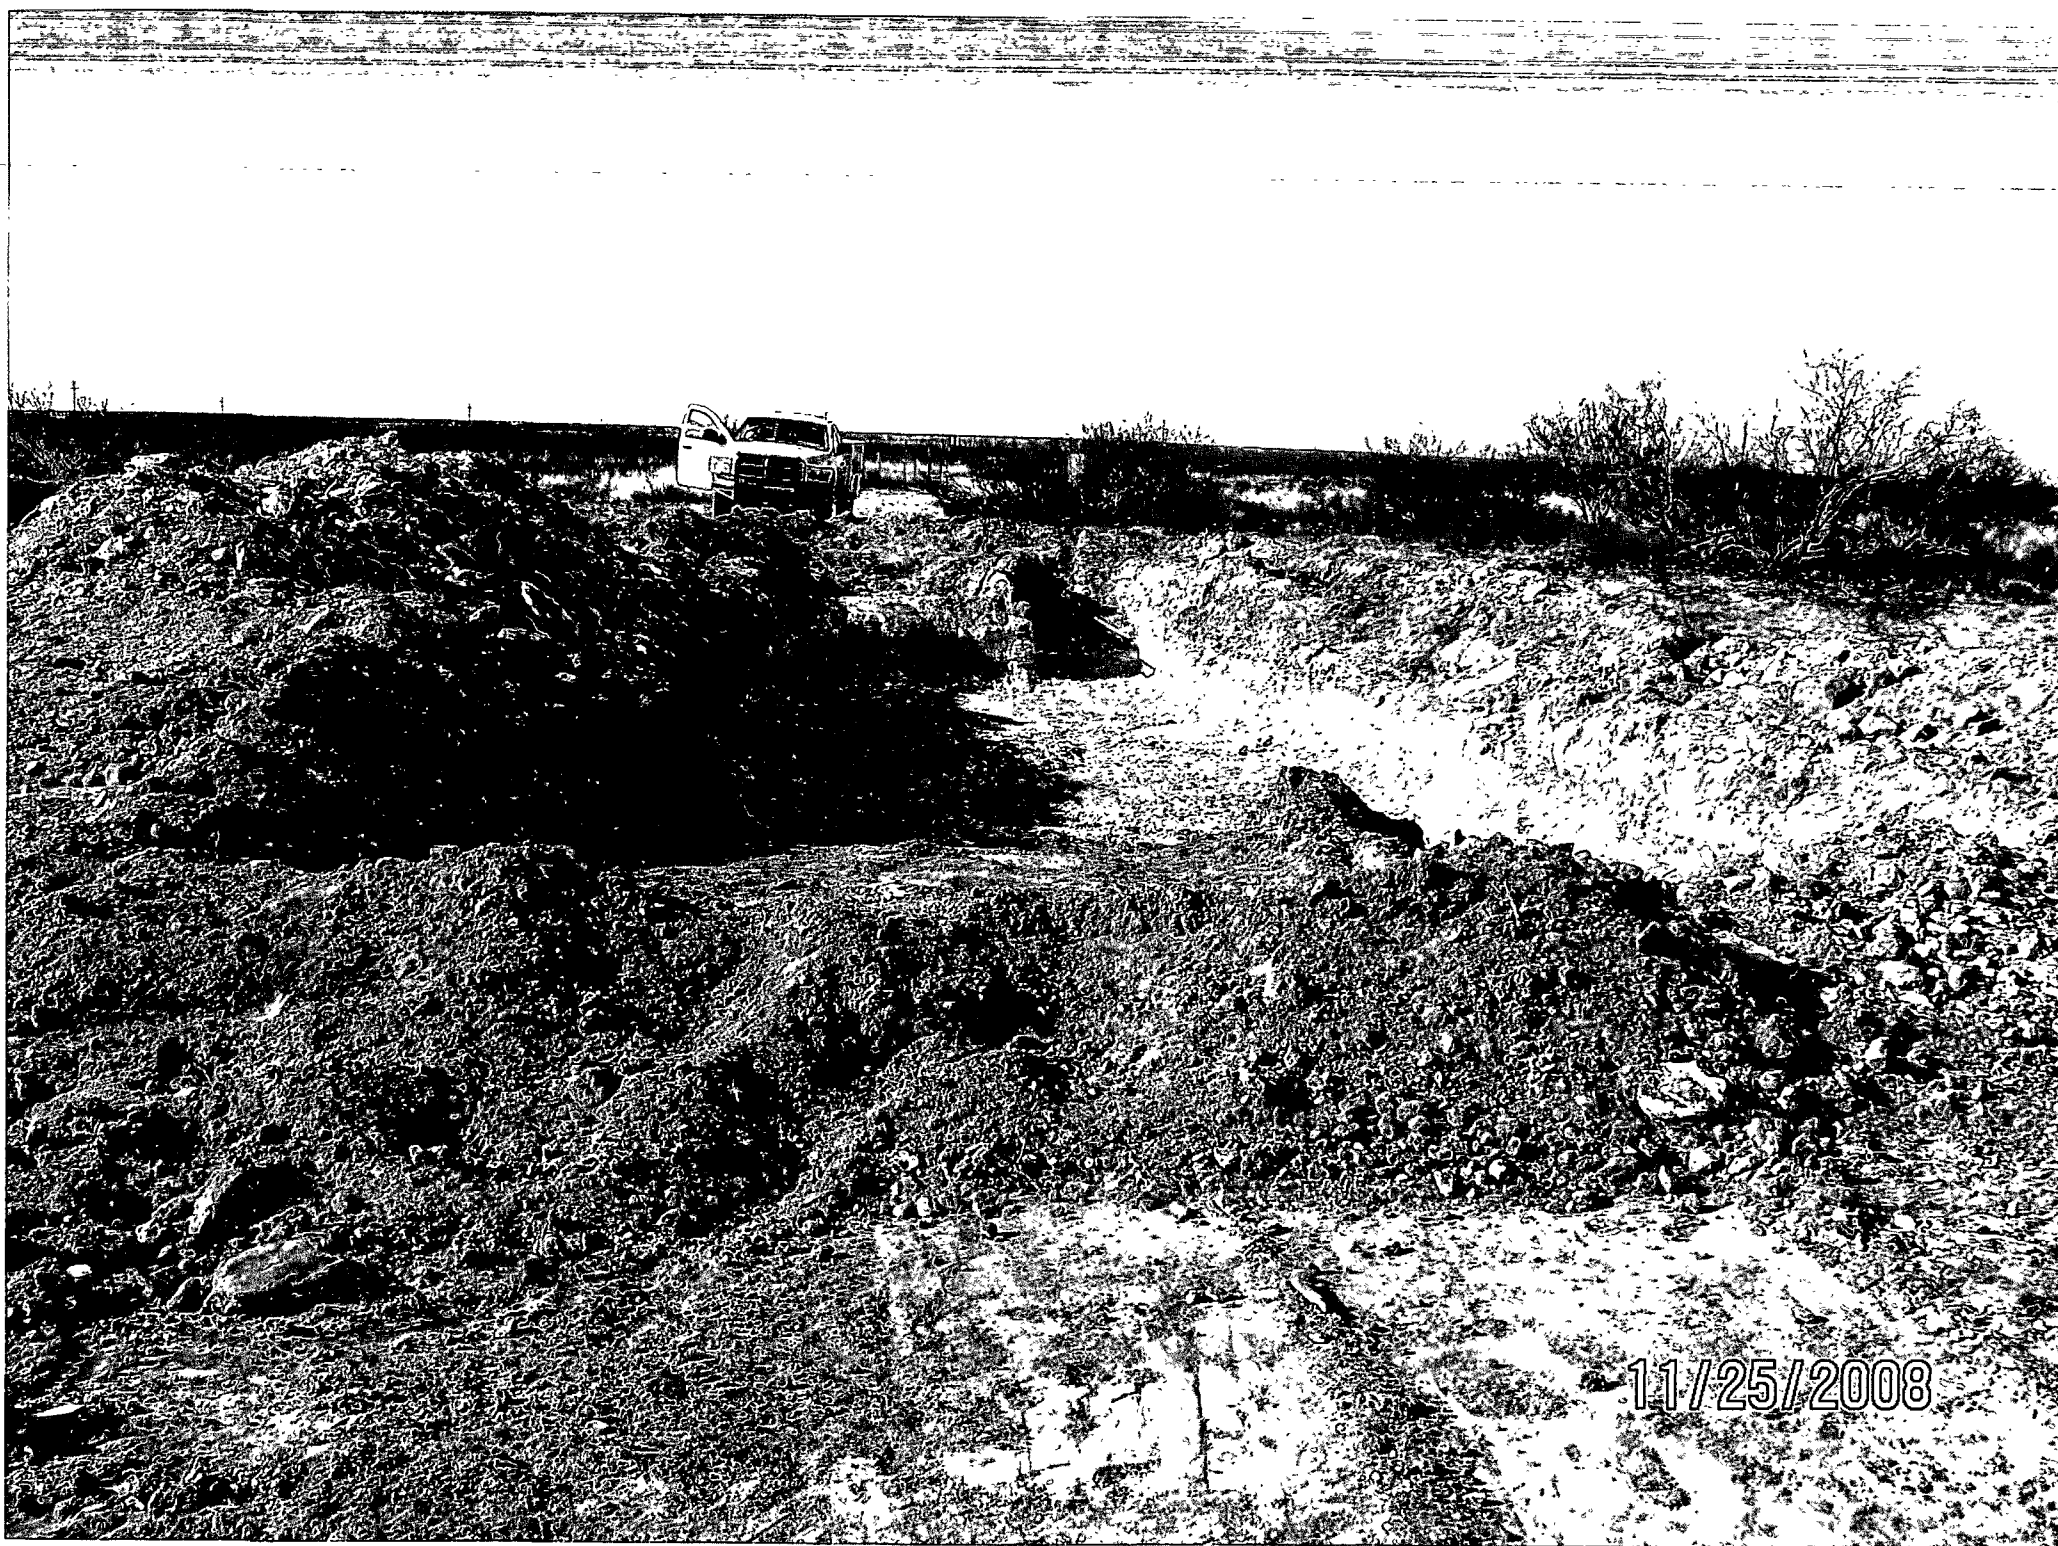
11/25/2008

The old pipe in the contaminated area has been removed and capped. 60 yards of contaminated soil was excavated and hauled to an approved OCD landfill. New soil was purchased from landowner to backfill. The area has been cleaned and tested per OCD Guidelines.
