CLOSURE

RICE OPERATING COMPANY
JUNCTION BOX FINAL REPORT

Vacuum Jct. C-6

Unit C, Section 6, T18S, R35E

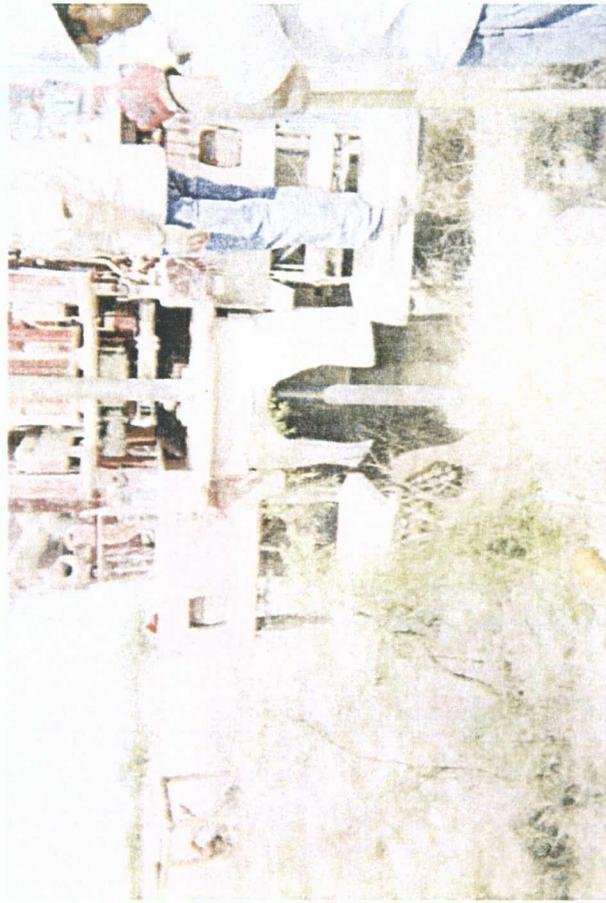
6/18/2009

drilling SB #1 at the former junction box site

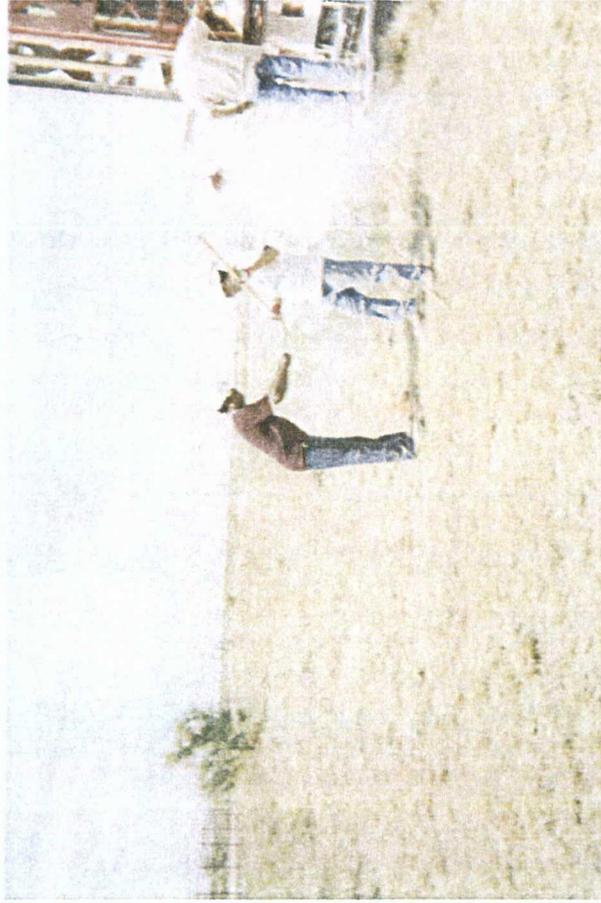
6/18/2009

collecting a soil sample

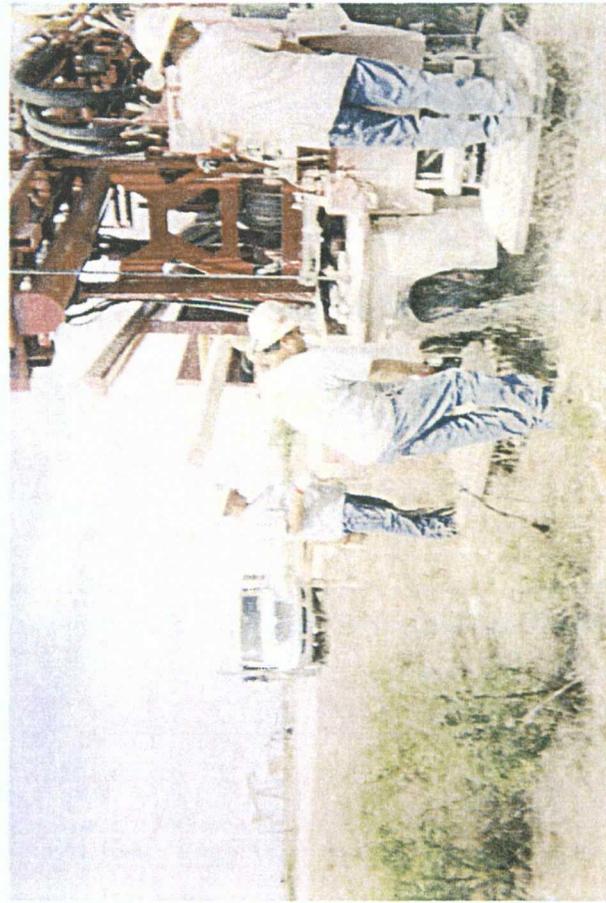
6/18/2009

plugged SB #1 with bentonite
