#### Vacuum N-28 Vent 2009

APD - 6 2010 Environmental Bureau Oil Conservation Division RICE OPERATING COMPANY JUNCTION BOX DISCLOSURE\* REPORT BOX LOCATION SWD SYSTEM JUNCTION UNIT SECTION TOWNSHIP RANGE COUNTY BOX DIMENSIONS - FEET Lenath Width Depth 35E N-28 vent Ν 28 17S Lea Vacuum eliminated LAND TYPE: BLM STATE X FEE LANDOWNER \_\_\_\_\_OTHER \_\_\_\_\_OTHER \_\_\_\_\_ Depth to Groundwater 65 feet NMOCD SITE ASSESSMENT RANKING SCORE: 10 Date Started 6/18/2009 Date Completed 6/18/2009 OCD Witness no Soil Excavated n/a cubic yards Excavation Length n/a Width n/a Depth n/a feet Soil Disposed \_\_\_\_\_0 \_\_\_\_ cubic yards Offsite Facility \_\_\_\_\_\_n/a \_\_\_\_\_ Location \_\_\_\_\_n/a FINAL ANALYTICAL RESULTS: Sample Date 6/18/2009 Sample Depth 12 ft TPH and Chloride laboratory test results completed by using an approved lab and CHLORIDE FIELD TESTS testing procedures pursuant to NMOCD guidelines. Sample PID (field) GRO DRO Chloride LOCATION DEPTH mg/kg Location ppm mg/kg mg/kg mg/kg SB #1 12' GRAB 6" 15.0 <10.0 80.3 2.560 background 149 3' 856 General Description of Remedial Action: This junction was addressed during the 4' 1.294 5' Vacuum SWD System abandonment. Clean, im

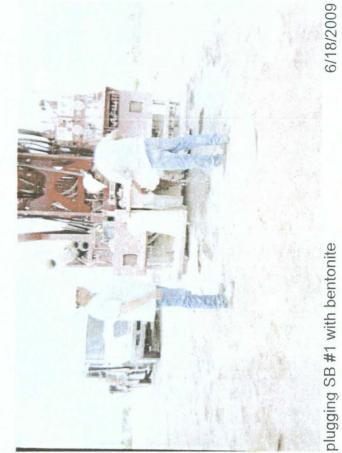
6/18/2009

drilling SB #1 at the former junction box site

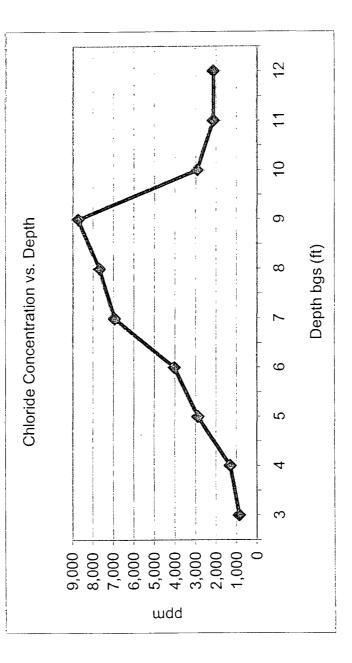
Soil Bore samples at the junction (source)

[ČĪ] ppm	856	1,294	2,875	4,013	6,920	7,662	8,714	2,905	2,098	2,117
Depth bgs (ft)	e	4	5	9	2	8	6	10	11	12

Groundwater = 65 ft
