DATE: August 3, 2010 REFERENCE NO.: 055212-09
PROJECT NAME: Gramma Ridge NOI: Remove and
Dispose Hydrotest Water for 12" P/L
TO: Brad Jones
New Mexico Oil Conservation Division
1120 South St. Francis Dr.
Santa Fe, New Mexico 87505

RE: **Request for Individual Temporary Permission for Hydrostatic Test Dewatering
Notice of Intent to Dewater New 12-inch Diameter Natural Gas Pipeline
Enstor Grama Ridge Storage and Transportation, LLC
Grama Ridge Morrow Storage Unit
Lea County, New Mexico**

GRAMA RIDGE EXPANSION PROSPECTIVE FACILITIES
GRAMA RIDGE MORROW GAS STORAGE AREA
LEA COUNTY, NEW MEXICO
Enstor Operating Company

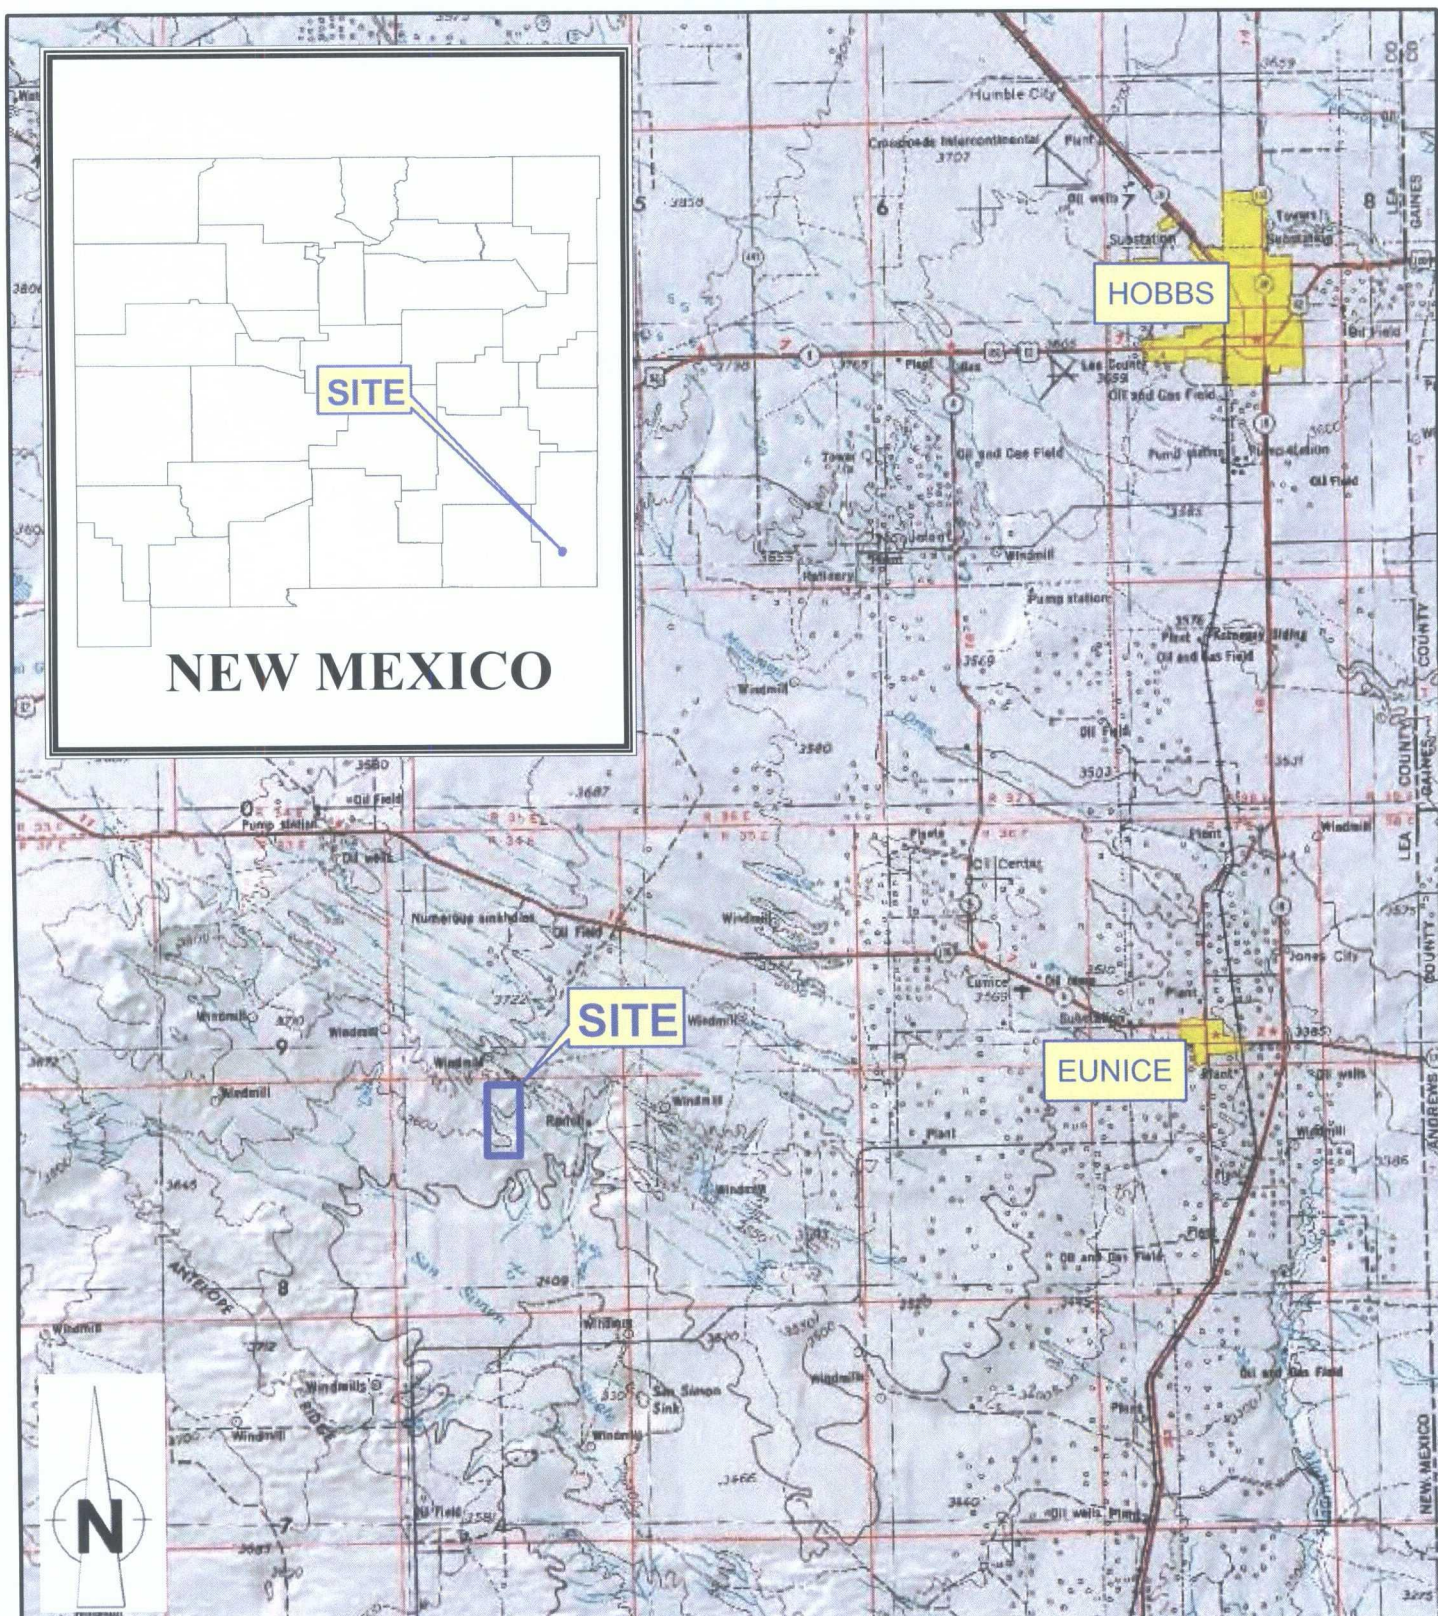
figure 1
VICINITY MAP
GRAMA RIDGE EXPANSION PROSPECTIVE FACILITIES
GRAMA RIDGE MORROW GAS STORAGE AREA
LEA COUNTY, NEW MEXICO
Enstor Operating Company

RE: USGS 7.5 Minute Topographic Maps, "Grama Ridge, New Mexico," and "San Simon Ranch, New Mexico."

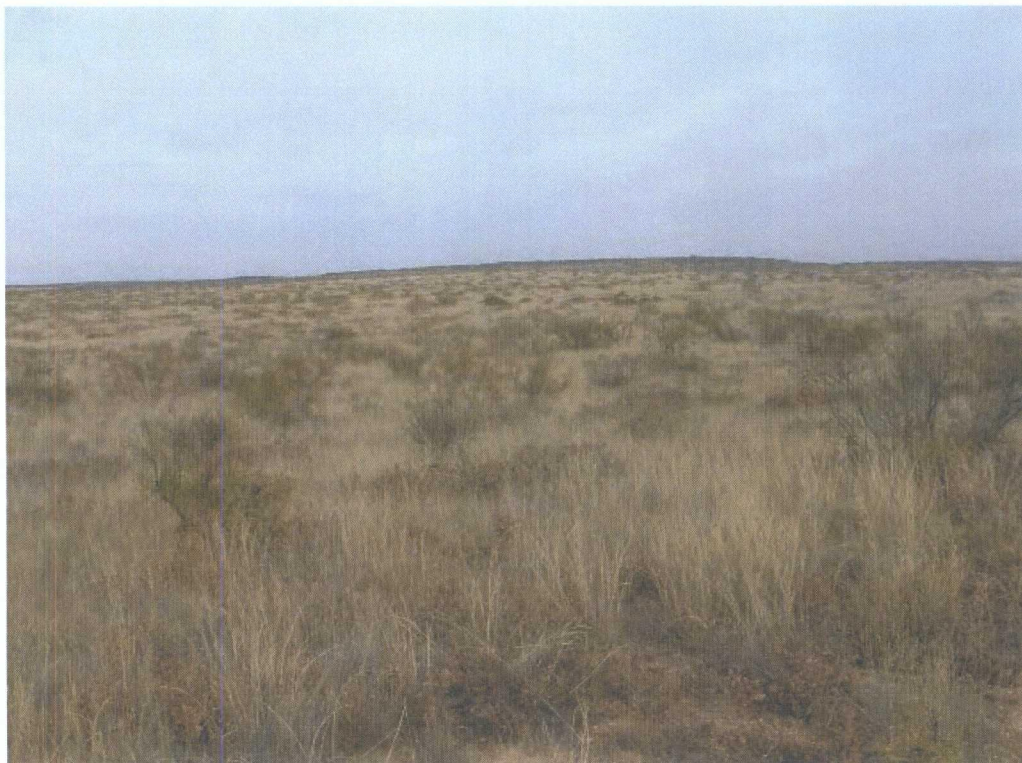
PHOTOGRAPH 1: Standing at Sample Location 1 and facing north.

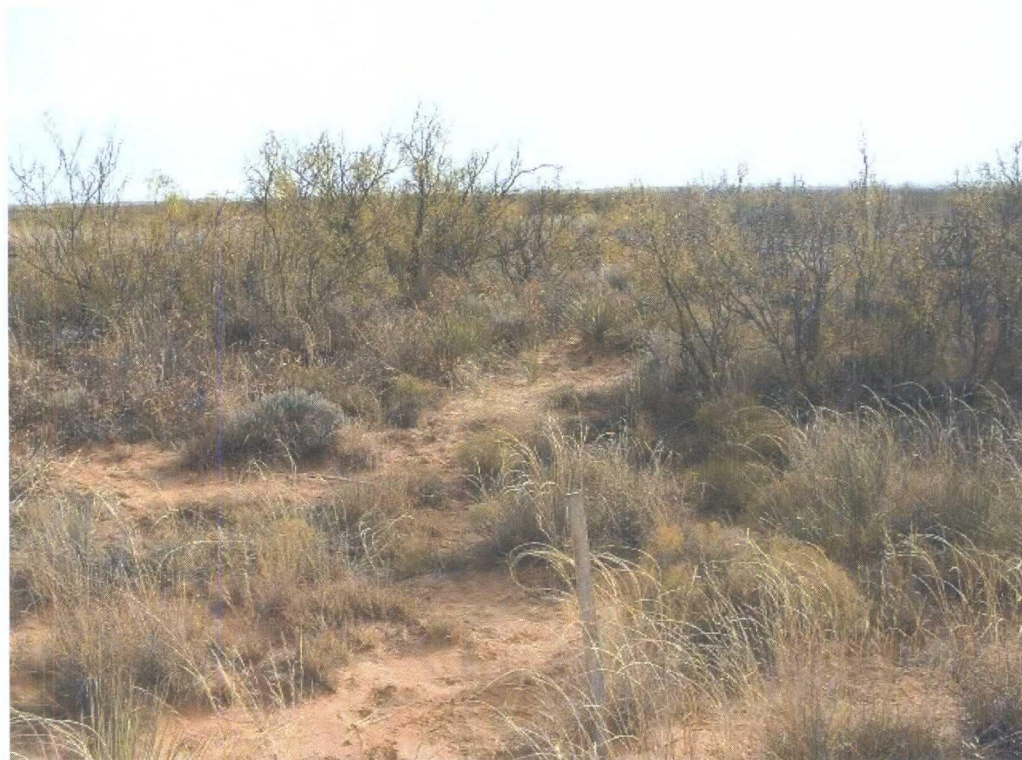
PHOTOGRAPH 2: Standing at Sample Location 2 and facing south.
