South Corbin - Bone Spring Pool Scooter Federal Com #1H Completion

Scooter Federal Com #1H

BEFORE THE OIL CONVERSION
DIVISION
Santa Fe, New Mexico
Exhibit No. 9
Submitted by: COG OPERATING LLC
Hearing Date: October 16, 2014

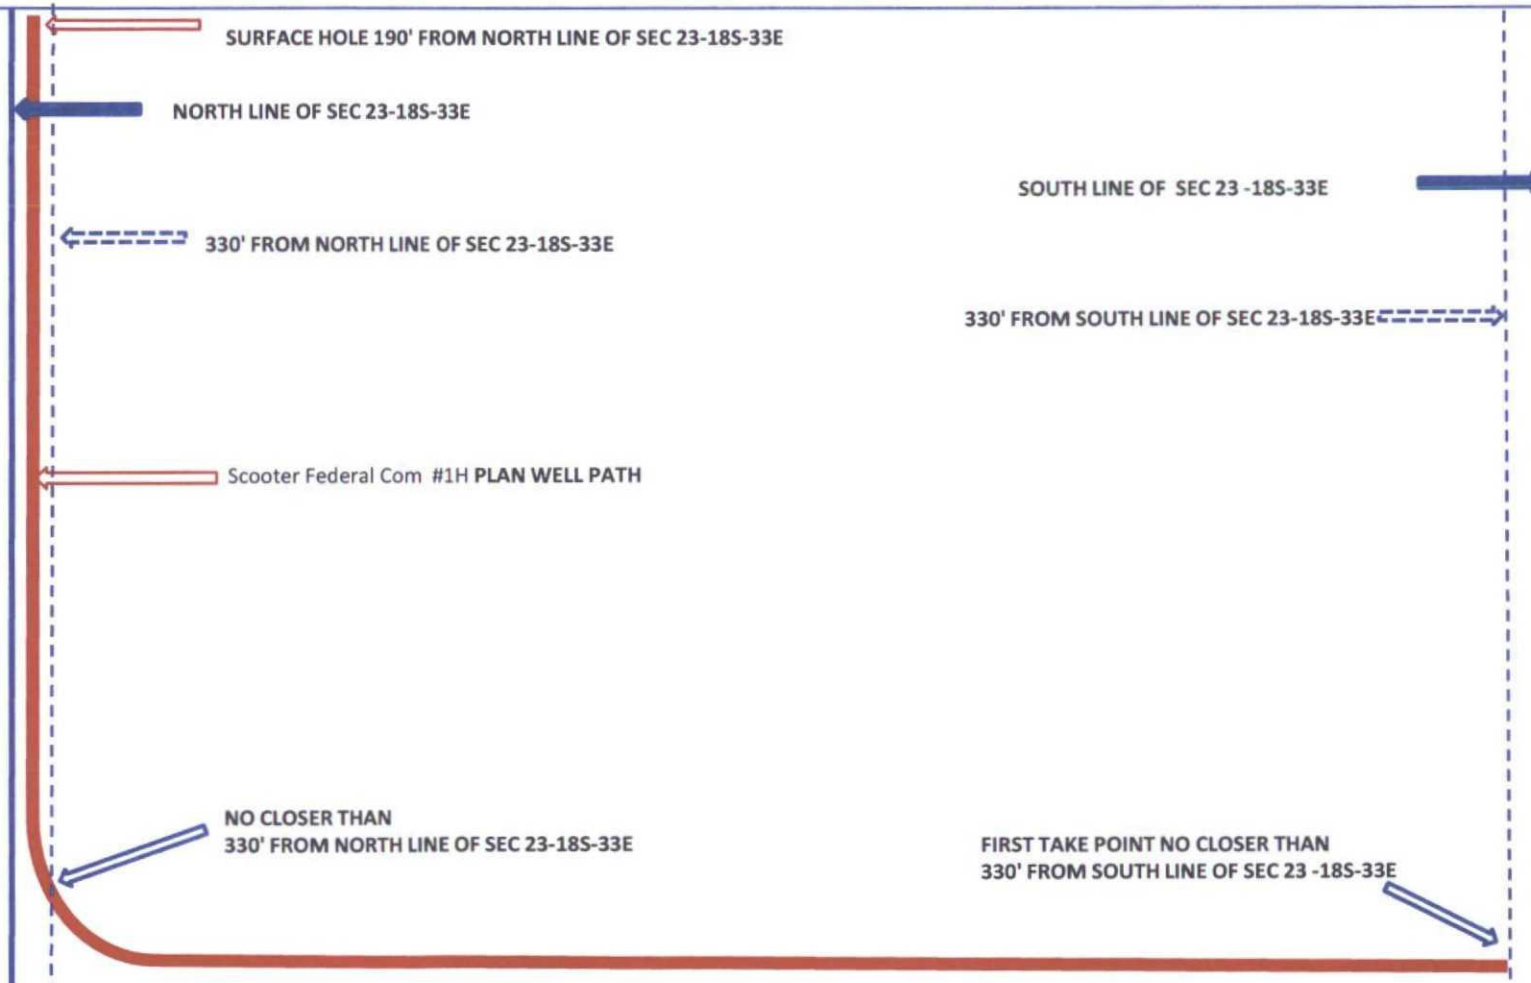
SURFACE HOLE 460' FROM WEST LINE OF SEC 23-18S-33E

DIAGRAM NOT TO SCALE

*No perforations will be performed closer than 330' from the section lines.
