# LRIC / CAPATAZ OPERATING

## MARSHALL #1

Lea County, New Mexico and Gaines County, Texas

## STRUCTURE MAP TOP OF DRINKARD POROSITY

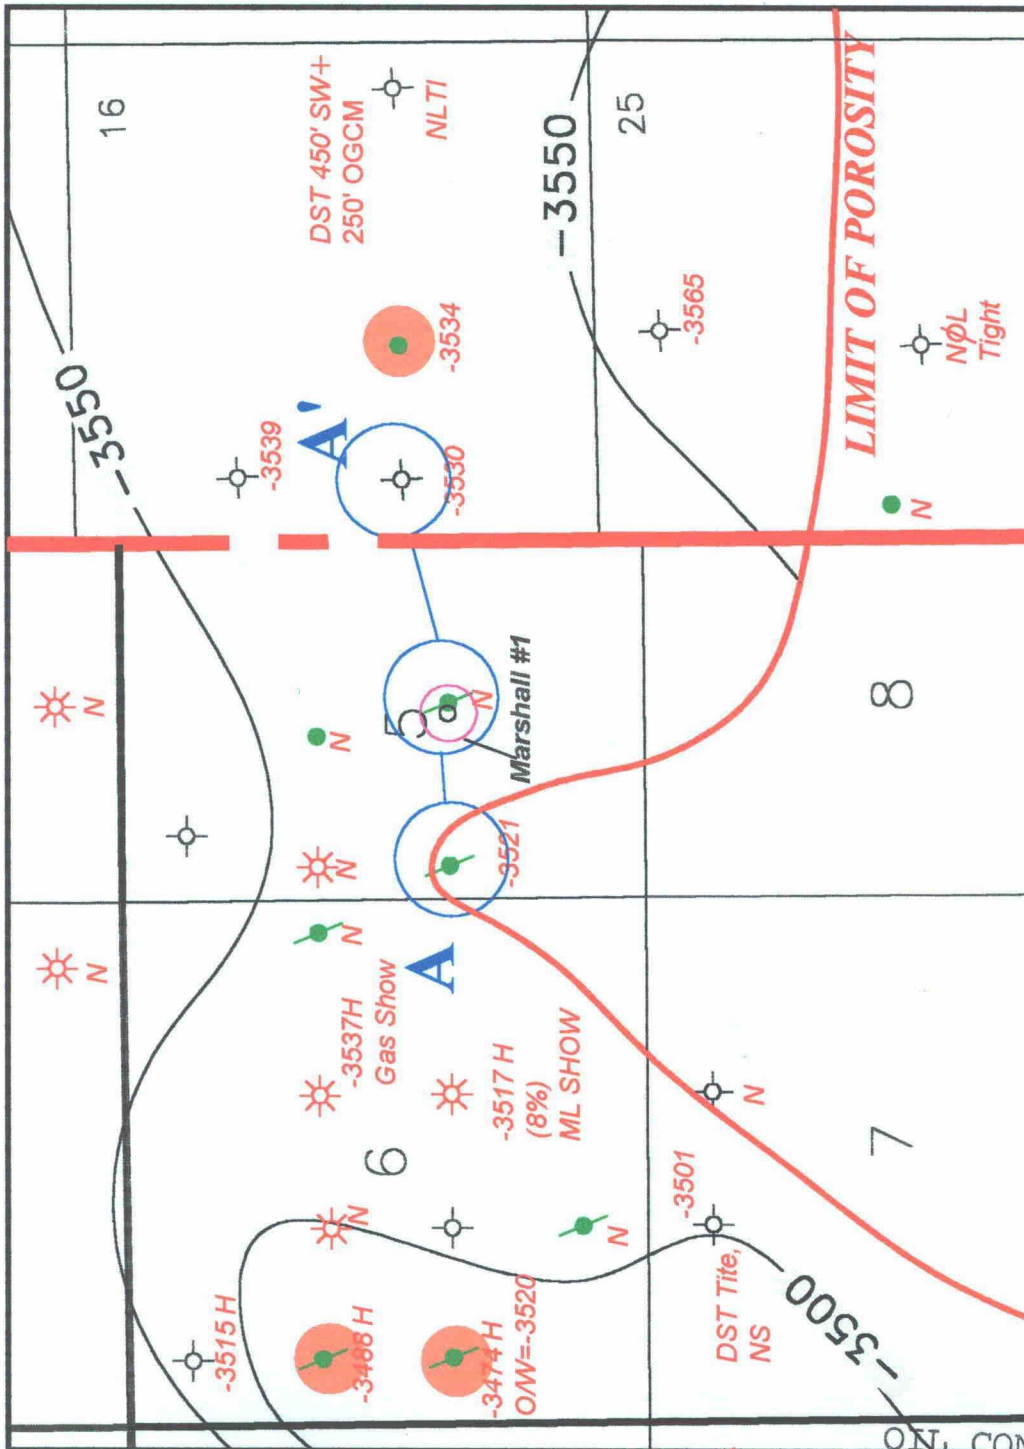
Contour Interval = 50'

Date: May, 2001

Geology by: John Worrall
