*Pan Am*  
EXHIBIT II  
3498

NET PAY ISOPACH  
GALLUP FORMATION  
PIÑON GALLUP OIL POOL  
SAN JUAN COUNTY, NEW MEXICO

PROPOSED PIÑON GALLUP PRESSURE  
MAINTENANCE PROJECT AREA

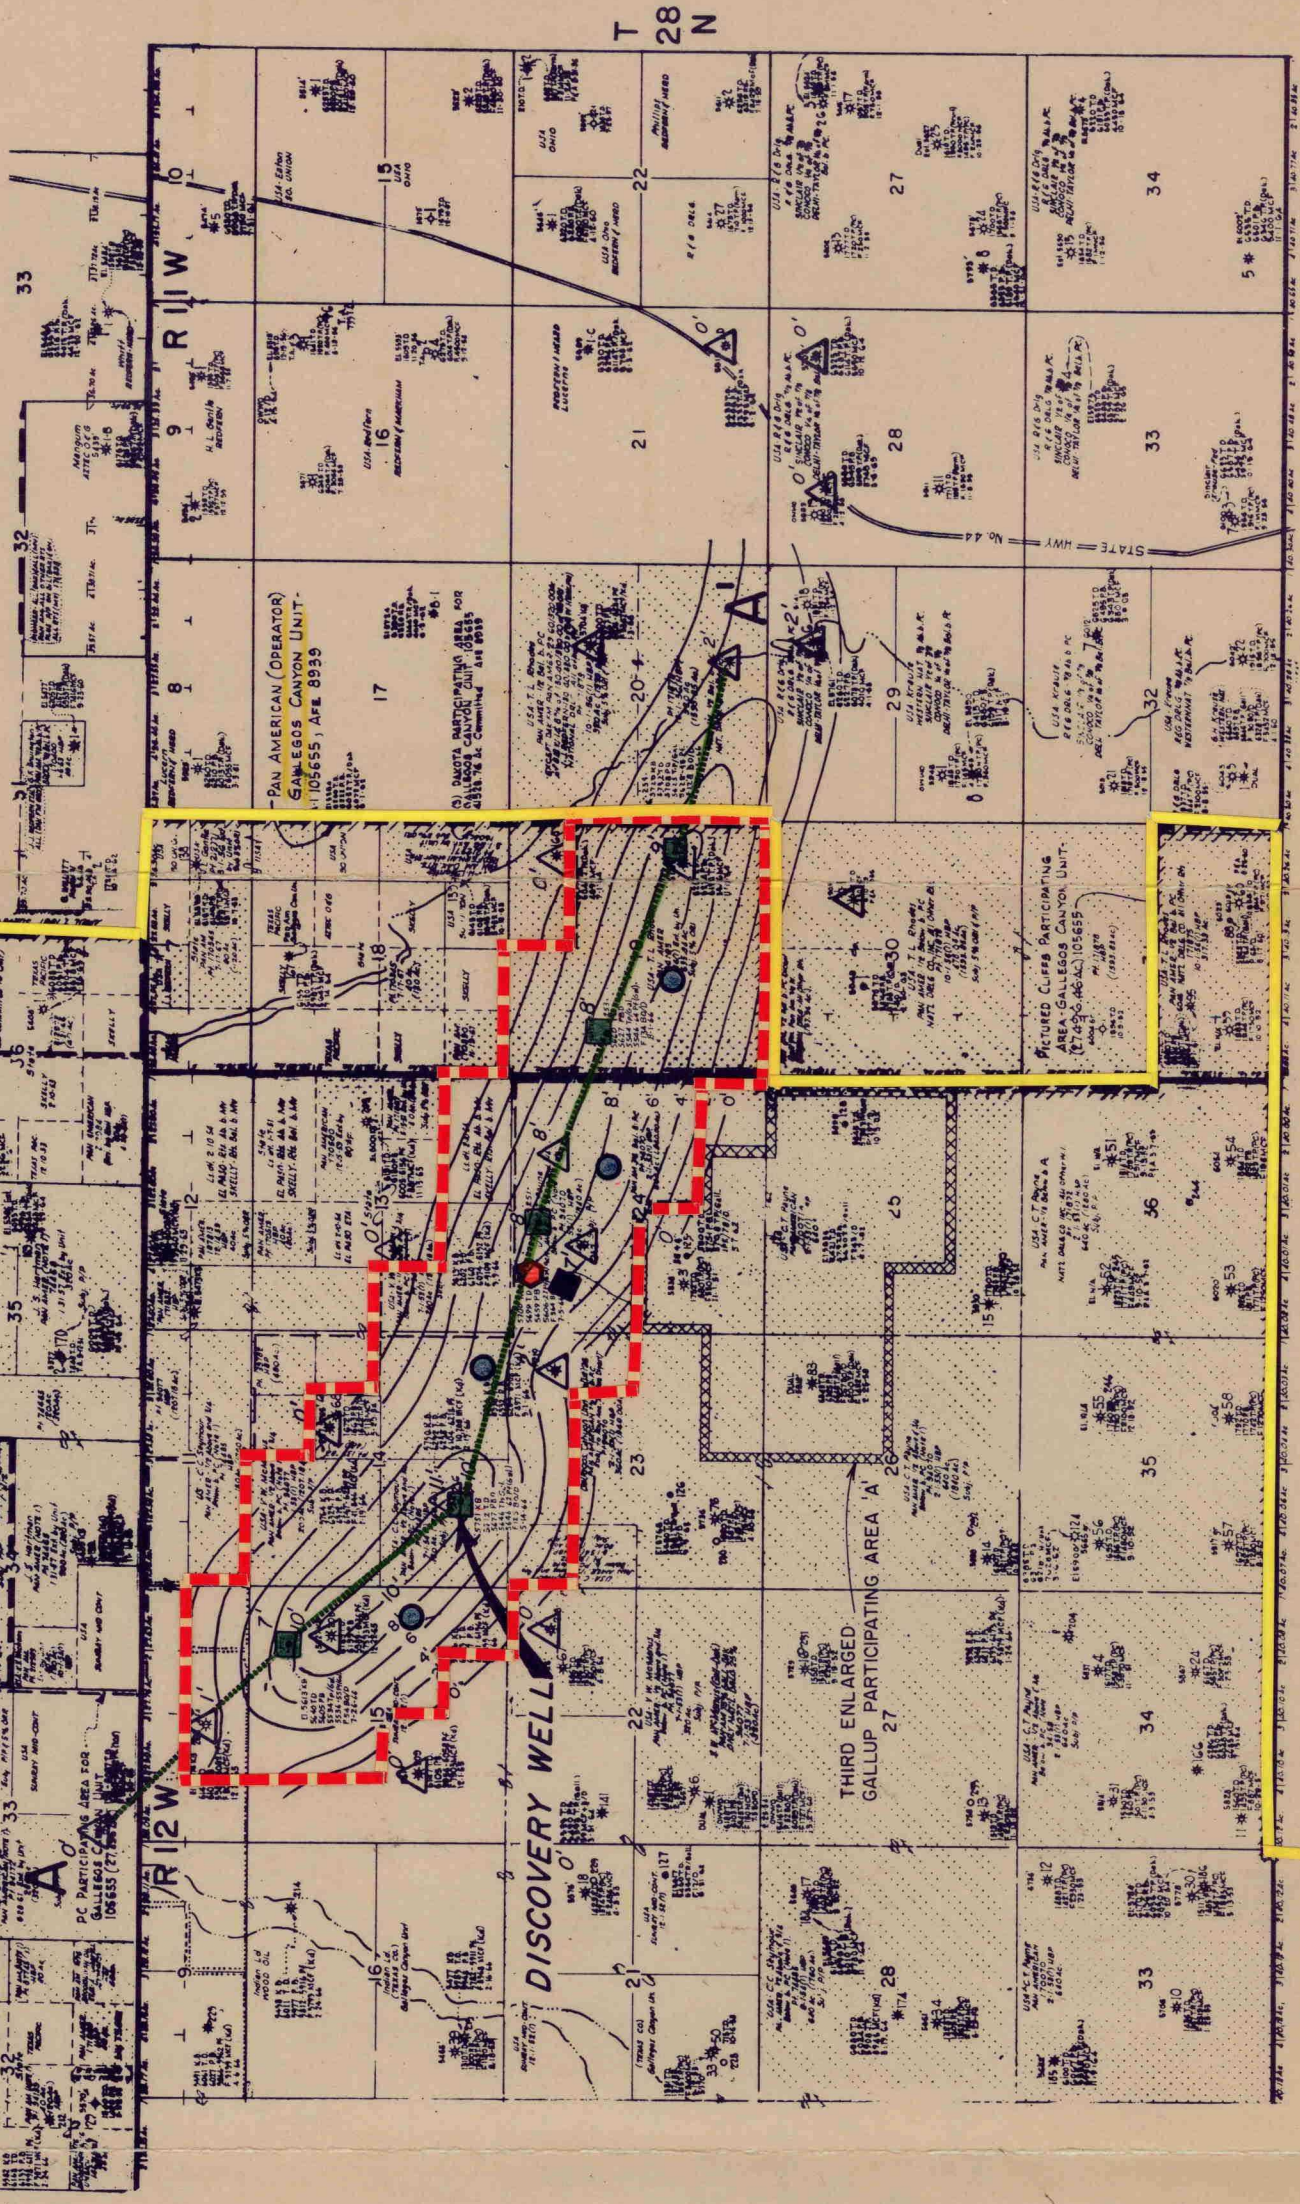
C.I. = 2'
