Exhibits 1 through 5A

HALLWOOD "LAPLATA AREA" COAL WELLS

NORTHWEST BLANCO AREA
SAN JUAN COUNTY, NEW MEXICO

BASIN FRUITLAND COAL FIELD
STRUCTURE TOP PICTURED CLIFFS (BASE COAL)
C.I.=20 FT.

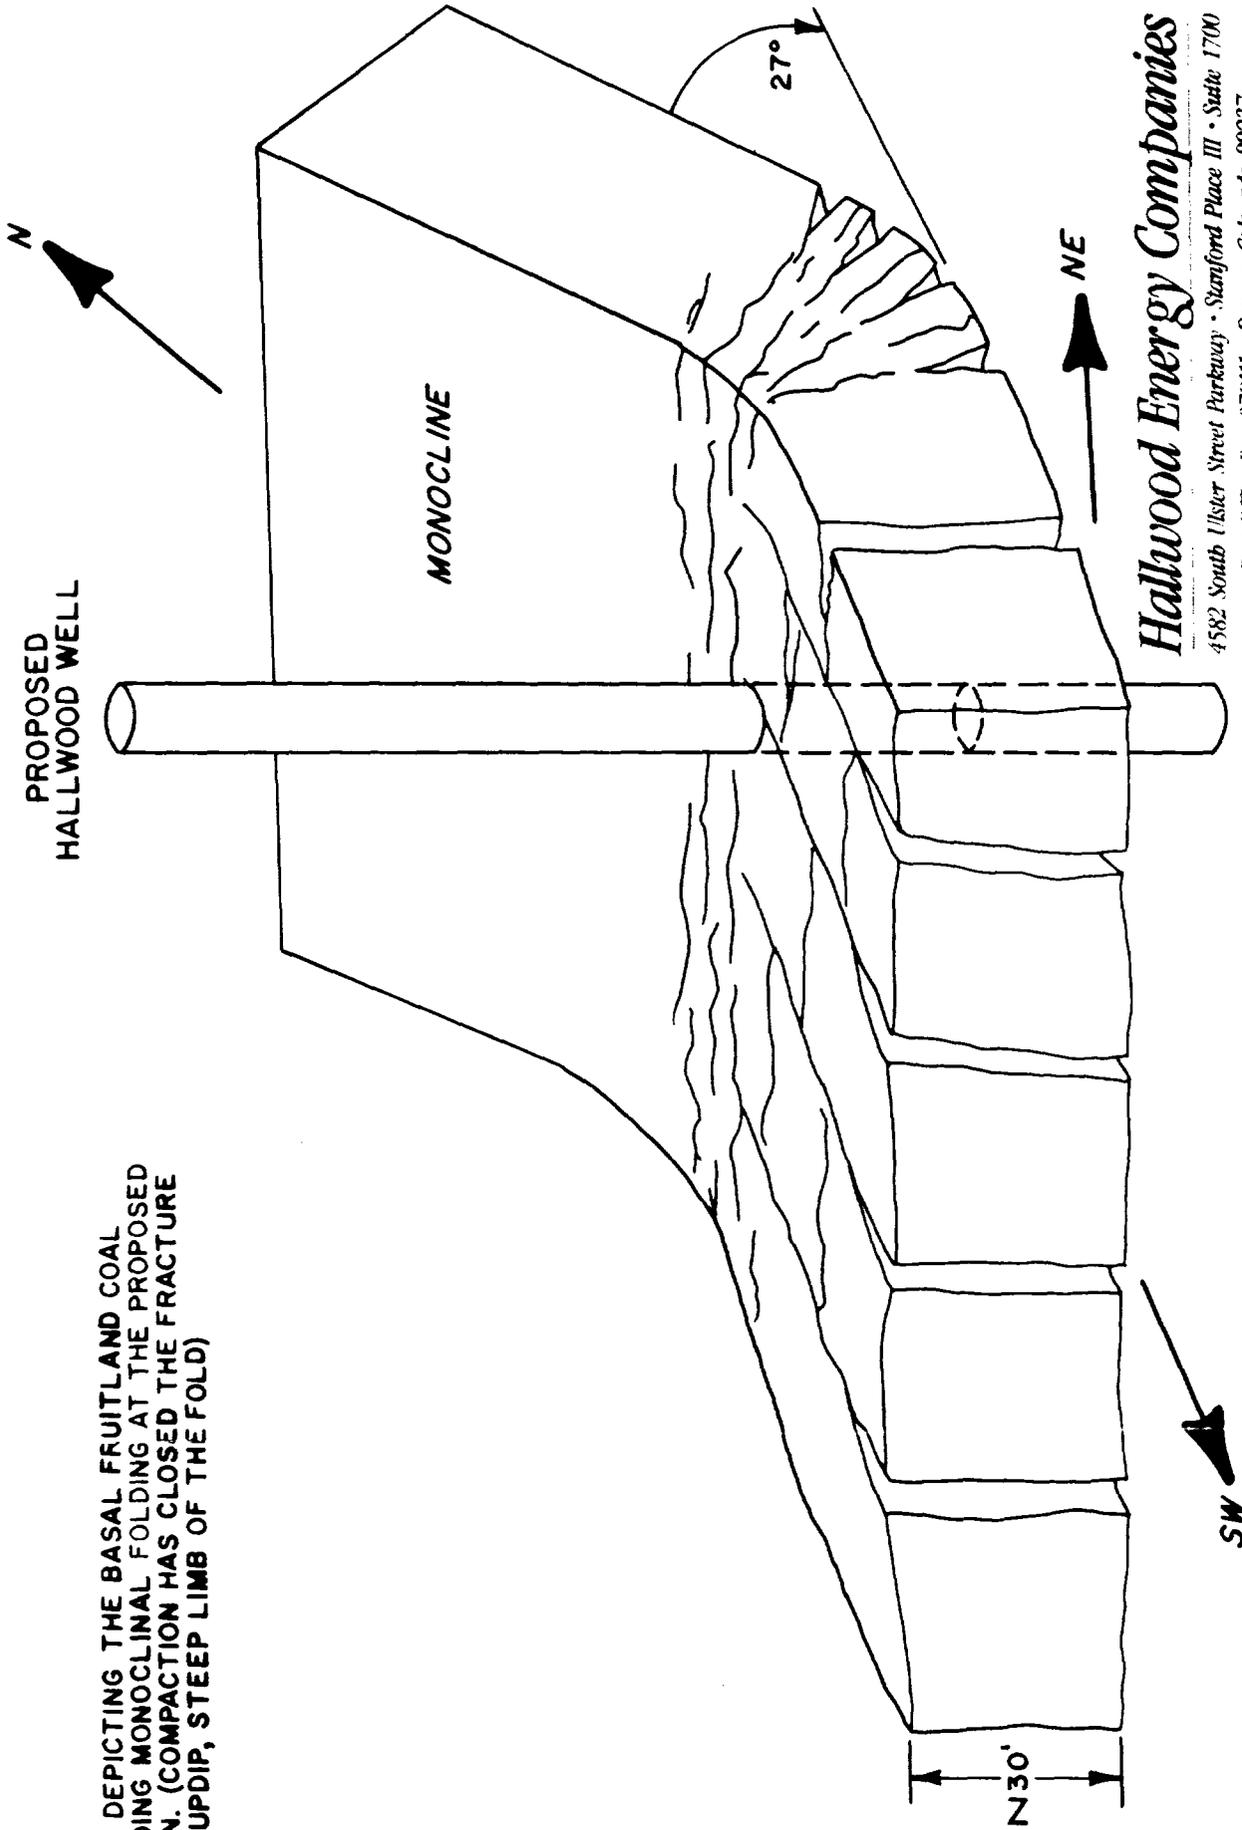
EXHIBIT 3
CASE NO. 10557
DG 9/92

DIAGRAM DEPICTING THE BASAL FRUITLAND COAL UNDERGOING MONOCLINAL FOLDING AT THE PROPOSED LOCATION. (COMPACTION HAS CLOSED THE FRACTURE ON THE UPDIP, STEEP LIMB OF THE FOLD)
