HALLWOOD PETROLEUM, INC.  
CASE NO. 10728 5-6-93  
MONTAYA #27-1 (FC)  
T32N-R13W, Sec 27: SE SE  
SAN JUAN COUNTY, NEW MEXICO

*Exhibits 1 through 7  
Complete Set*

## HALLWOOD "LAPLATA AREA" COAL WELLS

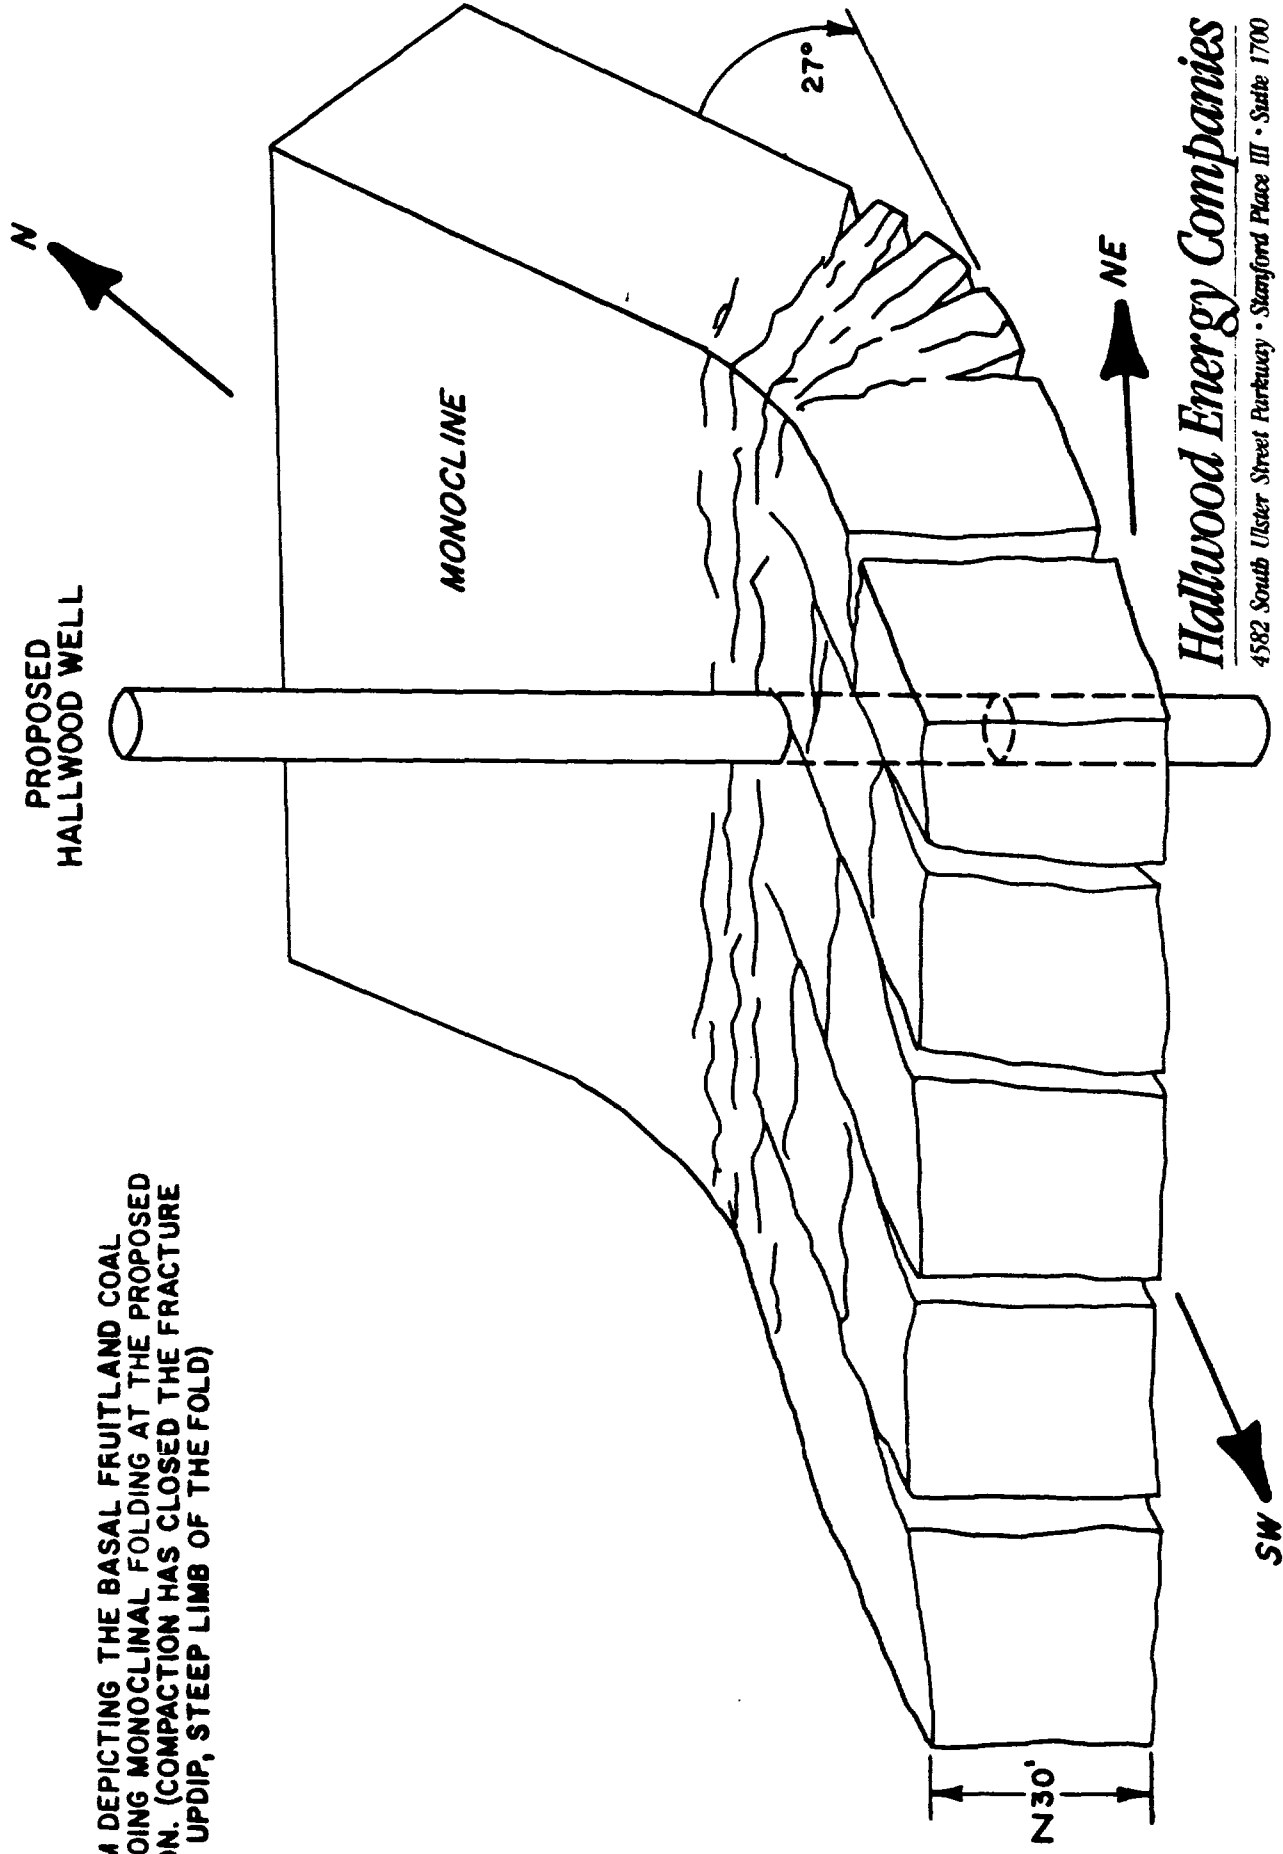
2

DIAGRAM DEPICTING THE BASAL FRUITLAND COAL UNDERGOING MONOCLINAL FOLDING AT THE PROPOSED LOCATION. (COMPACTION HAS CLOSED THE FRACTURE ON THE UPDIP, STEEP LIMB OF THE FOLD)
