| BEFORE THE<br>OIL CONSERVATION COMMISSION<br>Sante Fe, New Mexico<br>Case No. <u>8289</u> Exhibit No. <u>10</u><br>Submitted by <u>AMOCO</u><br>Hearing Date <u>8-3-84</u> |

# Bravo Dome Carbon Dioxide Gas Unit Central Facility Layout

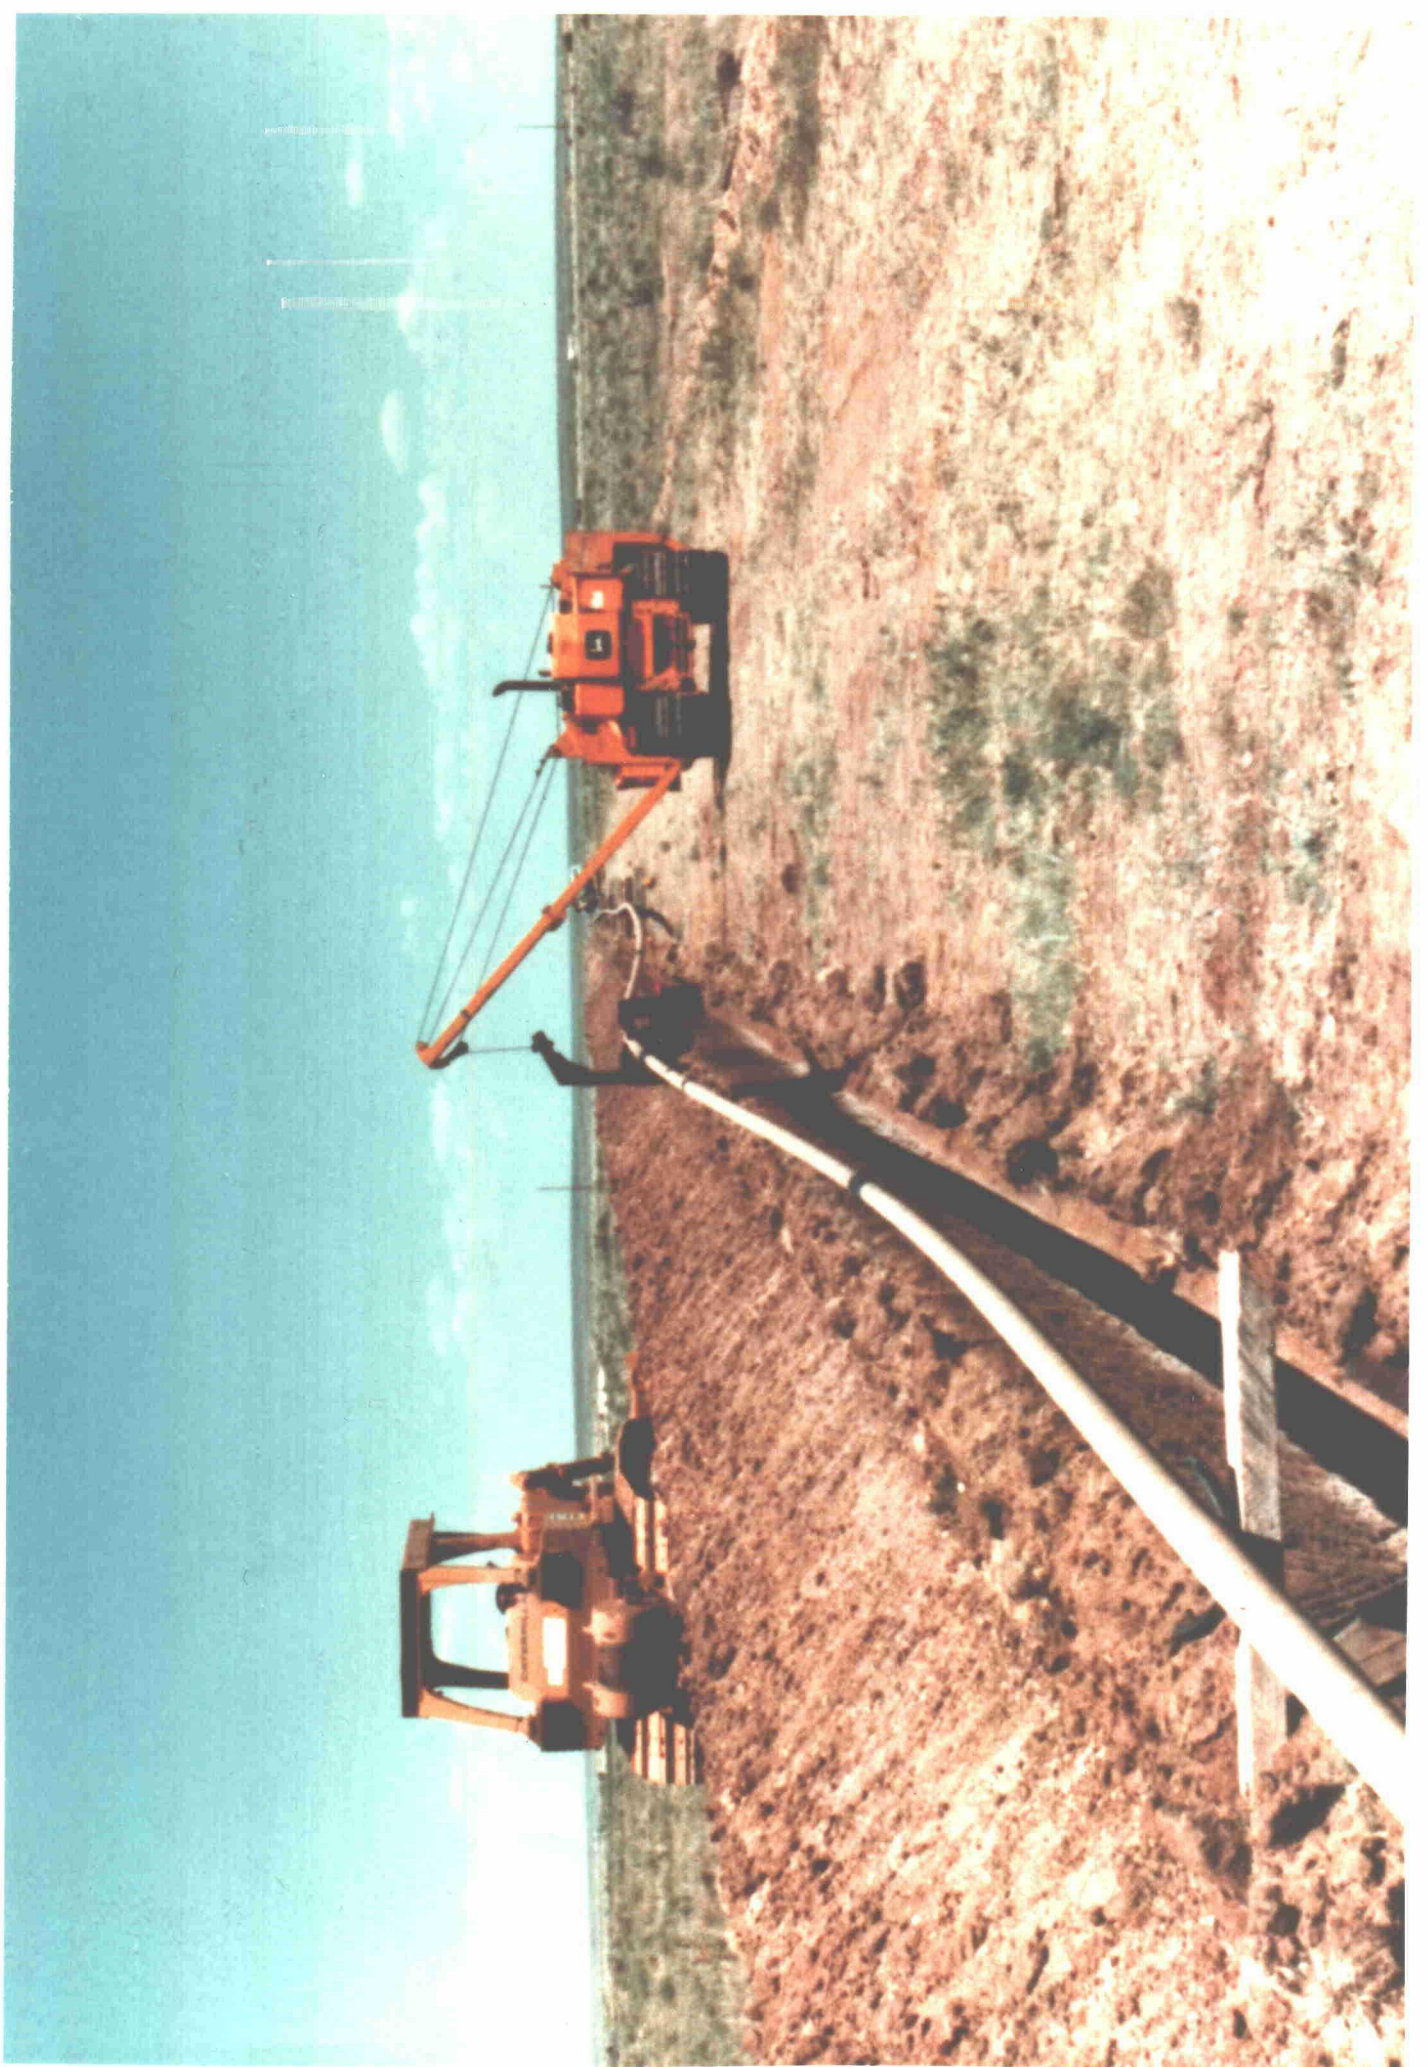
BDCDGU DRILLING

Typical drilling rig and location

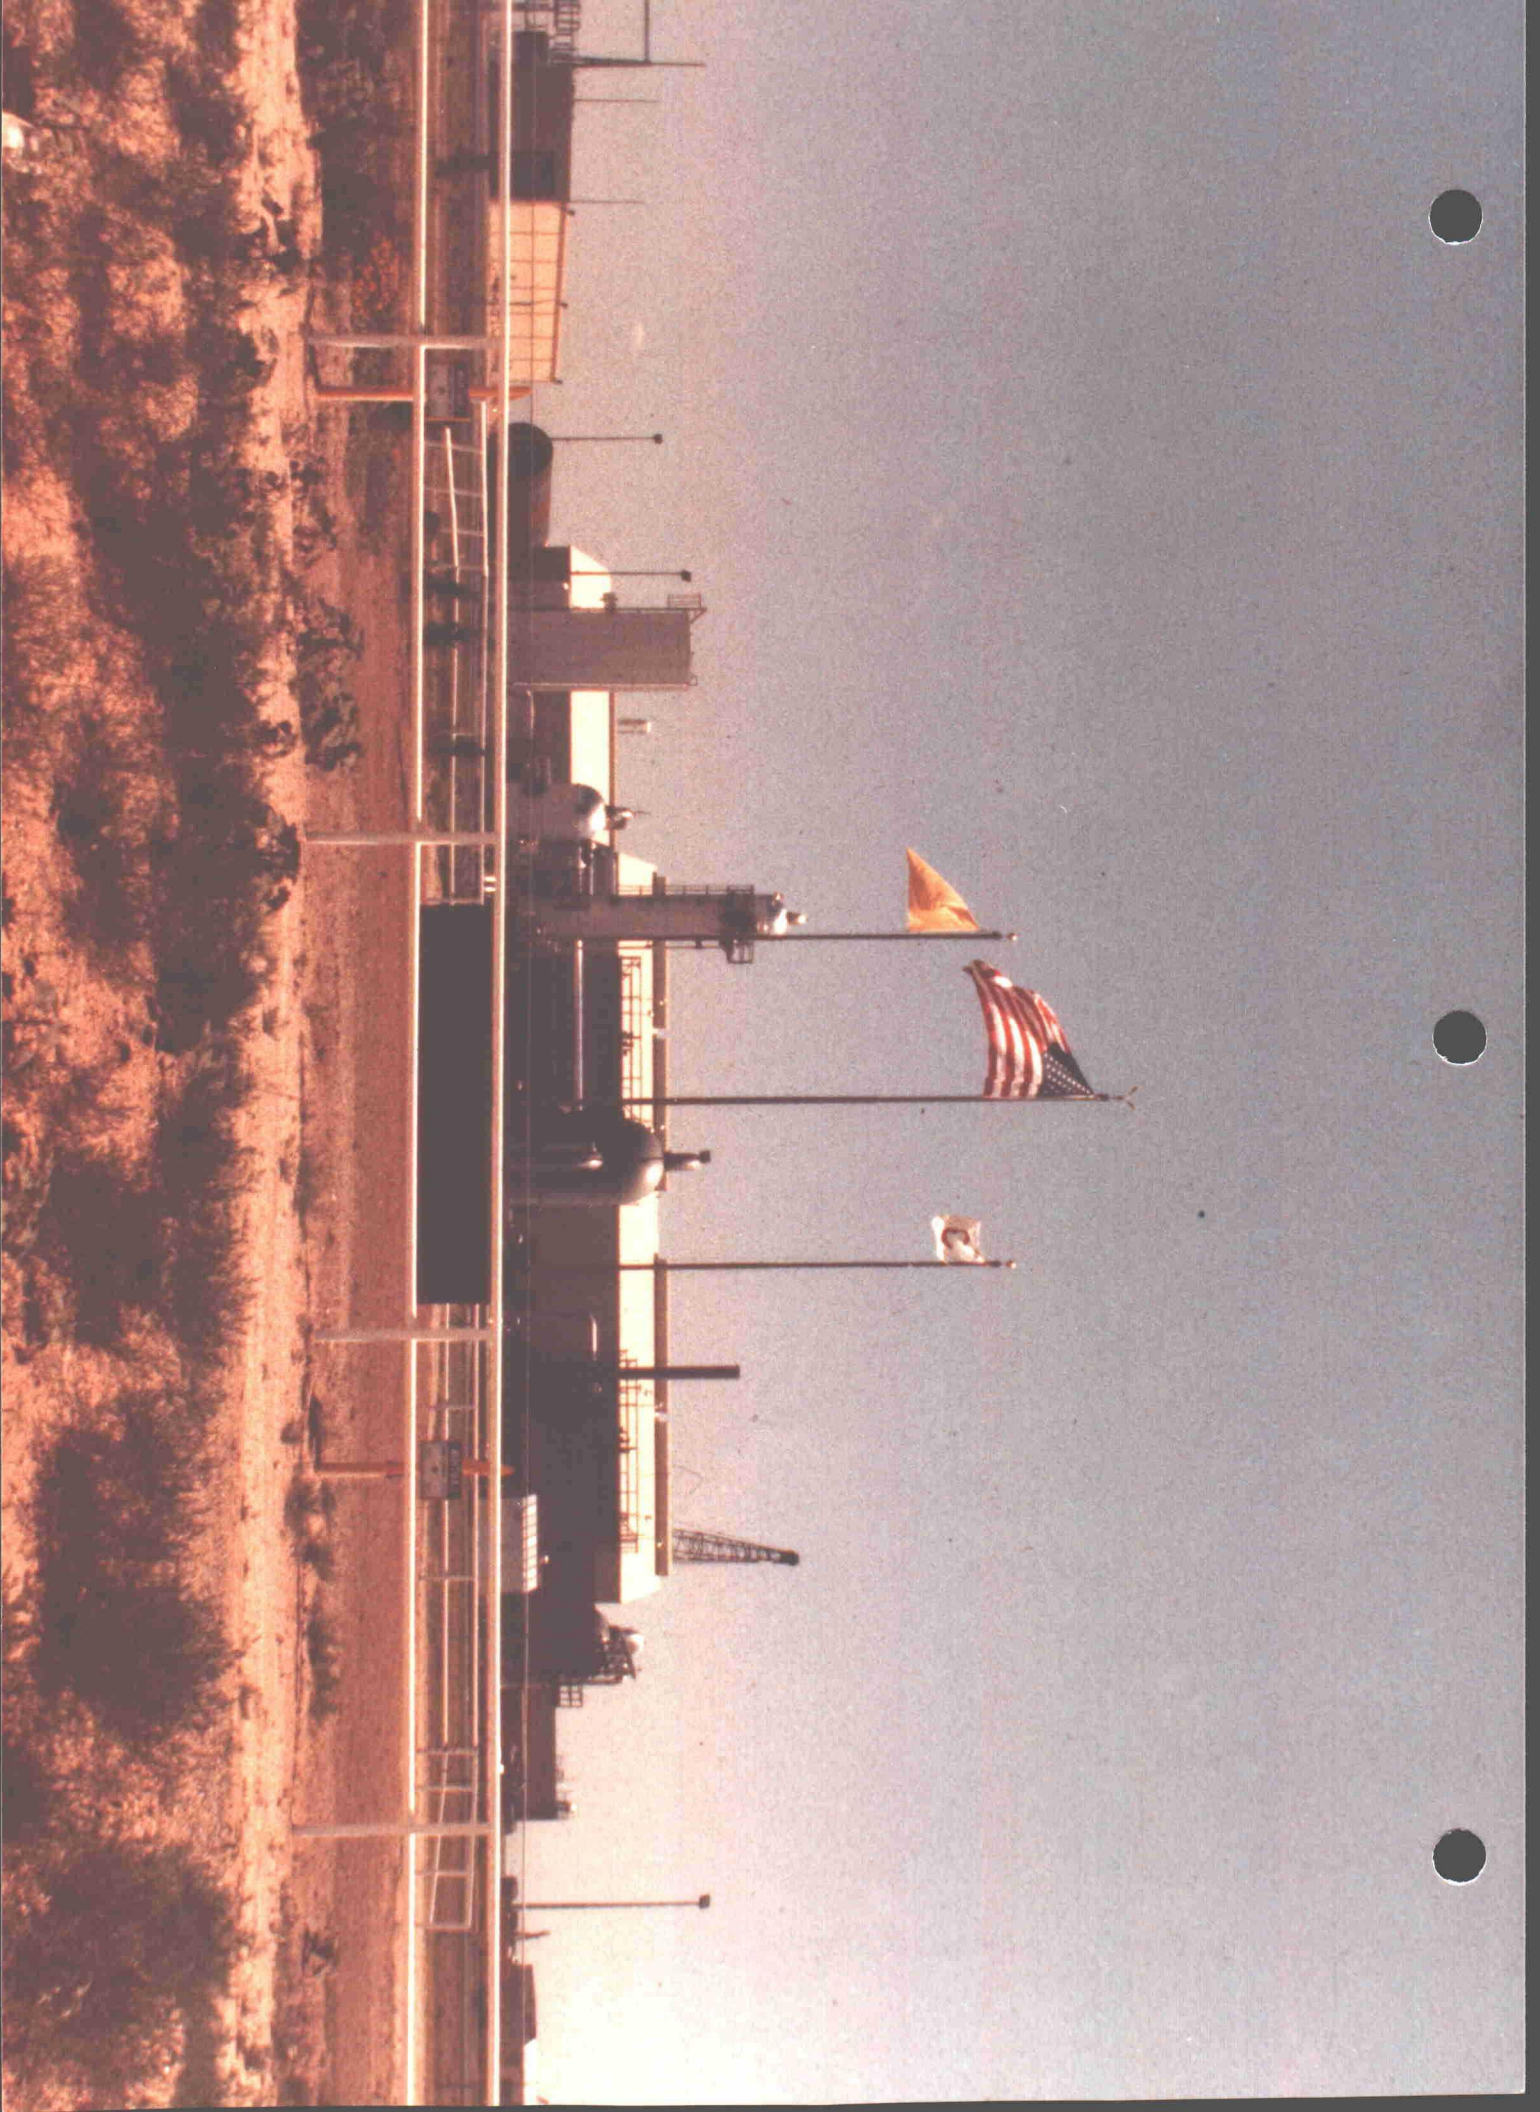
BDCDGU PHASE I FACILITY

Front view of compression/dehydration facility  
for Phase I

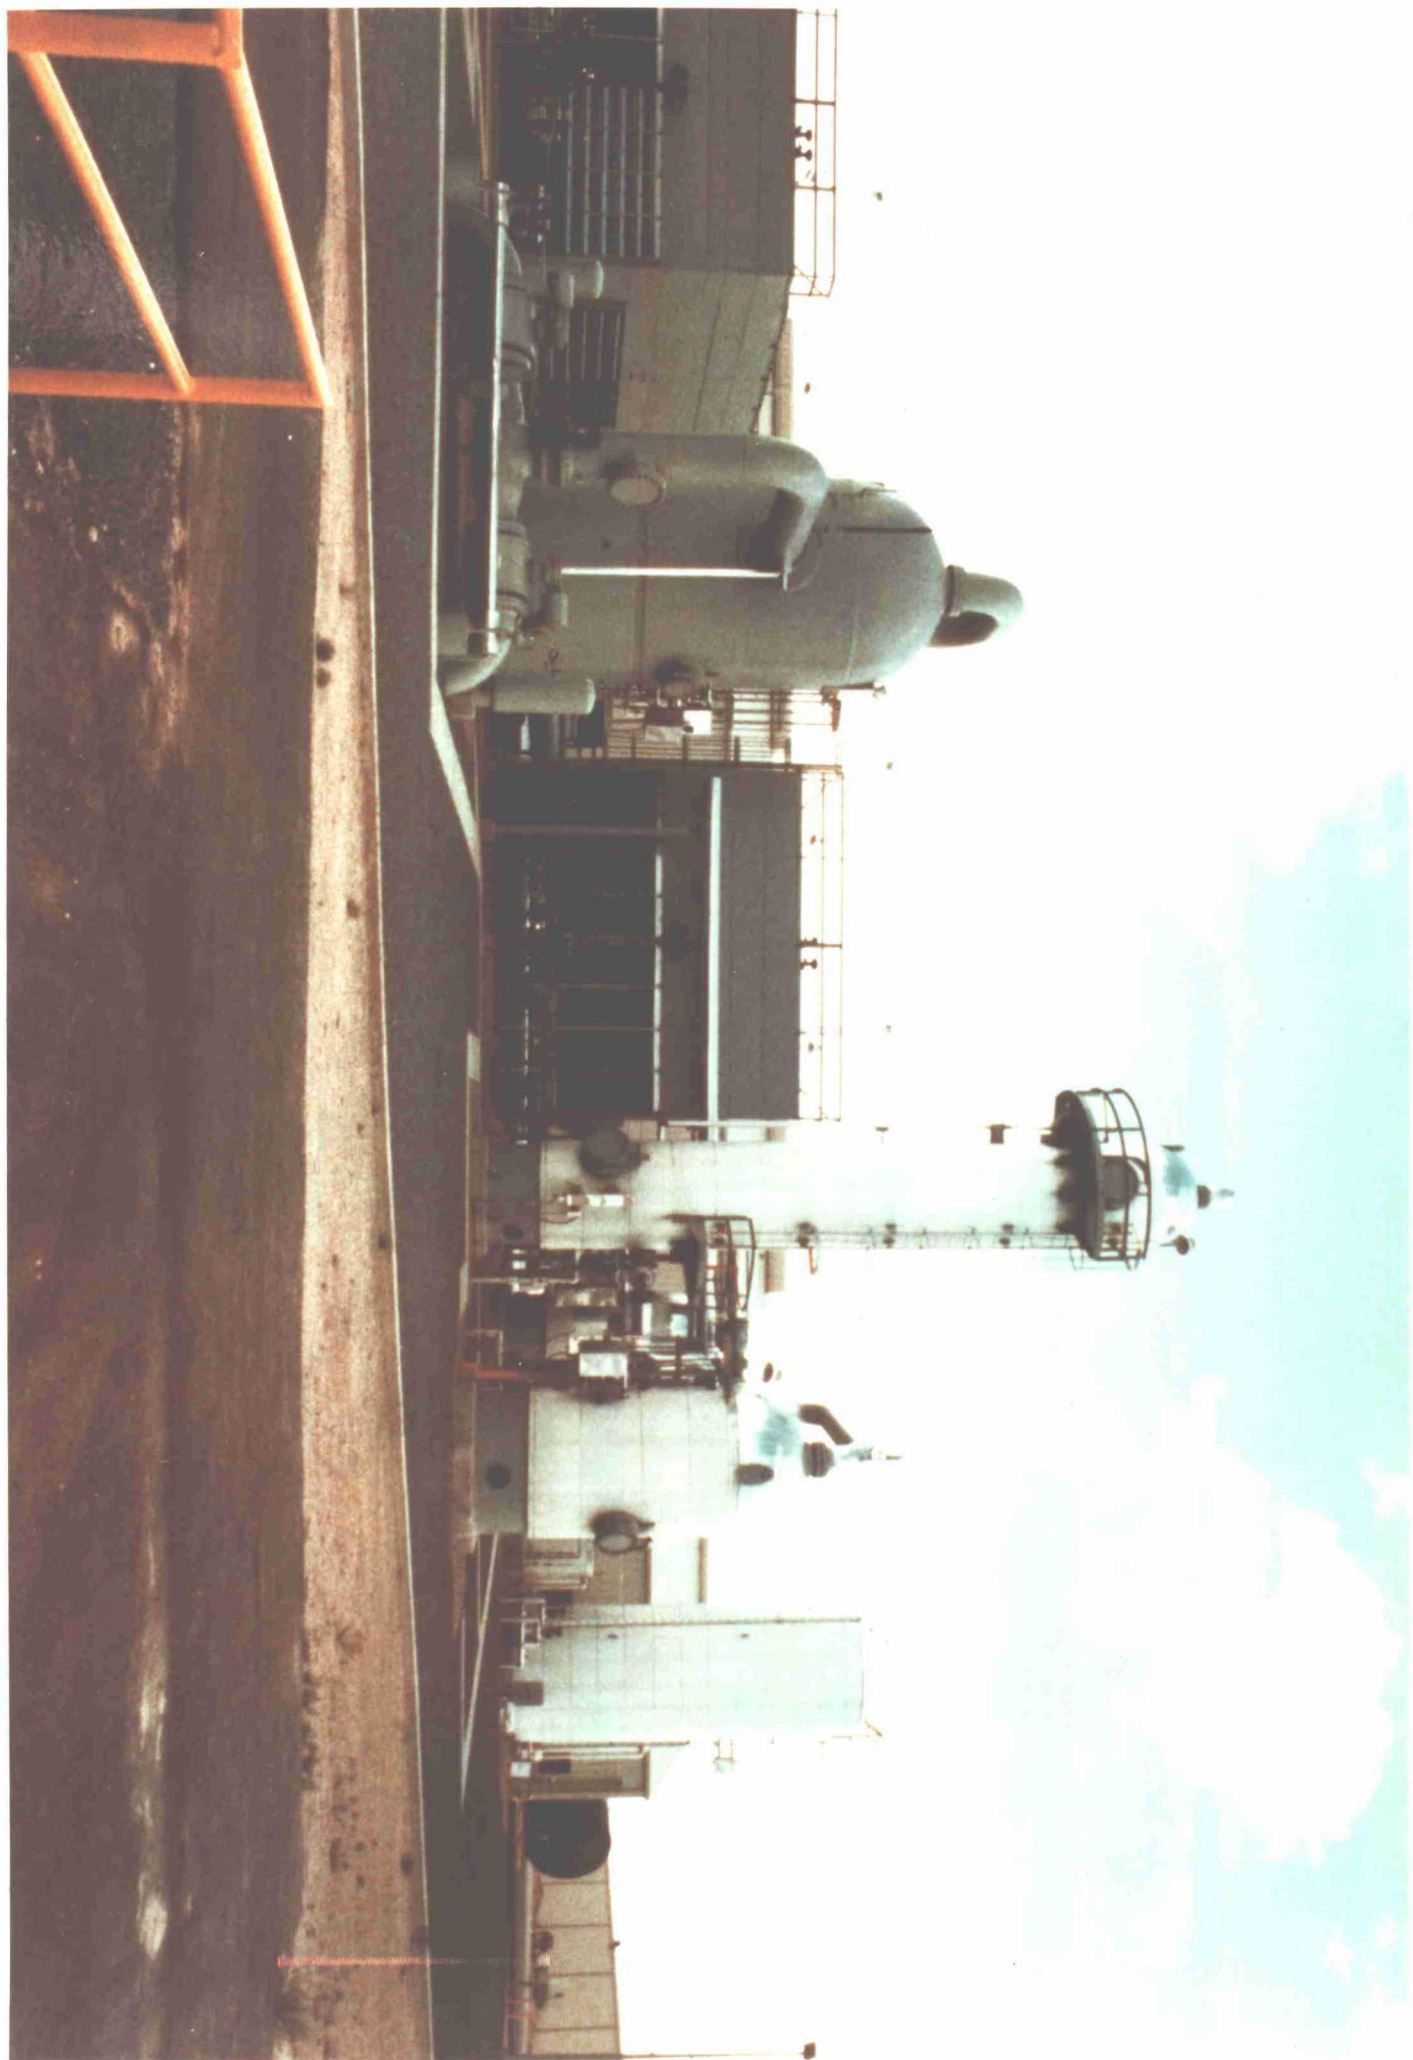
PHASE I FACILITY

Phase I compression/dehydration facility showing from  
left to right, cooler, inlet separator, cooler, glycol  
contactor, scrubber and water storage tank.

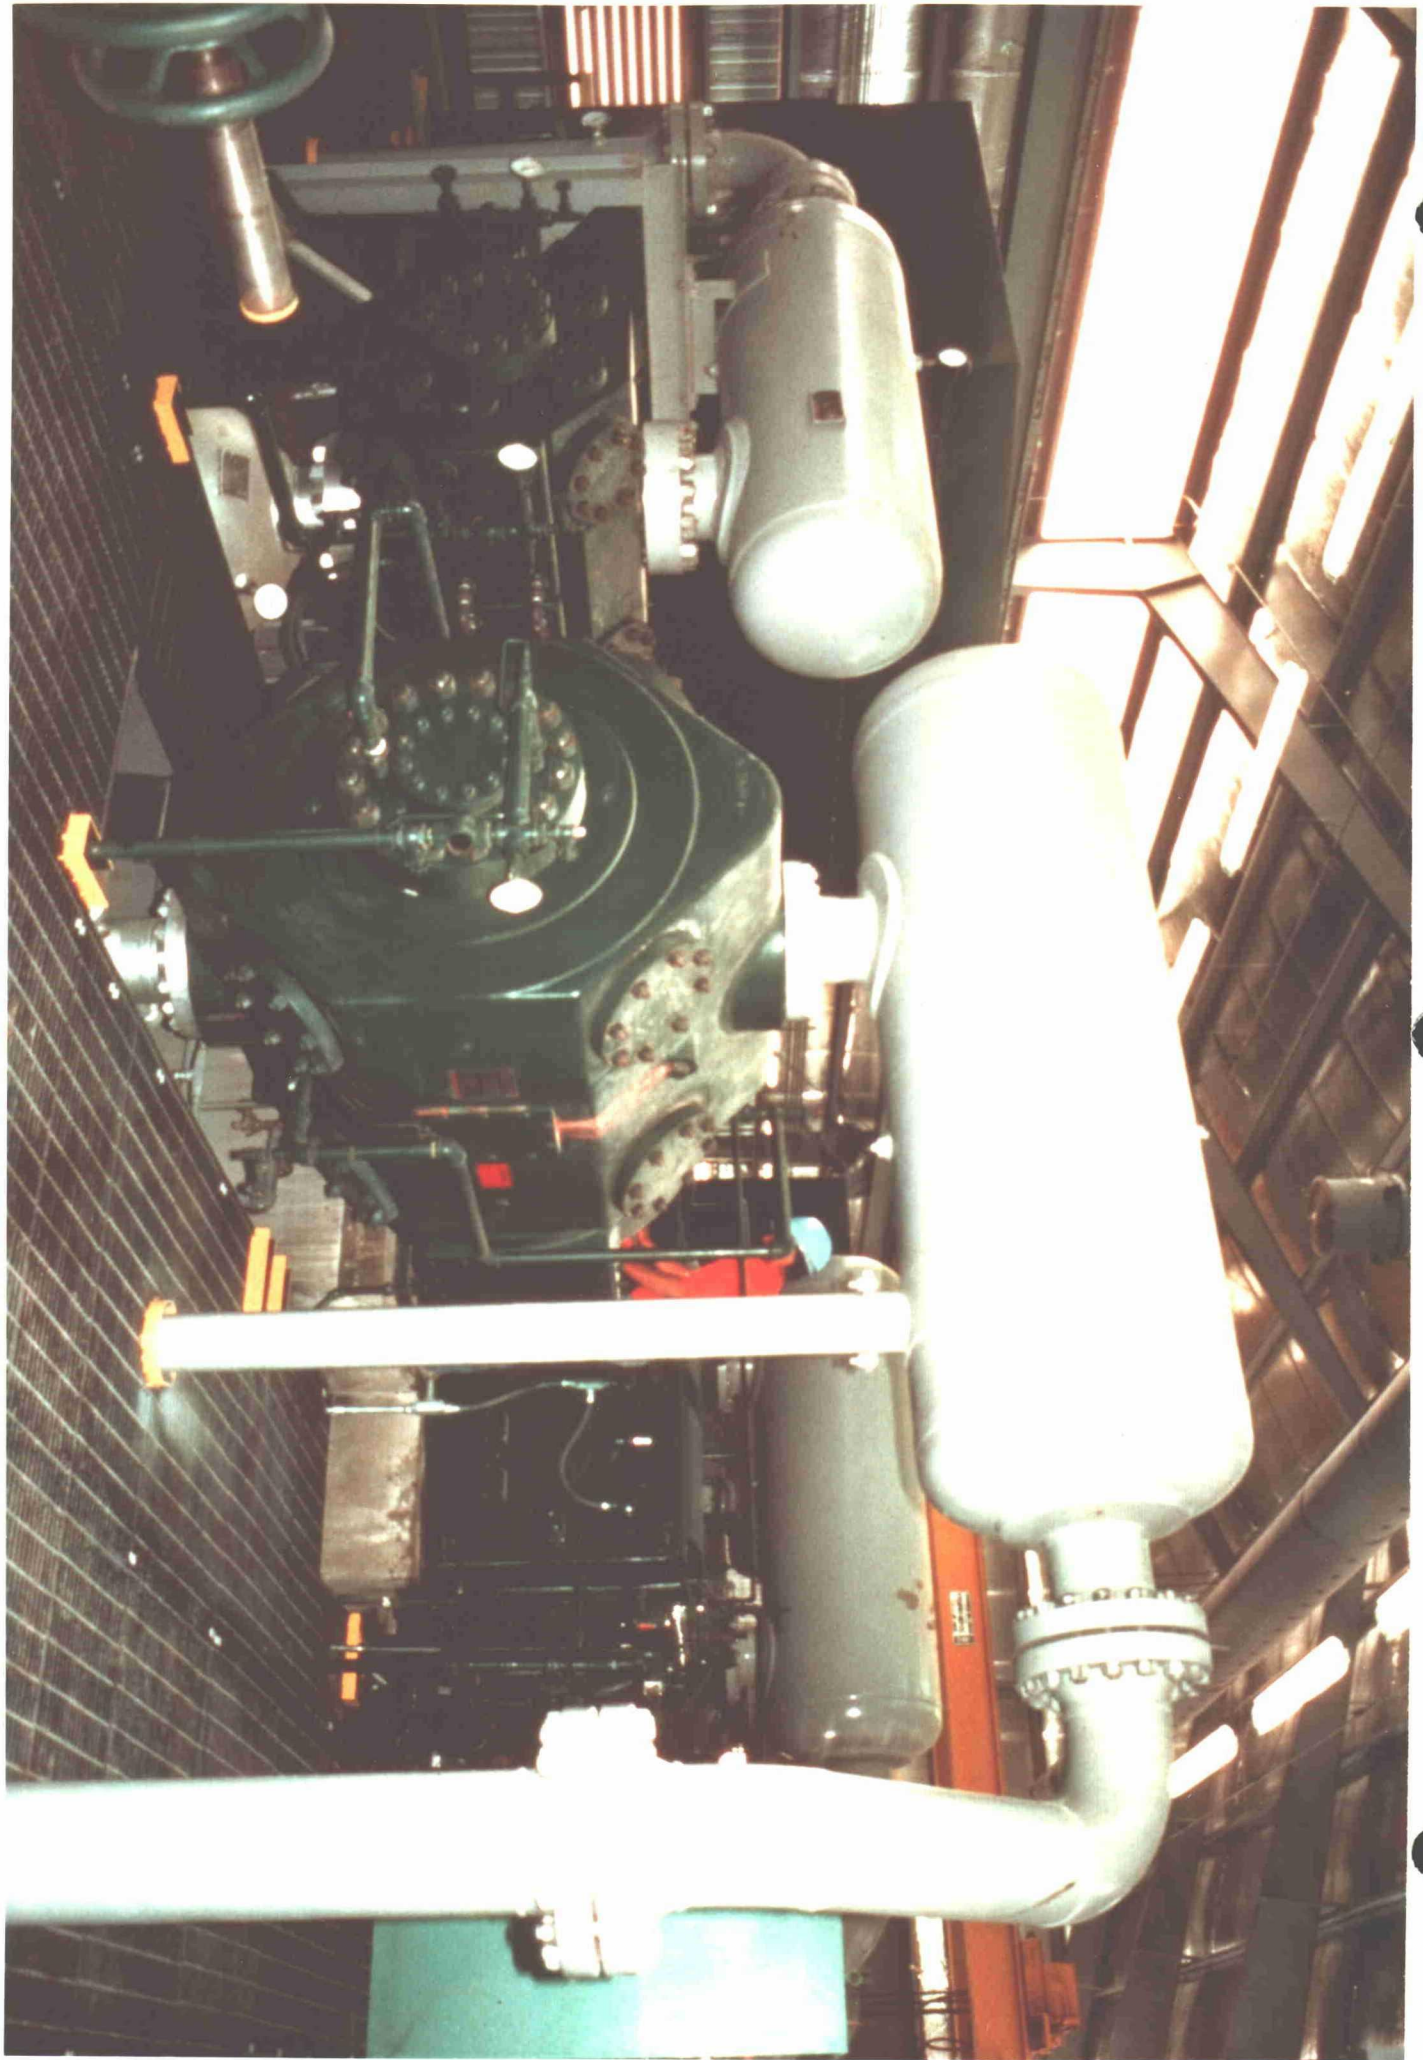
PHASE I FACILITY

Compressor pulsation bottles and cylinders for

Phase I 6000 HP compressors

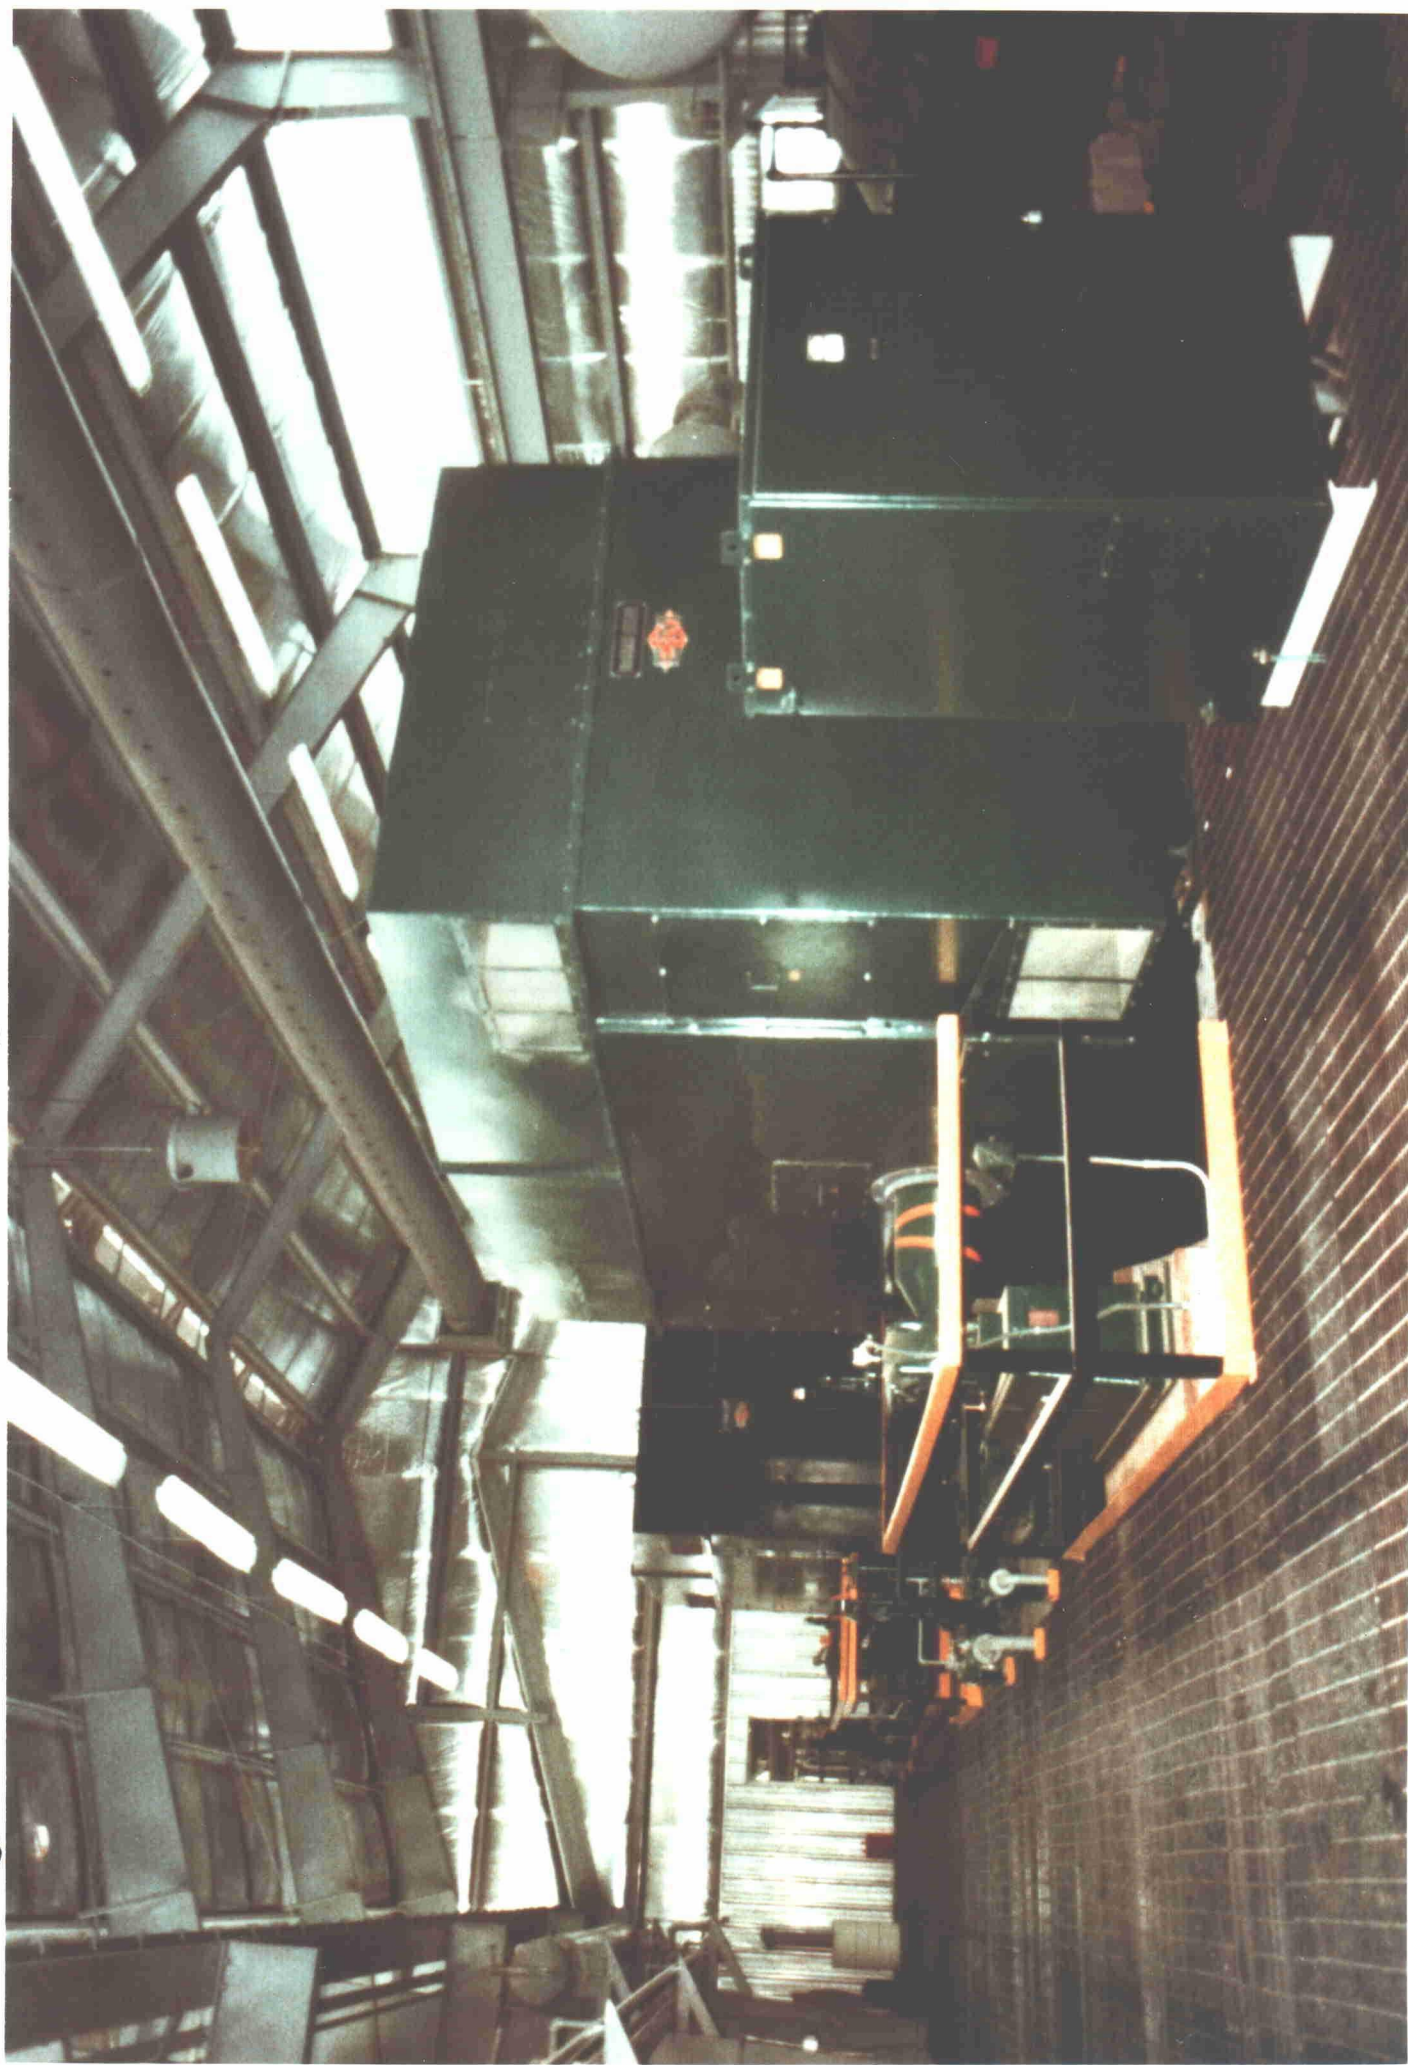
PHASE I FACILITY

Phase I compressor building showing compressor  
motor enclosures

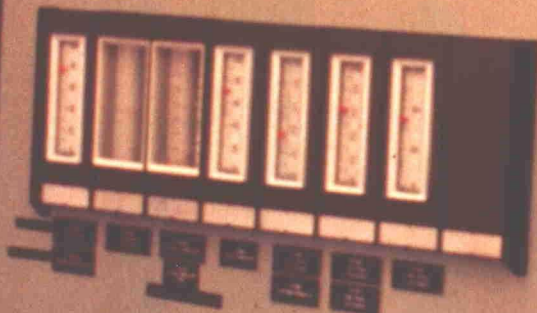
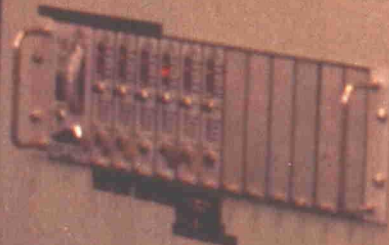
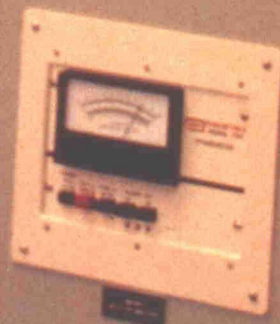
BDCDGU PHASE I FACILITY

View of control/annunciator panel

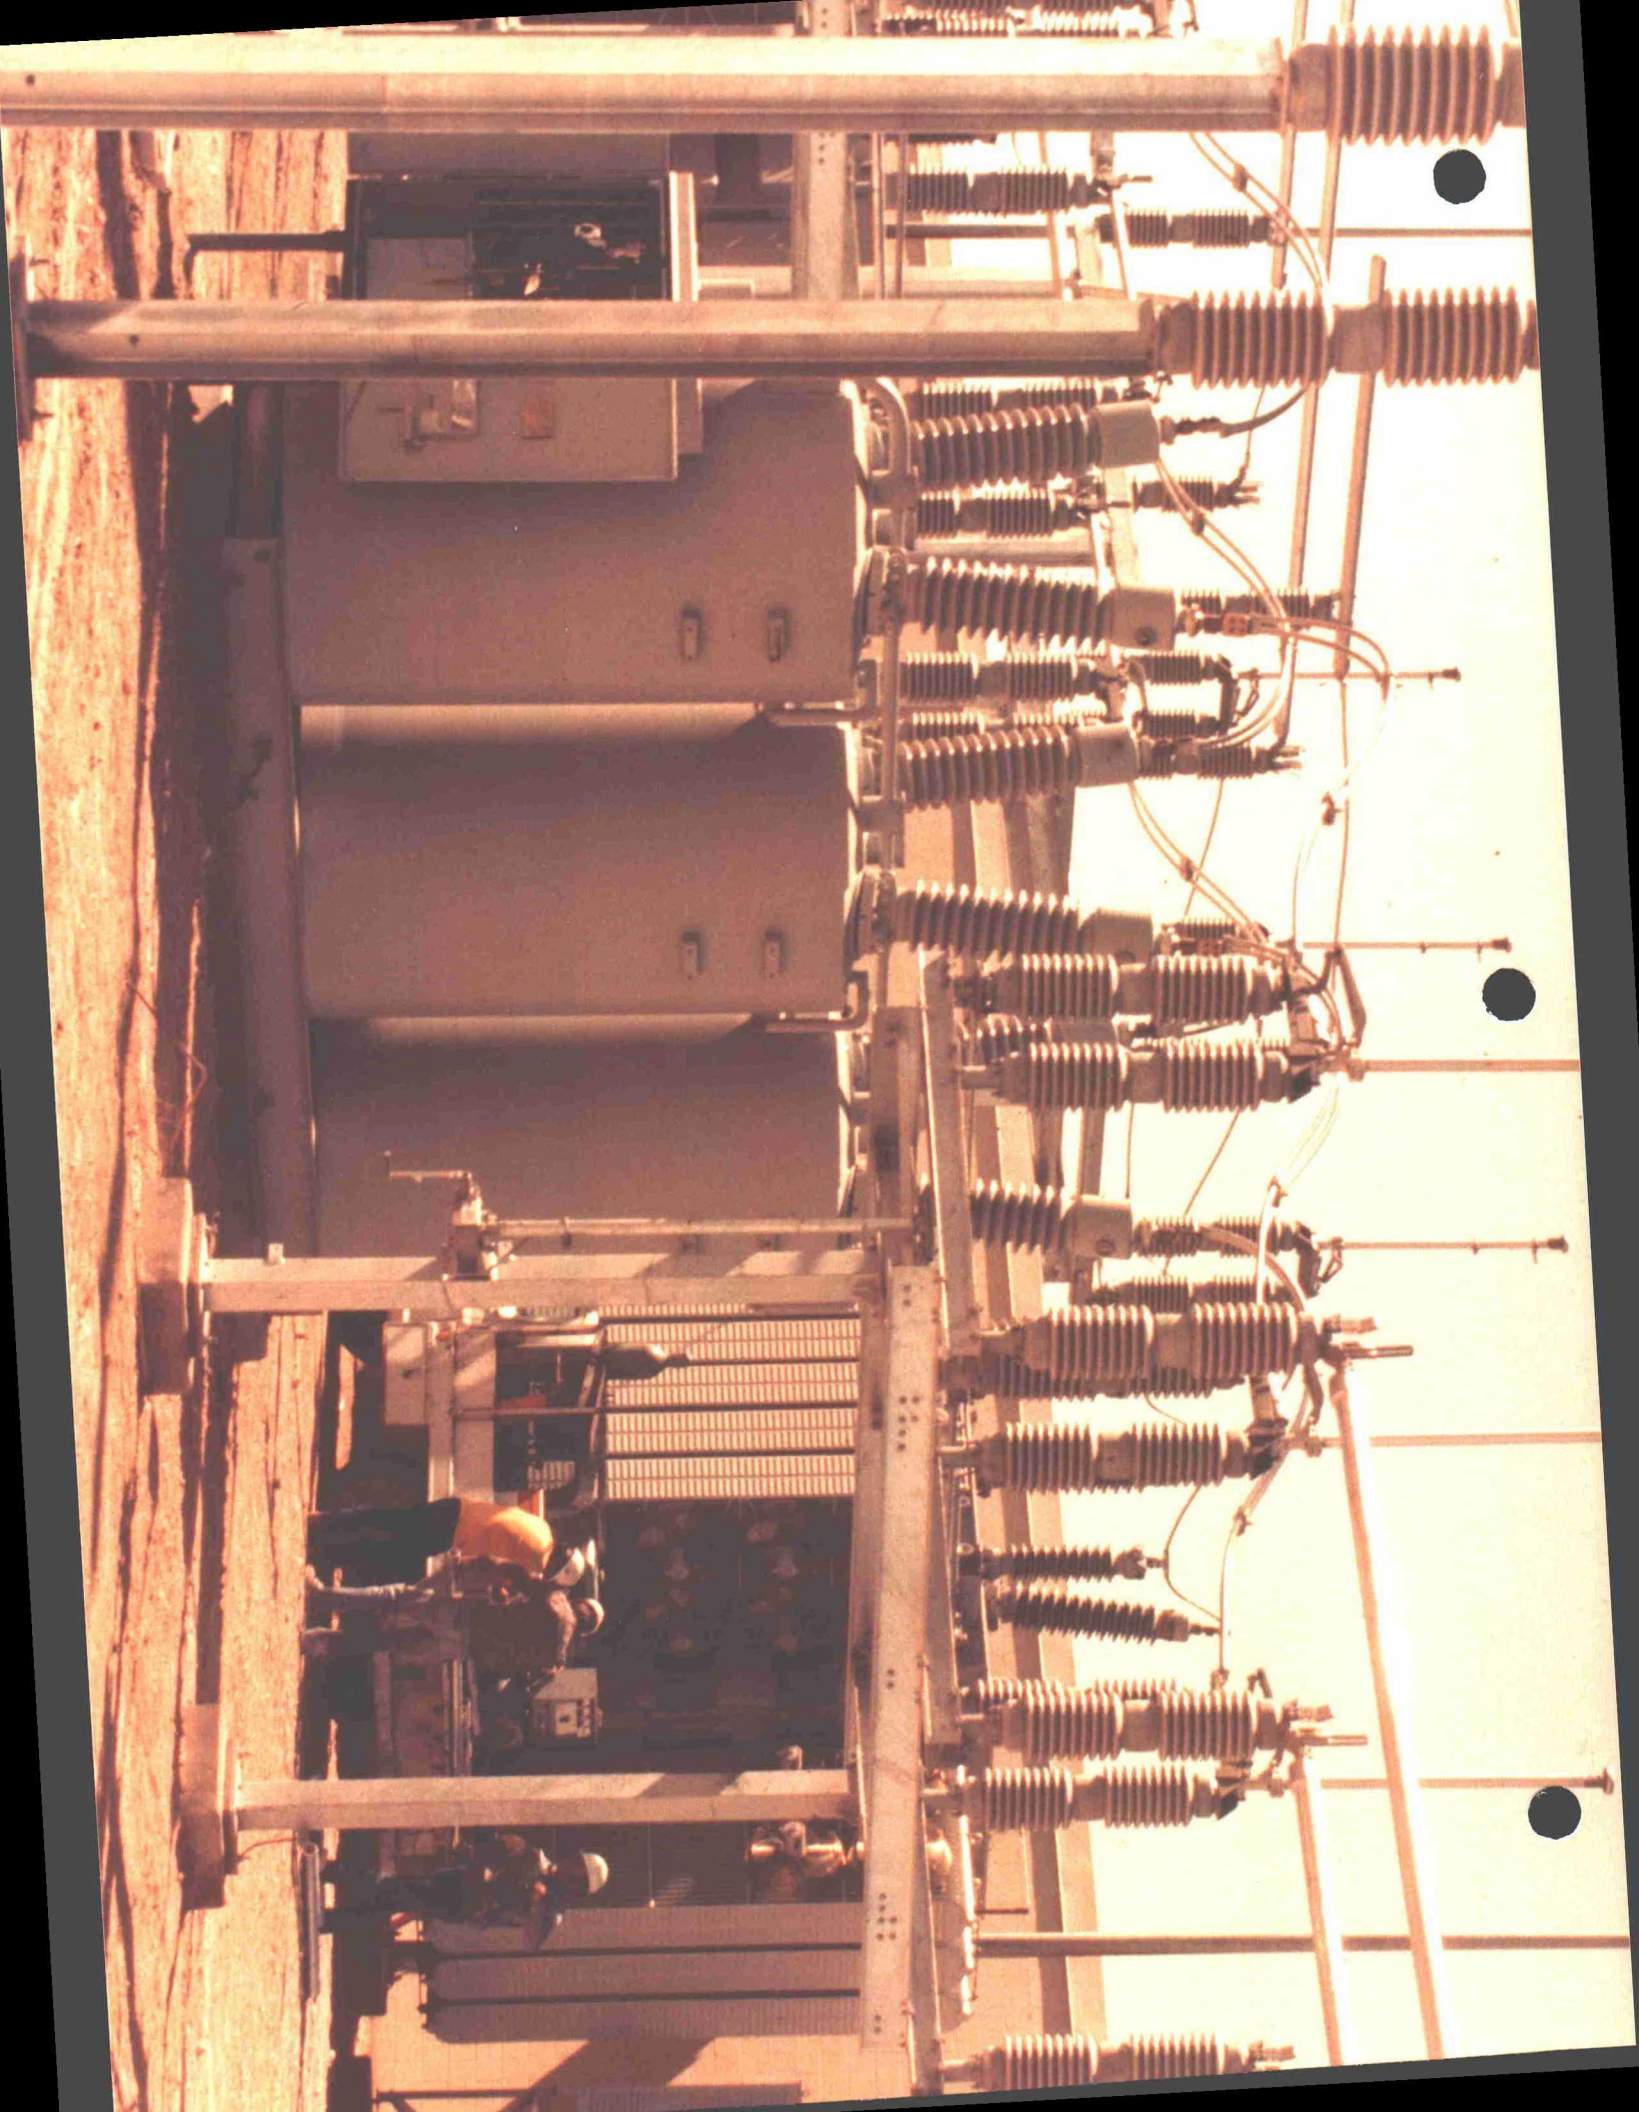
BDCDGU CENTRAL FACILITY

Central facility electric substation  
building and power line structures.

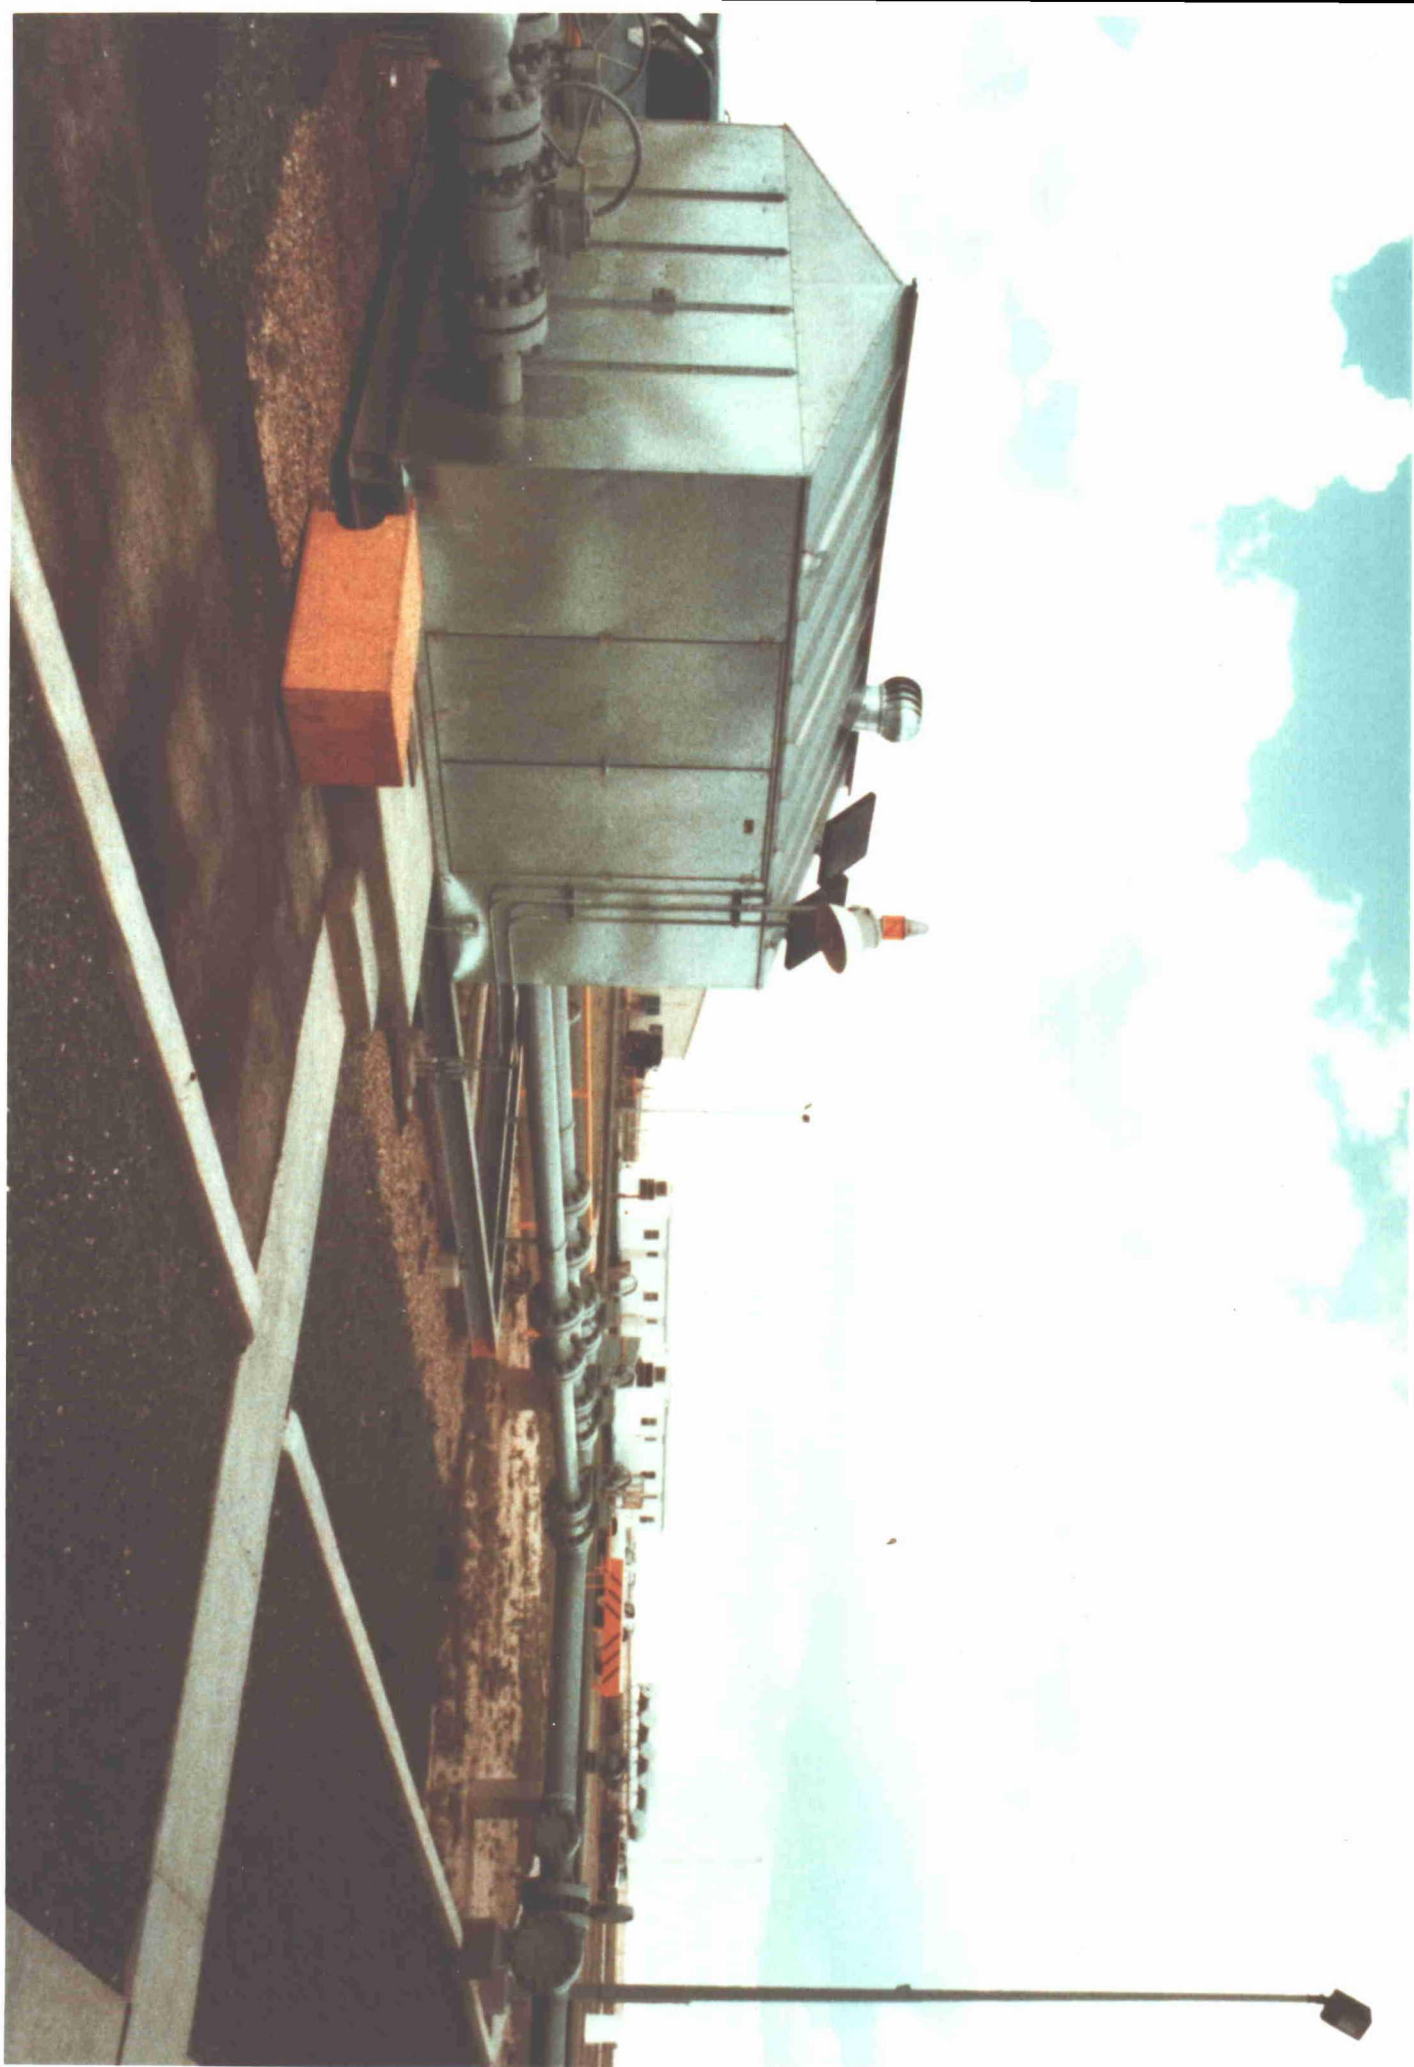
PHASE I FACILITY

Phase I sales meter house, with sales outlet to  
left & inlet to meter house from plant to right.

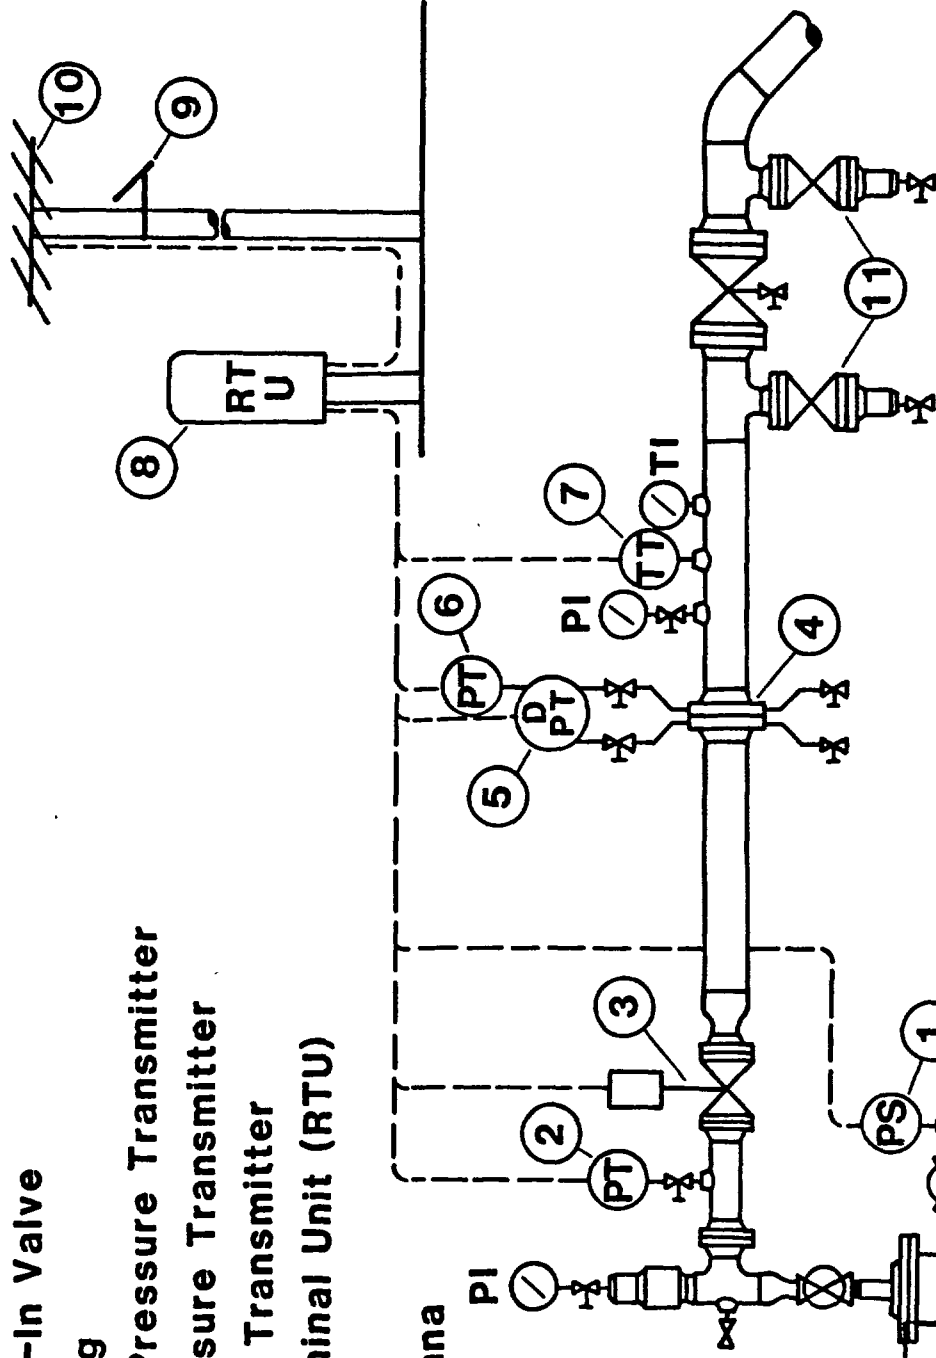
## Bravo Dome Producing Well Configuration

1. Casing Pressure Transmitter
2. Wellhead Pressure Transmitter
3. Remote Shut-In Valve
4. Orifice Fitting
5. Differential Pressure Transmitter
6. Flowing Pressure Transmitter
7. Temperature Transmitter
8. Remote Terminal Unit (RTU)
9. Solar Panel
10. Radio Antenna
11. Test Loop
