| BEFORE THE<br>OIL CONSERVATION COMMISSION<br>Sante Fe, New Mexico<br>Case No. <u>8289</u> Exhibit No. <u>10</u><br>Submitted by <u>AMOCO</u><br>Hearing Date <u>8-3-84</u> |

# Bravo Dome Carbon Dioxide Gas Unit Central Facility Layout

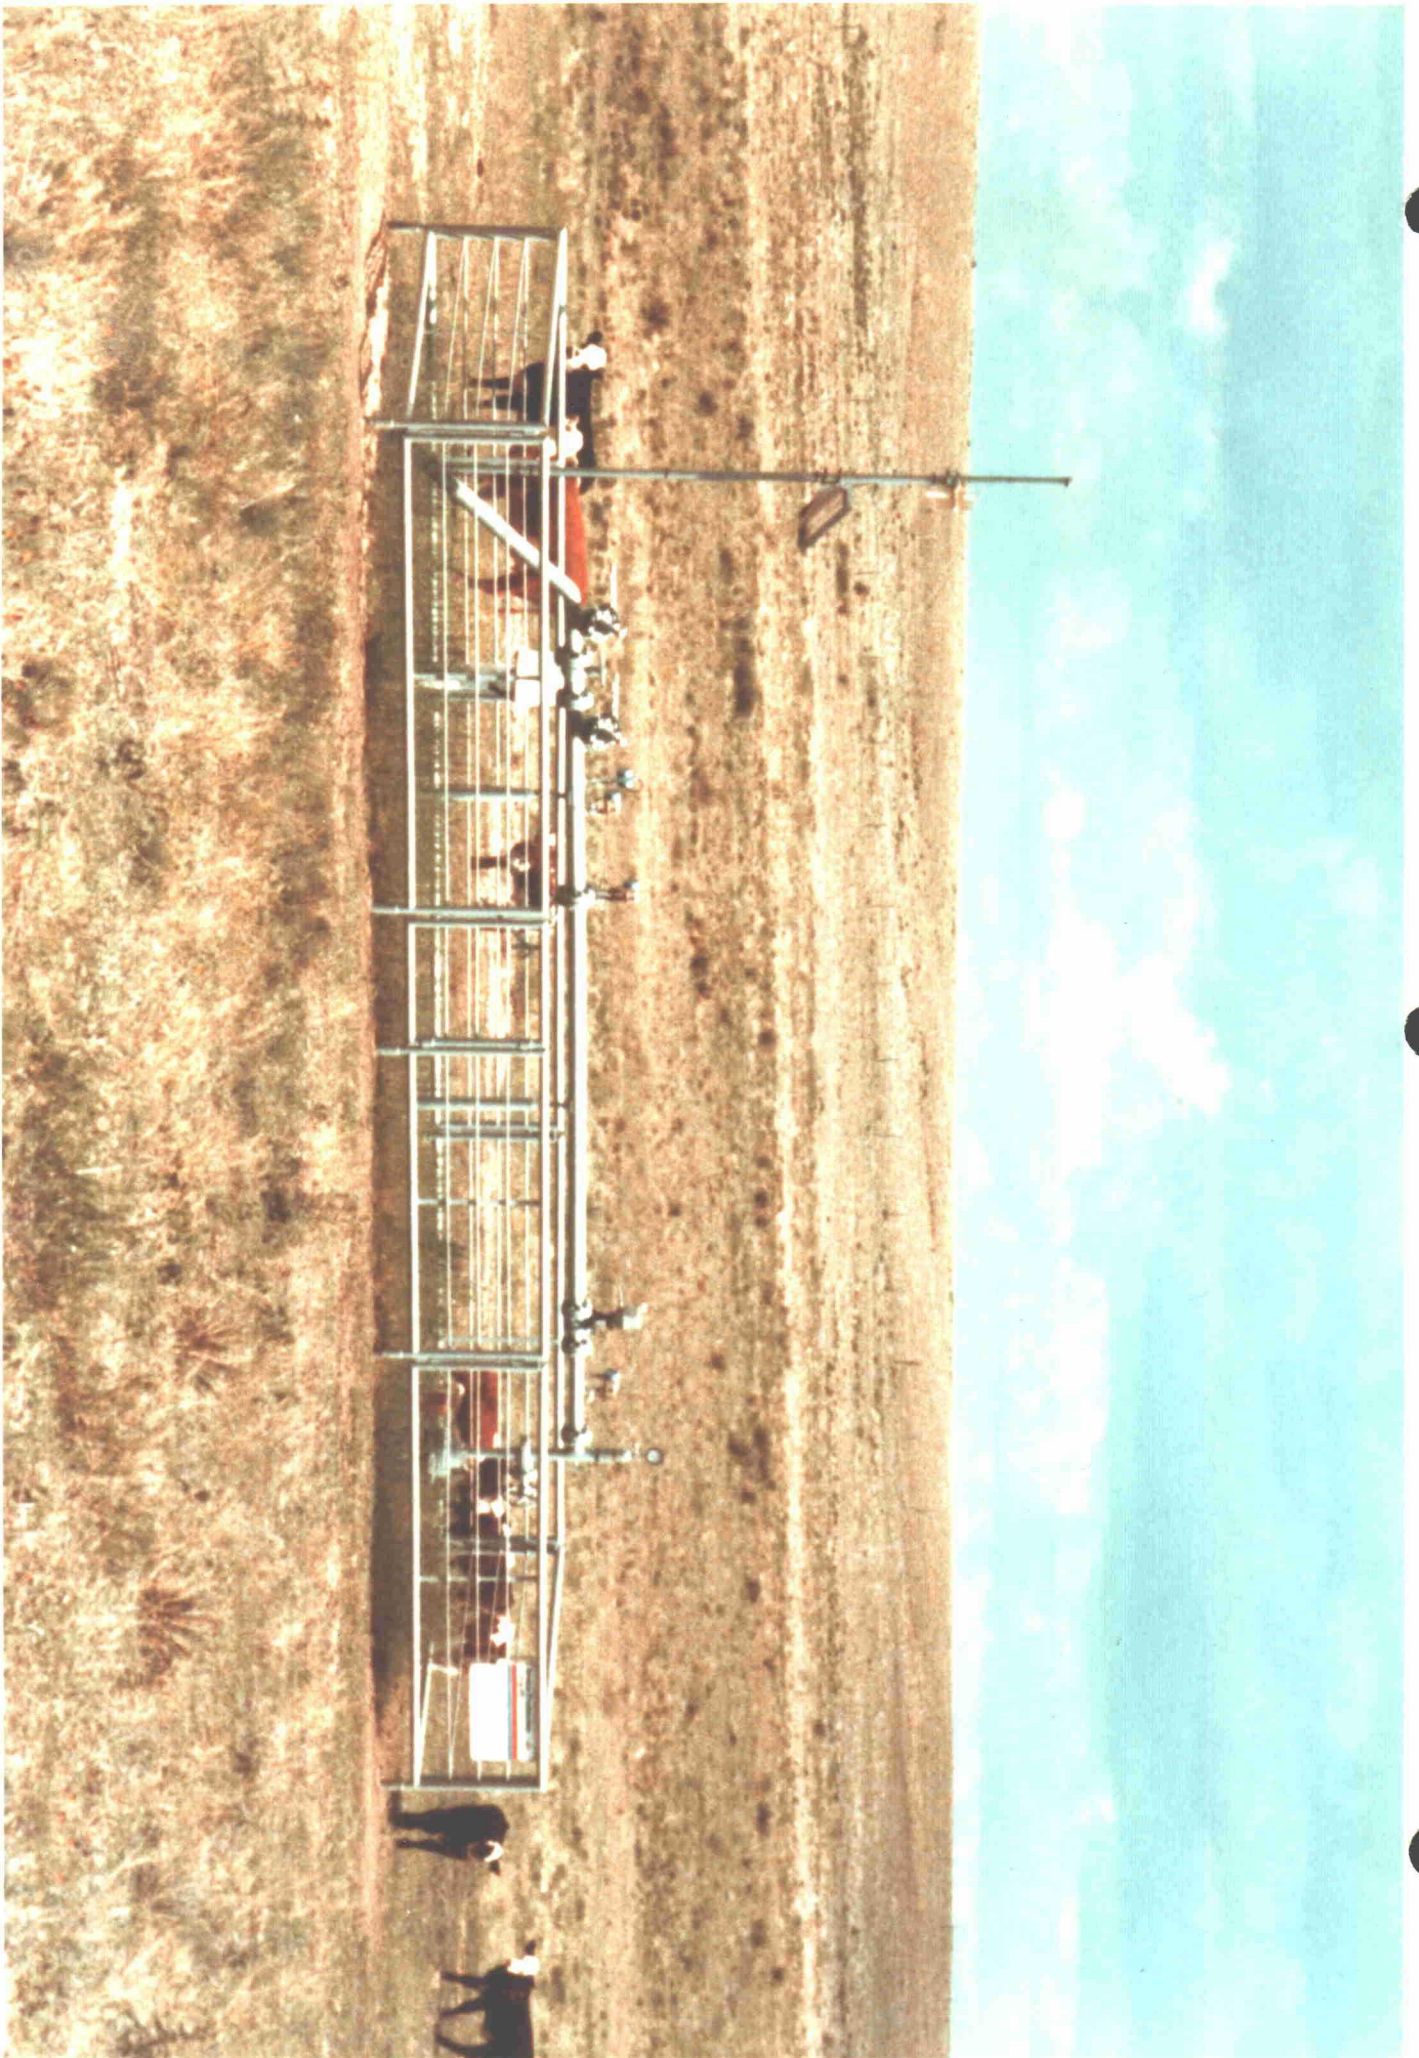
BDCDGU WELLSITE

Typical CO<sub>2</sub> producing wellhead installation  
showing meter run and solar powered automation  
system components.

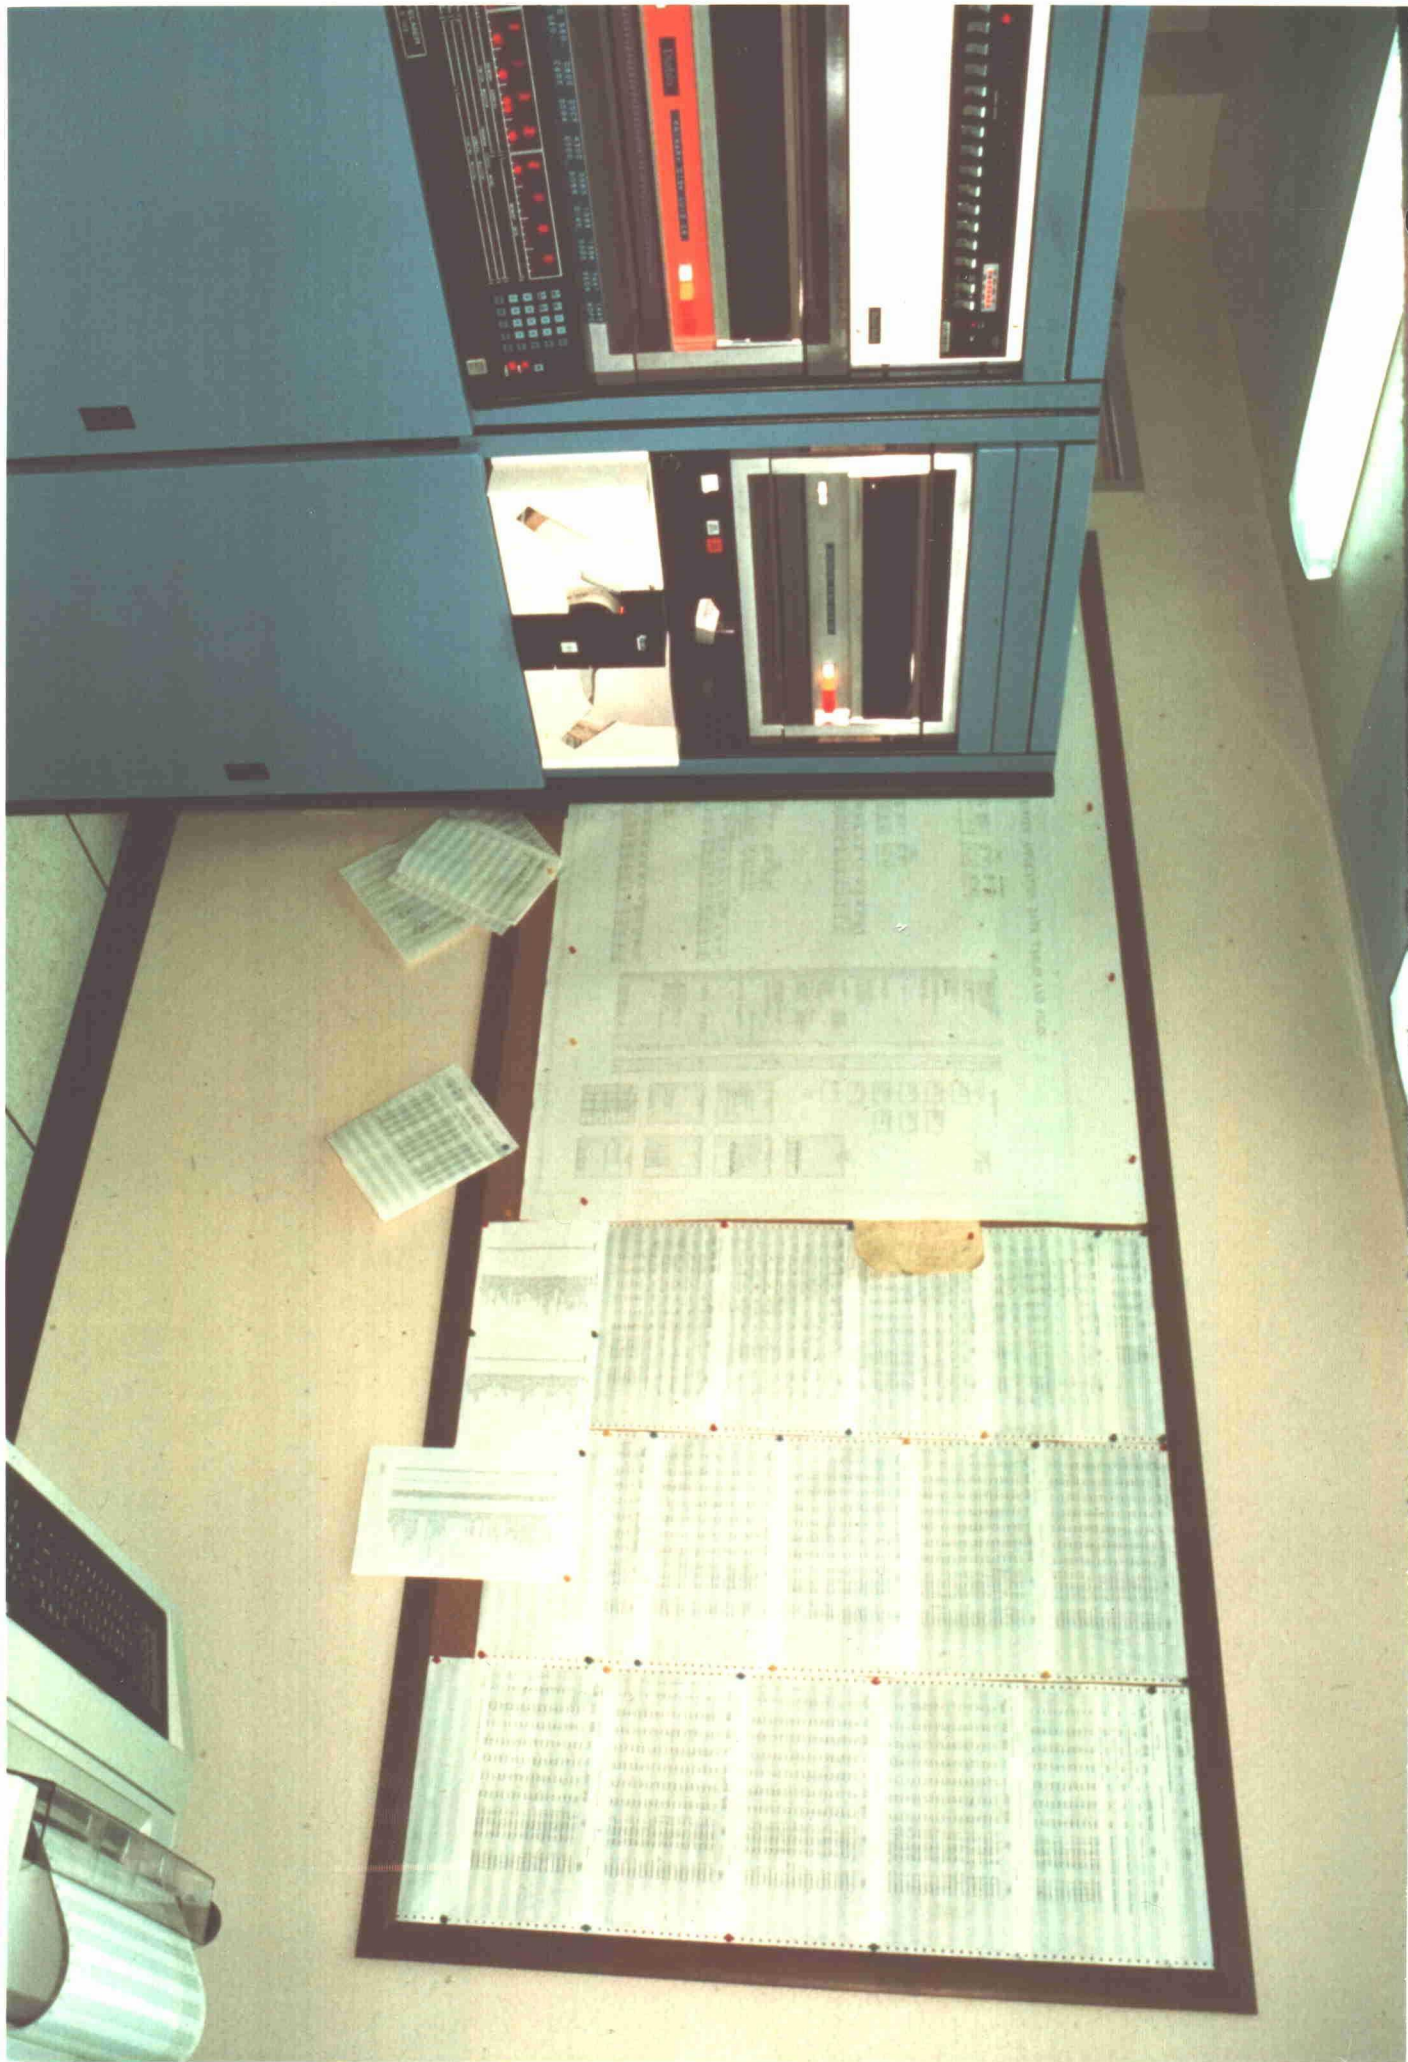
BDCDGU AUTOMATION

Perkin-Elmer automation computer located in the  
southeast station office building

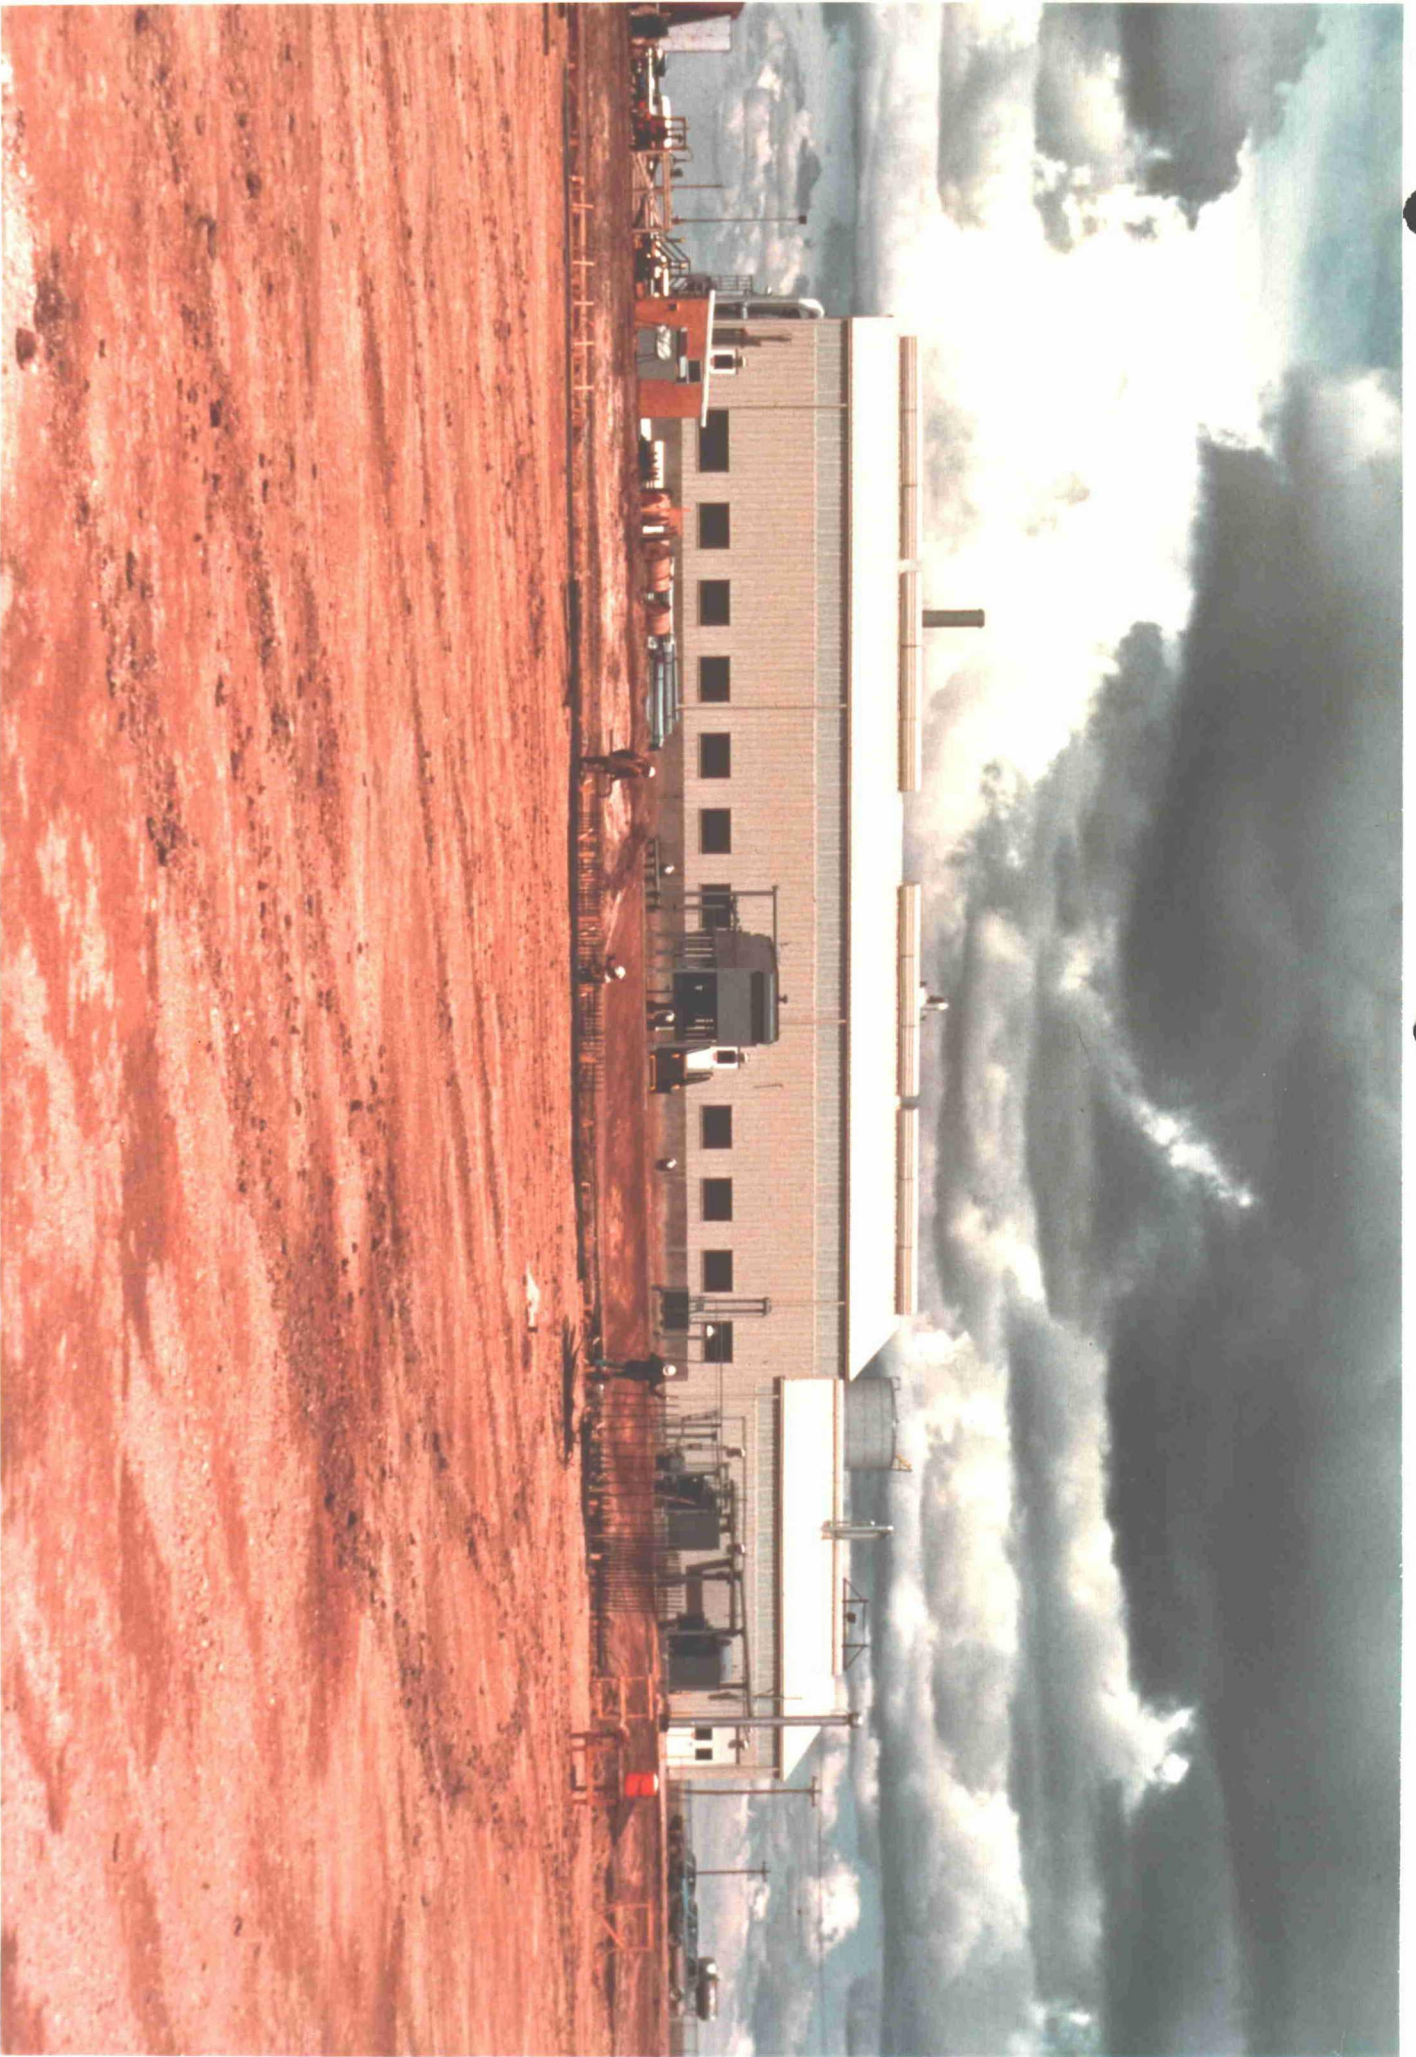
BDCDGU PHASE I & II

Phase II compressor foundation construction  
with Phase I compression building in background.

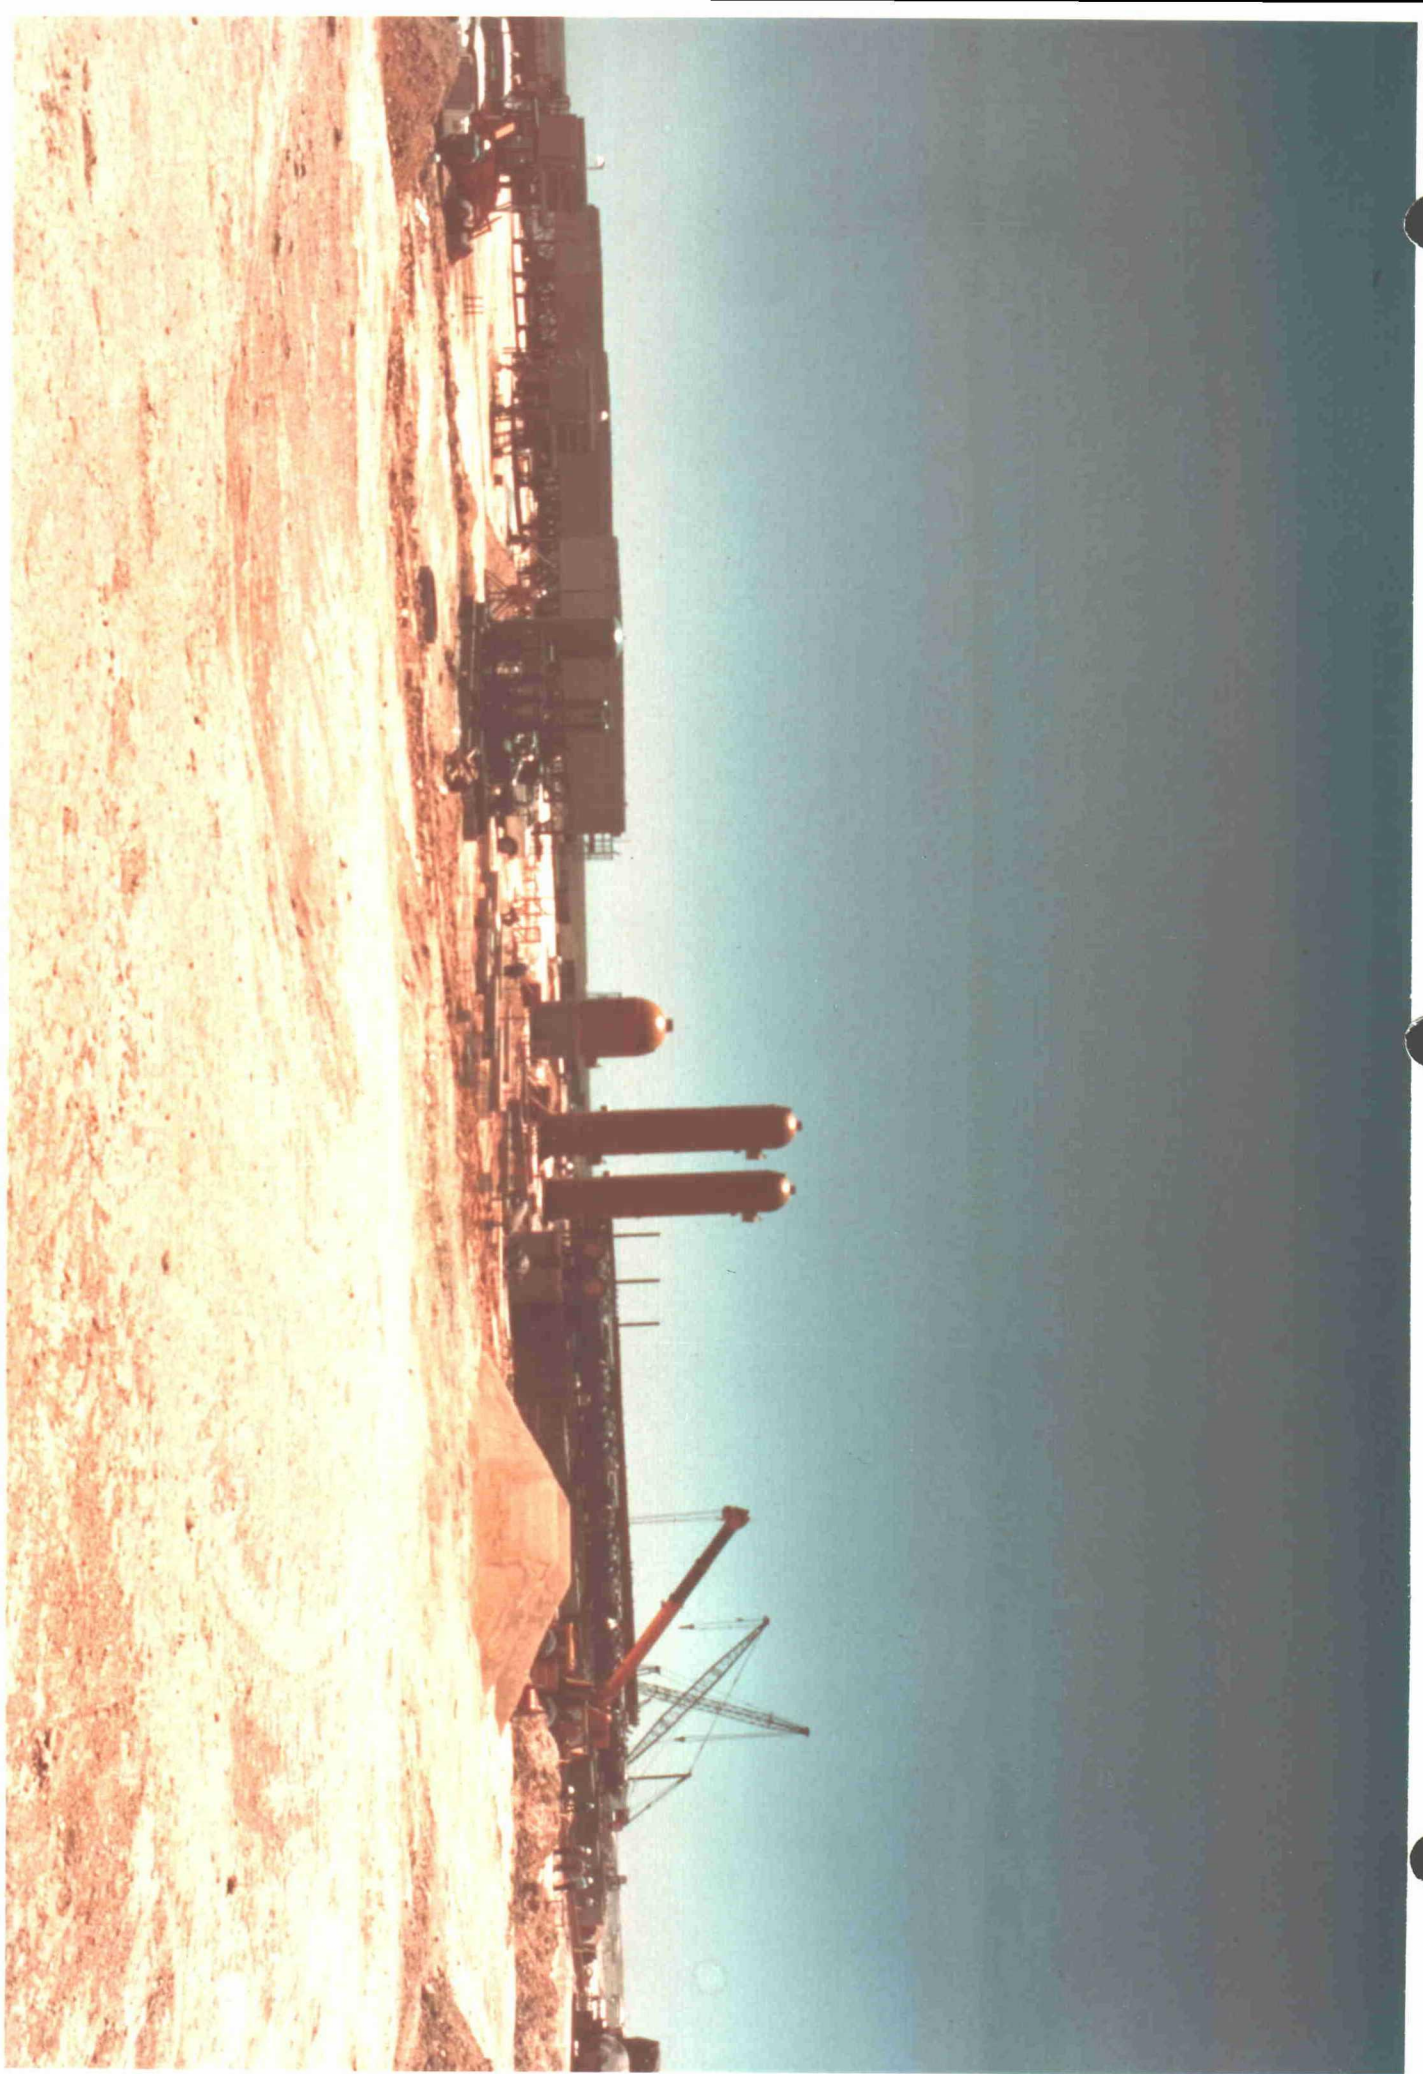
PHASE II FACILITY

Phase II construction area, coolers in background, instrument air skid in foreground, compressor frames to right, glycol contactors and scrubbers in center.

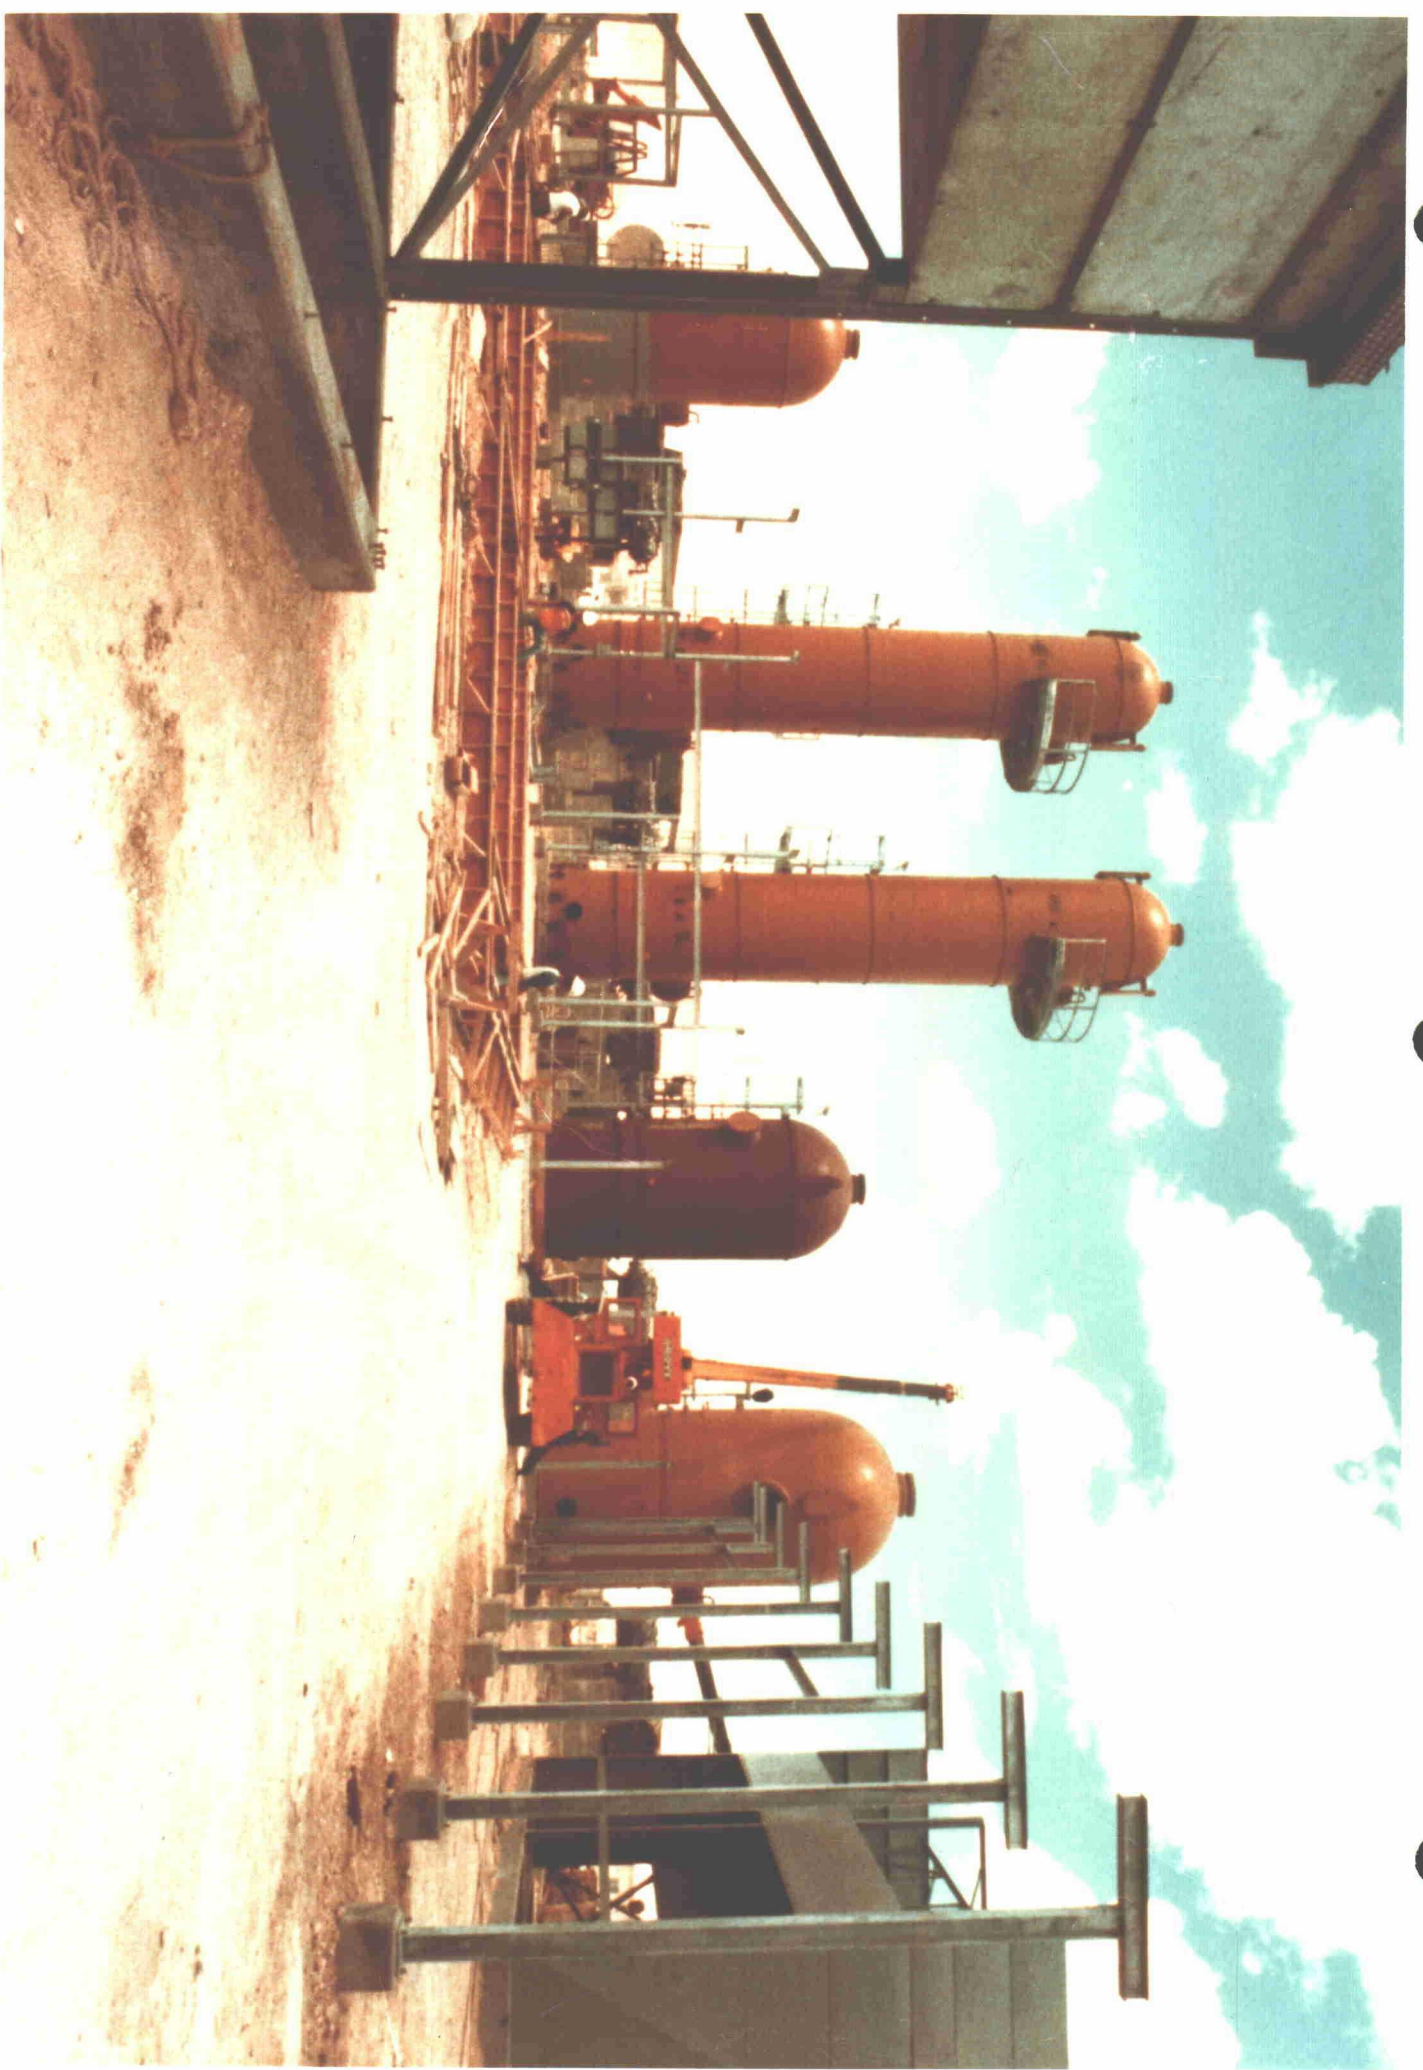
PHASE II FACILITY

Phase II scrubbers and glycol contactors  
during installation.

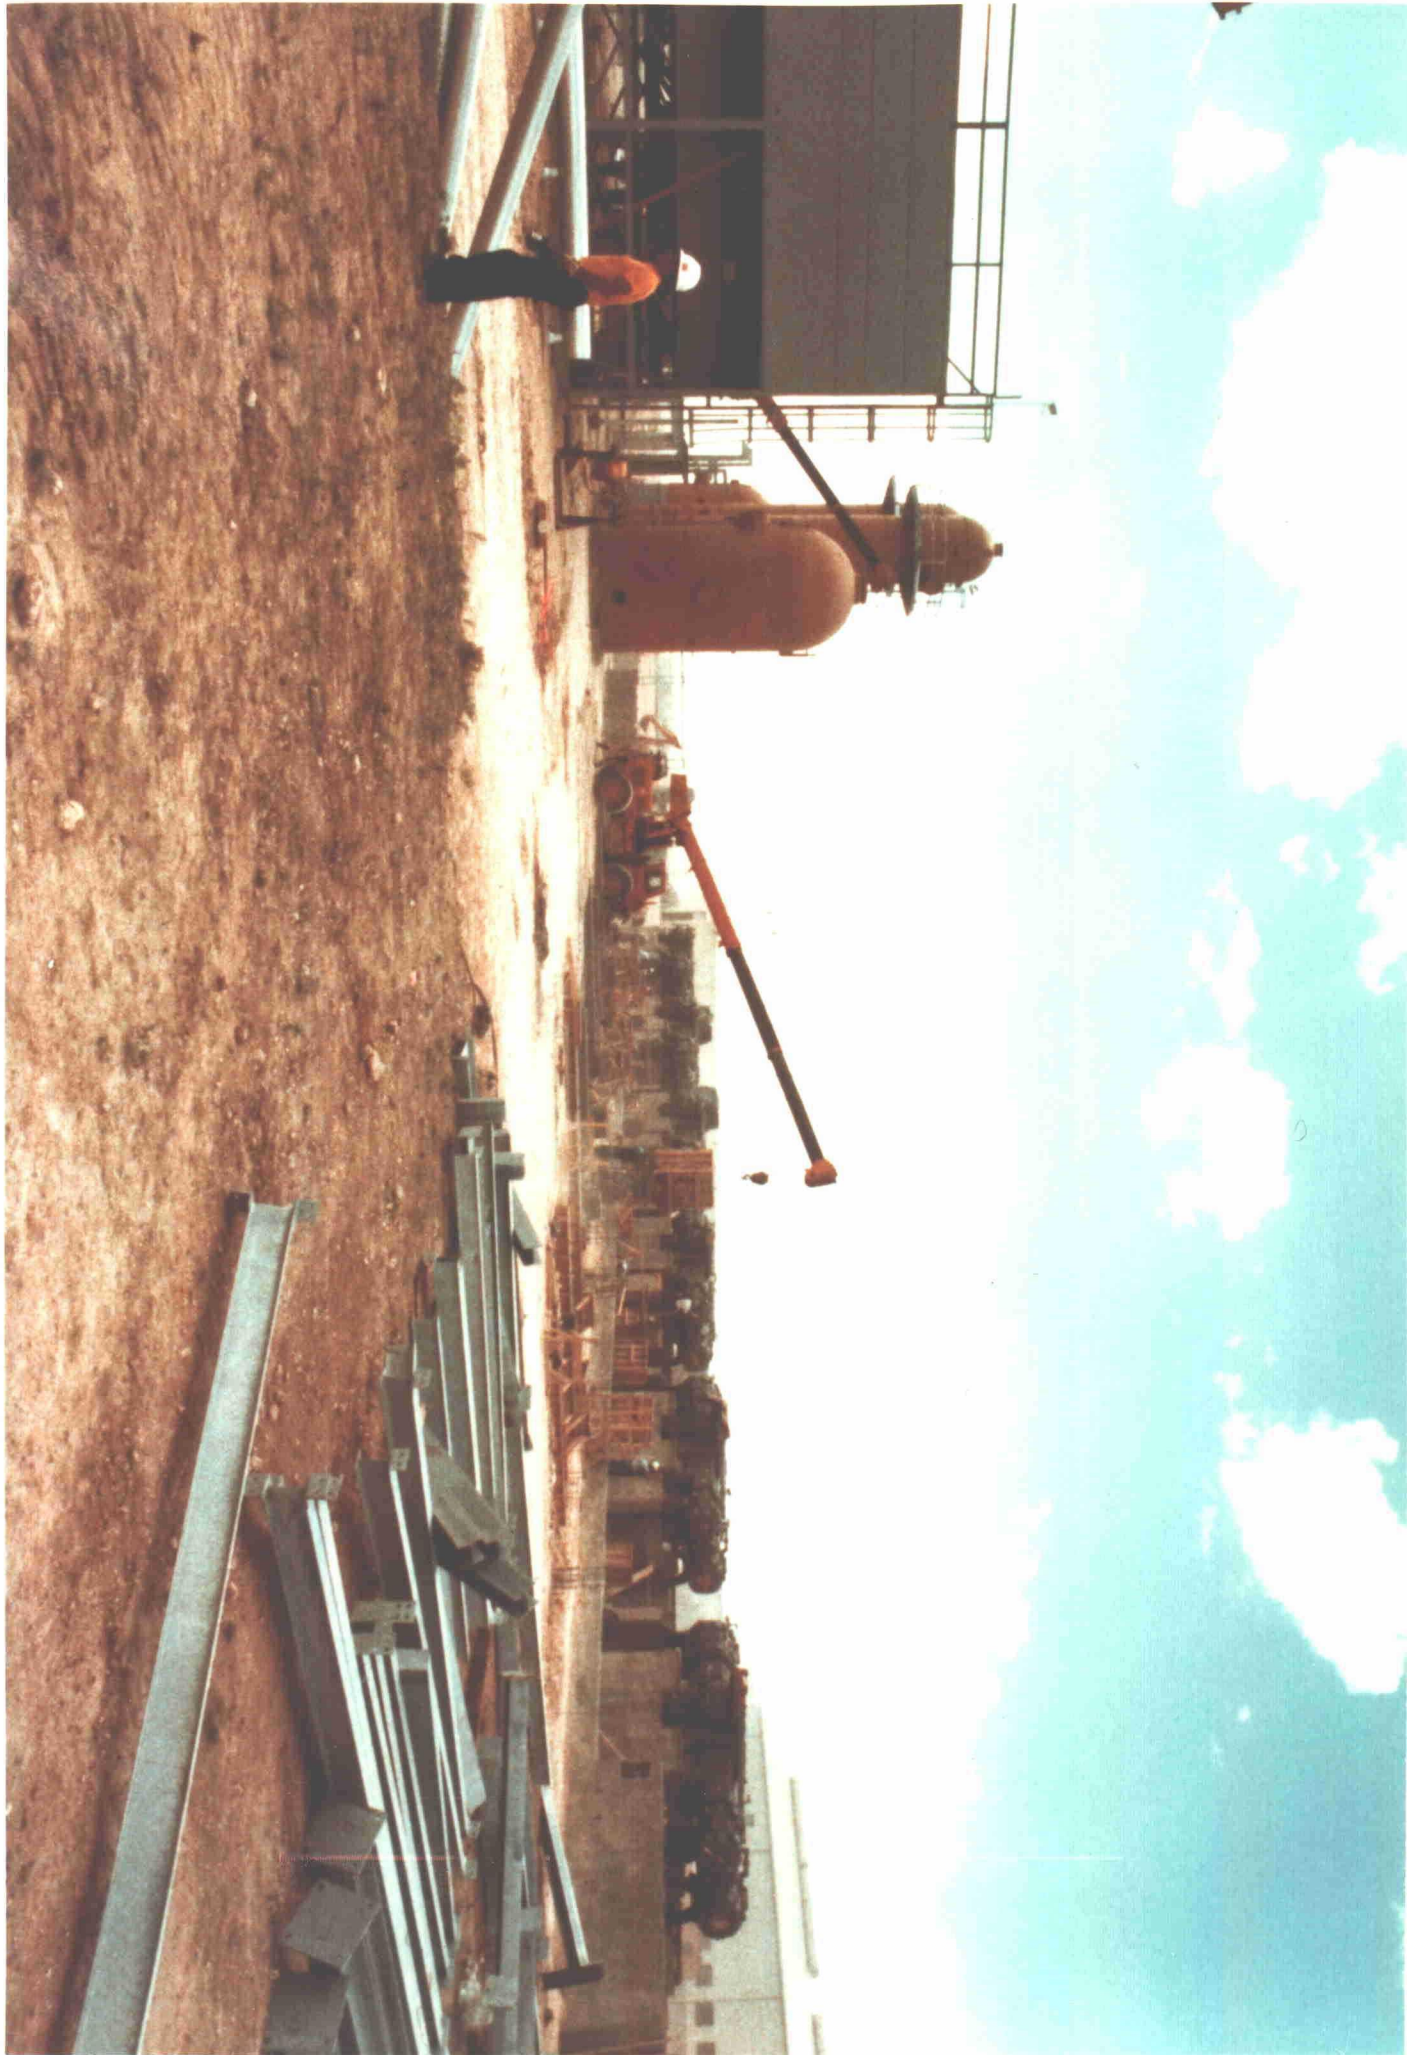
PHASE II FACILITY

Phase II plant construction shows six 8000 HP compressors (cylinder & frames) set on foundations.
