RE: Release Notification and Corrective Action (Form C-141)
Chevron Dollarhide Groundwater Project Site
Andrews County, Texas and Lea County, New Mexico

Release Notification and Corrective Action

PROPOSED MONITOR WELL LOCATION MAP
Chevron Environmental Management Company

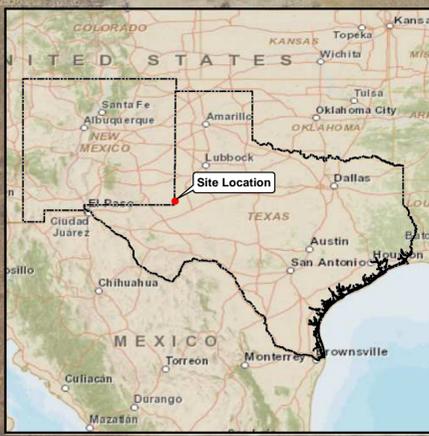
As discussed during our meeting, Chevron proposes to install eight new monitor wells on Chevron-owned property in New Mexico to assess groundwater quality with respect to chlorides and Total Dissolved Solids (TDS). These data points will provide additional information for the development of a conceptual site model. These monitor wells will be installed in accordance with State of New Mexico requirements and well permits will be obtained from the New Mexico Office of the State Engineer prior to initiating any field activities.
