AP__111__

C-141s

From: Moore, John <JMoore5@Marathonpetroleum.com>
Sent: Thursday, November 29, 2018 11:30 AM
To: Chavez, Carl J, EMNRD
Cc: Griswold, Jim, EMNRD; VanHorn, Kristen, NMENV
Subject: [EXT] RE: [EXTERNAL] FW: Release at Western Refining Southwest's Gallup Refinery
Attachments: 201811291103.pdf

Release Notification

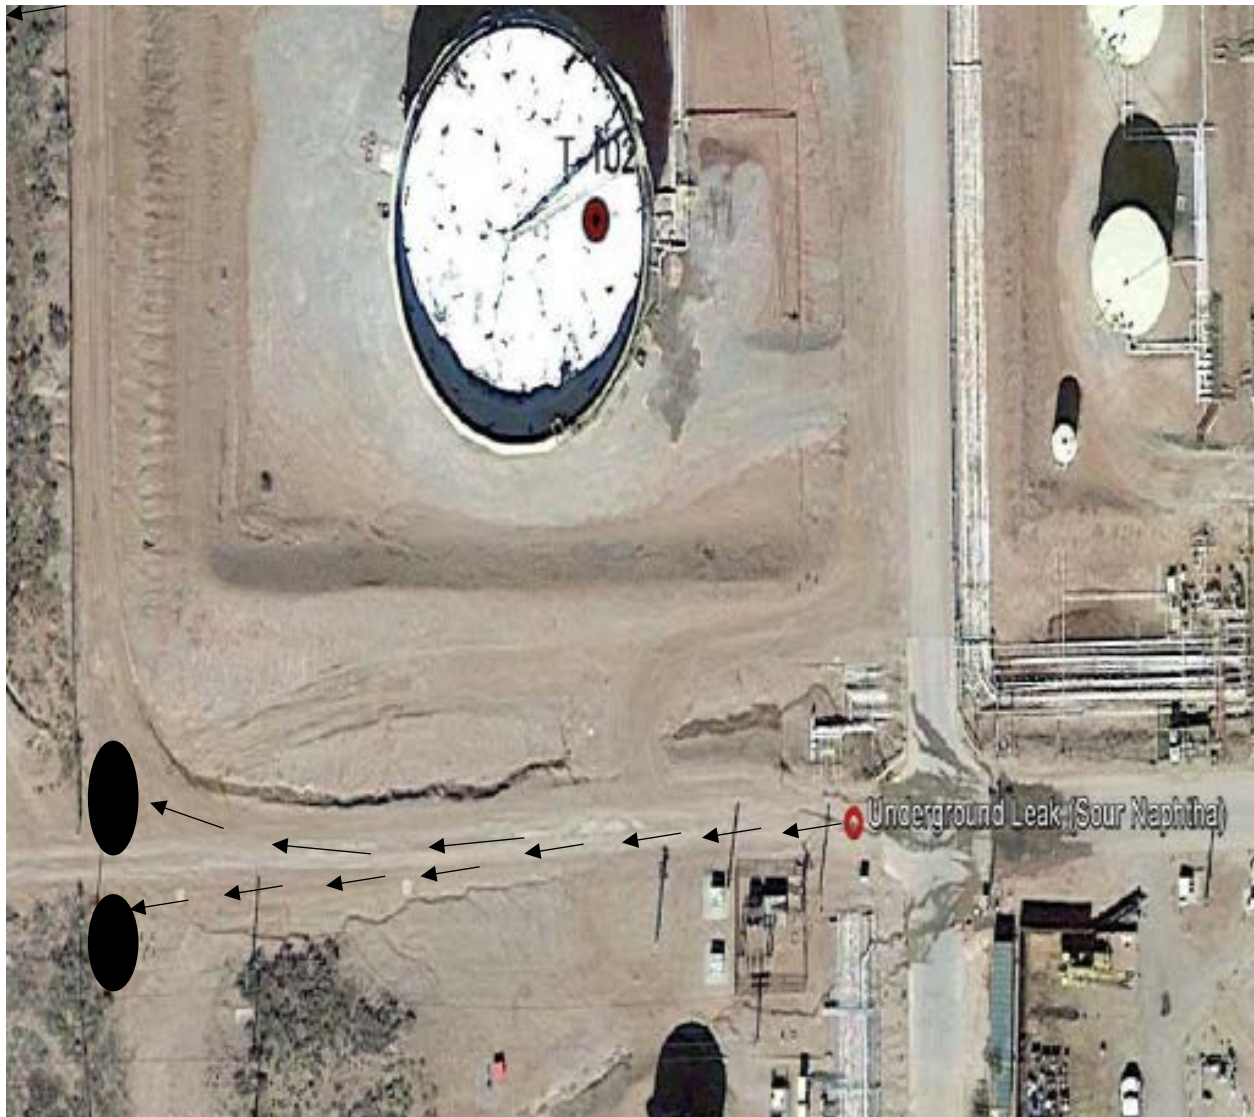
FIGURE 1

Describe Cause of Problem and Remedial Action Taken.* While operator was making his rounds, he smelled naphtha in the air and found a saturated area in the middle of the road where the naphtha was seeping up from the ground (See Figure 1,) and flowed in a westerly direction down the road for approximately 332 feet. Operator notified RSM, Environmental and Kurtz who responded by applying foam to the area to minimize vapors. Operator immediately isolated the line by blocking in valves. Area was isolated and taped off. Maintenance was notified to install earthen berms to control the flow of the spill. No injuries or fires were reported from this release.

Describe Area Affected and Cleanup Action Taken.* Area of the seep was approximately 4 ft x 4 ft section in the middle of the road. Area was excavated to a depth of 4 feet and found an underground 3 inch carbon steel pipe (sour naphtha line to Tank 567) with a 1 inch corroded hole. Maintenance replaced the damaged section of the line. The impacted soil surrounding the area was excavated and placed inside 30 yard bins for disposal. Six locations inside the excavated area were sampled (Figure 2) and sent off for analysis. Based on the analytical (Attachment A), the soil was treated as a hazardous waste (D018), soil with Benzene and sent offsite for disposal. Copies of the manifest are attached (Attachment B). The area was backfilled with clean soil and roadway was re-opened. All impacted soil from the spill was cleaned up from the site and disposed of.

Flow of sour naphtha leak – downward slope of road in a westerly direction.

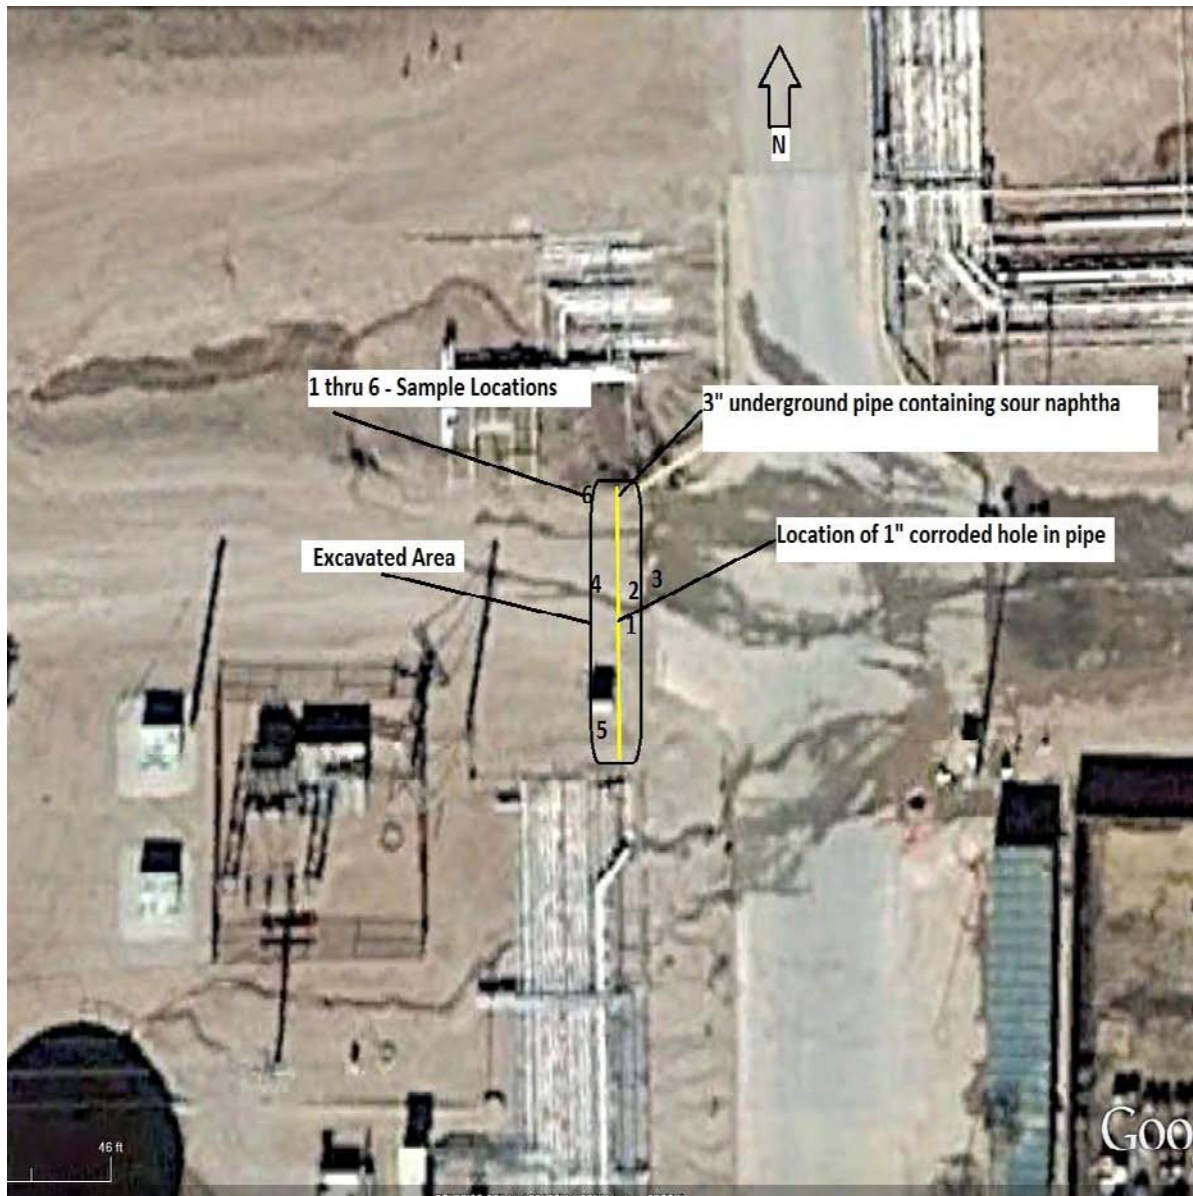
FIGURE 2

Sample Locations:

1. Bottom near break
2. Bottom near break
3. East wall near break
4. West wall near break
5. West wall (8 to 10 ft.) from break
6. West wall (8 to 10 ft.) from break

Pipe: 3" carbon steel pipe with a 1 inch diameter corroded hole.

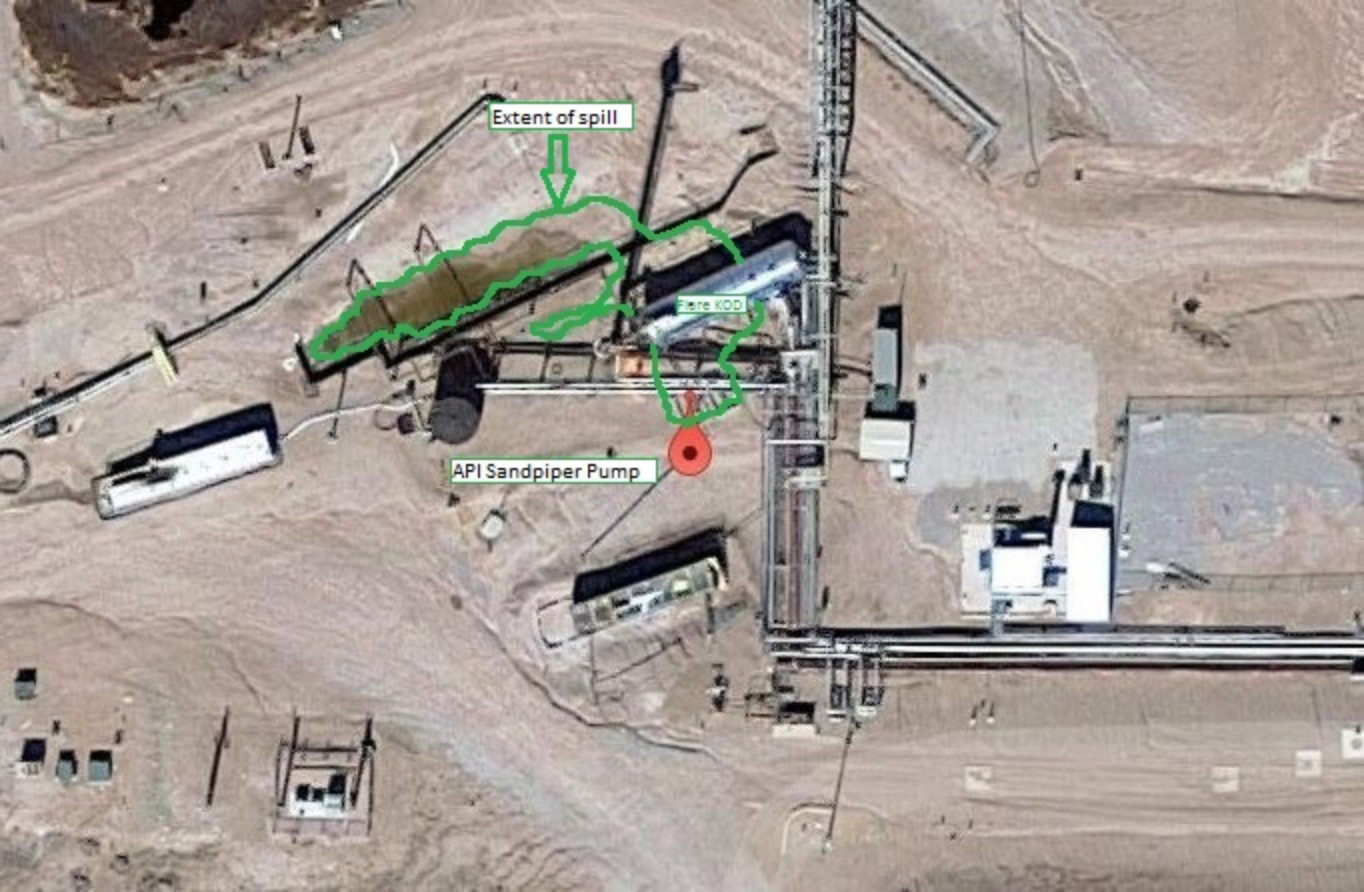
Attached please find our initial C-141 Report for the Sodium Hydroxide leak/spill we had at Western Refining – Gallup on 4/20/2017. Also attached is a picture of the location and extent of the spill, and the SDS for the Sodium Hydroxide we have on site.

At 2130 hr on 4/20/2017, during regular rounds, operator noticed the hose to the sandpiper pump had ruptured. Caustic (20-30% sodium hydroxide - SDS attached) was spraying out of the hole. Previous round of the area at approximately 1900 hr on 4/20/2017 had shown no problem with this pump hose. The operator who found the leak donned the proper PPE, turned off the sandpiper, and blocked it in. The shift foreman, refinery manager, and Environmental Department were notified of the incident. Maintenance pumped approximately 20-30 gallons of caustic into a vacuum truck. Initial estimates of the leak were less than 4 bbls. Maintenance also sprayed water on surrounding equipment in an attempt to clean off the caustic. Pumping of the caustic was switched to the east caustic pump. The area was taped off with barricade tape to limit access. After further investigation the following morning, it was apparent that the leak was larger than first thought.

Extent of spill

Fire KOD
