**Re: Submittal of Investigation Work Plan North Drainage Ditch (April 2019)**  
**WESTERN REFINING SOUTHWEST INC., GALLUP REFINERY**  
**EPA ID# NMD000333211**

# Investigation Work Plan North Drainage Ditch Area

Gallup Refinery  
Marathon Petroleum Company  
Gallup, New Mexico

**APRIL 2019**

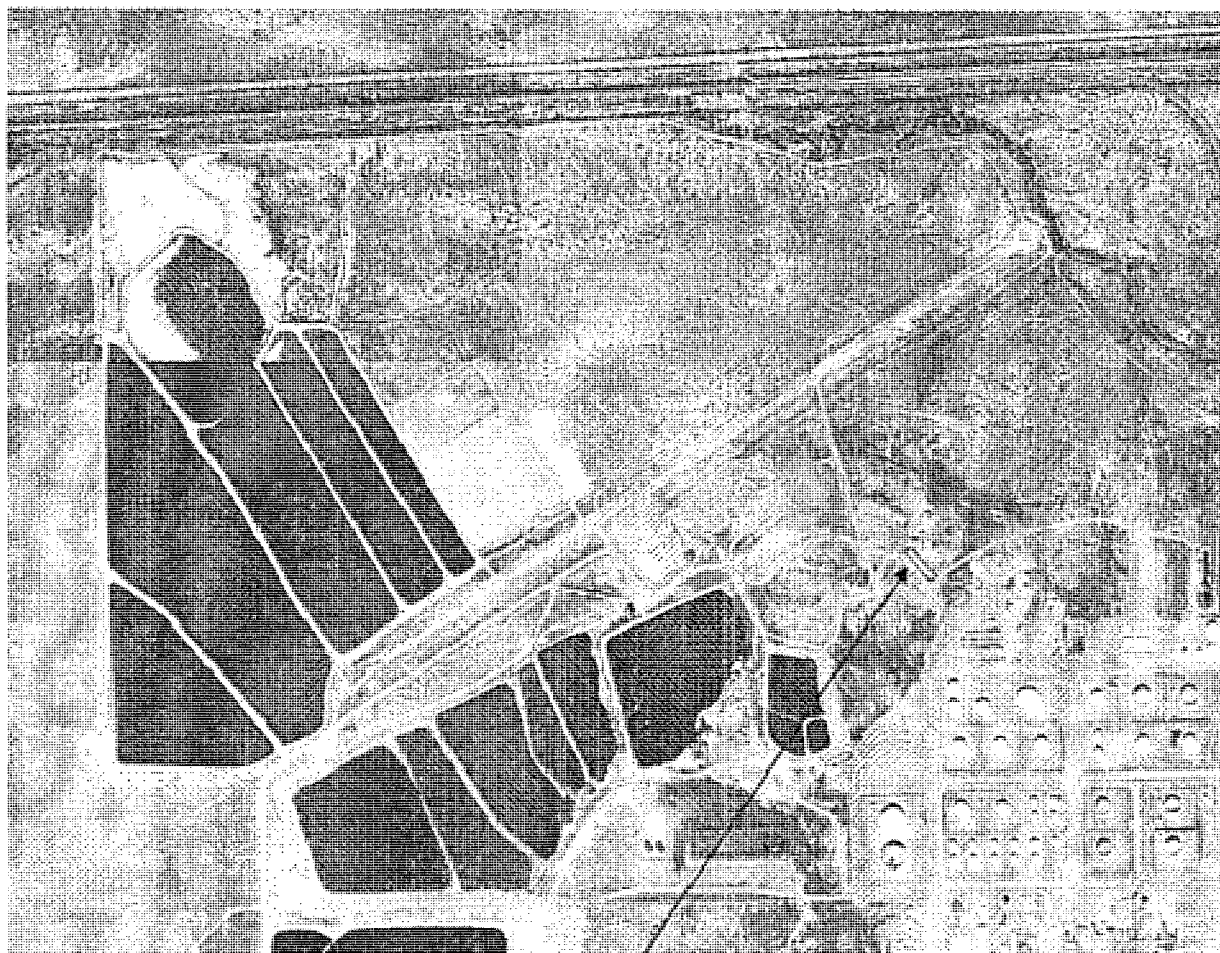
Approximate location of ditch – not to scale

Describe Cause of Problem and Remedial Action Taken.\* At approximately 1:30 pm on 10/19/2009, during a routine walk-through of arroyos and ditches in a field that lies immediately north of the hill on which the refinery is located, a ditch containing non-moving water was found to have some possible hydrocarbon staining – suspected from color of the water and smell of diesel.

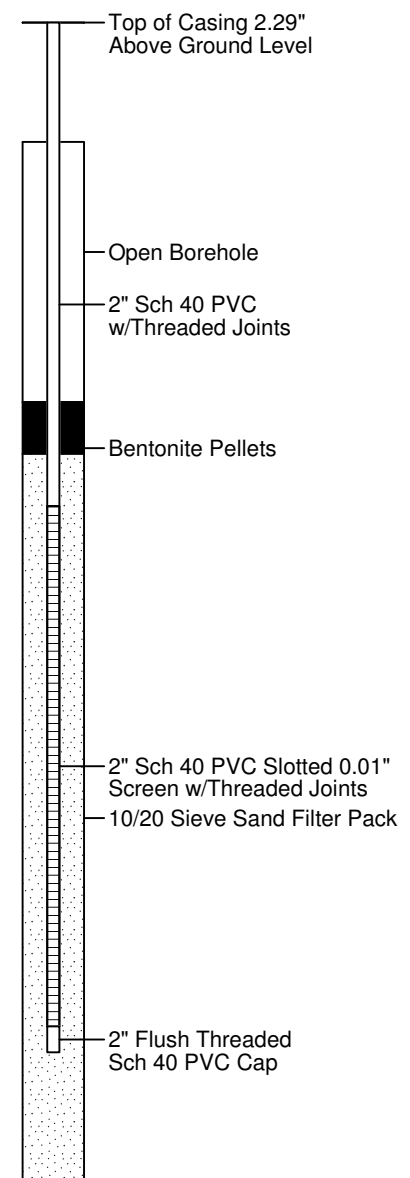
TEMP WELL NO. NDD-4

## Temporary Well Settings

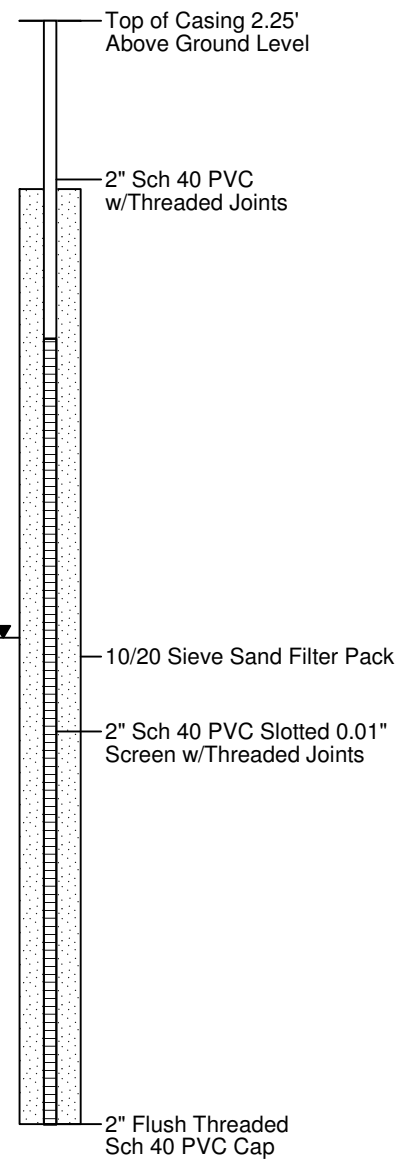
TEMP WELL NO. NDD-6

## Temporary Well Settings
