GW - 1

REPORTS

Giant Refining Company

Northern Boundary Barrier

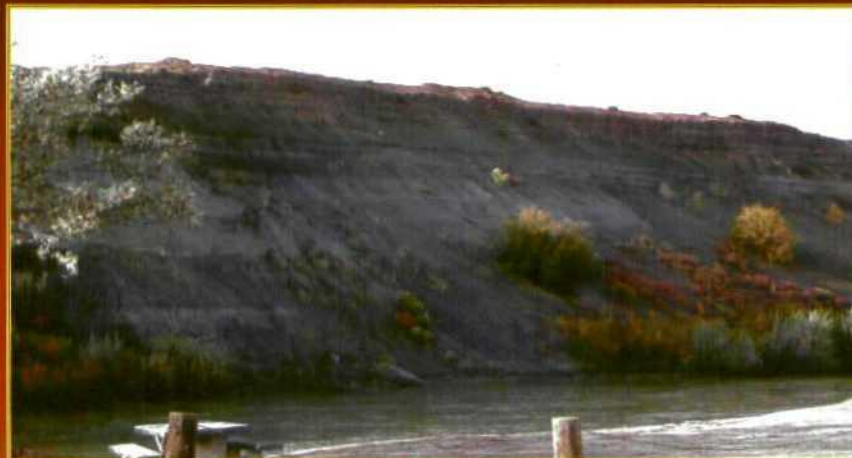
Stratigraphic Section

- **Surficial Windblown Sands**

- Depth: 0 to 4 feet deep near Hammond Ditch
- Permeability: Low to Moderate
- Saturation: Dry

- **Jackson Lake Terrace**

- Depth: 6 to 10 feet deep near Hammond Ditch
- Permeability: Moderate to High
- Saturation: Dry to 1-foot depth; water bearing
- Seeps located in erosional channels

- **Nacimiento Formation**

- Perching unit for Jackson Lake Terrace
- Thickness: Approximately 900 feet
- Permeability: Low
- Saturation: Non-water bearing
- Well defined below facility

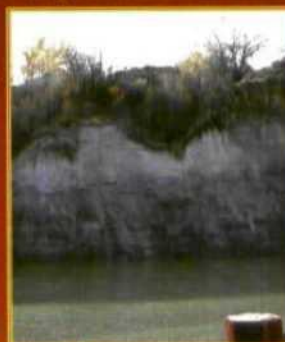
Monitoring Results Along Northern Boundary

- Separate Phase Hydrocarbon (SPH) not detected in 9 of 15 wells.
- Product thickness measured in 6 of 15 wells range between .05 to 1.05 ft.
- Product thickness appears over-estimated.
- Pump tests and slug tests dry-up wells, confirming minimal fluid levels on top of the Nacimiento Formation.
- Isolated seeps discharge very little water
