Volume II:
**Discharge Plan Application, Site Investigation
and Abatement Plan**

GIANT BLOOMFIELD REFINERY

Prepared for:
Giant Refining Company
P.O. Box 159
Bloomfield, New Mexico 87413

R.T. HICKS CONSULTANTS, LTD.

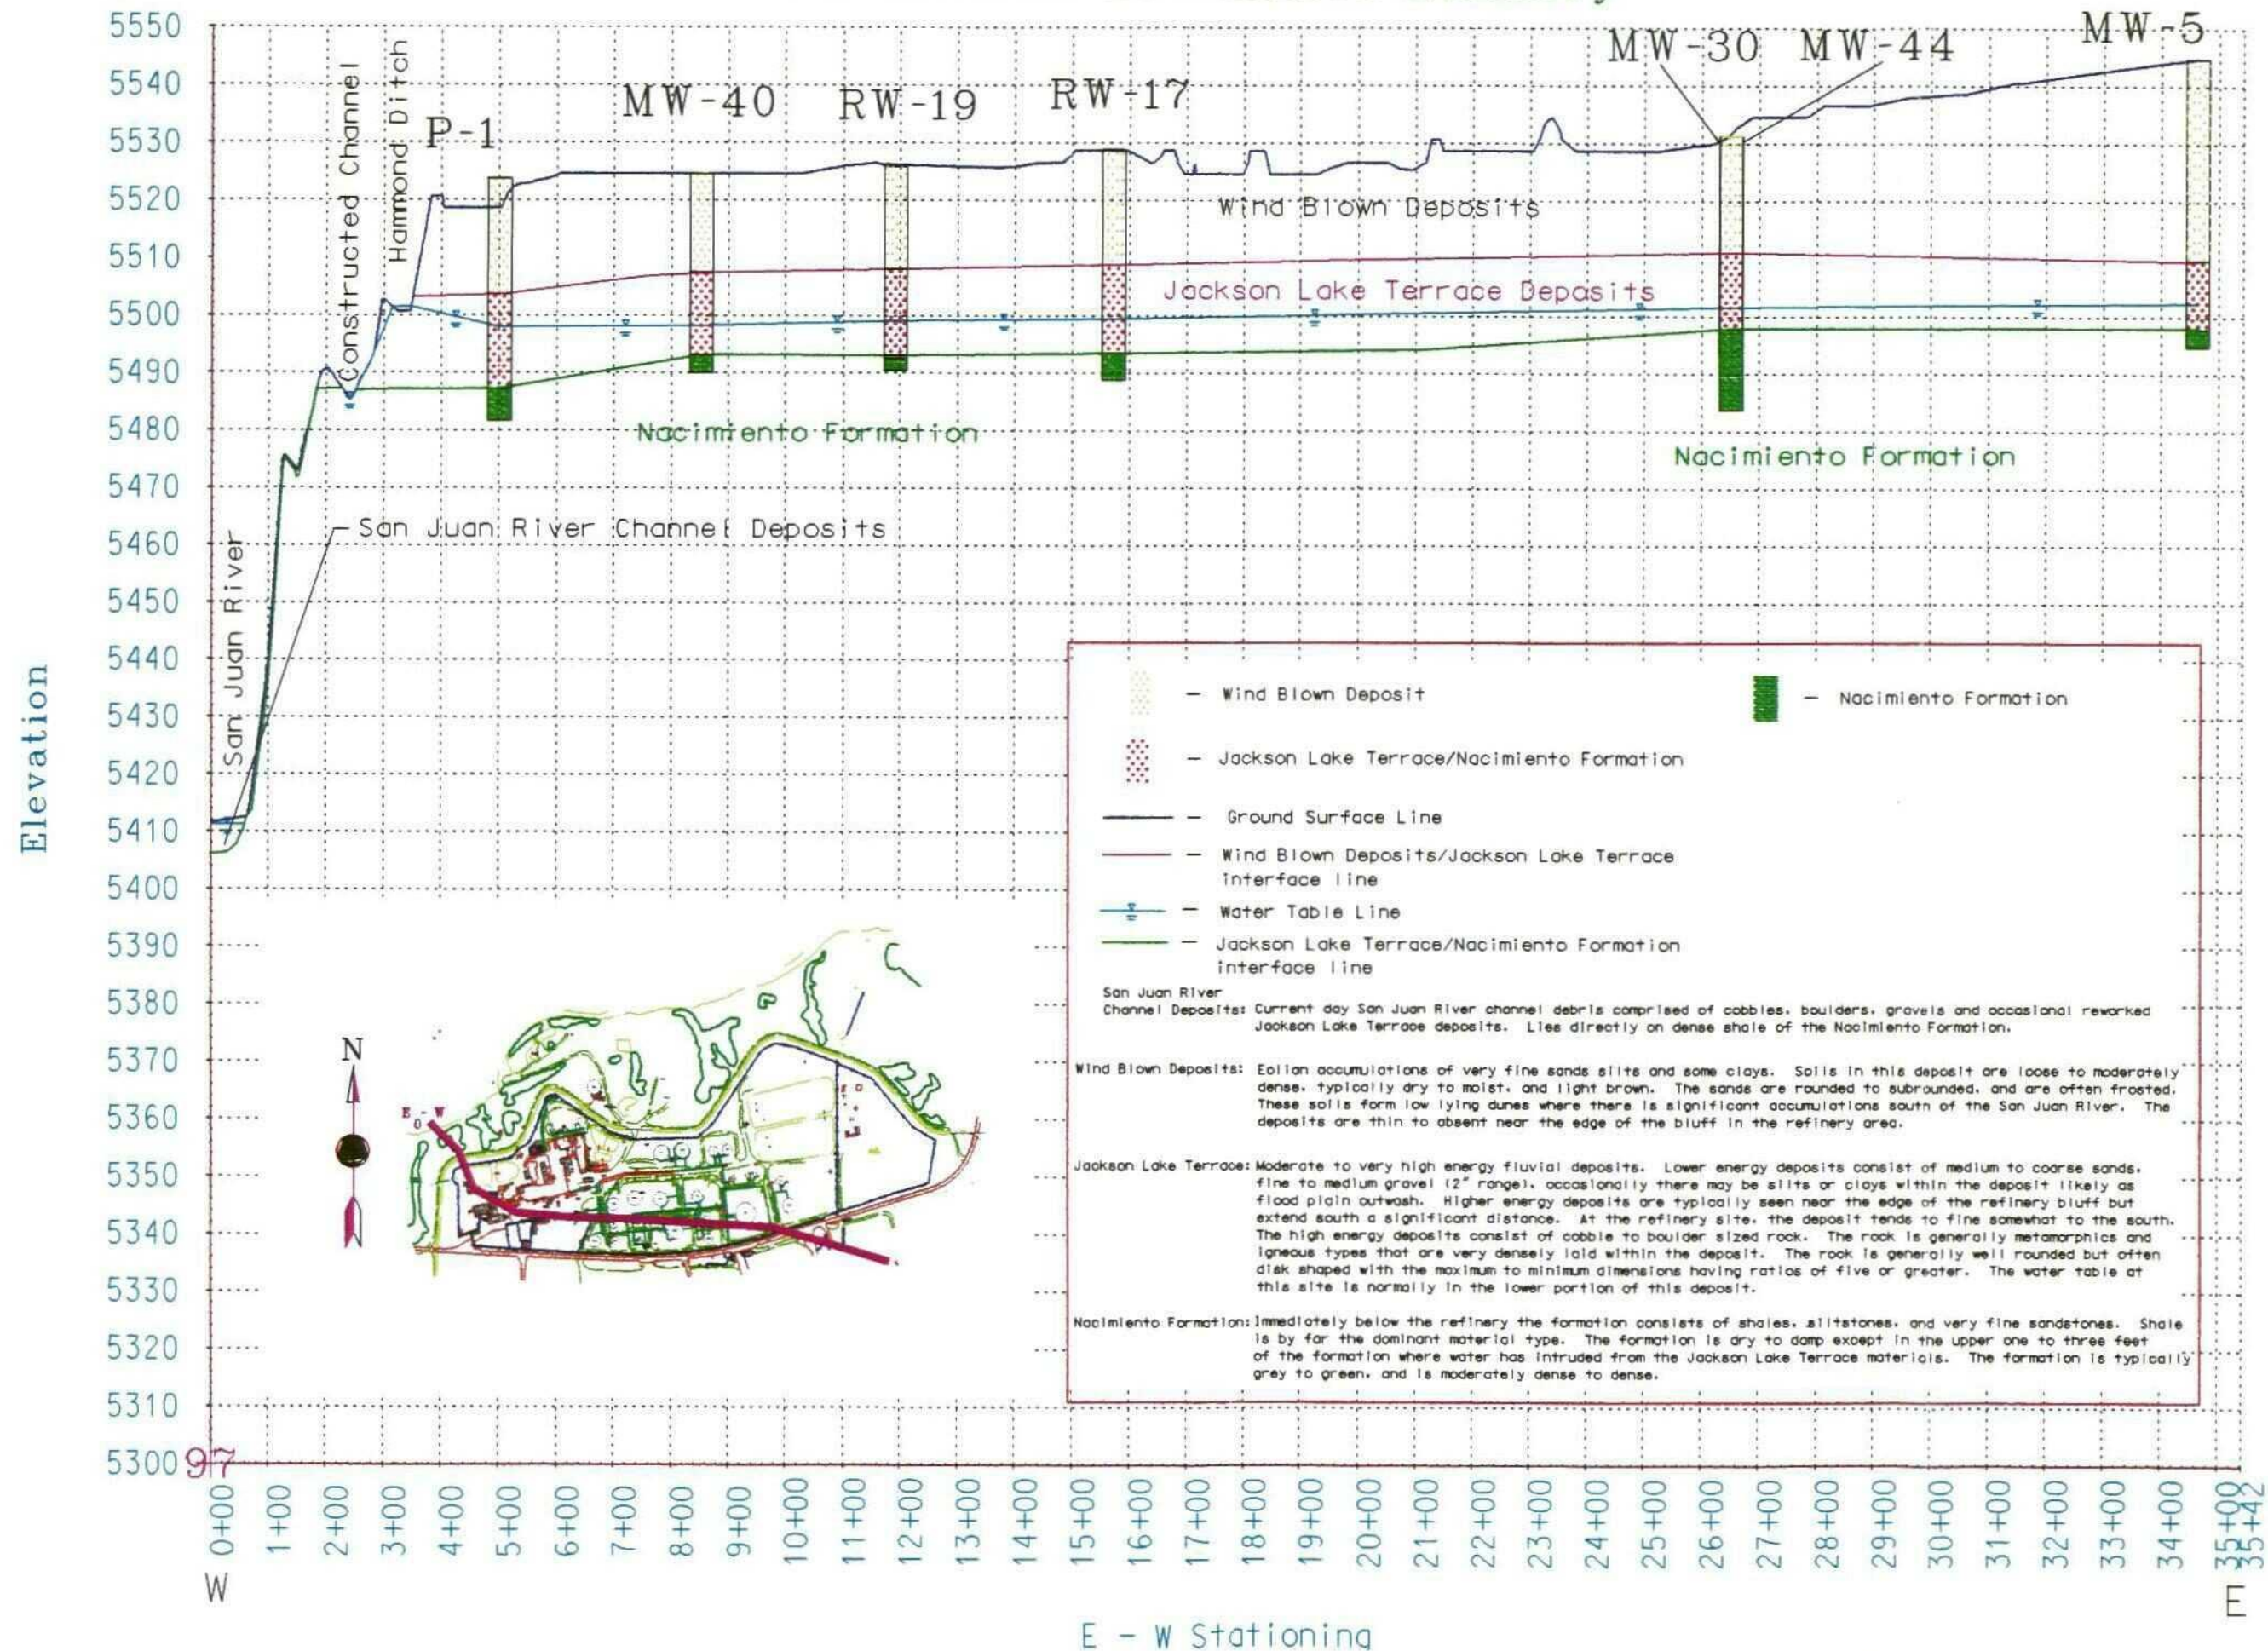
PLATE 8

E-W Profile Bloomfield Refinery

quaternary apron deposits north of the Refinery and a small deposit of San Juan River Alluvium. The stratigraphic relationship between these five units is presented in Plates 6, 7 and 8. These plates are discussed later in this section.

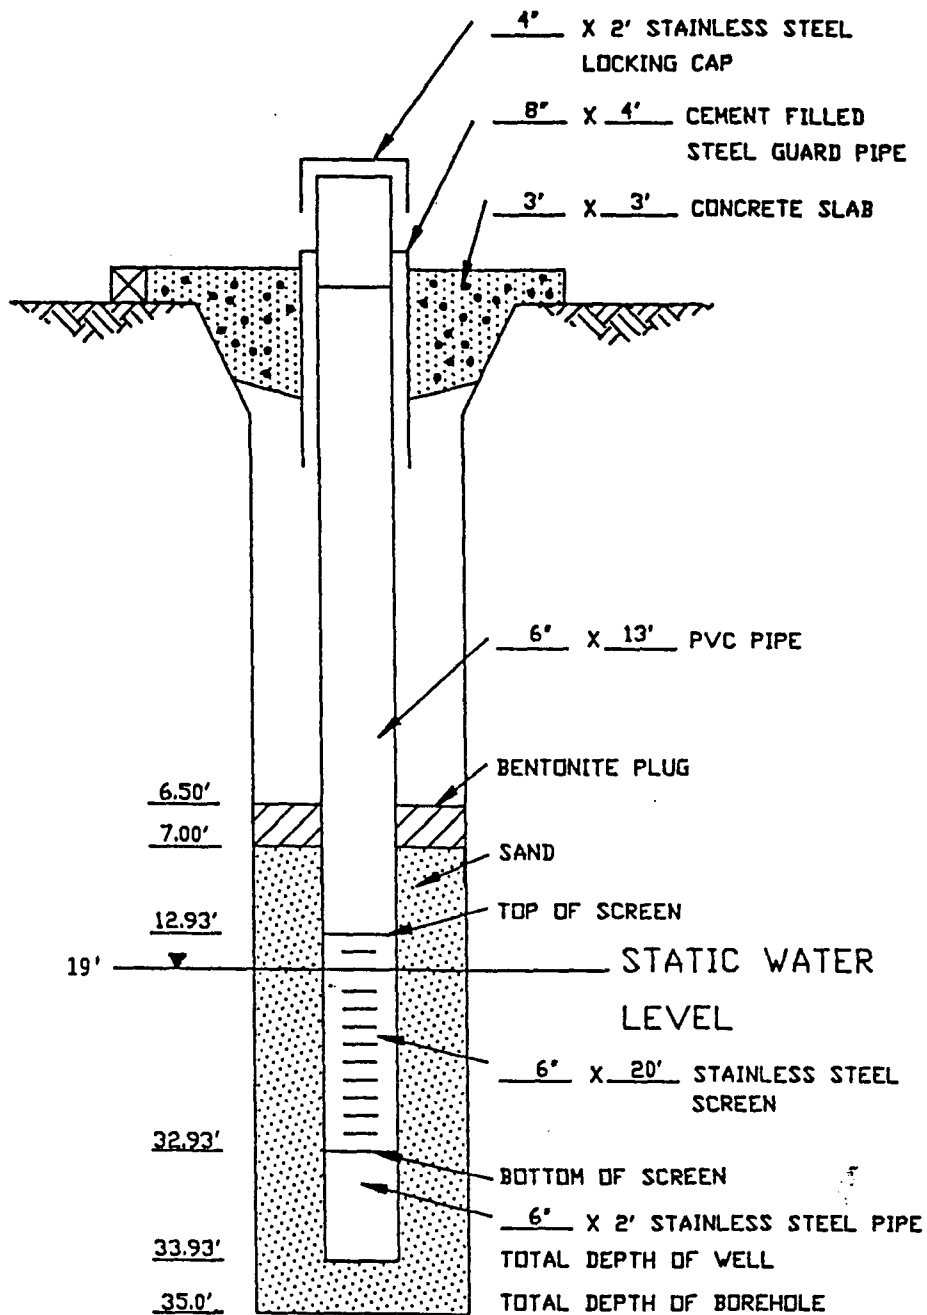
COMPLETION DIAGRAM
RECOVERY WELL MW-13 (RW-3)
(RECONSTRUCTED FROM VERBAL DESCRIPTION
SUPPLIED BY ENGINEERING-SCIENCE, 1987)

CONSTRUCTION COMMENTS: DRILLED BY CASING DRIVER 8" BIT. 4.5" O.D. FIBERGLASS CASING SET TO DEPTH INSIDE DRIVEN CASING; ANNULAR SPACE FILLED WITH 30/40 SAND AS DRIVEN CASING REMOVED; 50 LBS. OF BENTONITE DRILLING MUD & 100 LBS. OF CONCRETE PLACED ON TOP OF SAND PACK; BACKFILLED WITH DIRT TO SURFACE.
