REPORTS

Mariah Associates, Inc. (Mariah) conducted the Resource Conservation Recovery Act (RCRA) facility investigation (RFI) Phase I for Navajo (Navajo) Refining Company, a petroleum refinery located in Artesia, New Mexico. The RFI encompassed three solid waste management units on the refinery site: 1) the Truck Bypass Landfarm, 2) the Three-Mile Ditch and Eagle Creek, and 3) the evaporation ponds. The purpose of the Navajo RFI Phase I was to determine the nature and extent of hazardous waste or constituent releases from solid waste management units (SWMUs) and to provide rationale for proposal of a RFI Phase II investigation.

The Navajo refinery (U.S. Environmental Protection Agency [EPA] ID No. NMD 048918817) located in Artesia, New Mexico, is regulated under the RCRA and the Hazardous and Solid Waste Amendments (HSWA). One of the major provisions of HSWA (Section 3004-6) requires corrective action for releases of hazardous waste

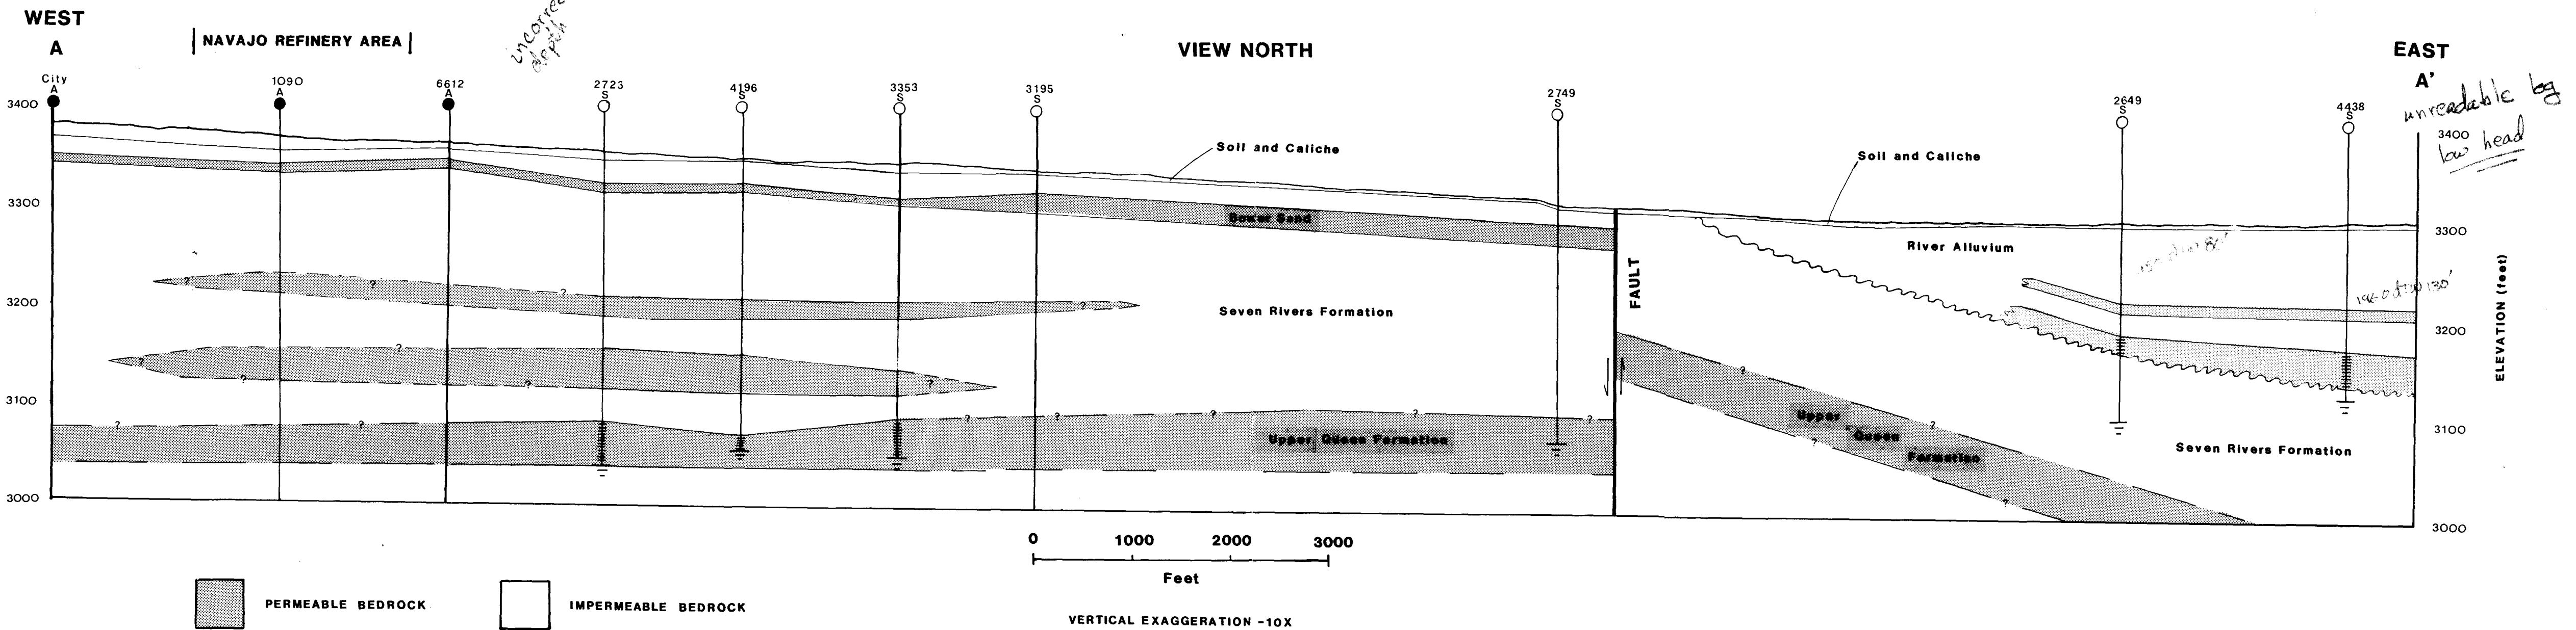
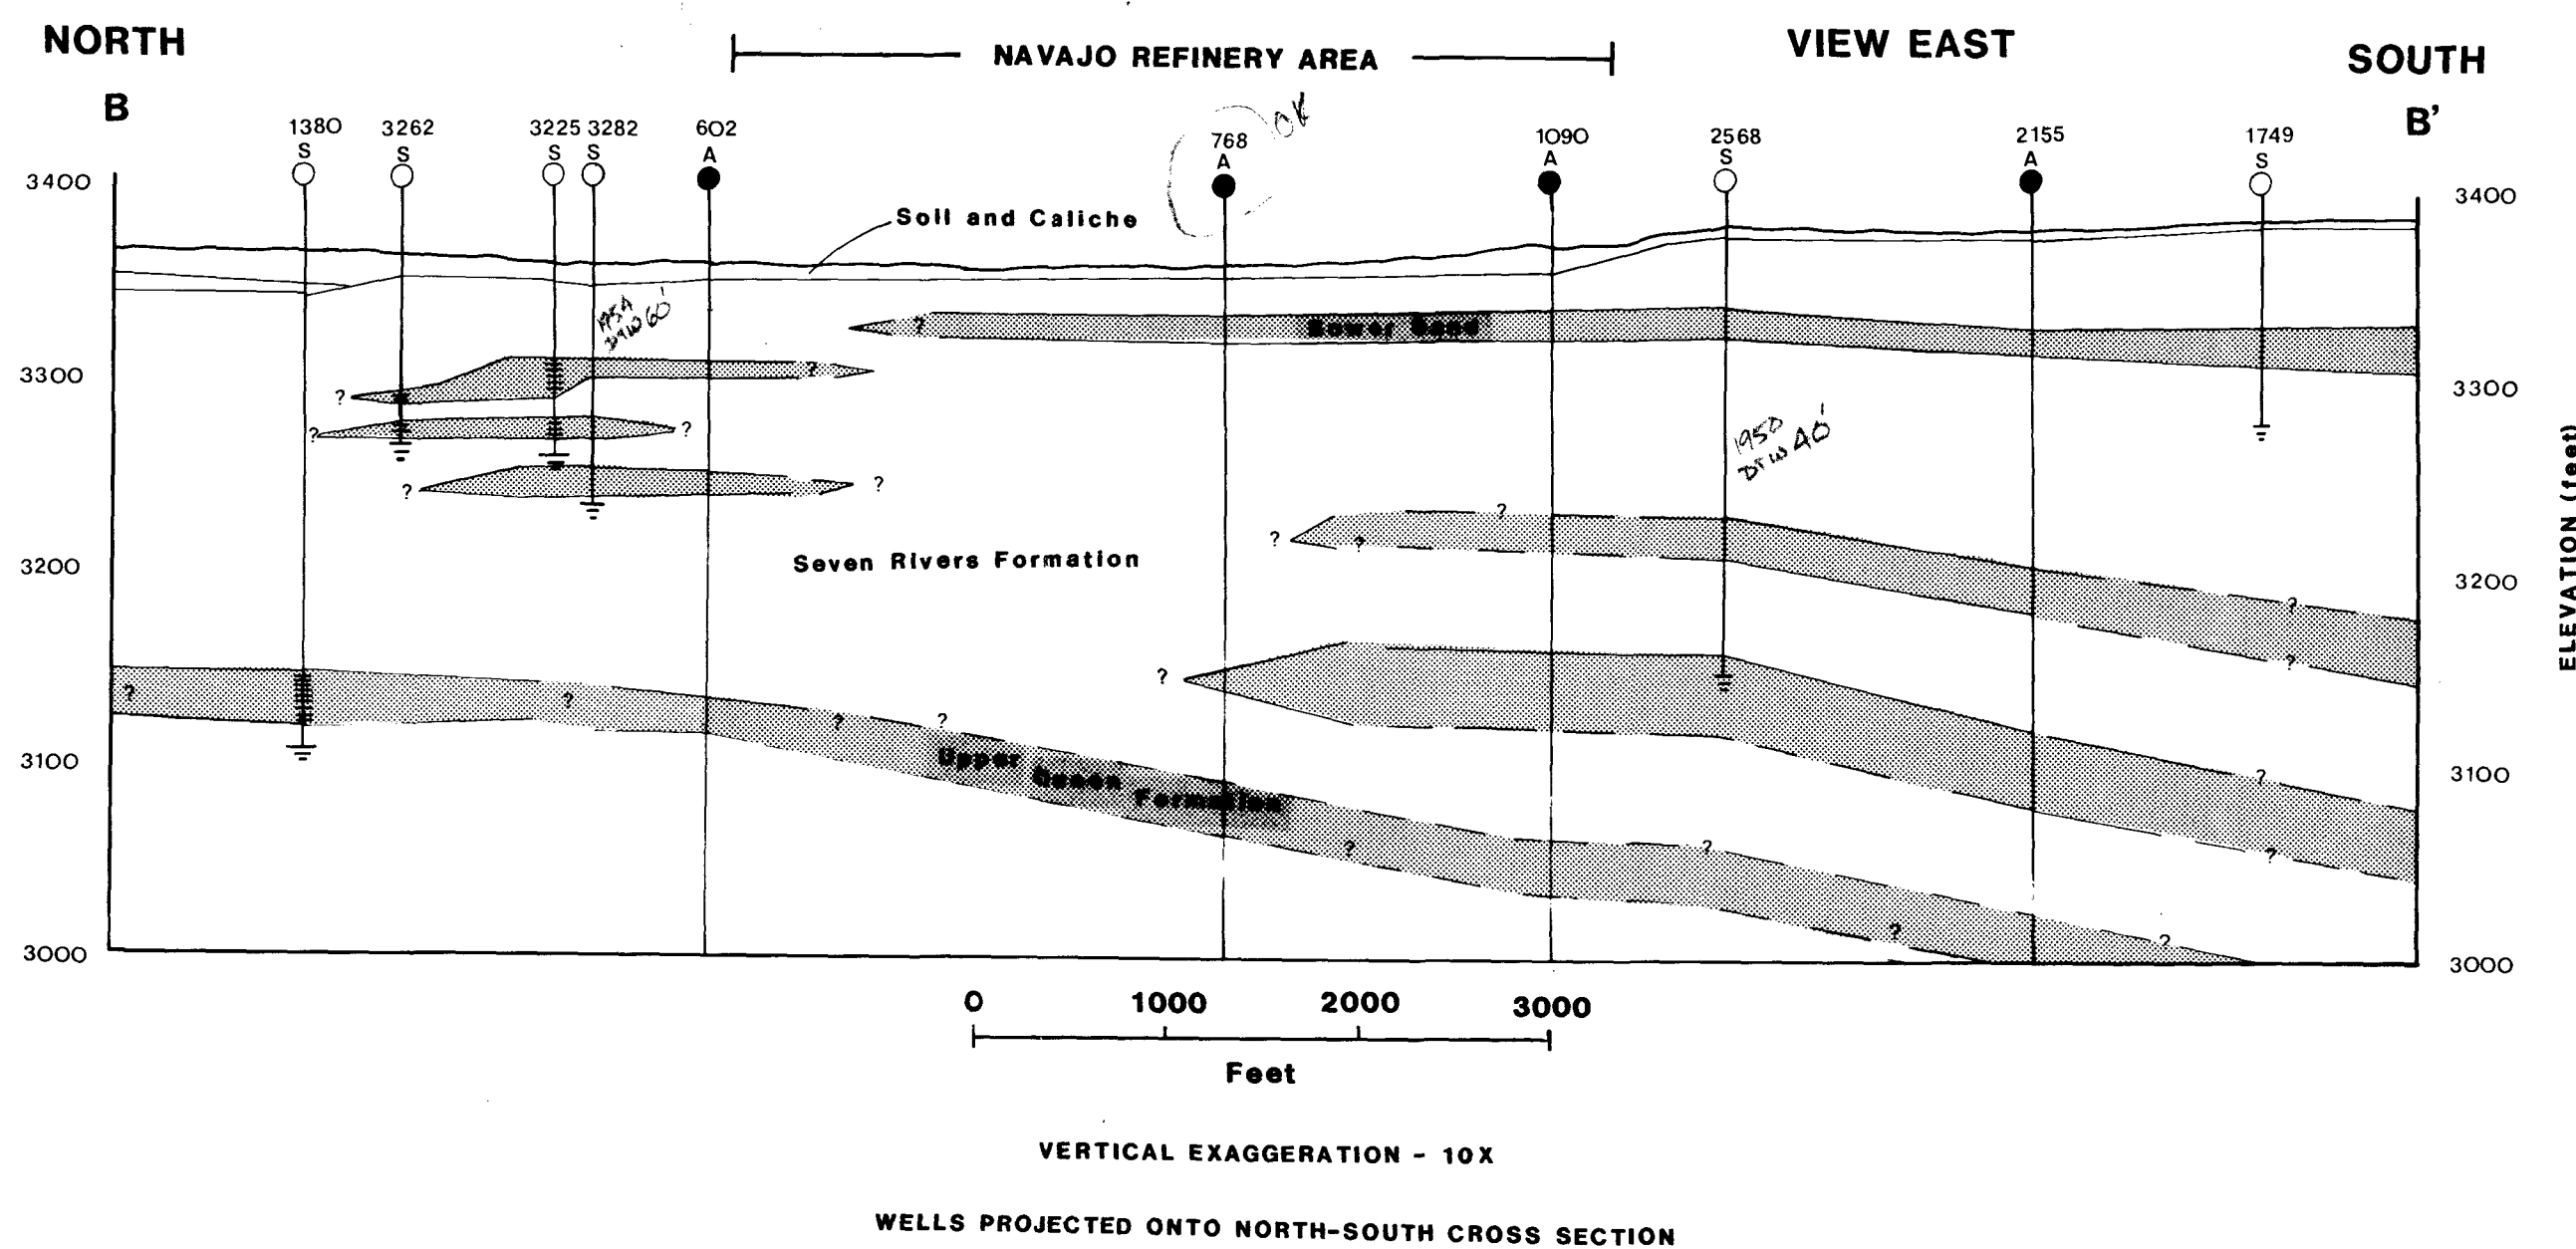
FIGURE 4-3

CROSS SECTIONS
NAVAJO REFINING COMPANY AND
ARTESIA, NEW MEXICO AREA

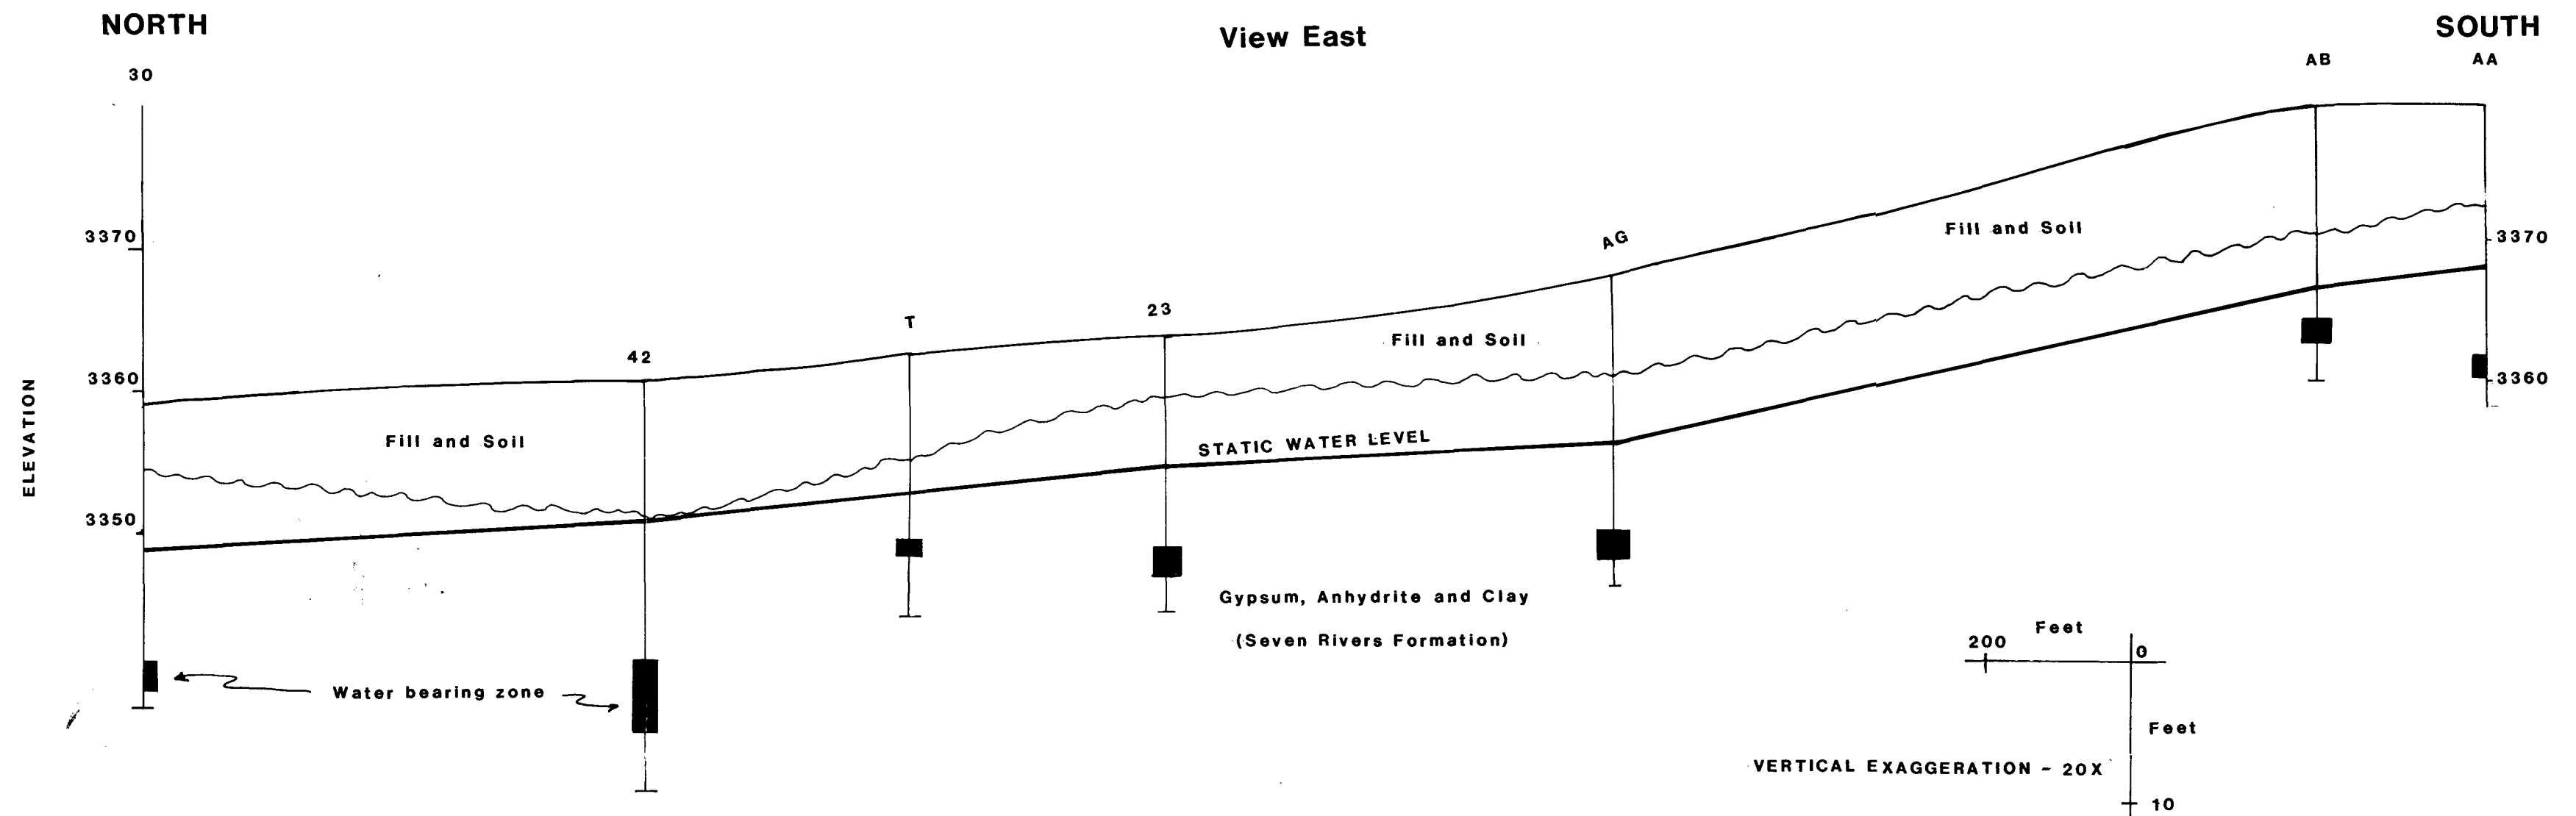
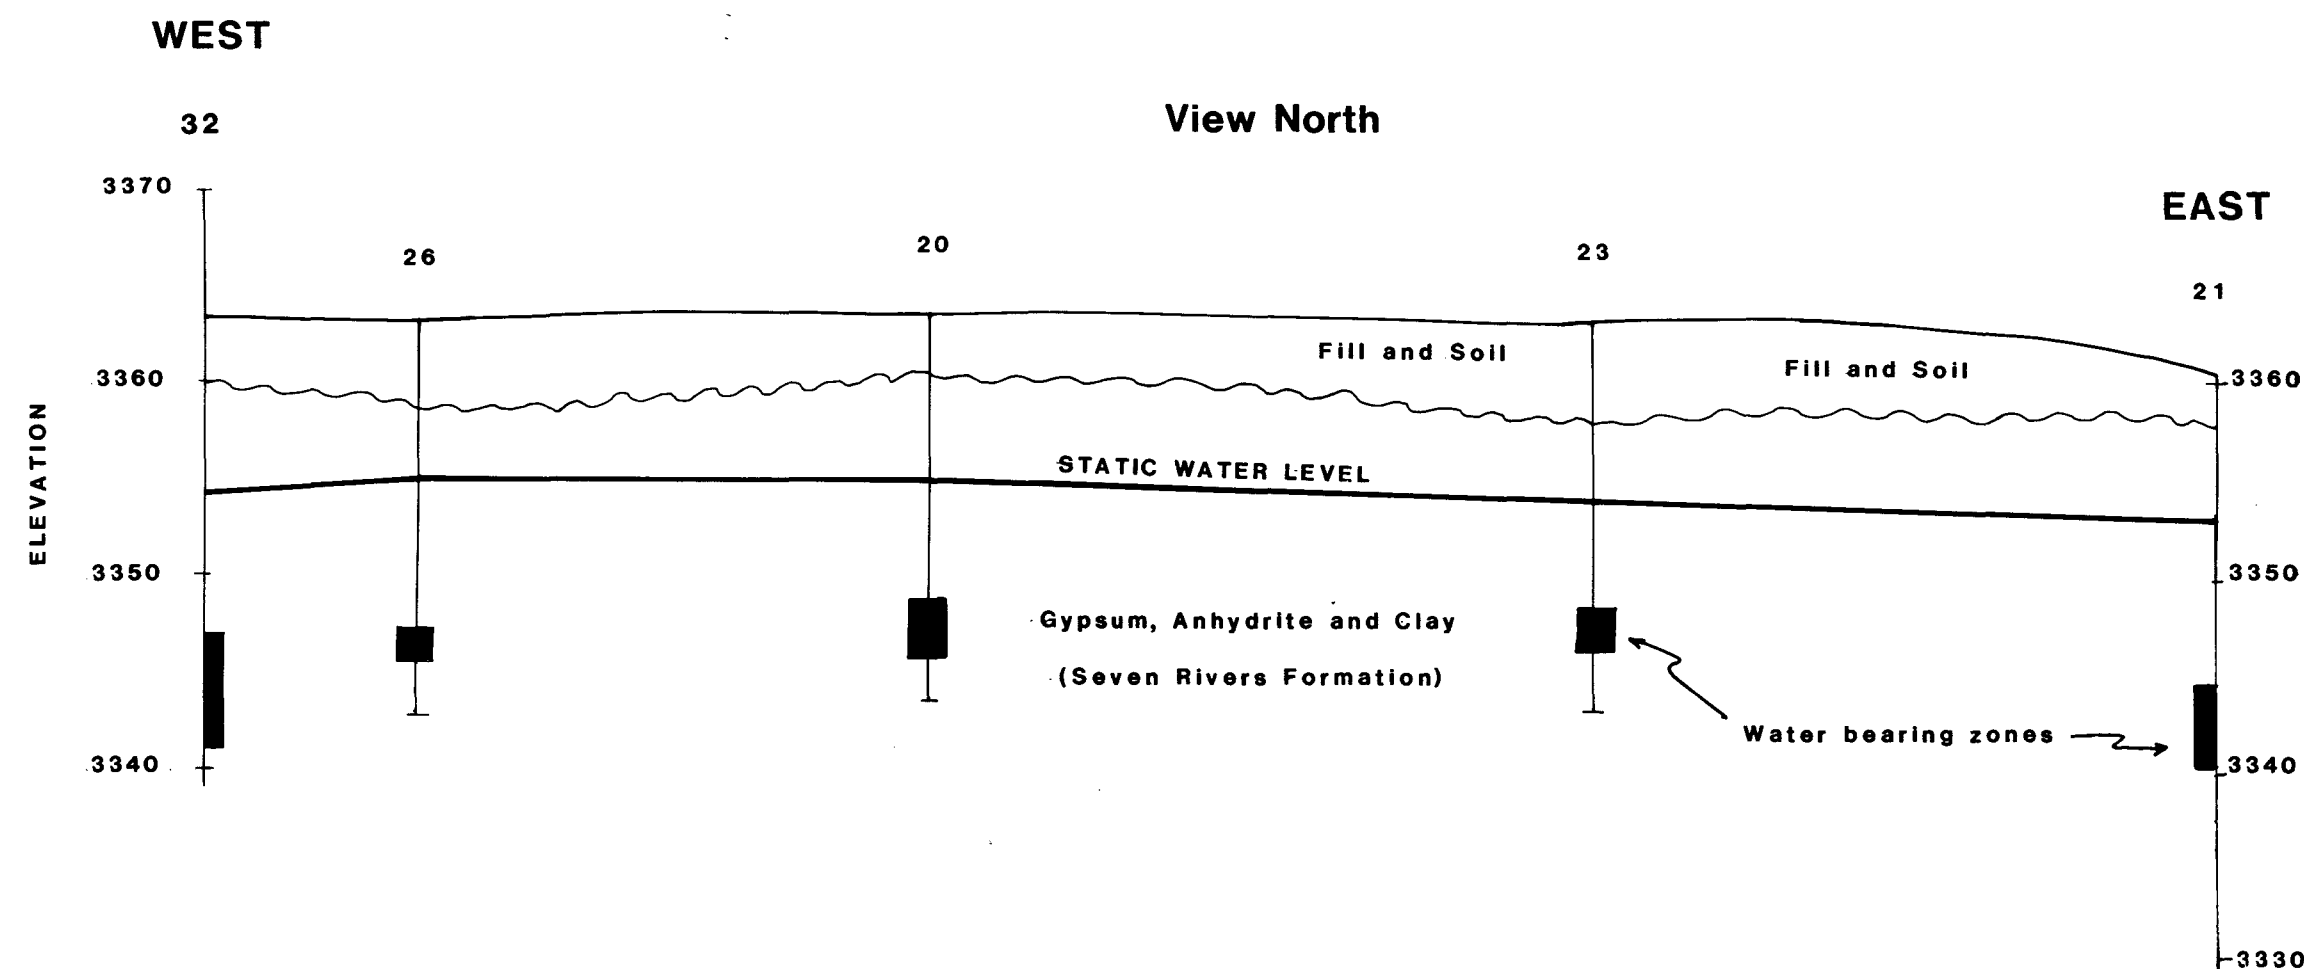
Geoscience Consultants, Ltd. 	HYDROGEOLOGIC CROSS SECTION OF REFINERY SITE AREA	
	CLIENT: NAVAJO REFINING CO.	
	DATE: 11/5/84	
	DRAWN BY: Anita Larson	
	CHECKED BY: James Hunter	
REVISED:		
SCALE:

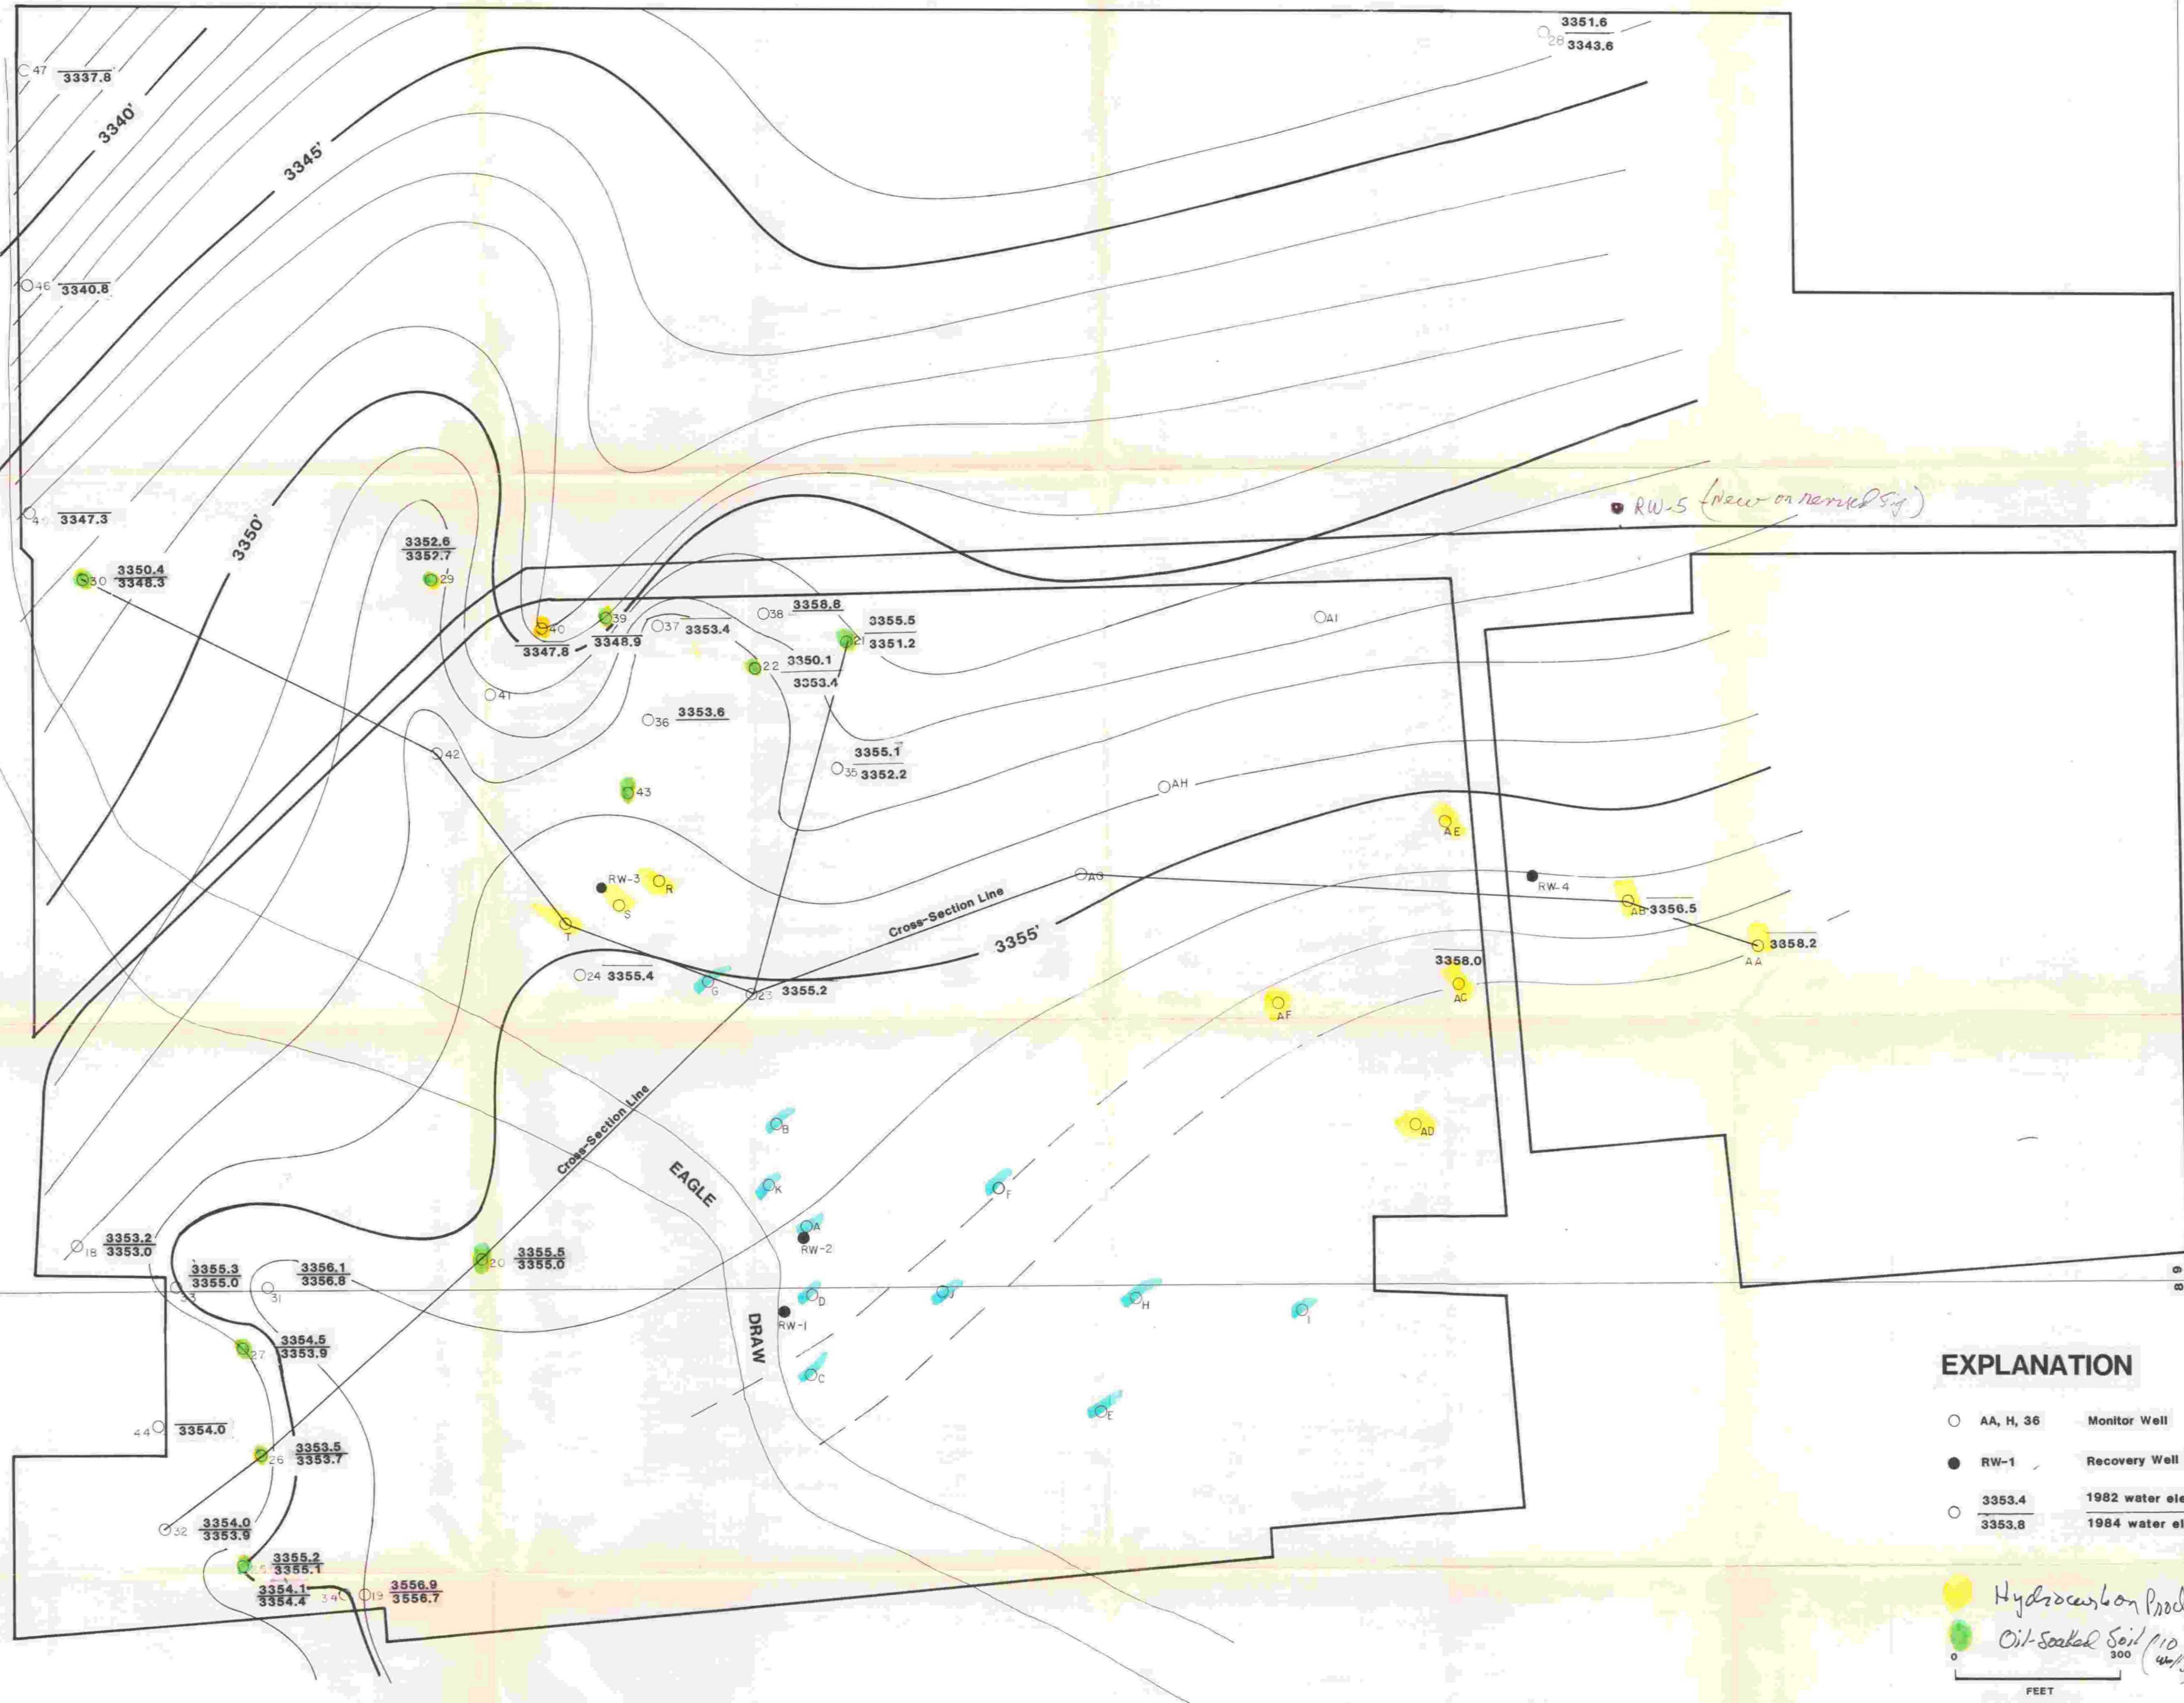
- AA, H, 36 Monitor Well
- RW-1 Recovery Well
- 3353.4 1982 water elevation
- 3353.8 1984 water elevation

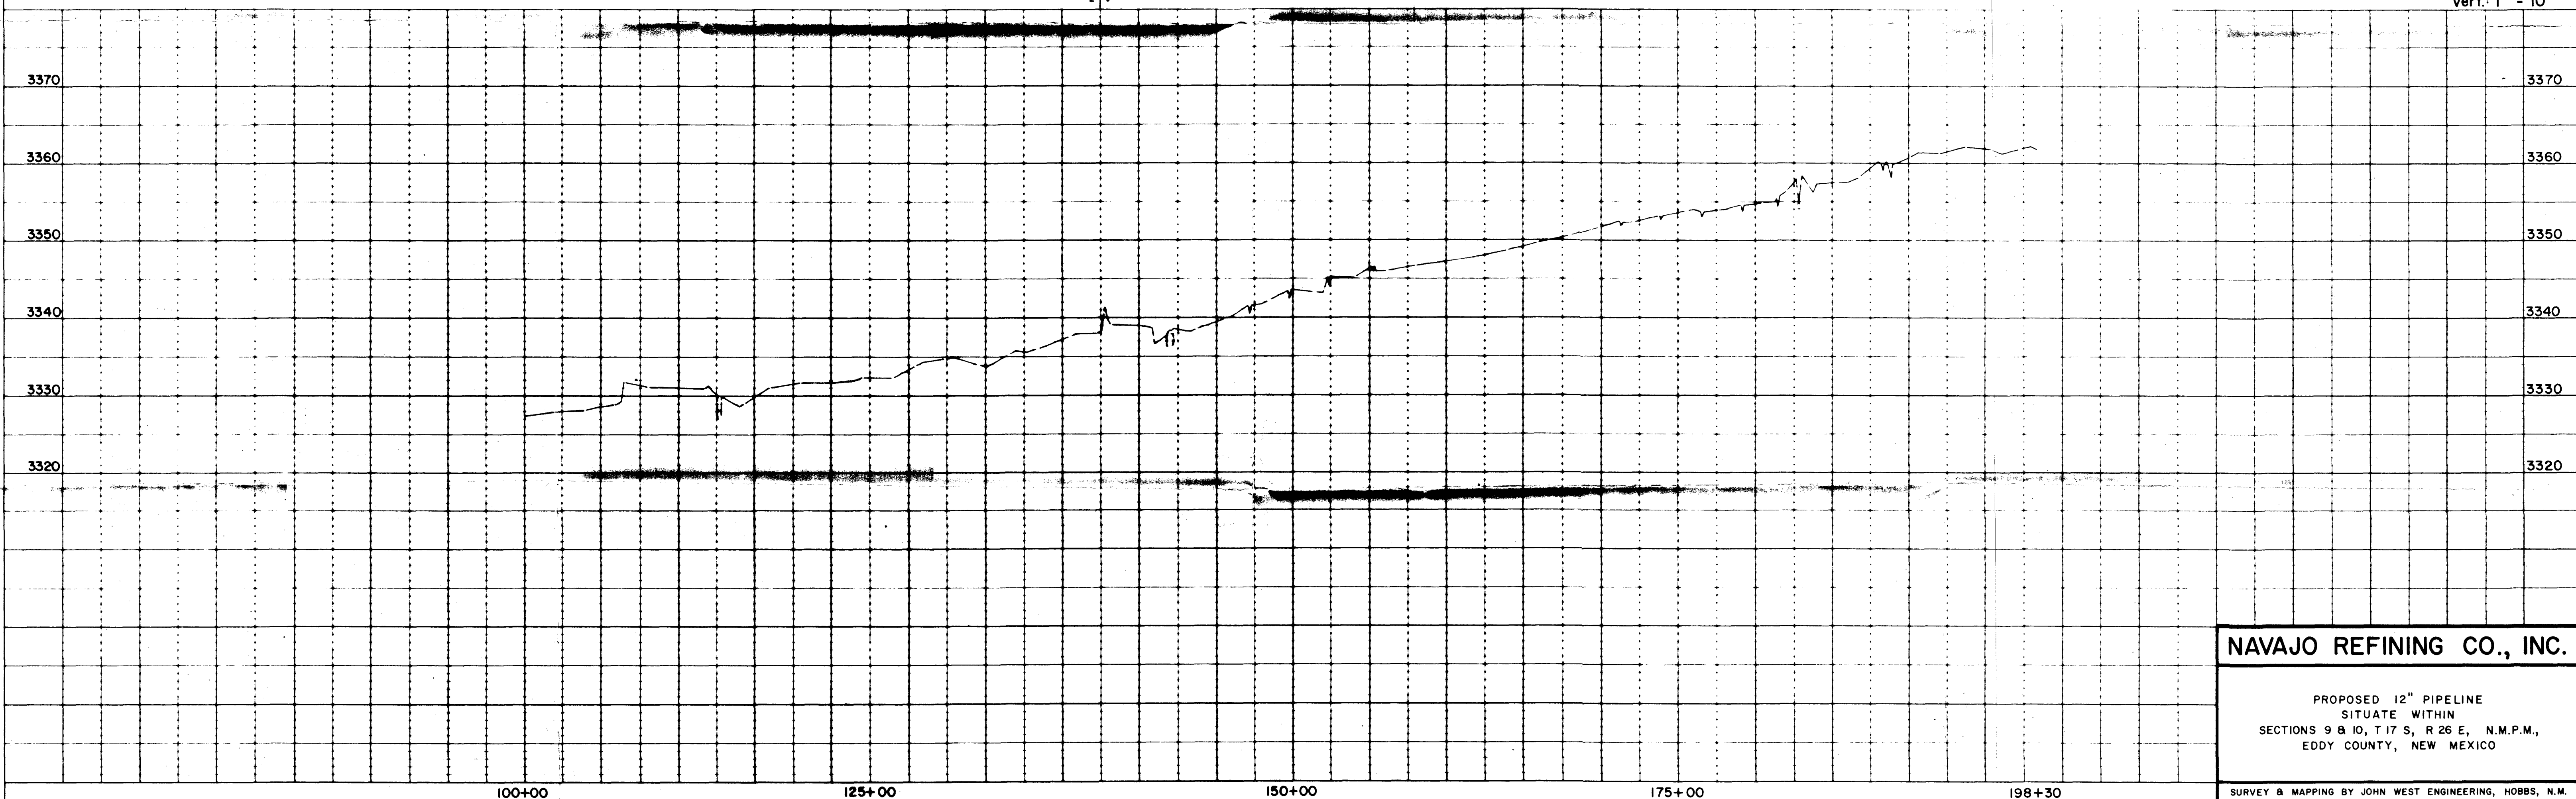
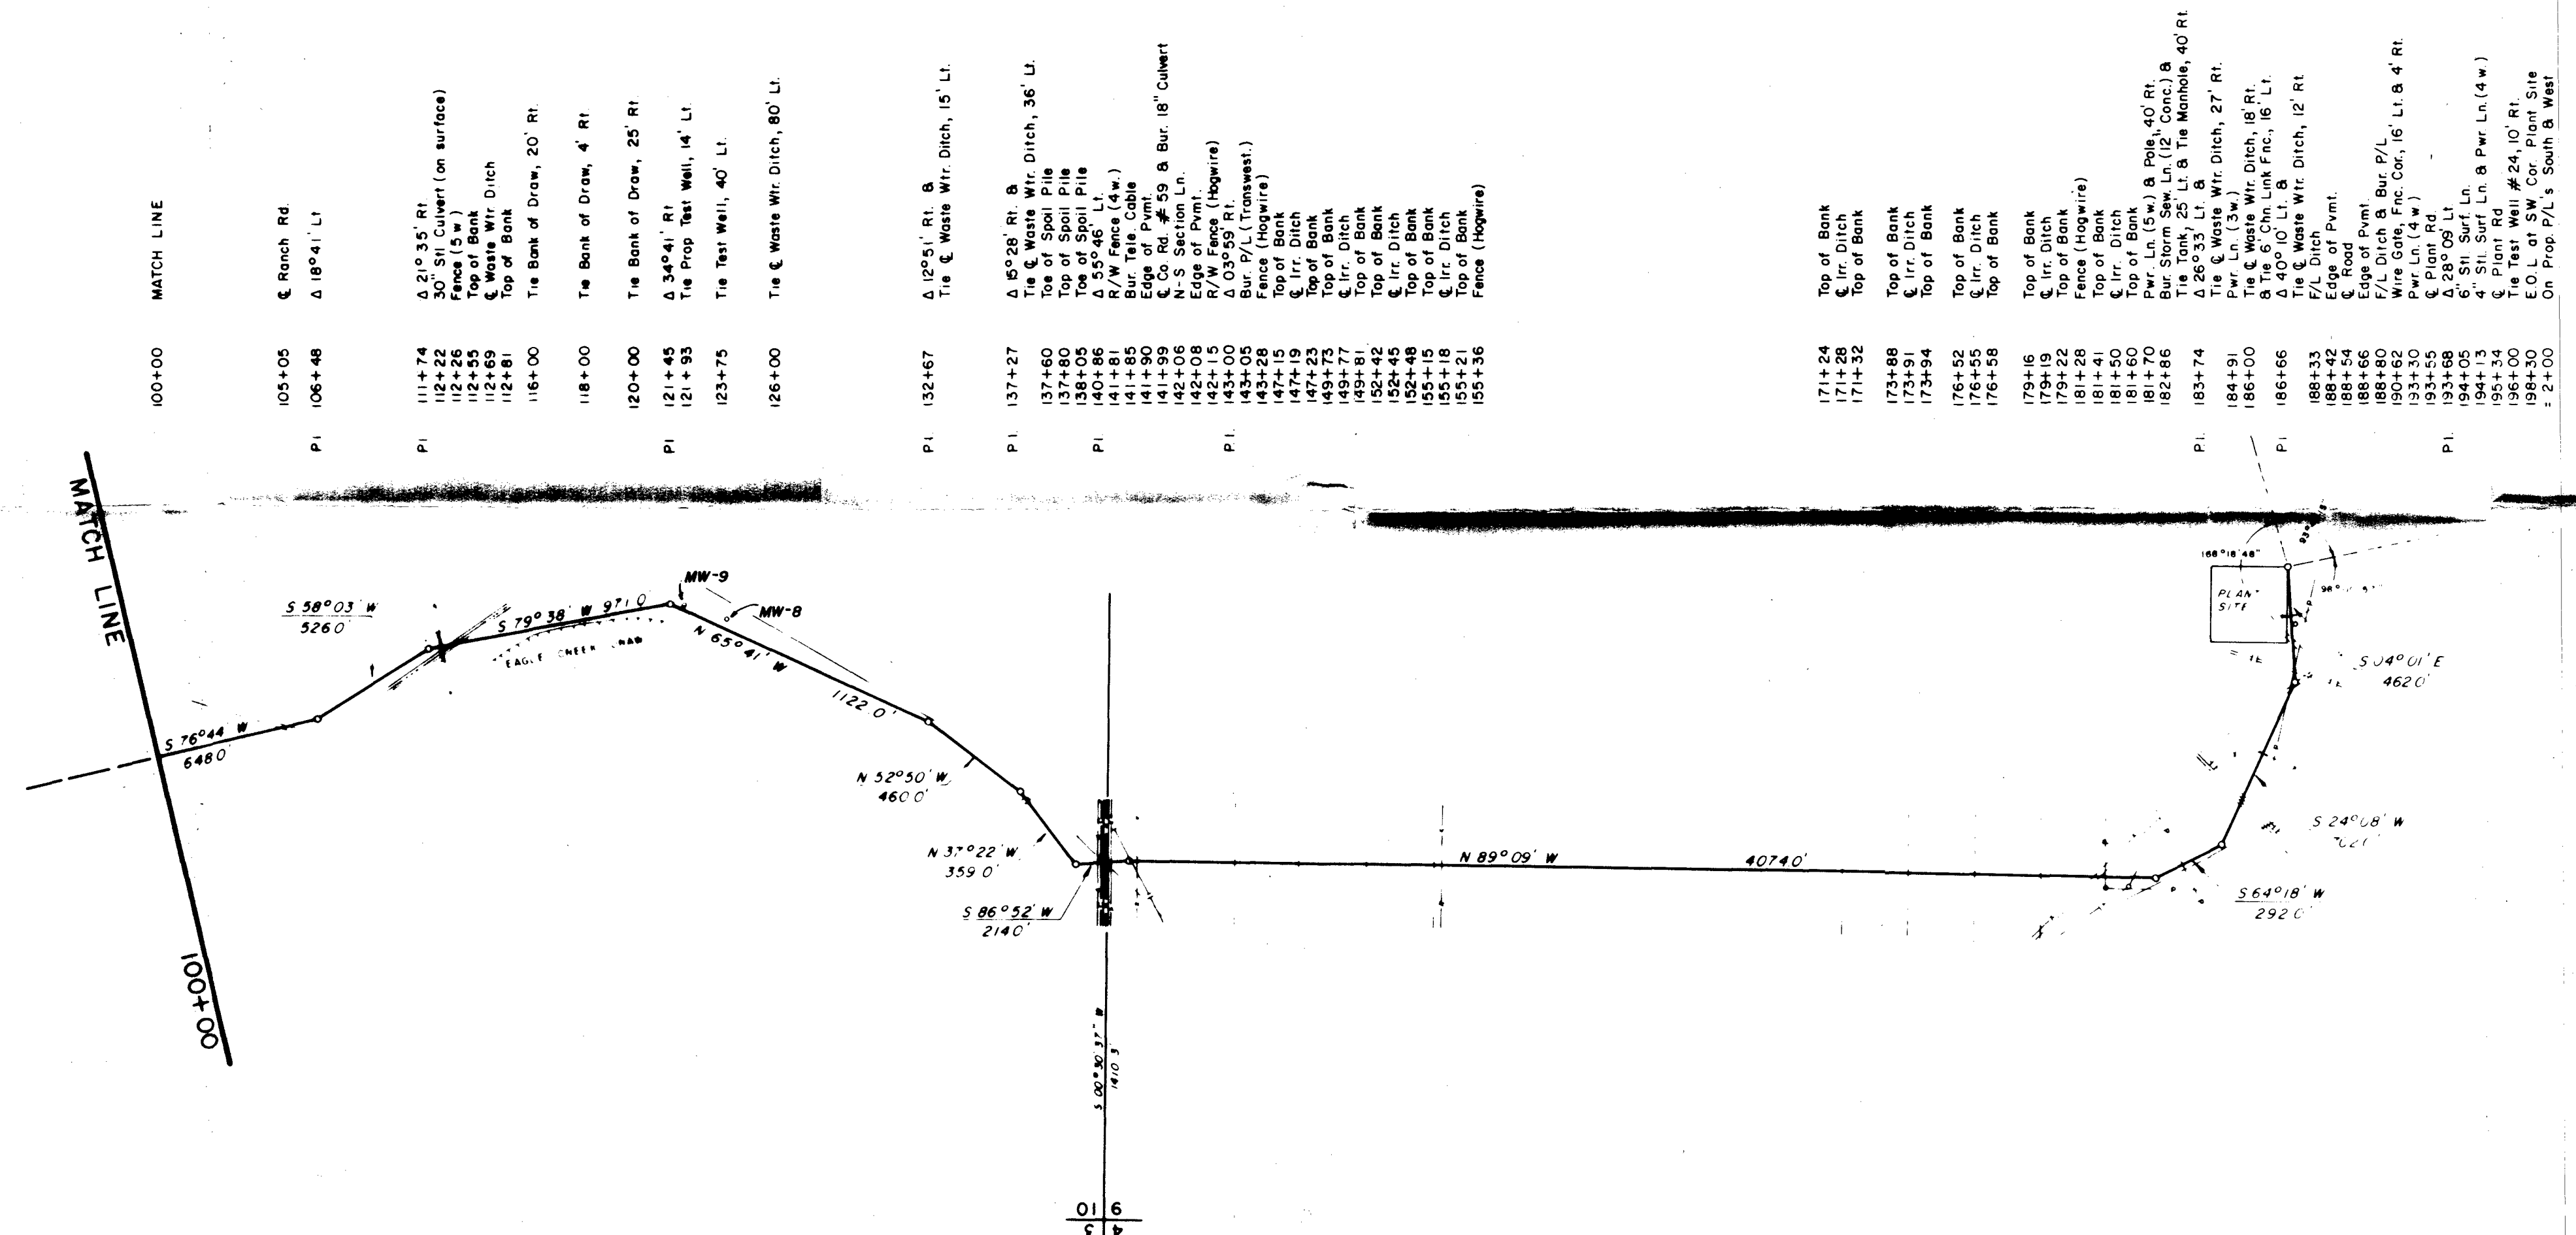
PROPOSED 12" PIPELINE
SITUATE WITHIN
SECTIONS 9 & 10, T 17 S, R 26 E, N.M.P.M.,
EDDY COUNTY, NEW MEXICO

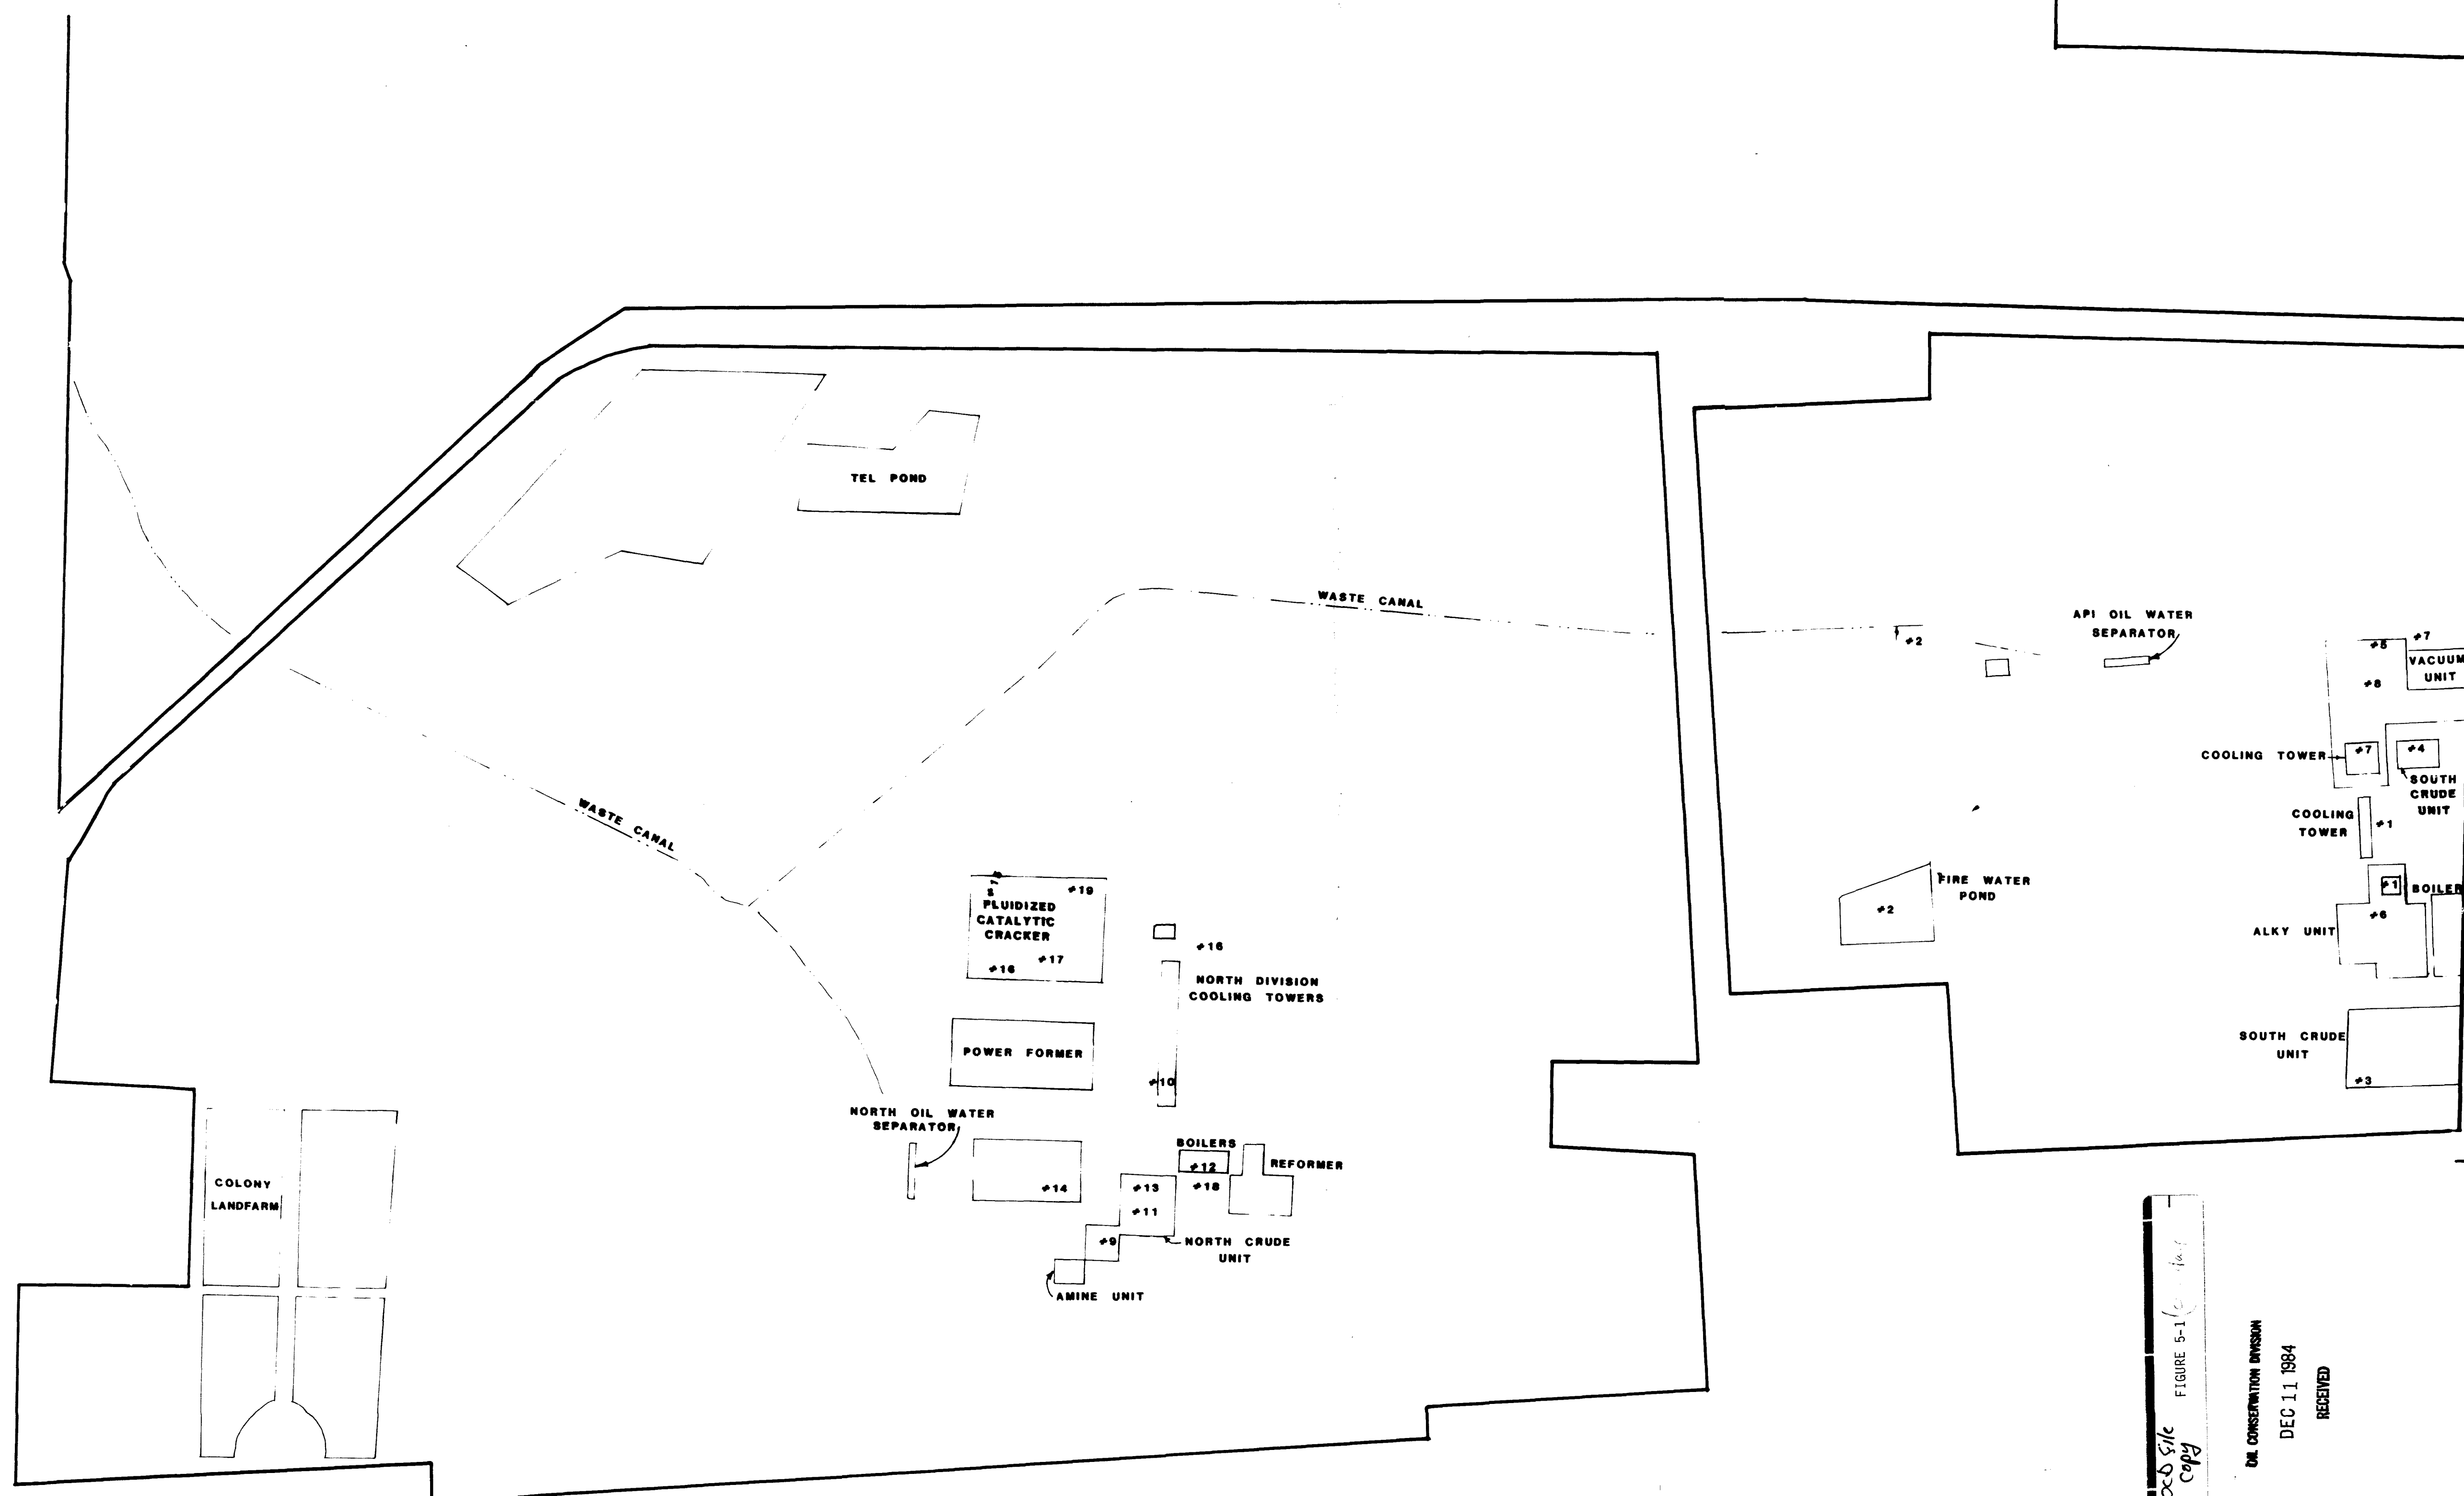
- ocd file
 copy
 FIGURE 5-1 (1/2" = 1' x 1")

Geoscience Consultants, Ltd. 	LOCATION OF PROCESS UNITS AND DISCHARGE POINTS OVERLAY FOR AERIAL PHOTOGRAPH	
	CLIENT: <i>Revejo Services Company</i> DATE: <i>10/2/84</i> DRAWN BY: <i>Robert Hogg</i> CHECKED BY: _____ REVISED: _____ SCALE: <i>1:1000</i>
