REPORTS

Mariah Associates, Inc. (Mariah) conducted the Resource Conservation Recovery Act (RCRA) facility investigation (RFI) Phase I for Navajo (Navajo) Refining Company, a petroleum refinery located in Artesia, New Mexico. The RFI encompassed three solid waste management units on the refinery site: 1) the Truck Bypass Landfarm, 2) the Three-Mile Ditch and Eagle Creek, and 3) the evaporation ponds. The purpose of the Navajo RFI Phase I was to determine the nature and extent of hazardous waste or constituent releases from solid waste management units (SWMUs) and to provide rationale for proposal of a RFI Phase II investigation.

The Navajo refinery (U.S. Environmental Protection Agency [EPA] ID No. NMD 048918817) located in Artesia, New Mexico, is regulated under the RCRA and the Hazardous and Solid Waste Amendments (HSWA). One of the major provisions of HSWA (Section 3004-6) requires corrective action for releases of hazardous waste

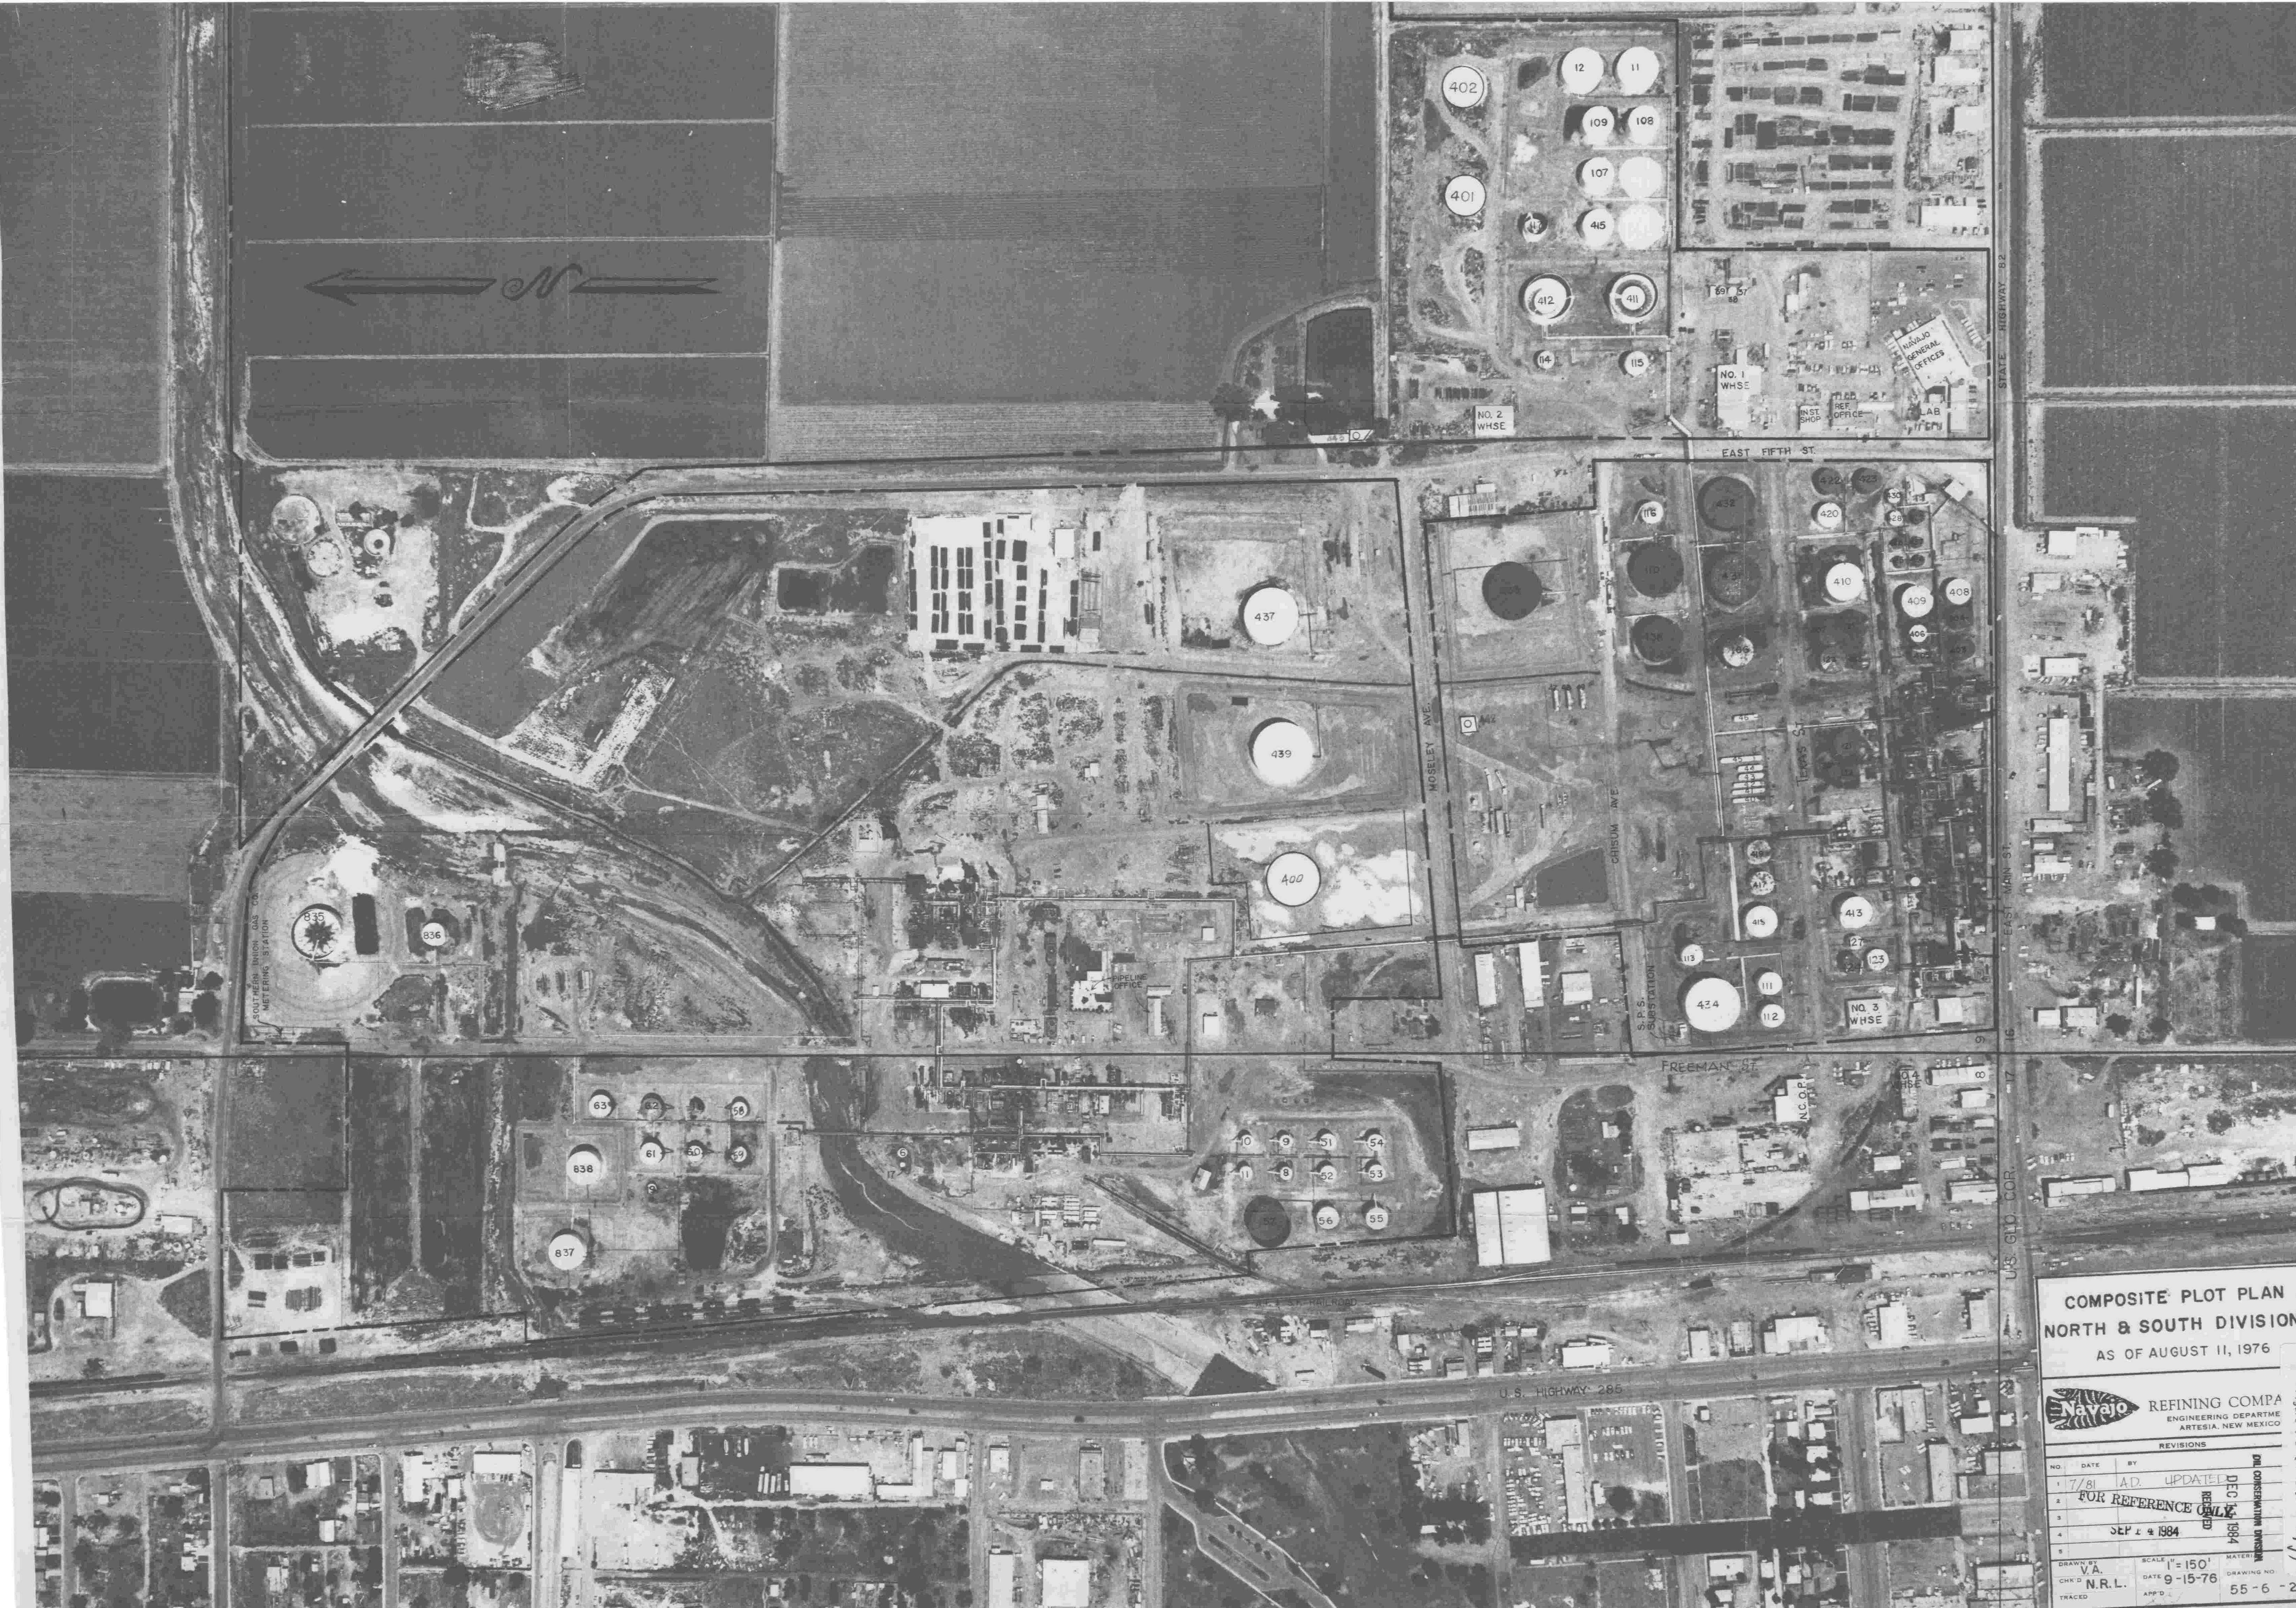
Figure 5-1 (add file copy)

COMPOSITE PLOT PLAN
NORTH & SOUTH DIVISION
AS OF AUGUST 11, 1976

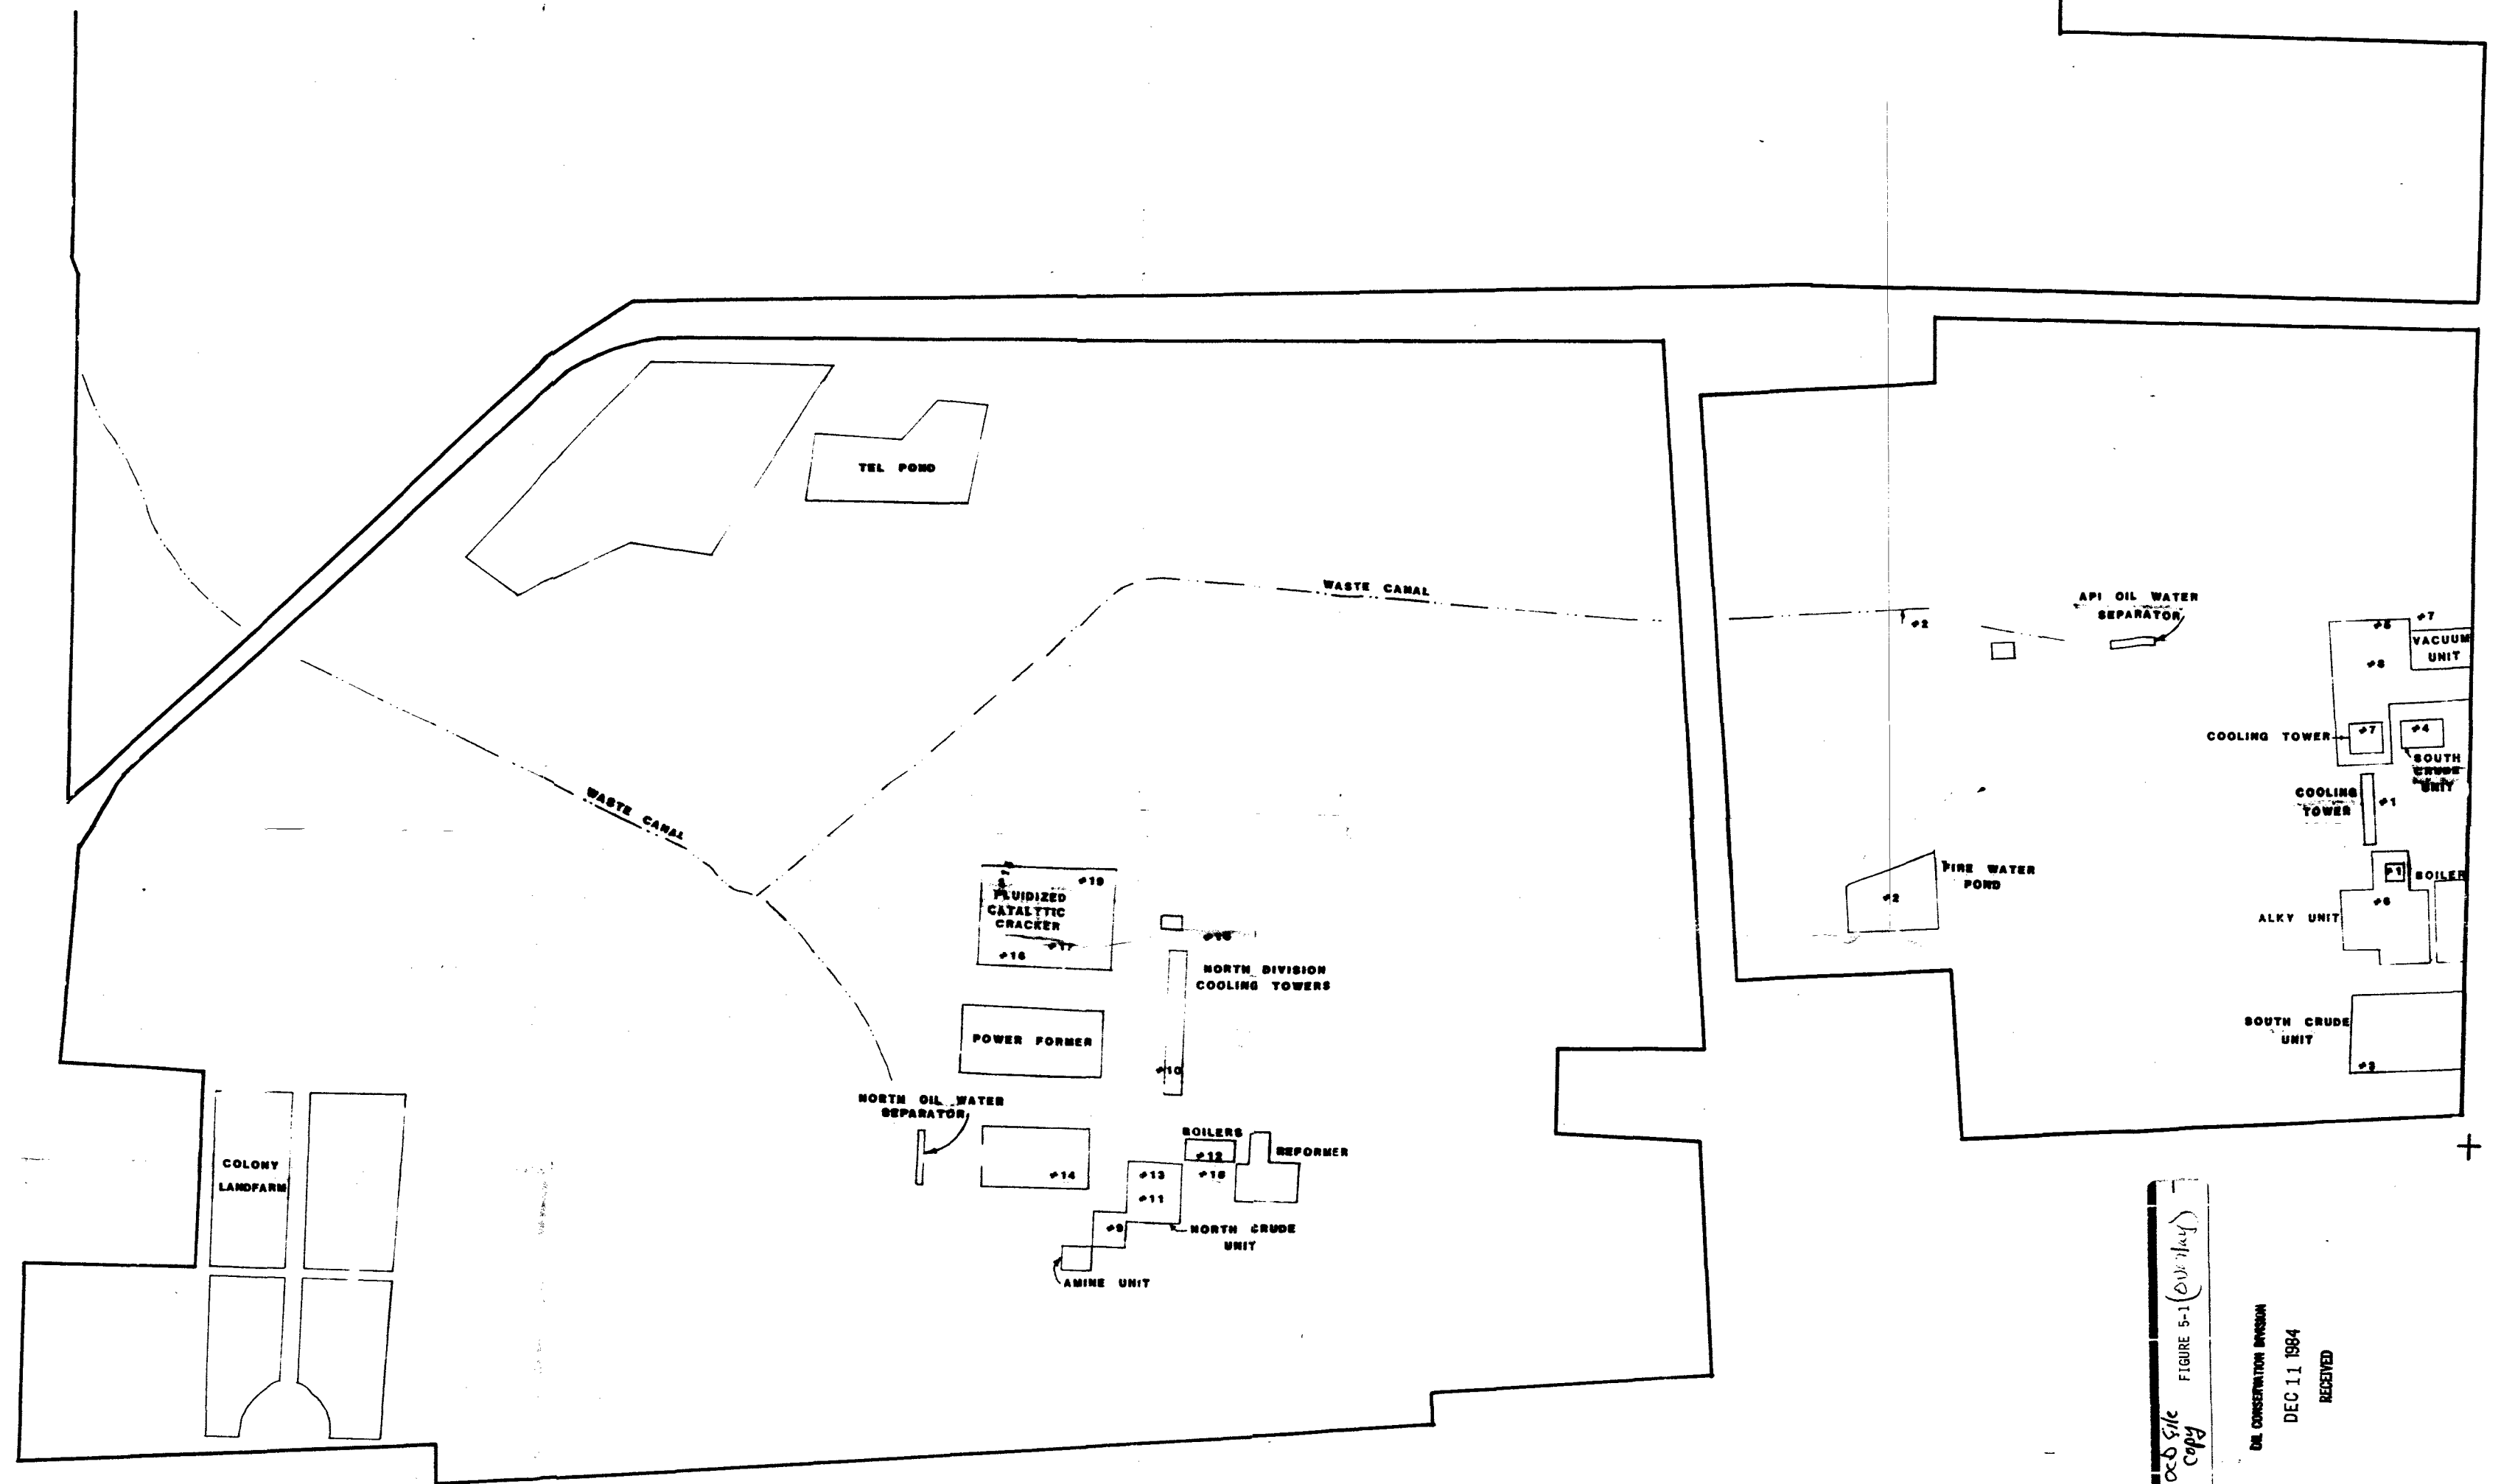
FIGURE 5-1 (REV. 11/84)
 Copy

LOCATION OF PROCESS UNITS OVERLAY FOR AERIAL	
	CLIENT: <i>Shell Refining Company</i>	
	DATE: <i>11/84</i>	
	DRAWN BY: <i>Geoffrey Hogg</i>	
	CHECKED BY:	
	REVISOR:	
SCALE: <i>1:1000</i>

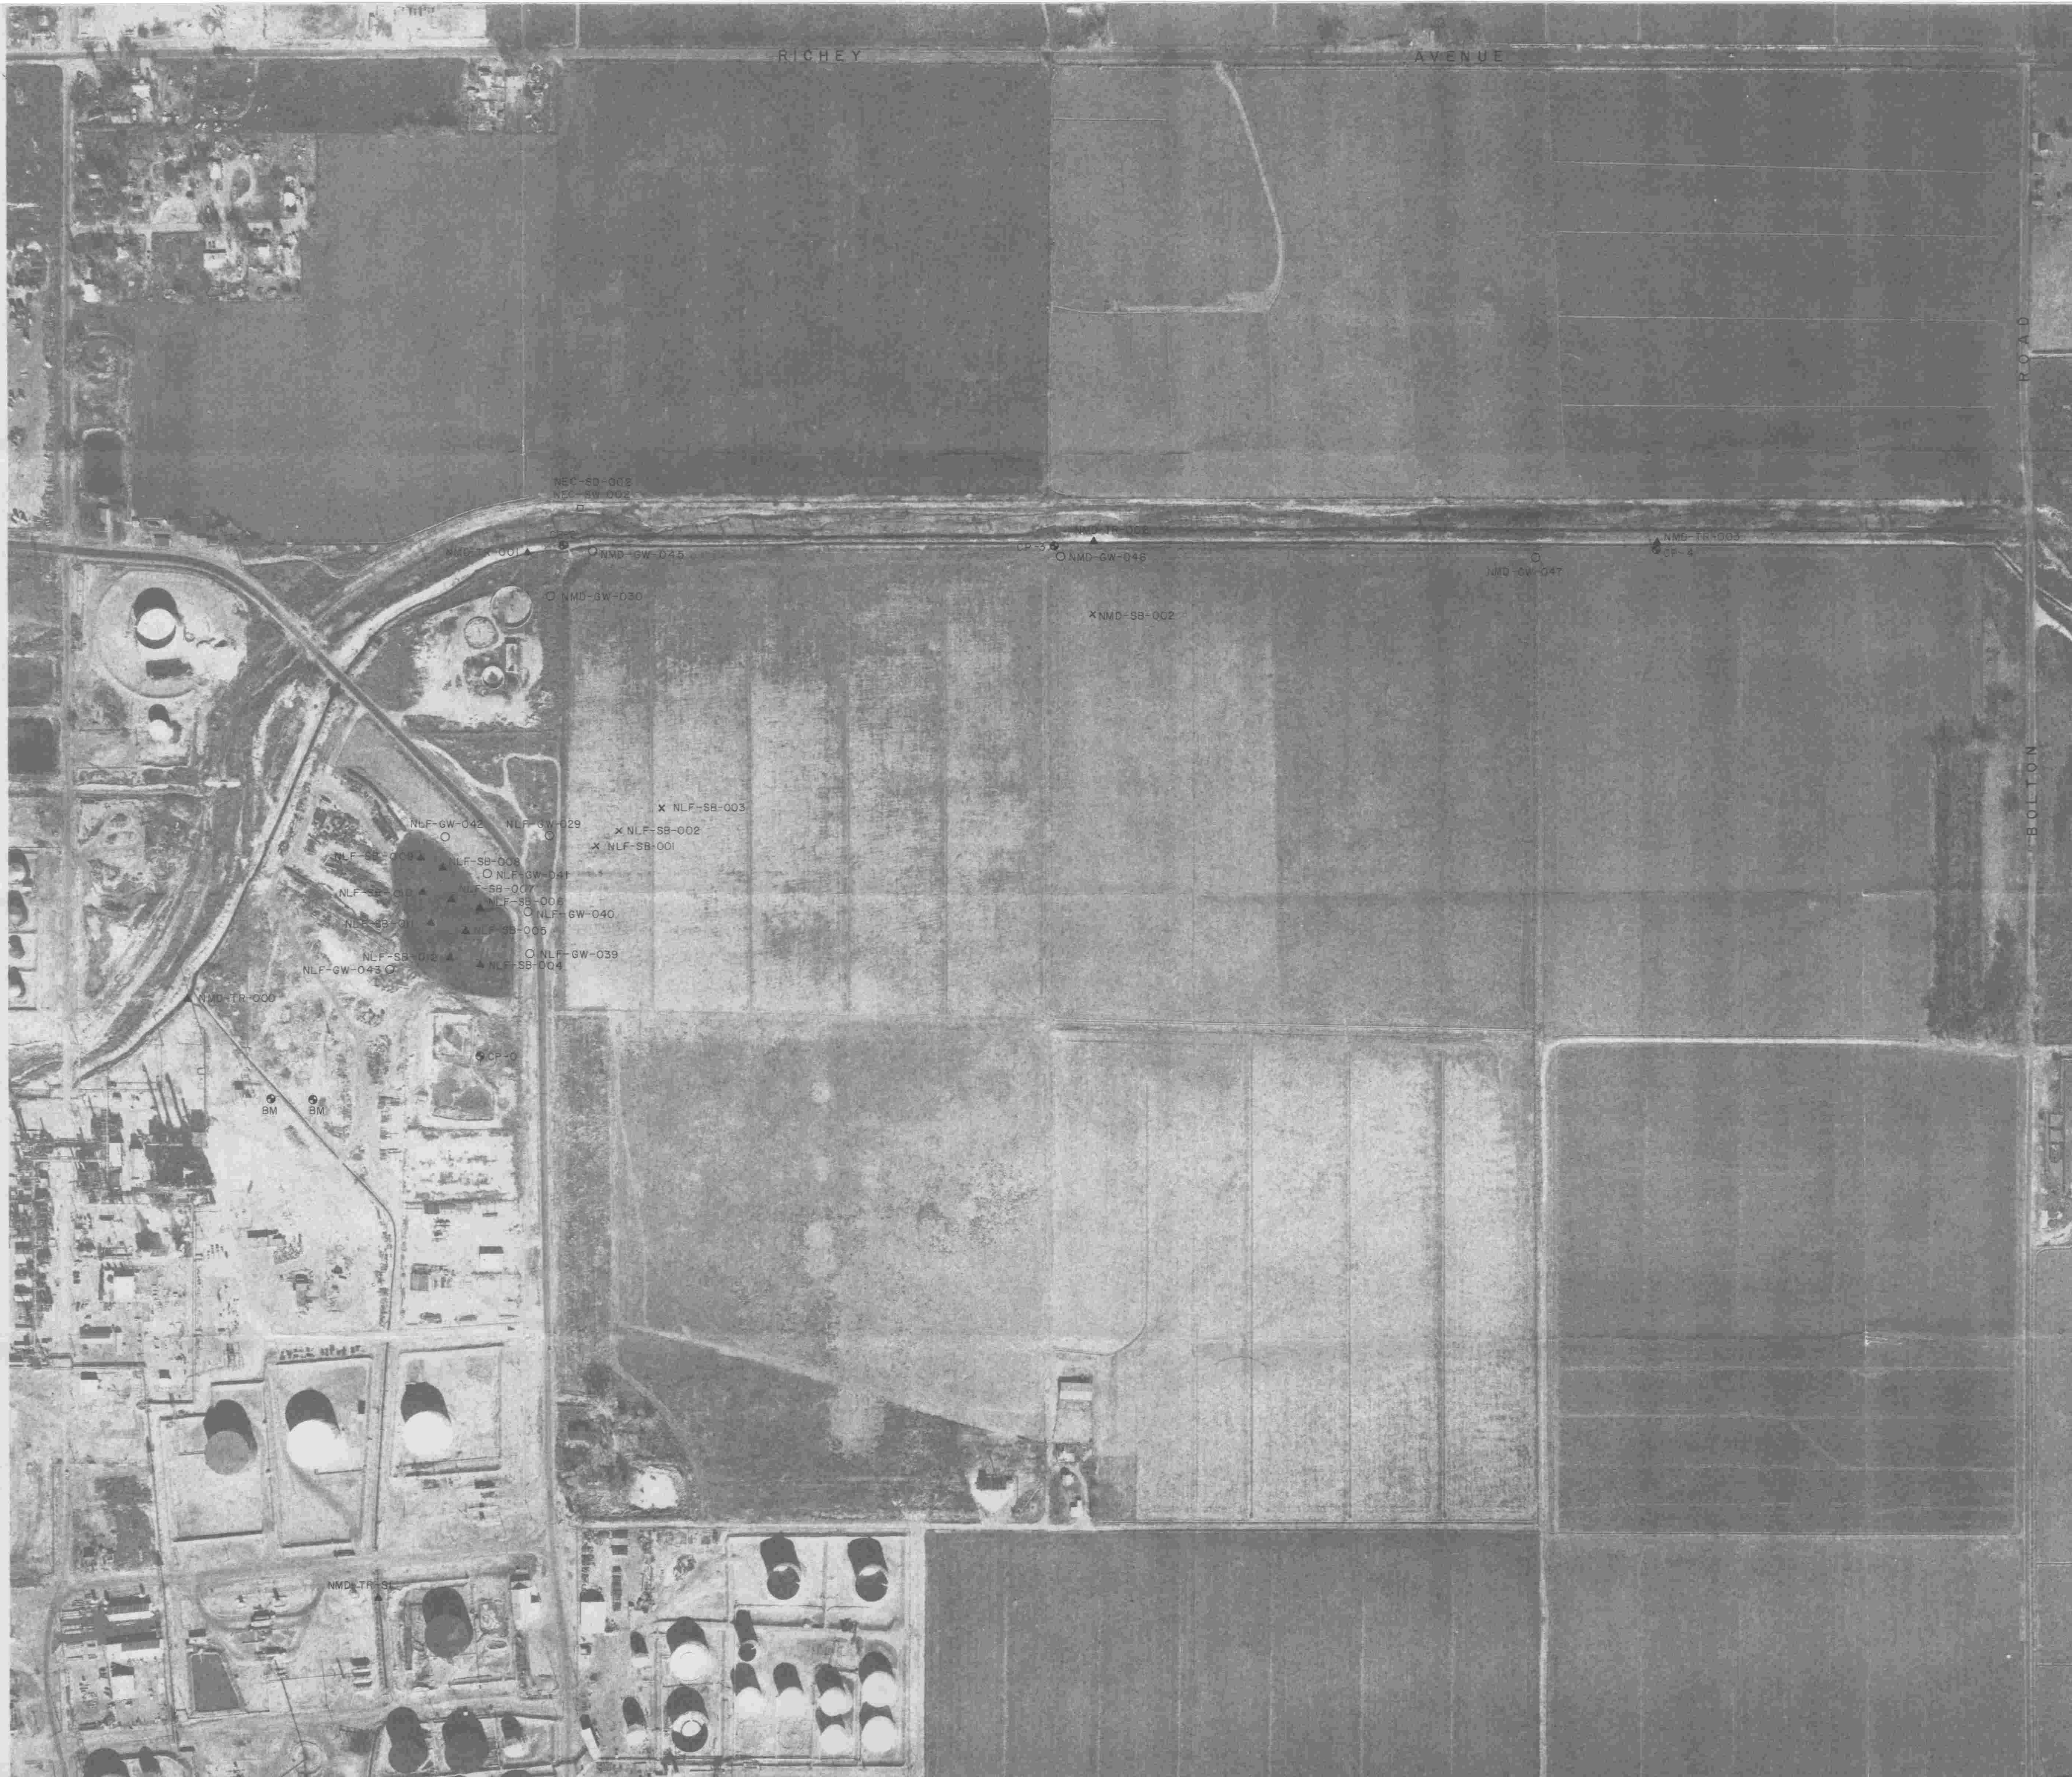
RFI DRAWING NO. 2	JCB NO. 90149	DATE SEPT. 1990	90-33-D-2
----------------------	------------------	--------------------	-----------

EAGLE CREEK & 3 MILE DITCH
TRUCK BYPASS LANDFARM
SAMPLE LOCATION MAP
NAVAJO REFINING CO.
ARTESIA EDDY COUNTY NEW MEXICO
PREPARED FOR MARIAH ASSOCIATES
BY MCFARLAND ENGINEERING

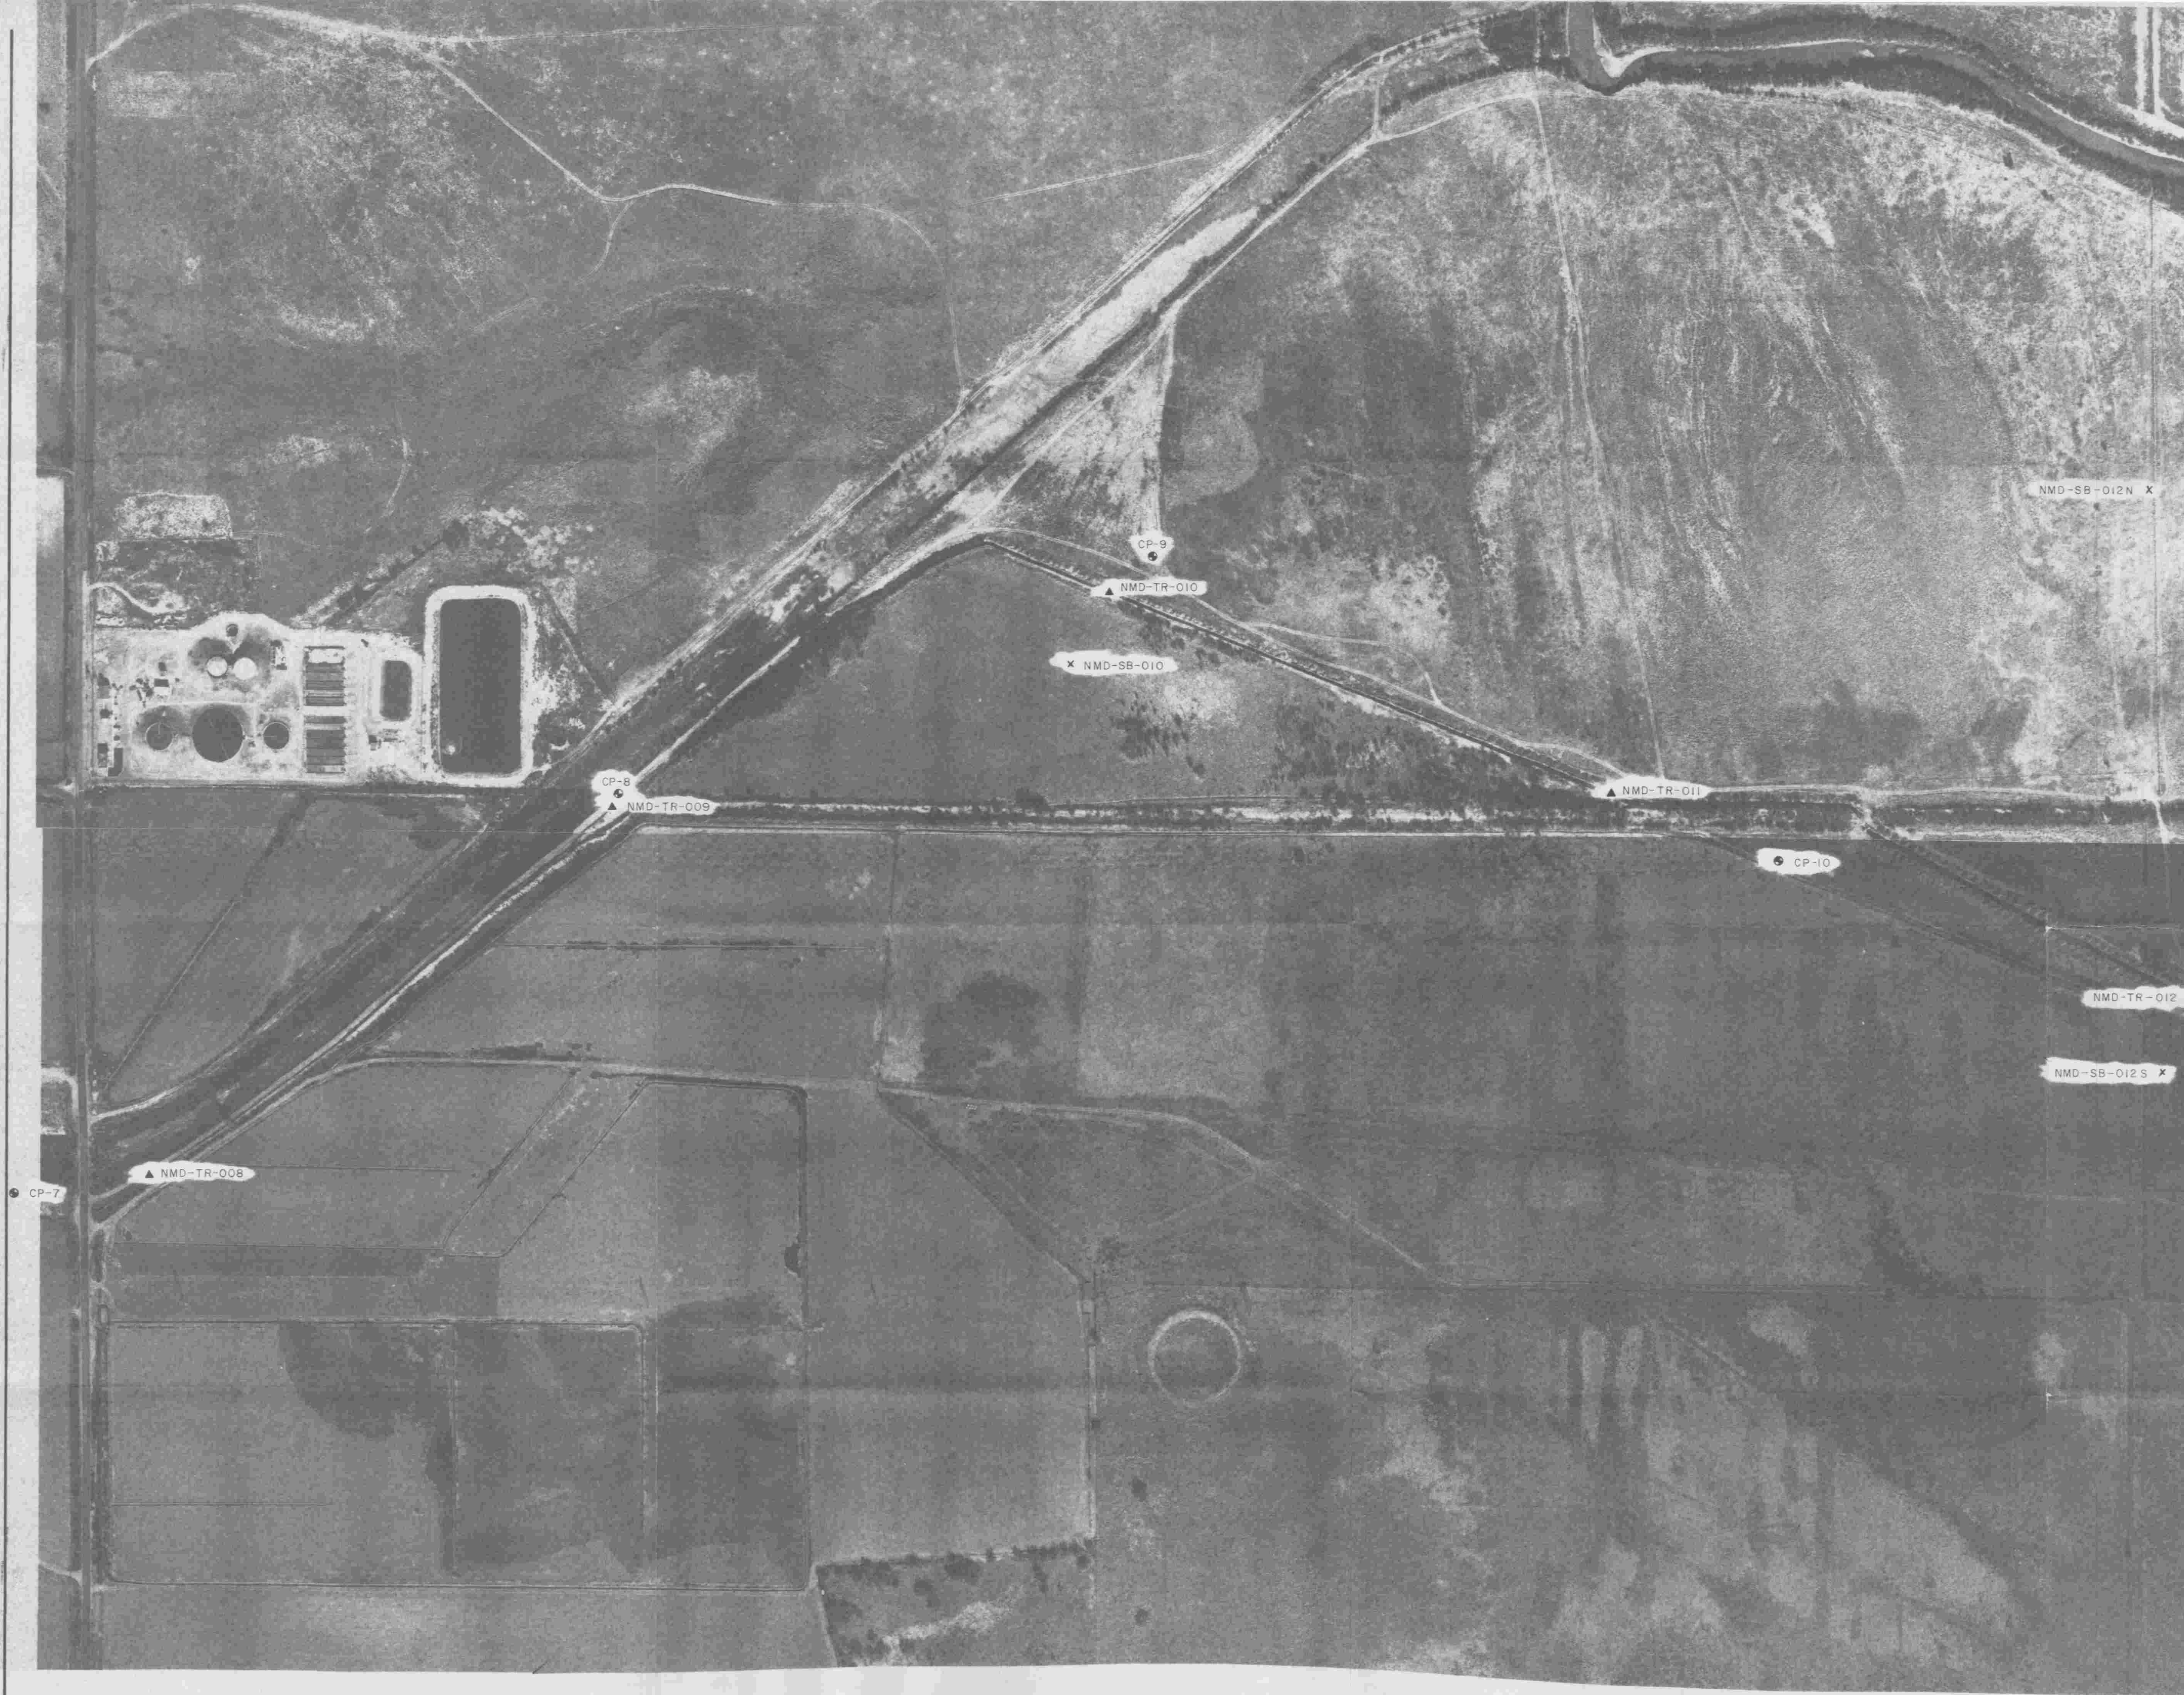
EAGLE CREEK & 3 MILE DITCH			
SAMPLE LOCATION MAP			
NAVAJO REFINING CO.			
ARTESIA		EDDY COUNTY	
		NEW MEXICO	
PREPARED FOR MARIAH ASSOCIATES			
BY MCFARLAND ENGINEERING			
RFI DRAWING NO. 4		JOB NO. 90149	
		DATE SEPT. 1990	
		90-33-D-4

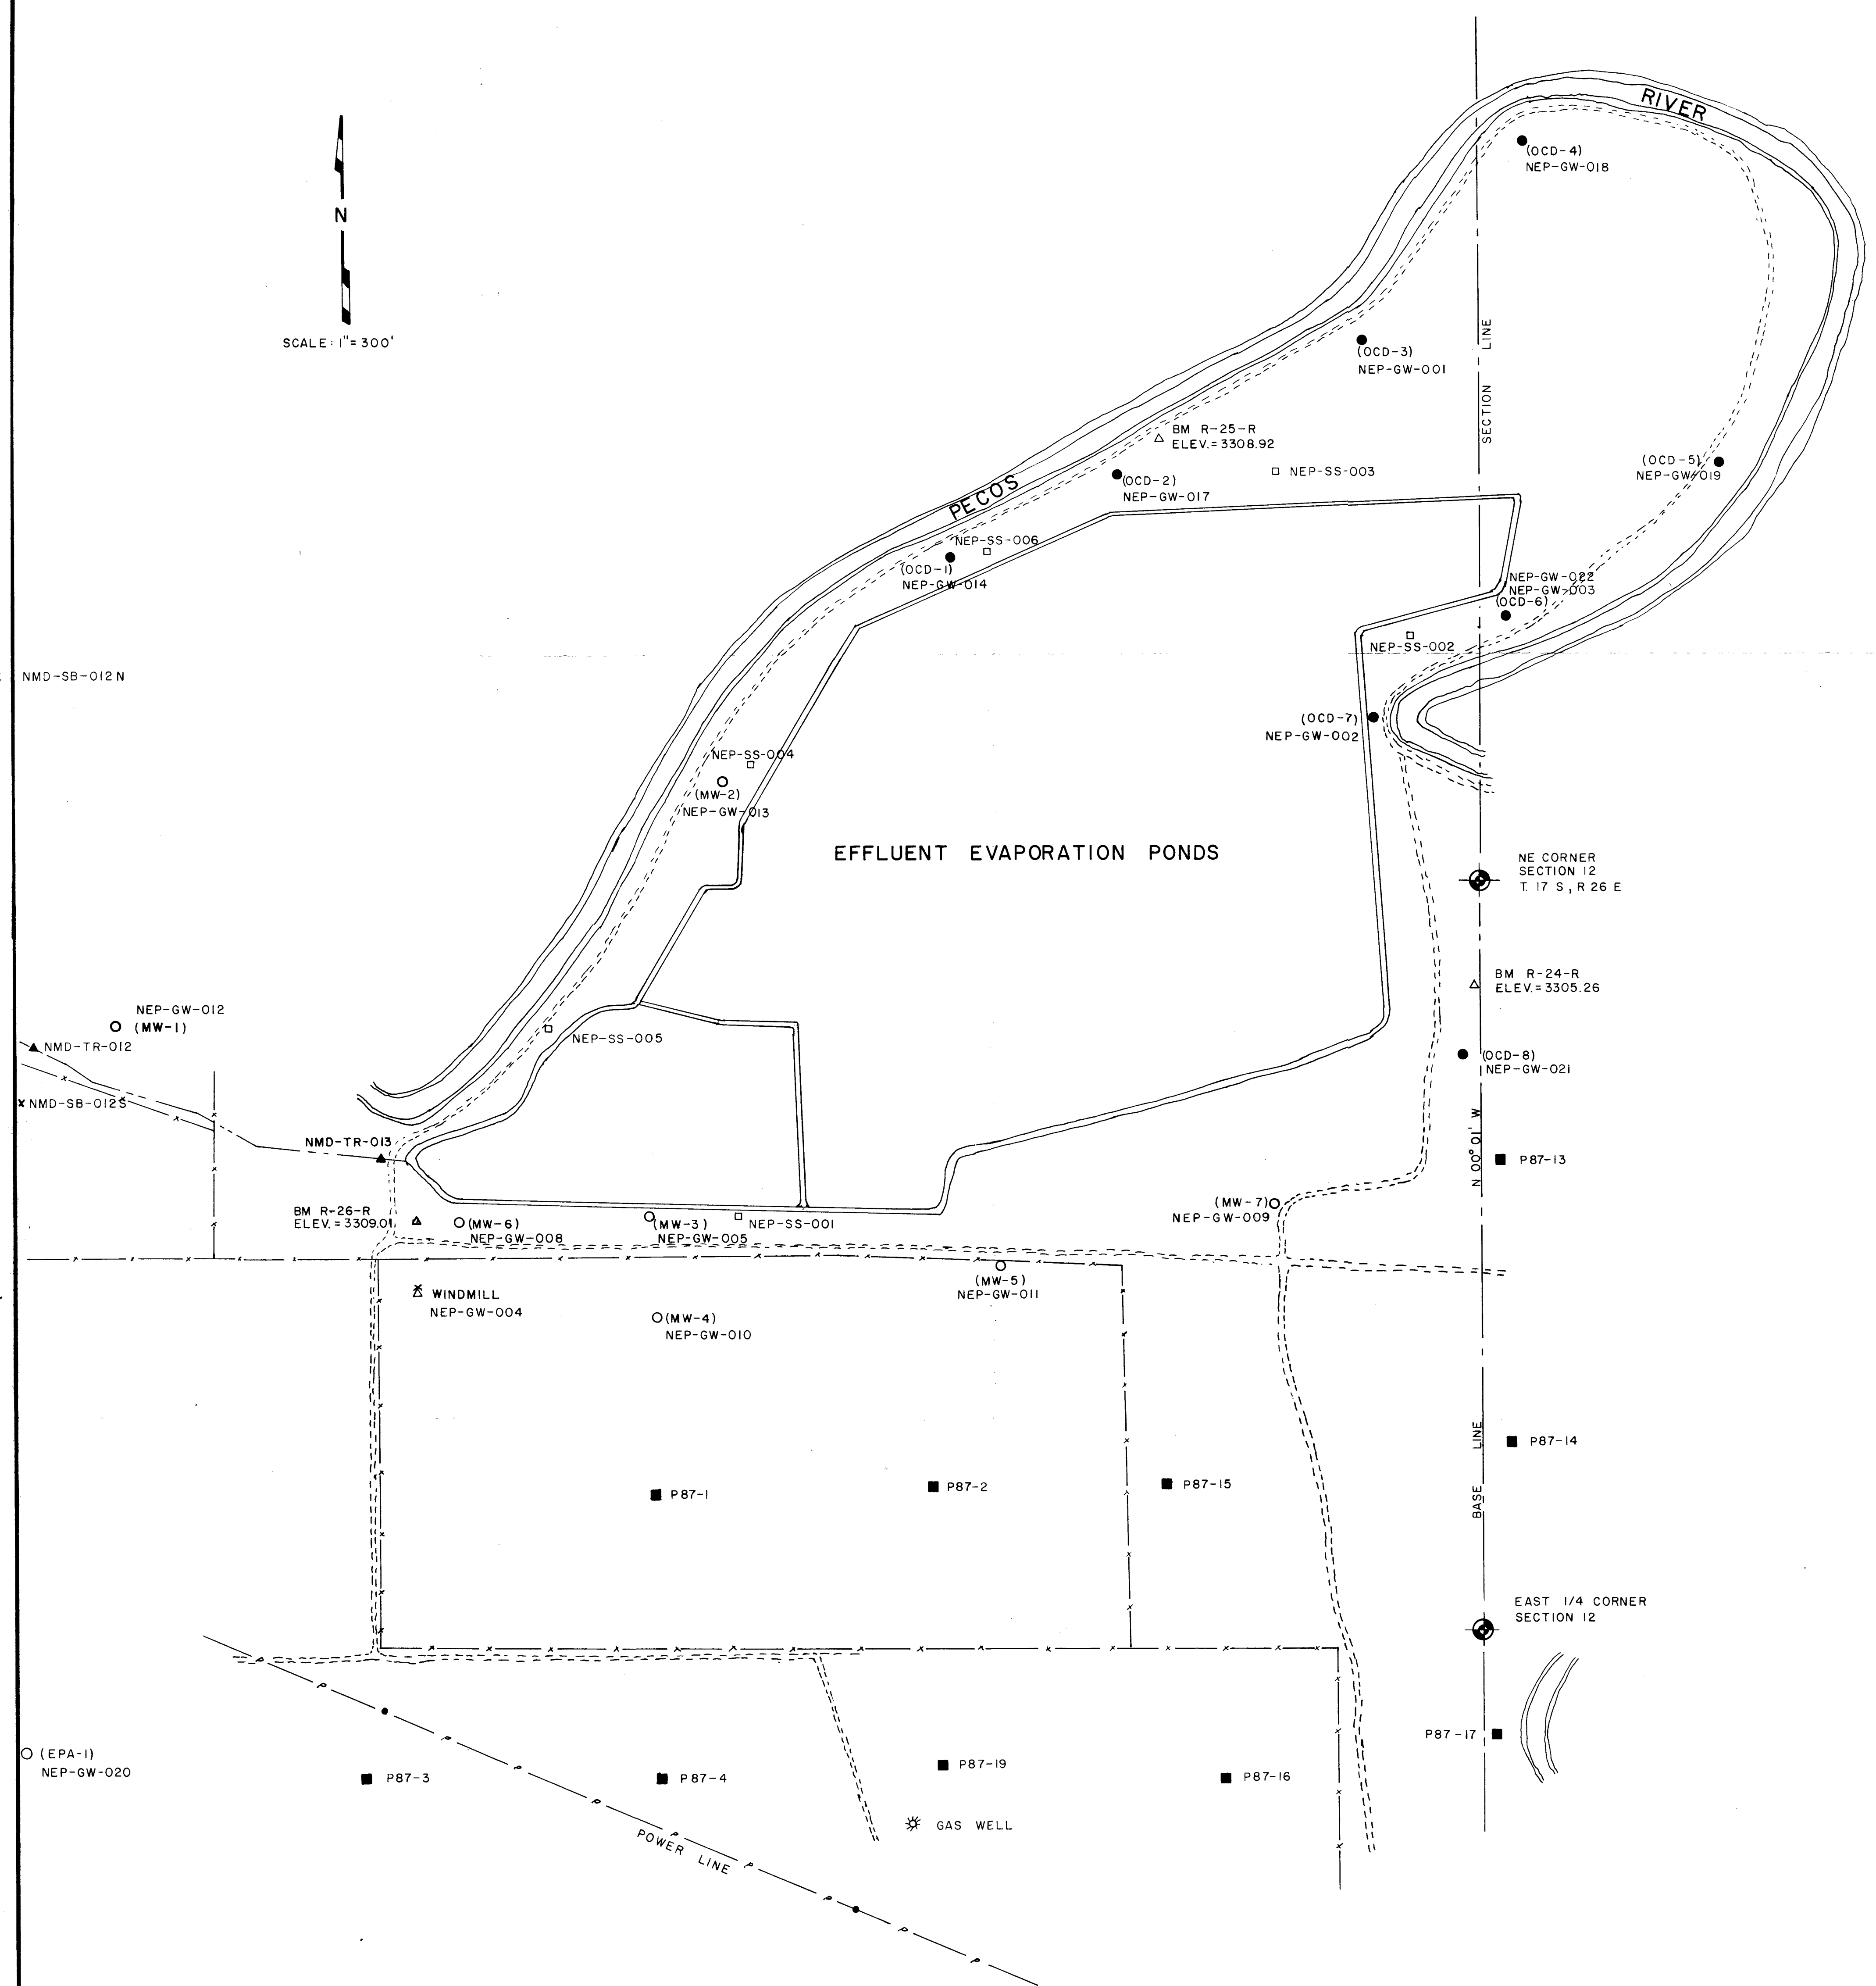
NOTE: ELEVATIONS ON WELLS ARE FROM U.S.G.S. B.M.
AT RAILROAD DEPOT IN ARTESIA.
THEY ARE 0.40 FEET HIGHER THAN THE
U.S.B.R. ELEVATIONS SHOWN ON R-24-R, R-25-R,
AND R-26-R.

EVAPORATION PONDS	
SAMPLE LOCATION MAP	
NAVAJO REFINING CO.	
ARTESA	EDDY COUNTY
NEW MEXICO	
PREPARED FOR MARIAH ASSOCIATES	
BY MCFARLAND ENGINEERING	
REF. DRAWING NO. 5	JOB NO. 90149
DATE	SEPT. 1990
70°-33'-D.5

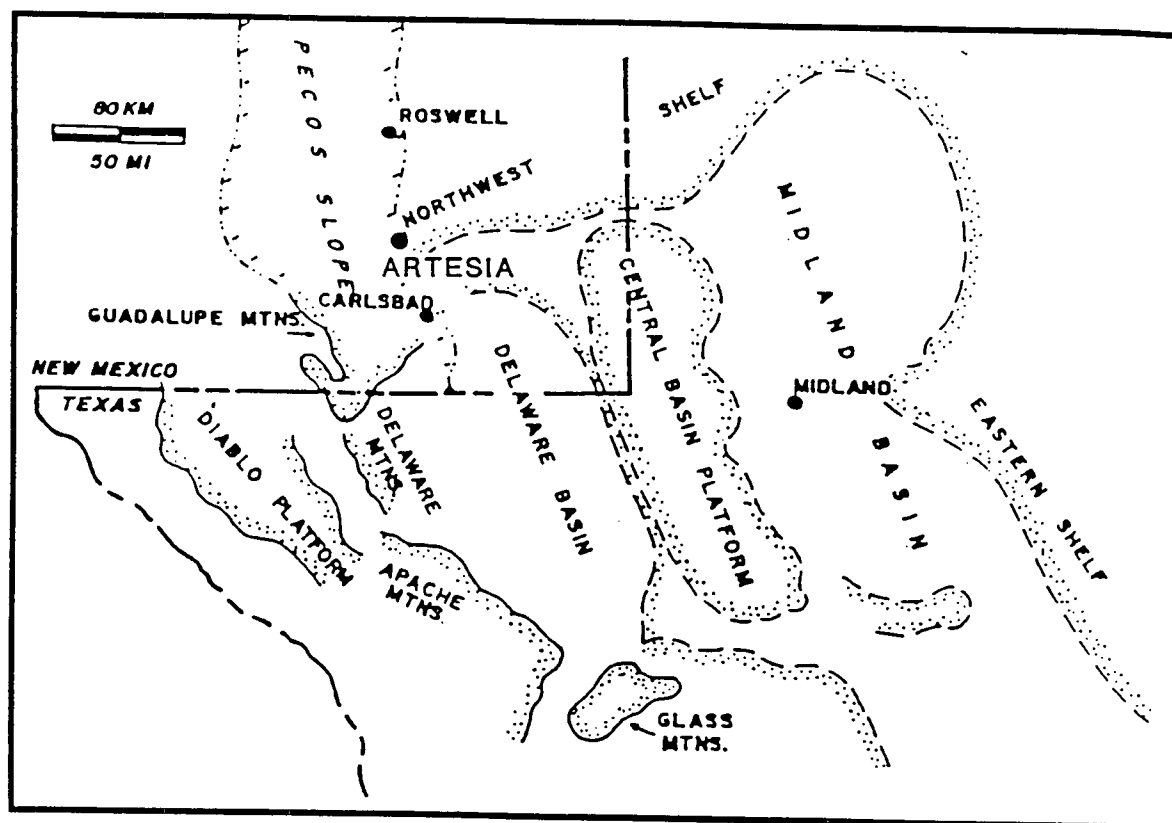
Figure 3.1 Regional Geologic Provinces.

The Navajo facility and the city of Artesia are located in southeast New Mexico on the Northwest Shelf of the Permian Basin, a large, sedimentary basin which developed primarily between Early Pennsylvanian and Late Permian time (Hiss 1975). Southeast of the Northwest Shelf, strata grade into the Permian Reef facies and farther south into the Delaware Basin (Figure 3.1).

The Navajo refinery is located on the Northwest Shelf of the Permian Basin (Figure 3.1). In this region, deposits are comprised of approximately 250 ft of Quaternary (and late Tertiary?) alluvium unconformably overlying approximately 2,000 ft of Permian clastic and carbonate rocks. These Permian deposits unconformably overlies Precambrian syenite, gneiss, and diabase crystalline rocks (Kelley 1971).

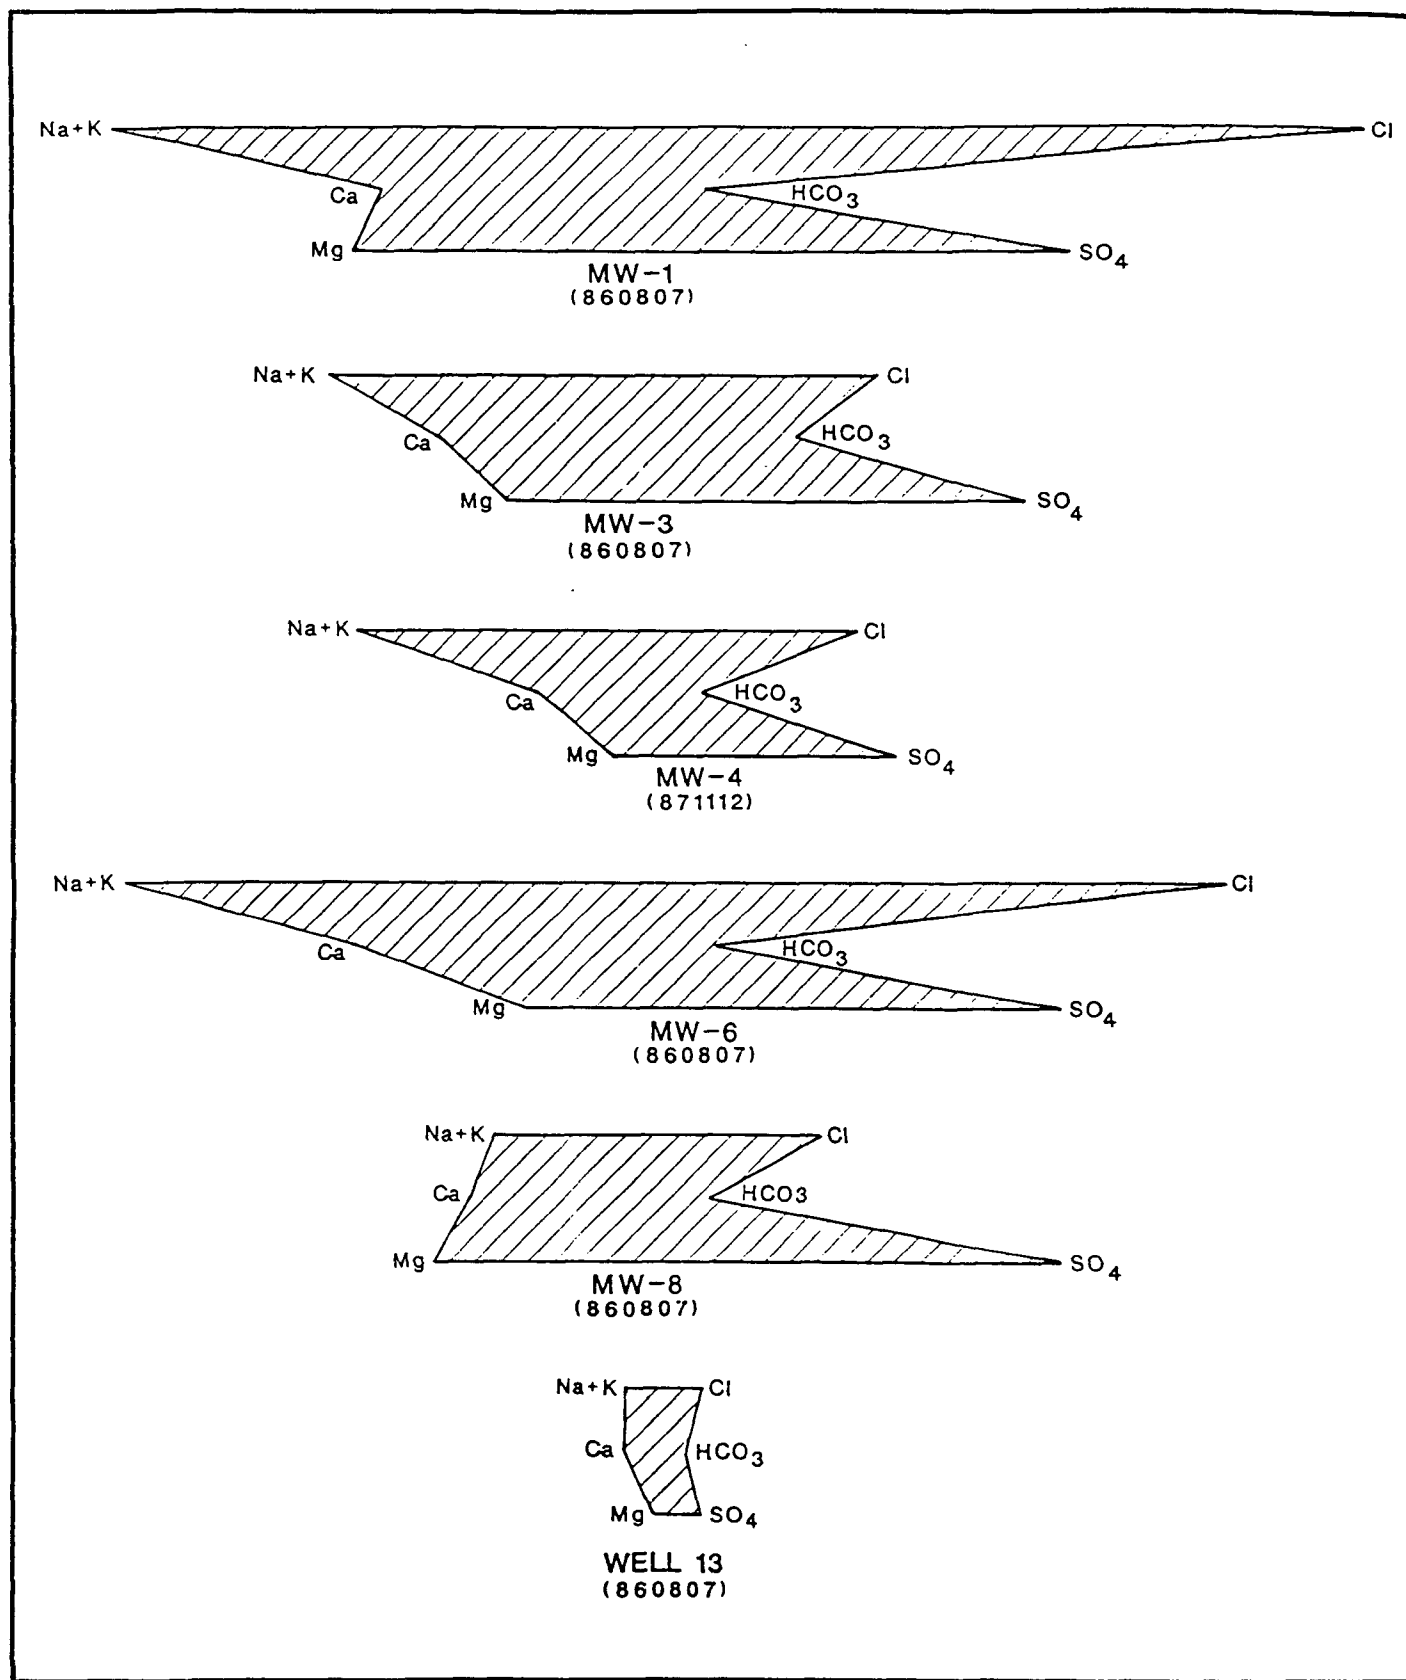
Figure 3.2 Shallow Valley Fill Aquifer Water Quality, Stiff Diagrams.

The shallow valley fill aquifer system is generally composed of gravel, sand, silt, and clay associated with alluvial deposits and is approximately 150 to 250 ft thick in the vicinity of Artesia, New Mexico. At the Pecos River, water occurs in this aquifer at a depth of approximately five to 35 ft below the surface (approximately 3300 ft amsl). Recharge of the shallow valley fill aquifer is generally attributed to irrigation return flow from pumpage in both the shallow valley fill and the artesian aquifers, and from infiltration from the Pecos River. Minor recharge is thought to occur from precipitation and upward leakage through the confining zone from the artesian aquifer (Welder 1983).
