REPORTS

Mariah Associates, Inc. (Mariah) conducted the Resource Conservation Recovery Act (RCRA) facility investigation (RFI) Phase I for Navajo (Navajo) Refining Company, a petroleum refinery located in Artesia, New Mexico. The RFI encompassed three solid waste management units on the refinery site: 1) the Truck Bypass Landfarm, 2) the Three-Mile Ditch and Eagle Creek, and 3) the evaporation ponds. The purpose of the Navajo RFI Phase I was to determine the nature and extent of hazardous waste or constituent releases from solid waste management units (SWMUs) and to provide rationale for proposal of a RFI Phase II investigation.

The Navajo refinery (U.S. Environmental Protection Agency [EPA] ID No. NMD 048918817) located in Artesia, New Mexico, is regulated under the RCRA and the Hazardous and Solid Waste Amendments (HSWA). One of the major provisions of HSWA (Section 3004-6) requires corrective action for releases of hazardous waste

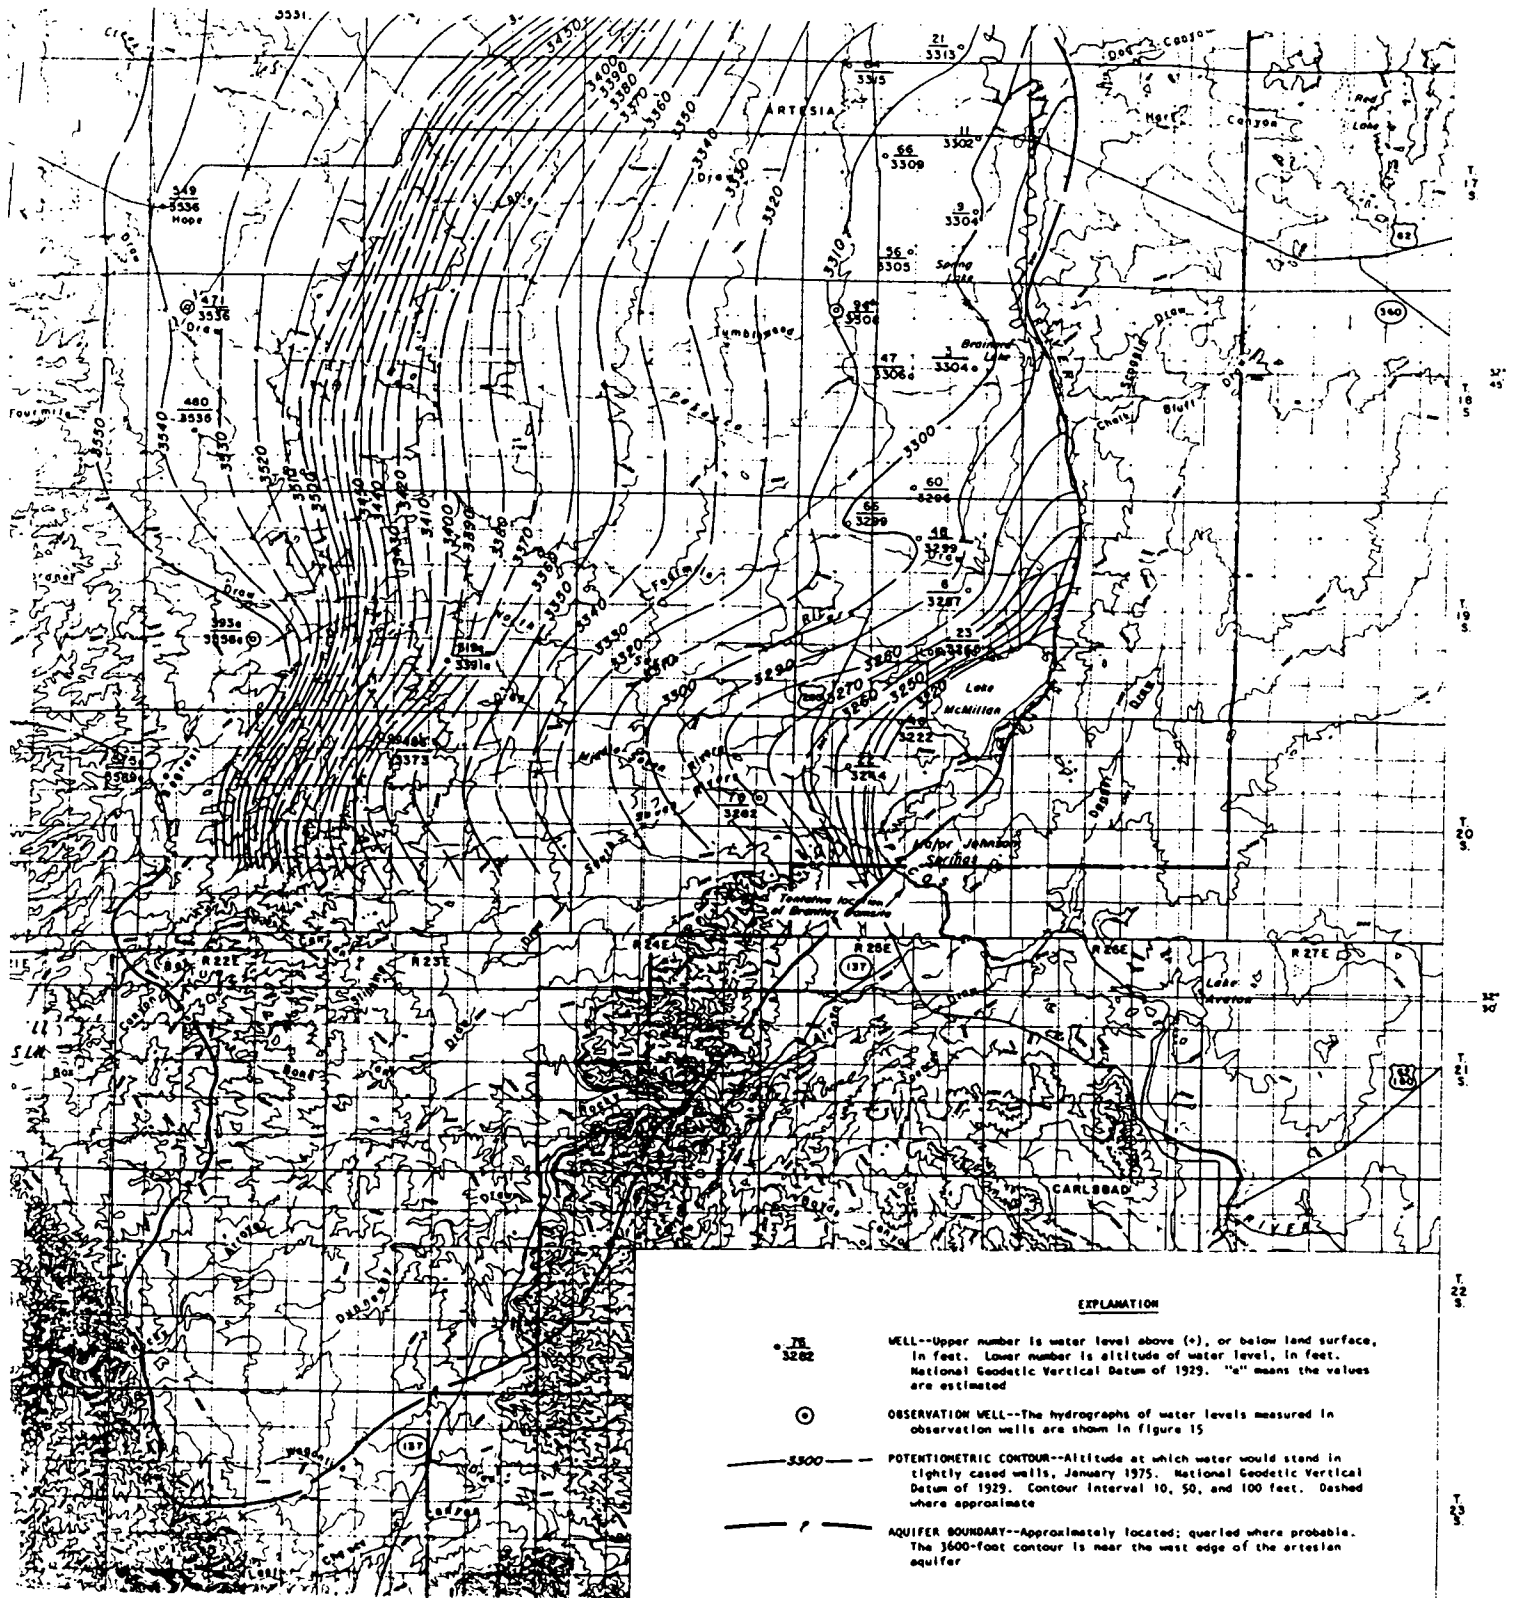
Figure 3.3 Artesian Aquifer, Potentiometric Surface Map.

Potentiometric elevations in the artesian aquifer in the vicinity of Artesia occur at approximately 3305 to 3320 ft amsl, or five to 50 ft below the ground surface (Figure 3.3). Historically, flowing artesian wells were common in the aquifer; however, only a few wells currently flow naturally. Recharge of the artesian aquifer is thought to be primarily from infiltration of precipitation and intermittent streambed leakage on outcrop portions of the aquifer (Welder 1983). Ground water flow in the

artesian aquifer is generally eastward with discharge occurring through vertical upward leakage and through water production wells (Welder 1983).

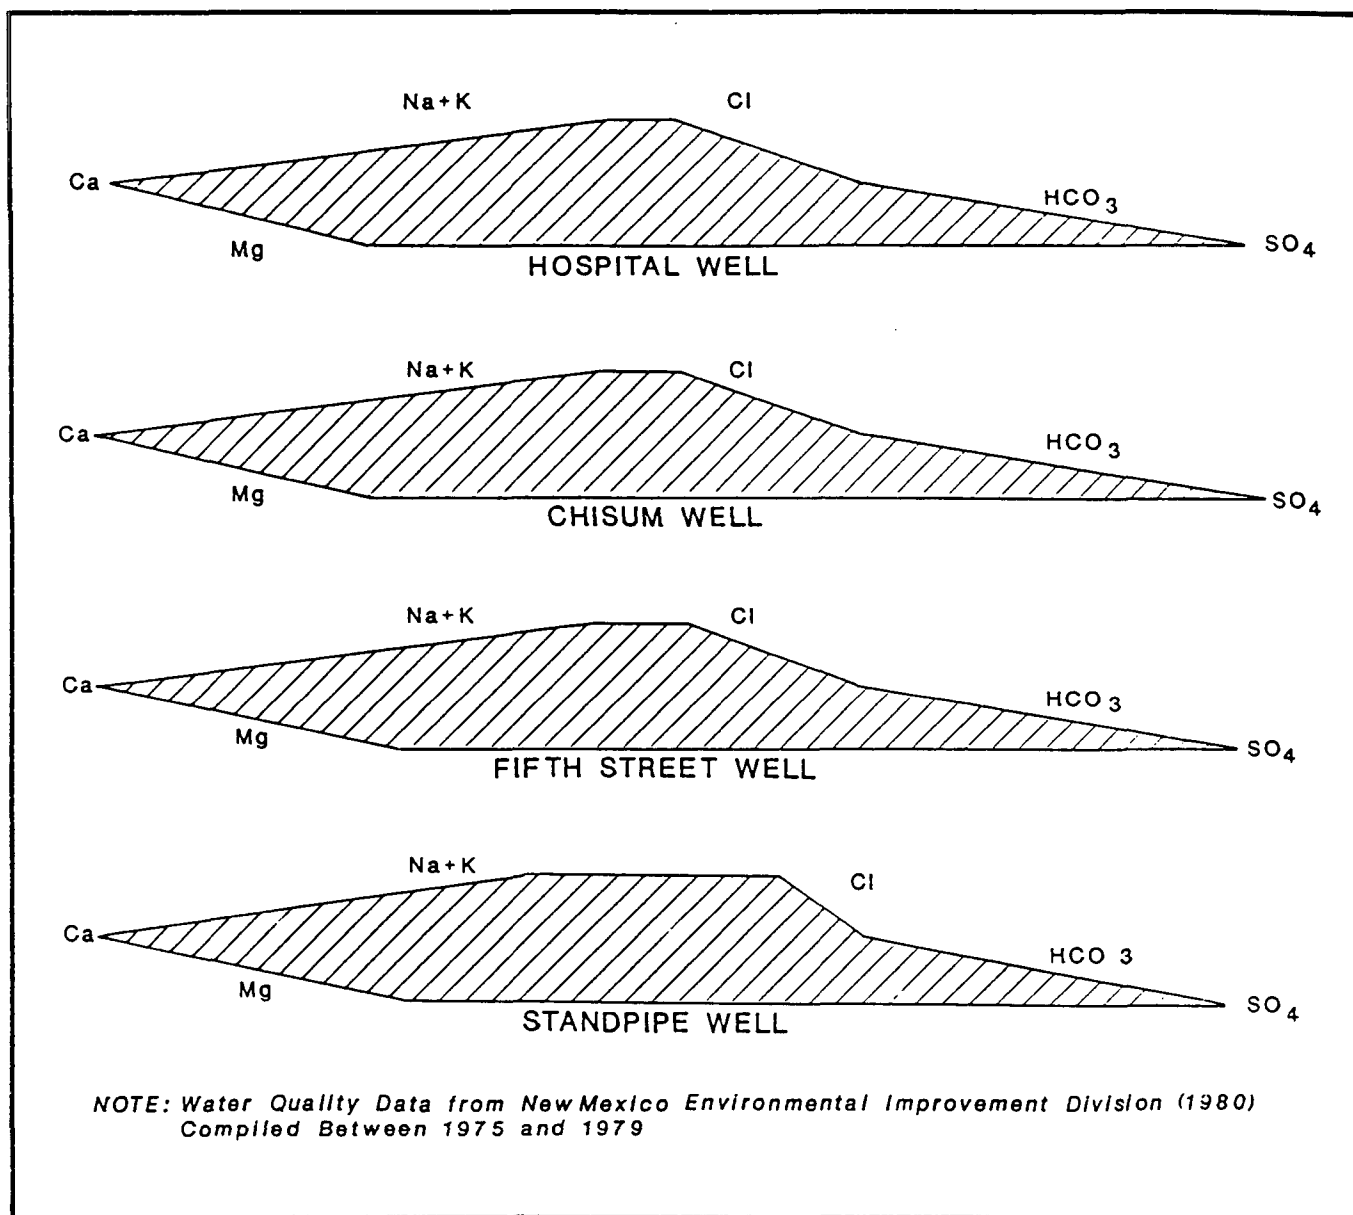
Figure 3.4 Artesian Aquifer Water Quality, Stiff Diagrams.

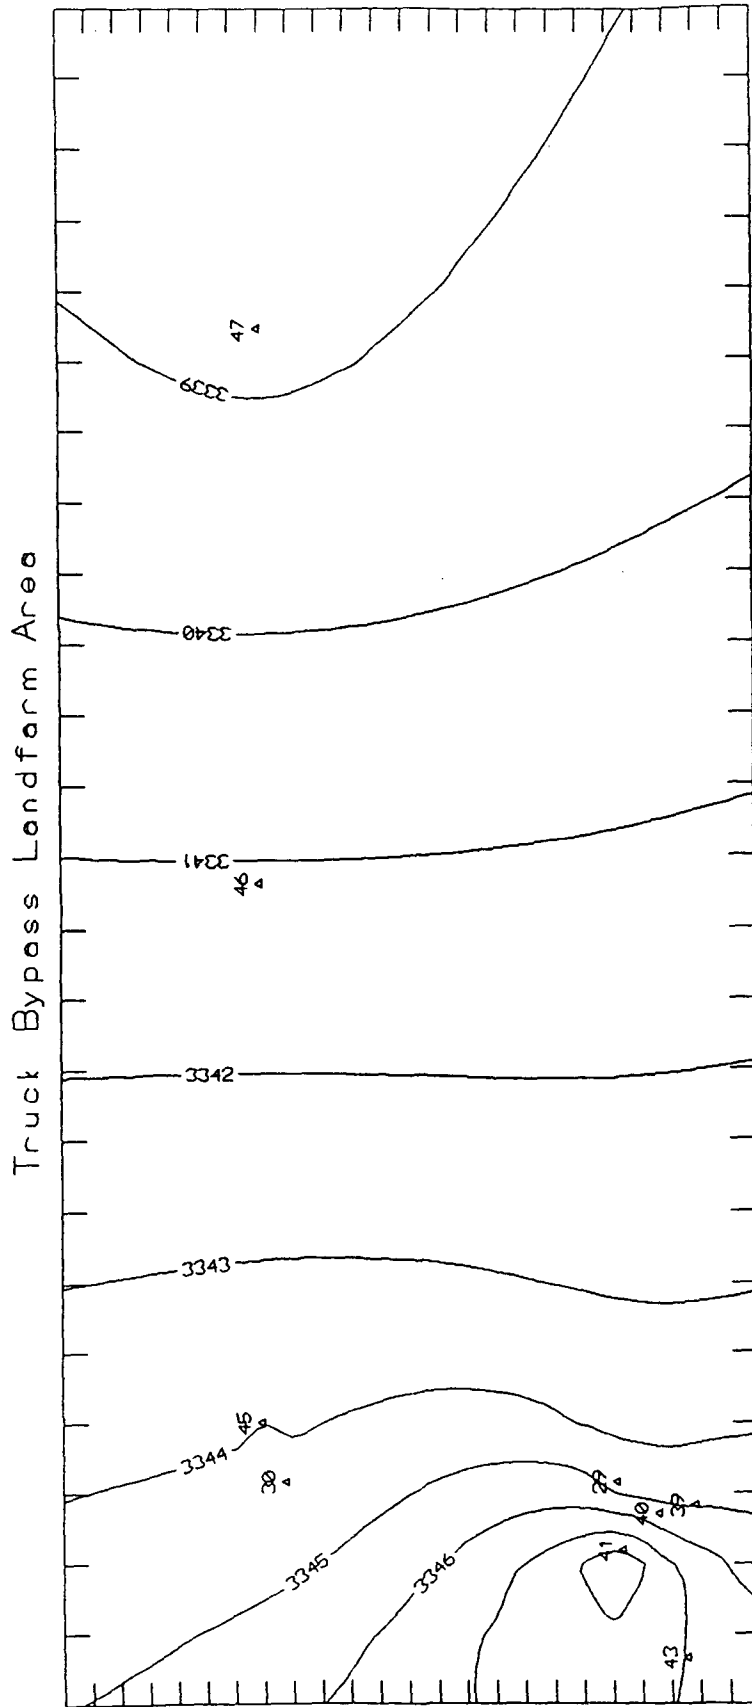
Figure 4.14 Truck Bypass Landfarm Area, Potentiometric Surface Map, RFI Phase I Report, Navajo Refining Company, October 1990.

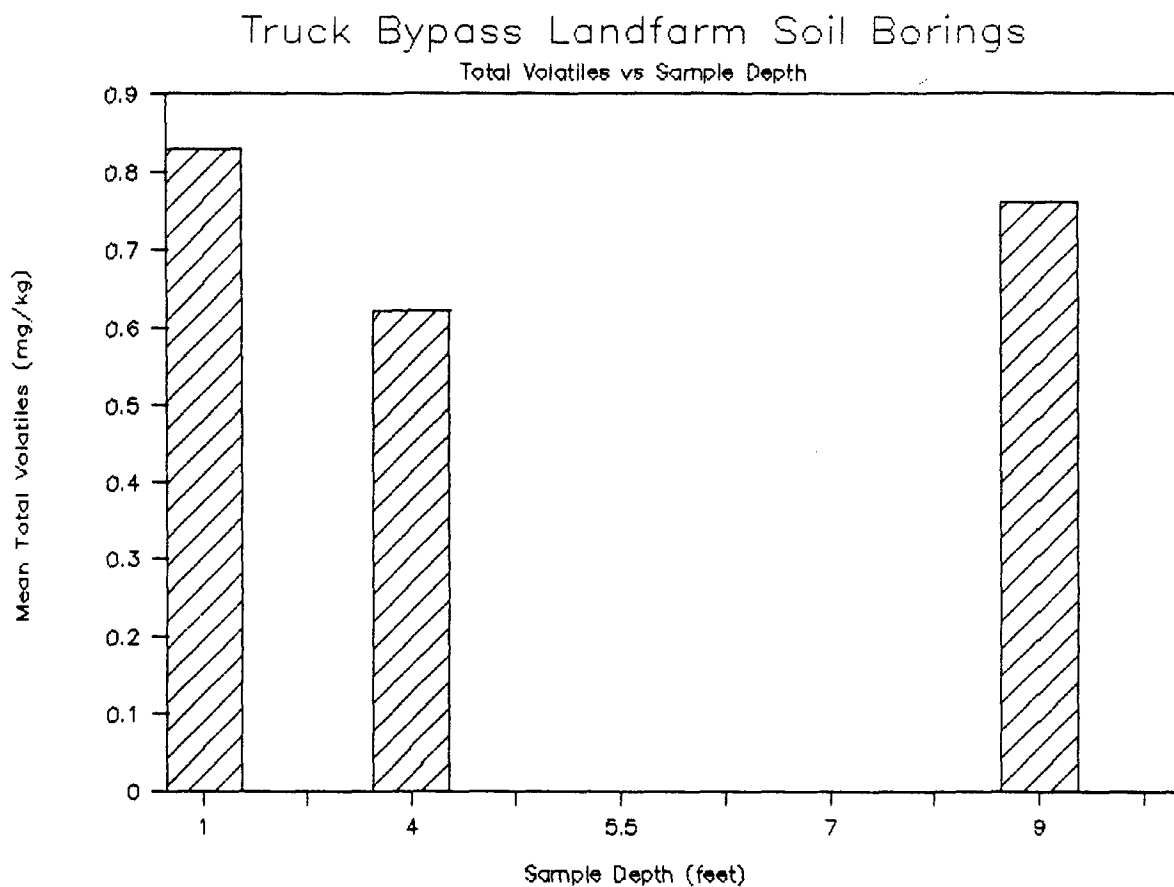
Figure 4.15 Truck Bypass Landfarm Soils, Total Volatiles vs. Sample Depth, RFI Phase I Report, Navajo Refining Company, October 1990.

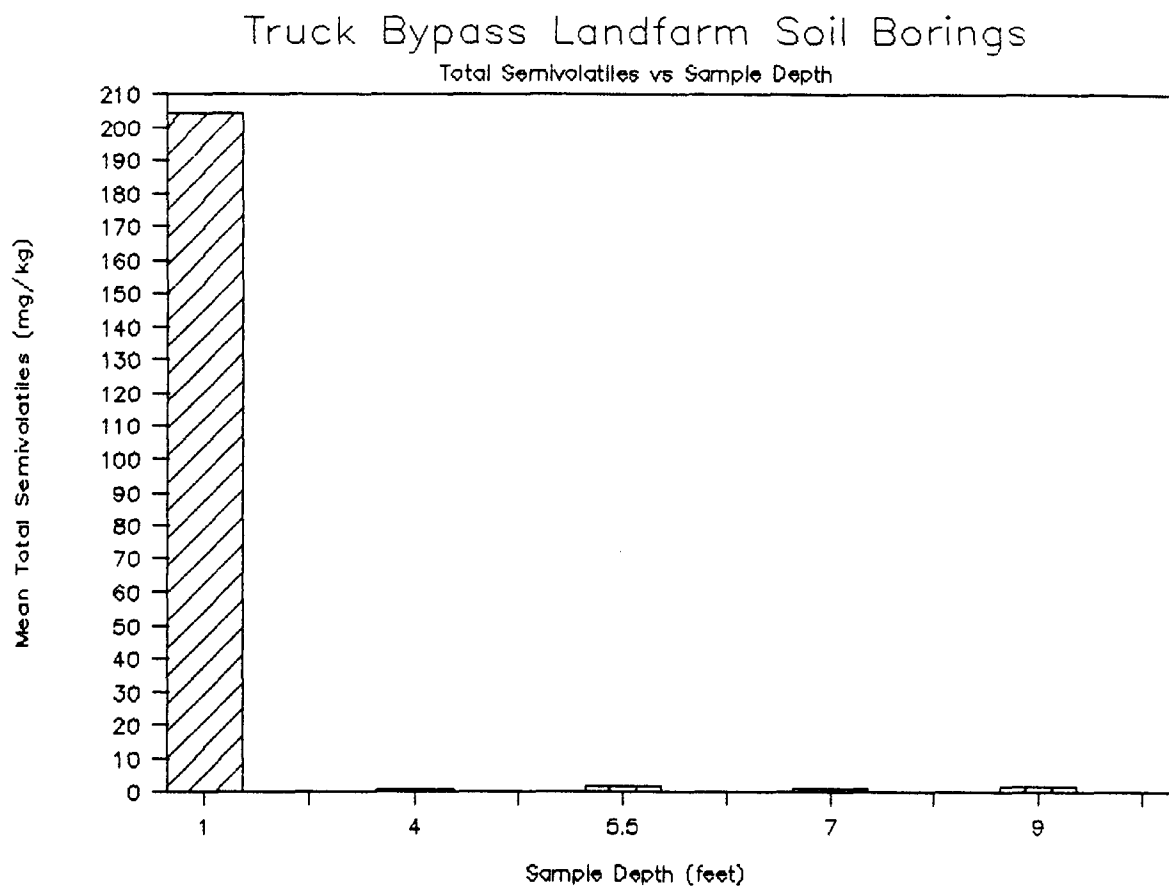
Figure 4.16 Truck Bypass Landfarm Soils, Total Semivolatiles vs. Sample Depth, RFI Phase I Report, Navajo Refining Company, October 1990.

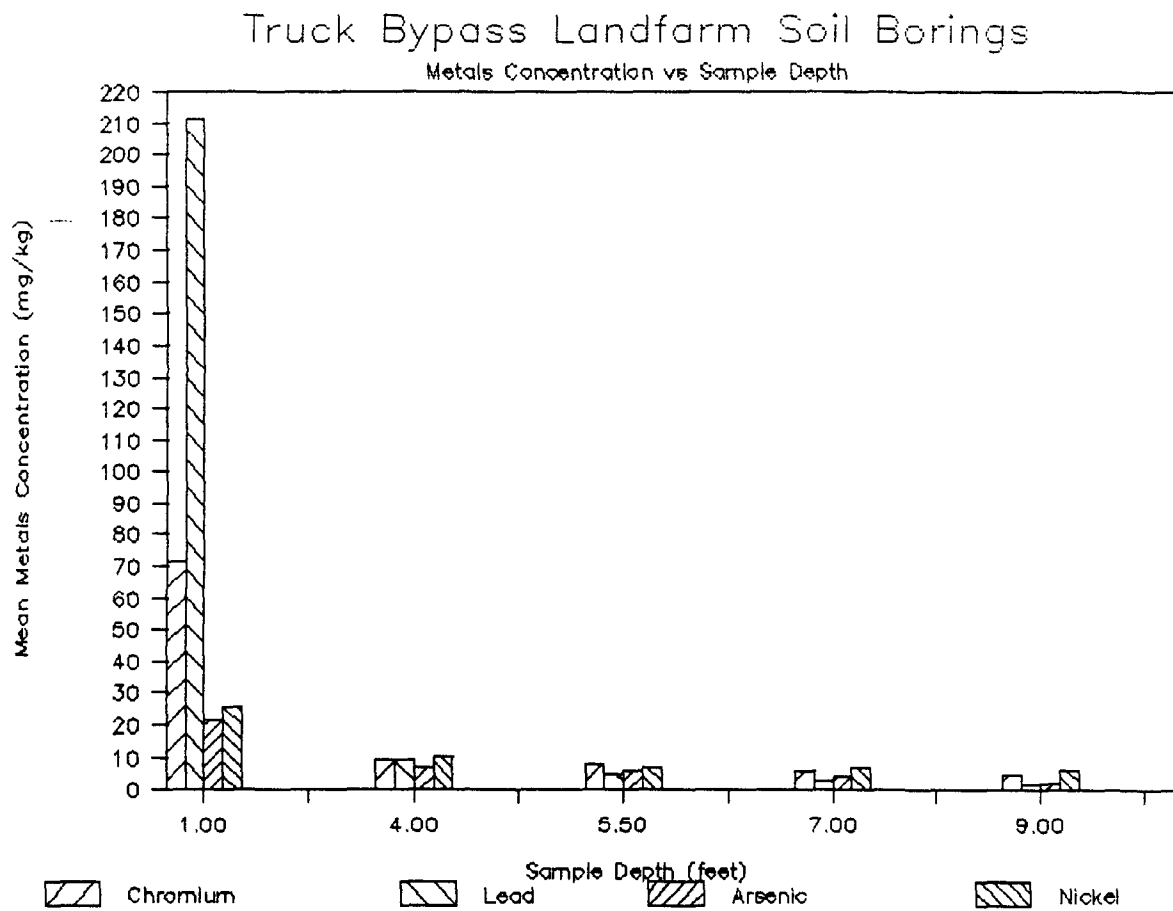
Figure 4.17 Truck Bypass Landfarm Soils, Metal Concentrations vs. Sample Depth, RFI Phase I Report, Navajo Refining Company, October 1990.

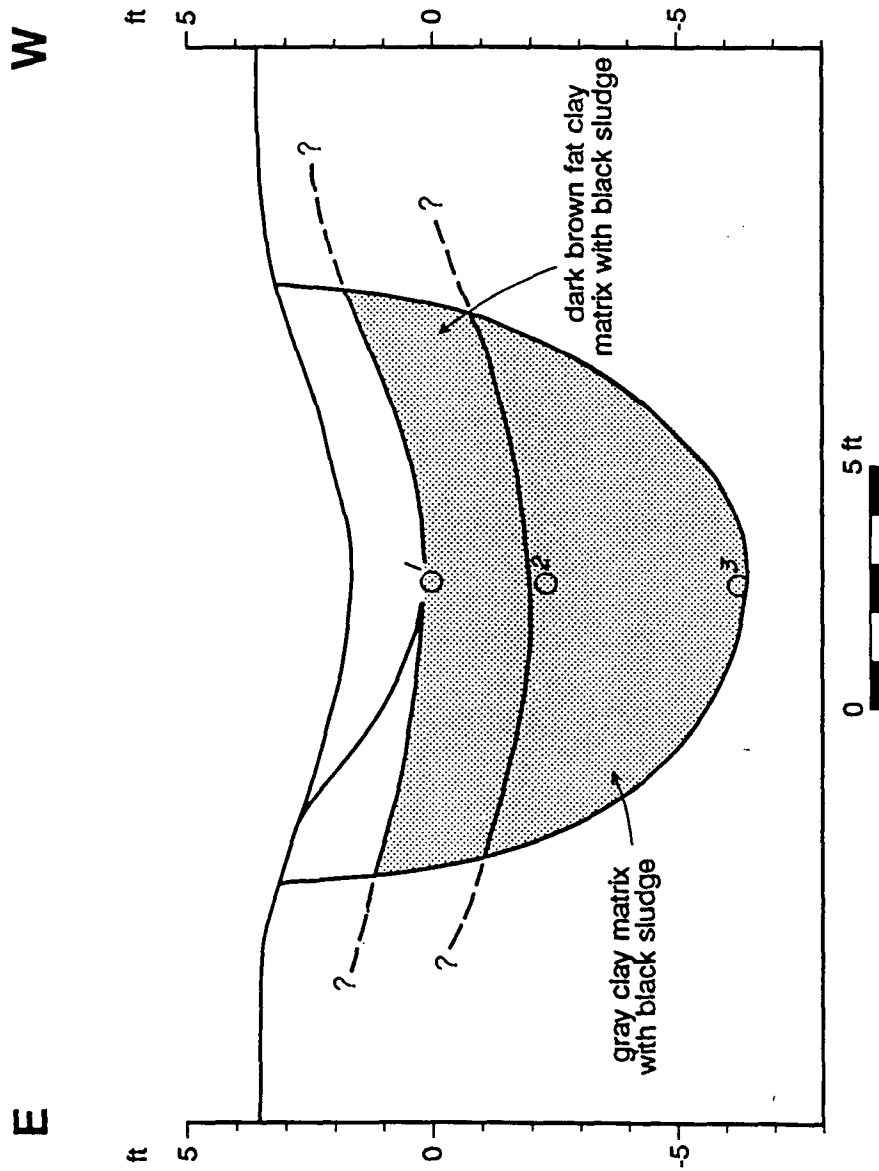
Figure 5.1 Three-Mile Ditch, Trench Cross Section NMD-TR-S1, RFI Phase I Report, Navajo Refining Company, October 1990.

Localization of significantly large volumes of sludge appears to be controlled by several factors. Trenches NMD-TR-011, NMD-TR-012, and NMD-TR-013 contained sludge to the deepest levels. These trenches are located nearest the ditch terminus and probably result from wastewater backup into the evaporation ponds. Sufficient

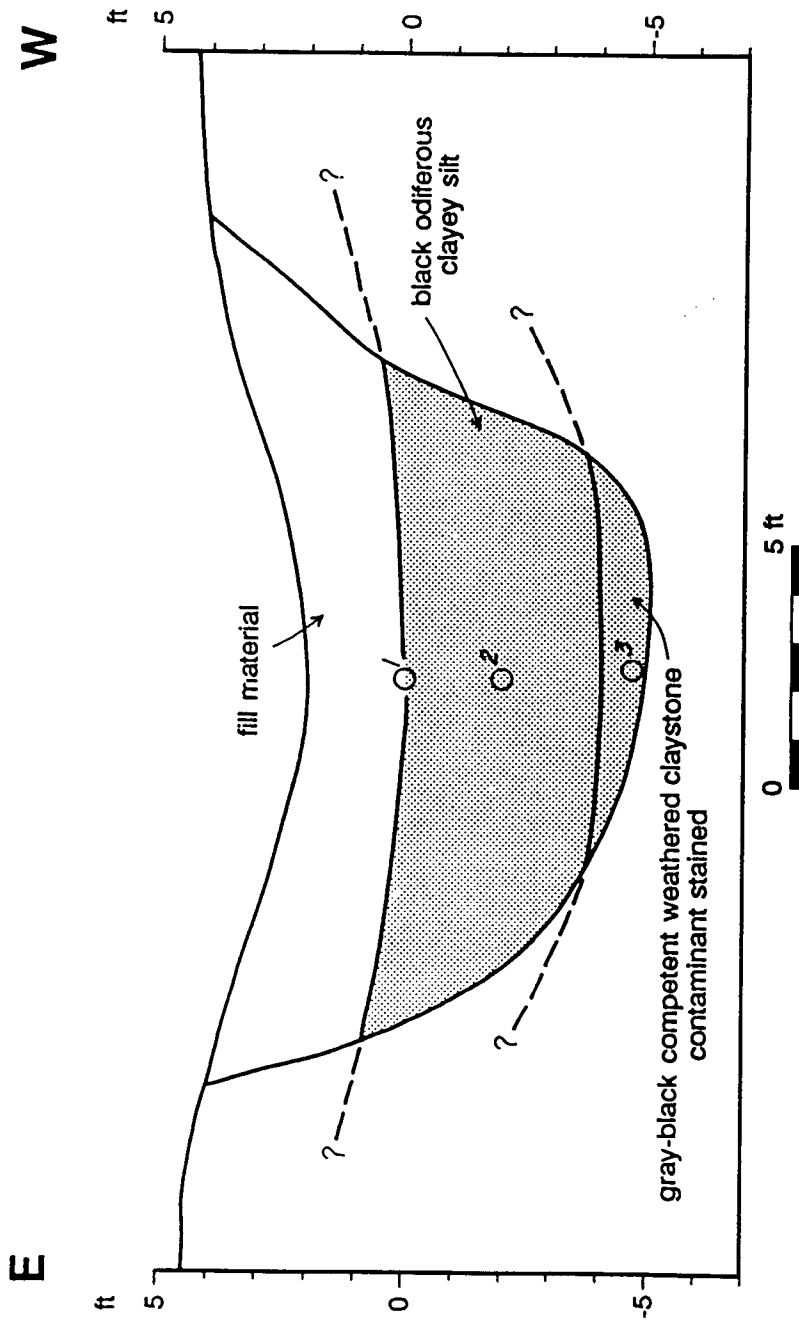
Figure 5.2 Three-Mile Ditch, Trench Cross Section NMD-TR-000, RFI Phase I Report, Navajo Refining Company, October 1990.

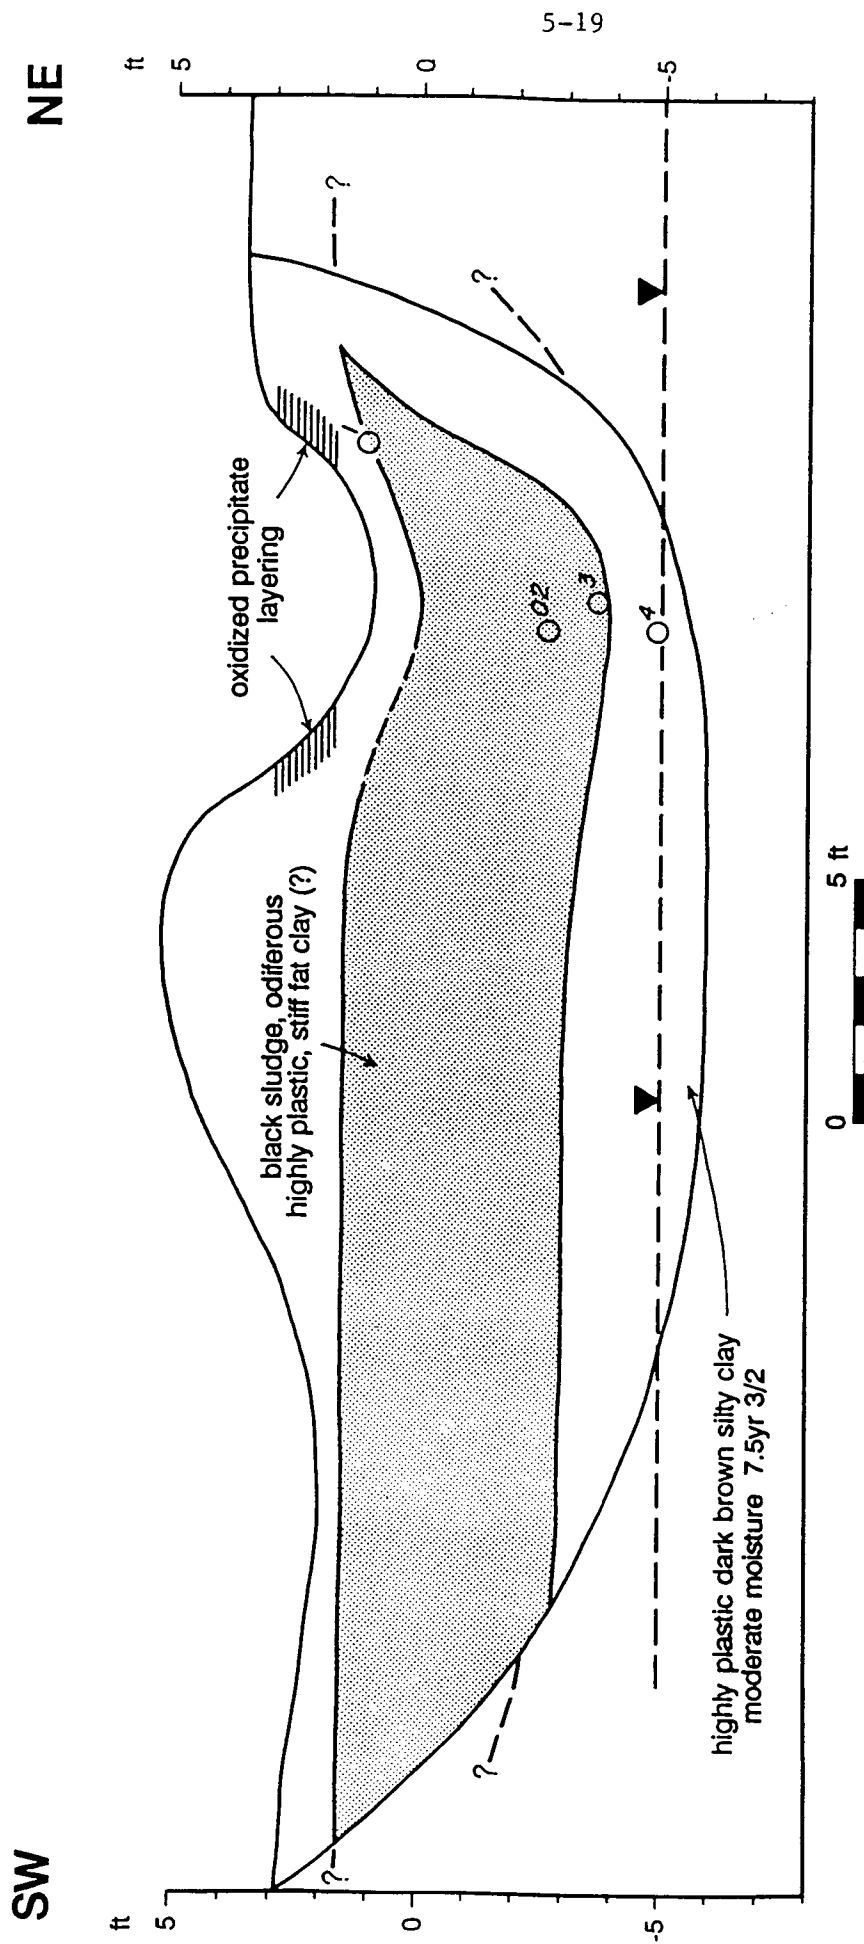
Figure 5.7 Three-Mile Ditch, Trench Cross Section NMD-TR-004, RFI Phase I Report, Navajo Refining Company, October 1990.

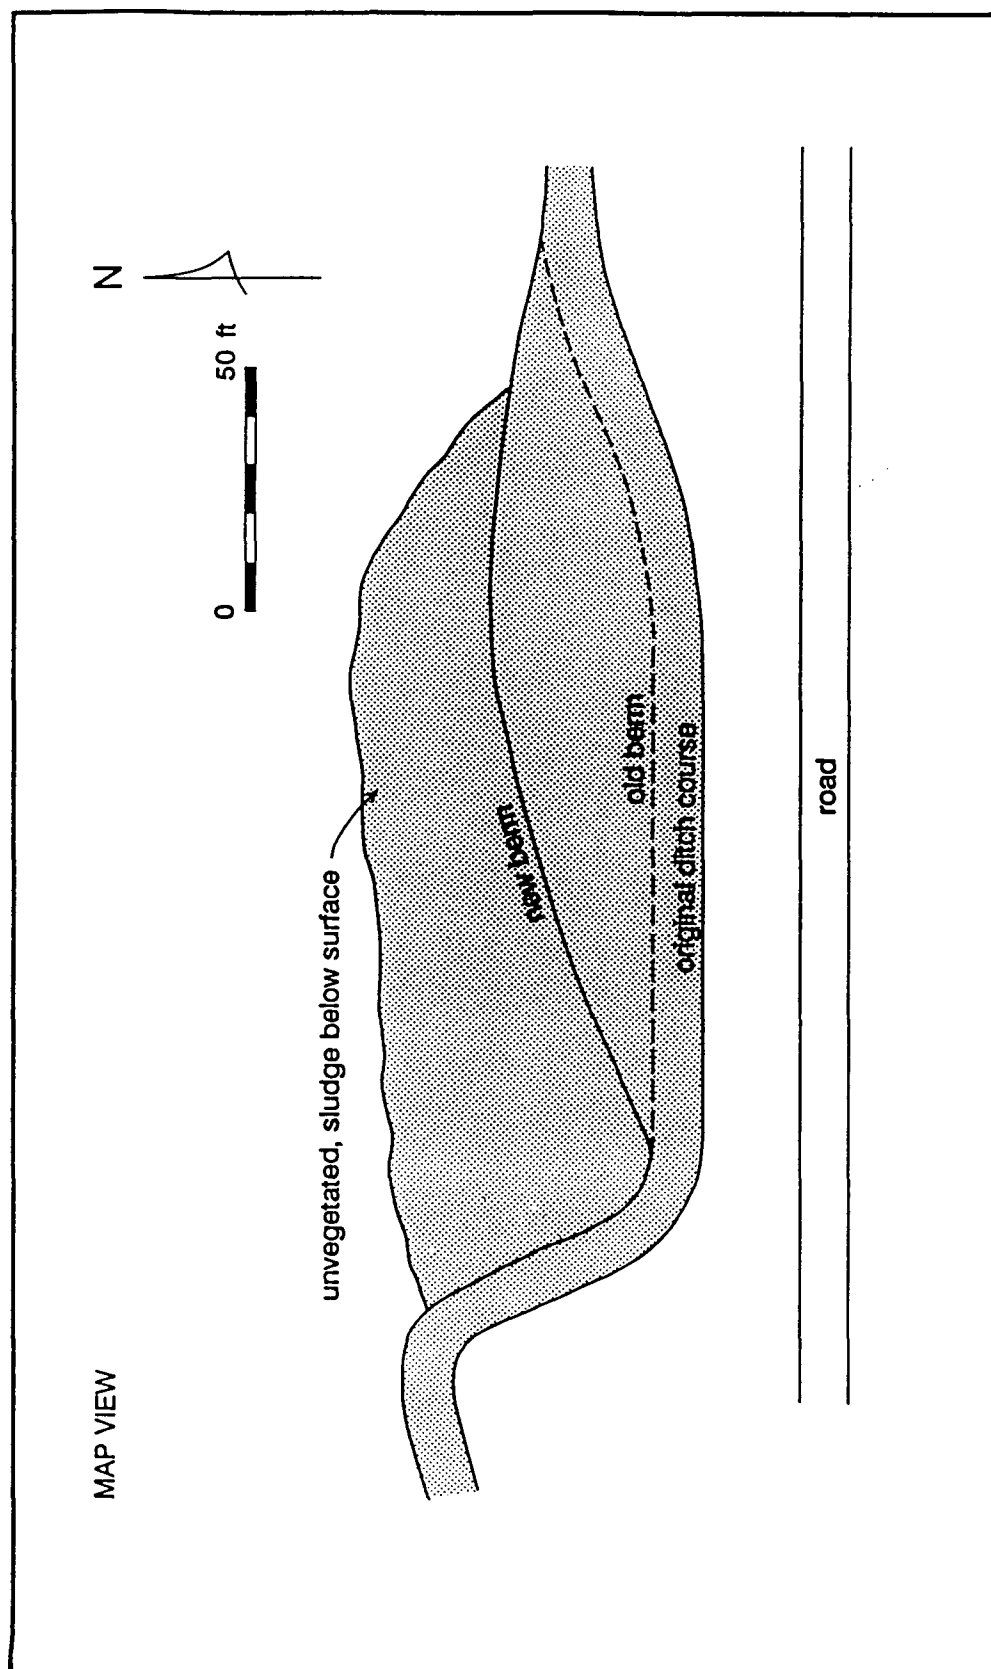
Figure 5.8 Three-Mile Ditch, Trench Map NMD-TR-005, RFI Phase I Report, Navajo Refining Company, October 1990.

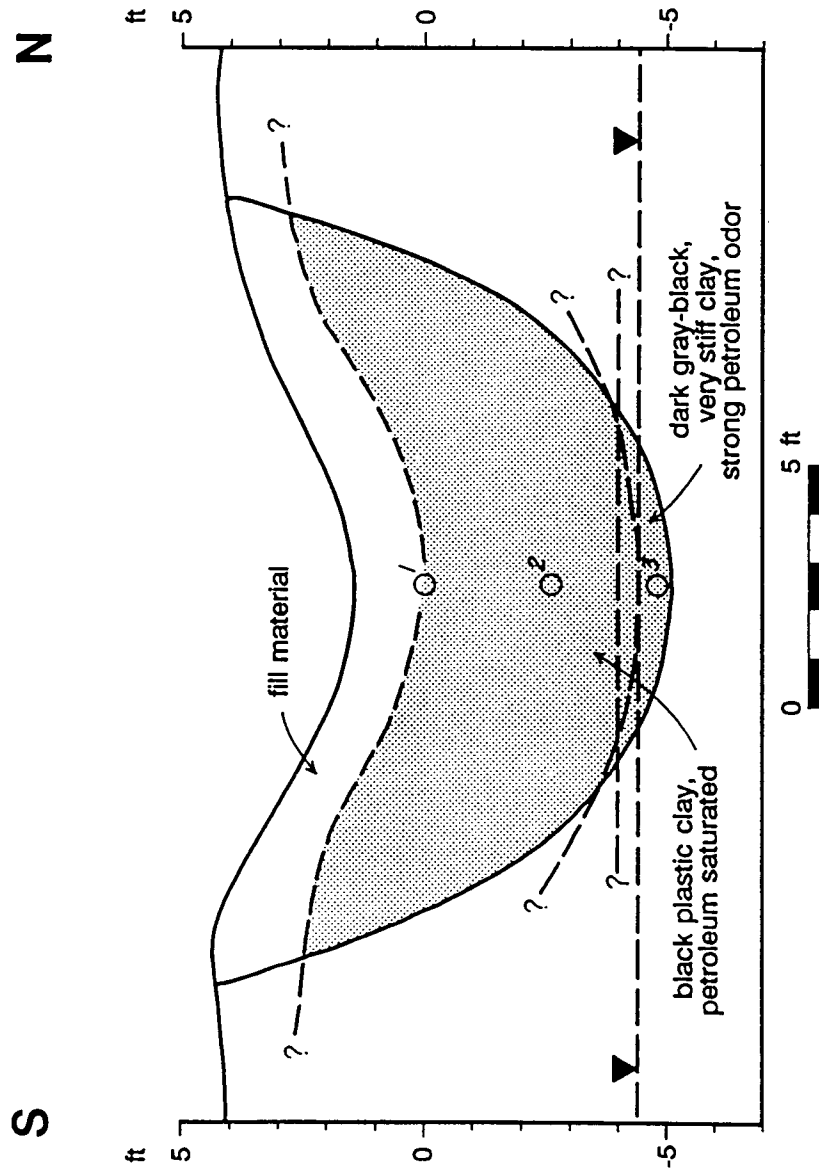
Figure 5.9 Three-Mile Ditch, Trench Cross Section NMD-TR-005, RFI Phase I Report, Navajo Refining Company, October 1990.

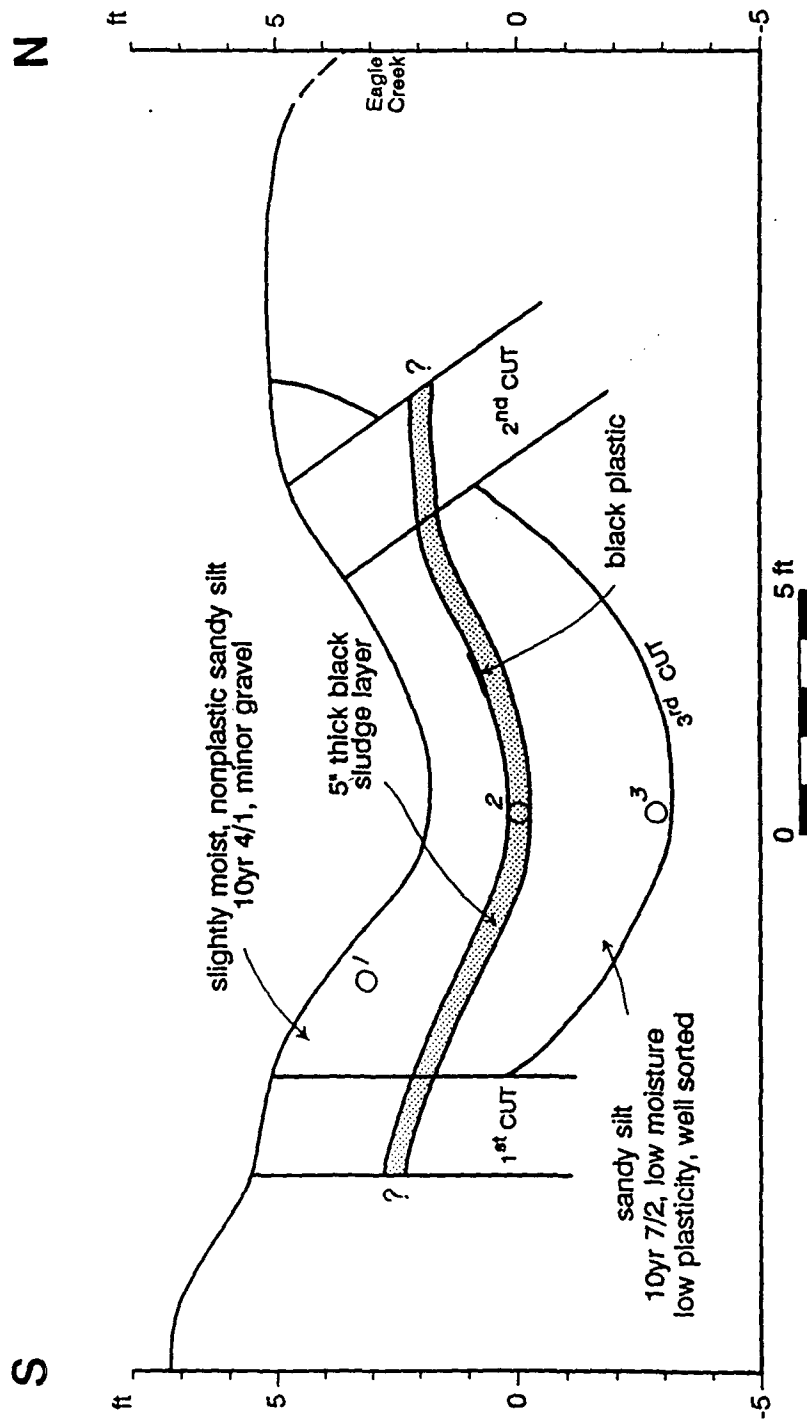
Figure 5.10 Three-Mile Ditch, Trench Cross Section NMD-TR-006, RFI Phase I Report, Navajo Refining Company, October 1990.

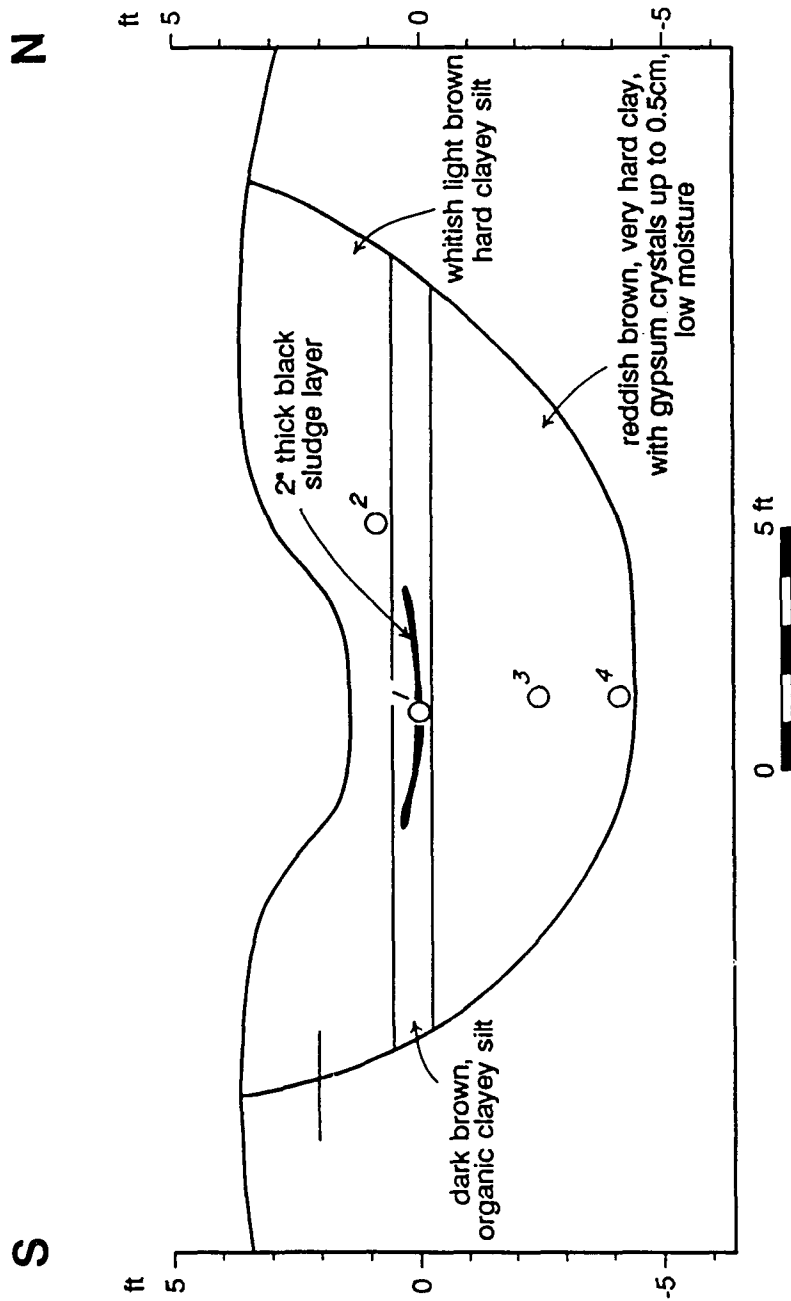
Figure 5.11 Three-Mile Ditch, Trench Cross section NMD-TR-007, RFI Phase I Report, Navajo Refining Company, October 1990.

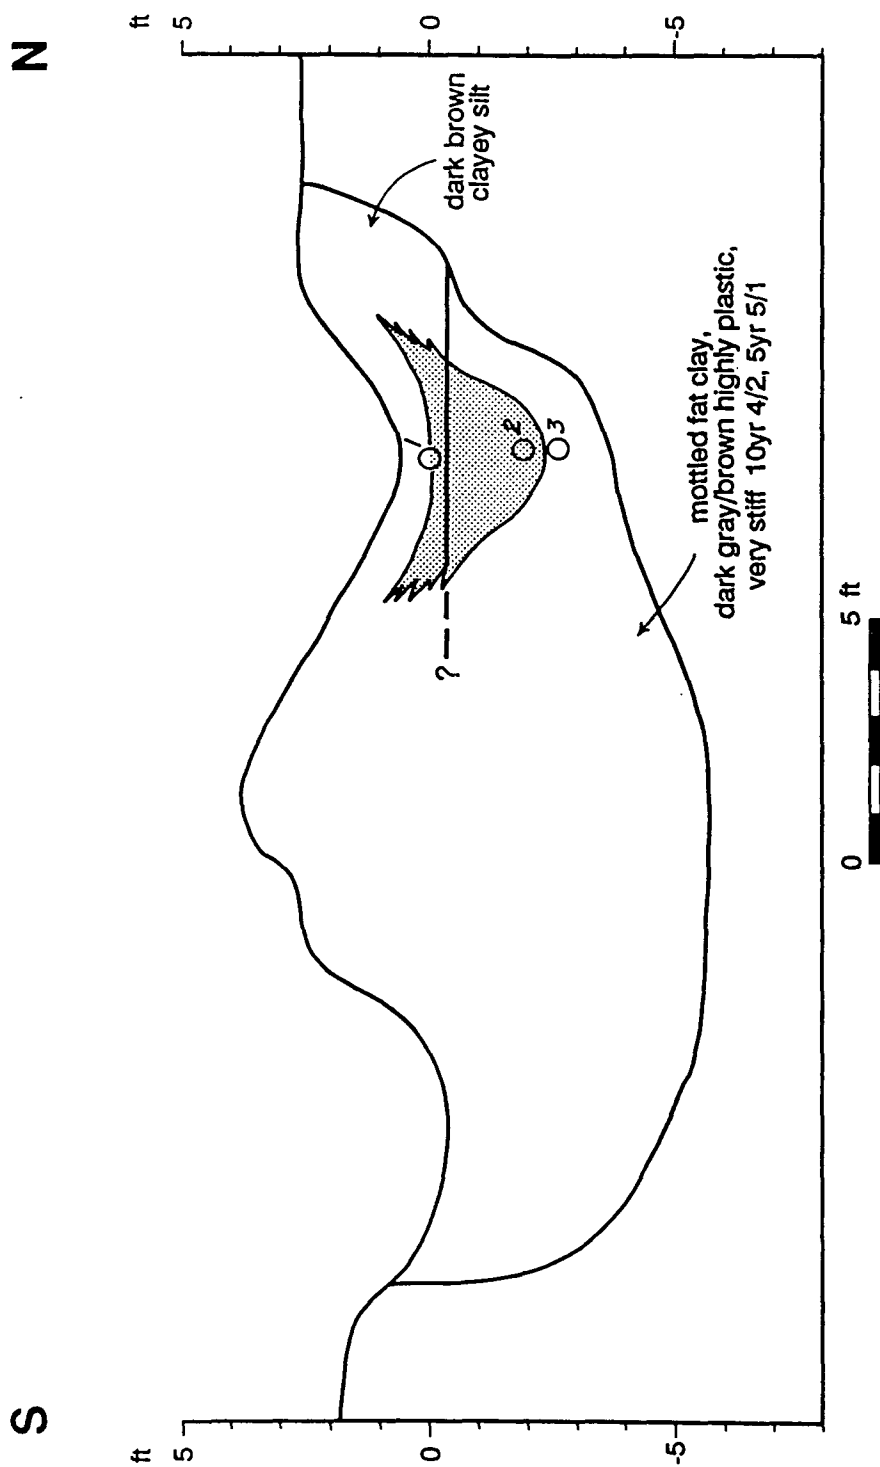
Figure 5.12 Three-Mile Ditch, Trench Cross Section NMD-TR-008, RFI
Phase I Report, Navajo Refining Company, October 1990.

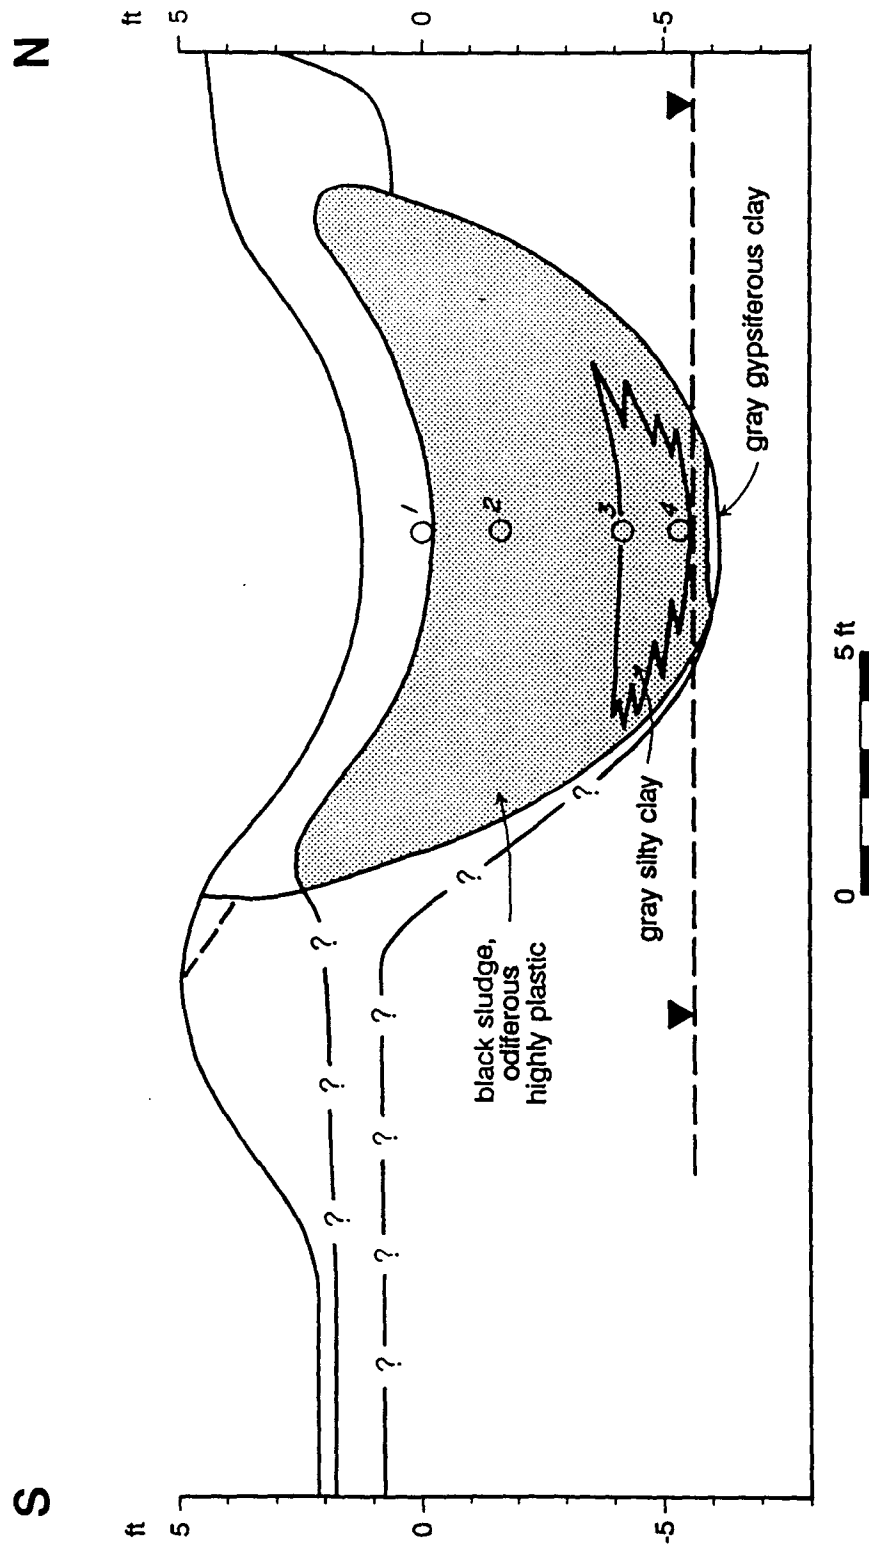
Figure 5.13 Three-Mile Ditch, Trench Cross Section NMD-TR-009, RFI Phase I Report, Navajo Refining Company, October 1990.

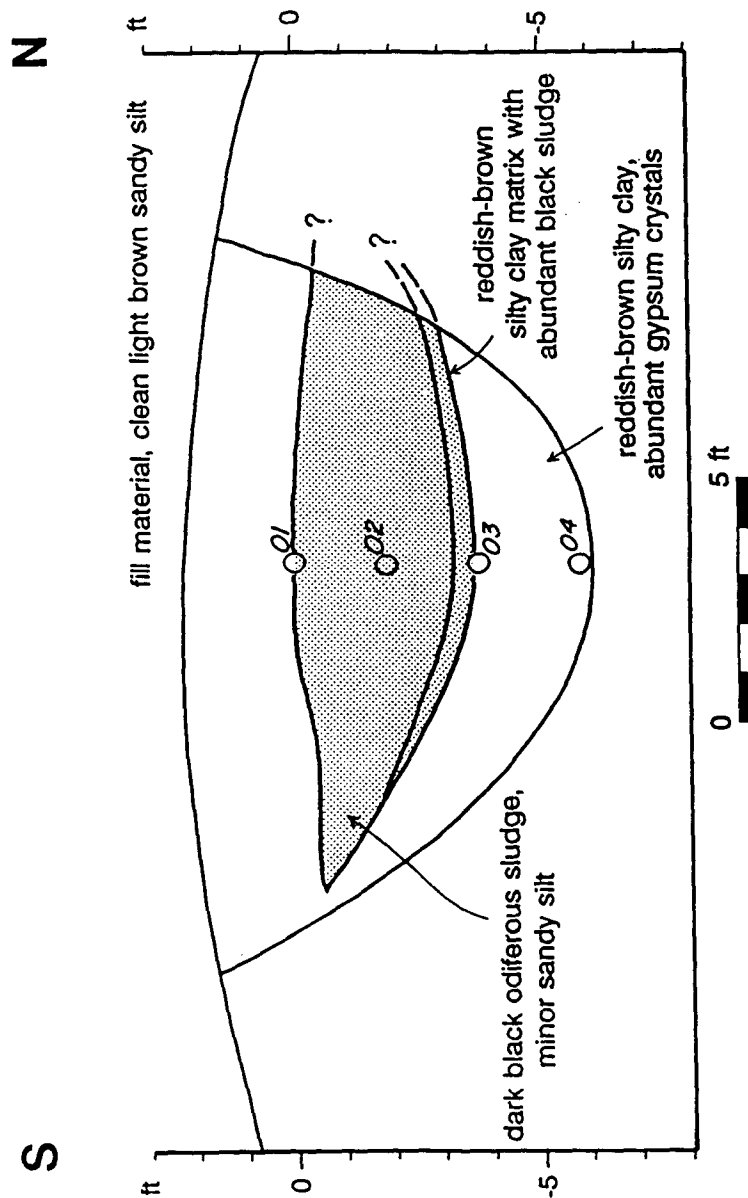
Figure 5.14 Three-Mile Ditch, Trench Cross Section NMD-TR-010, RFI Phase I Report, Navajo Refining Company, October 1990.

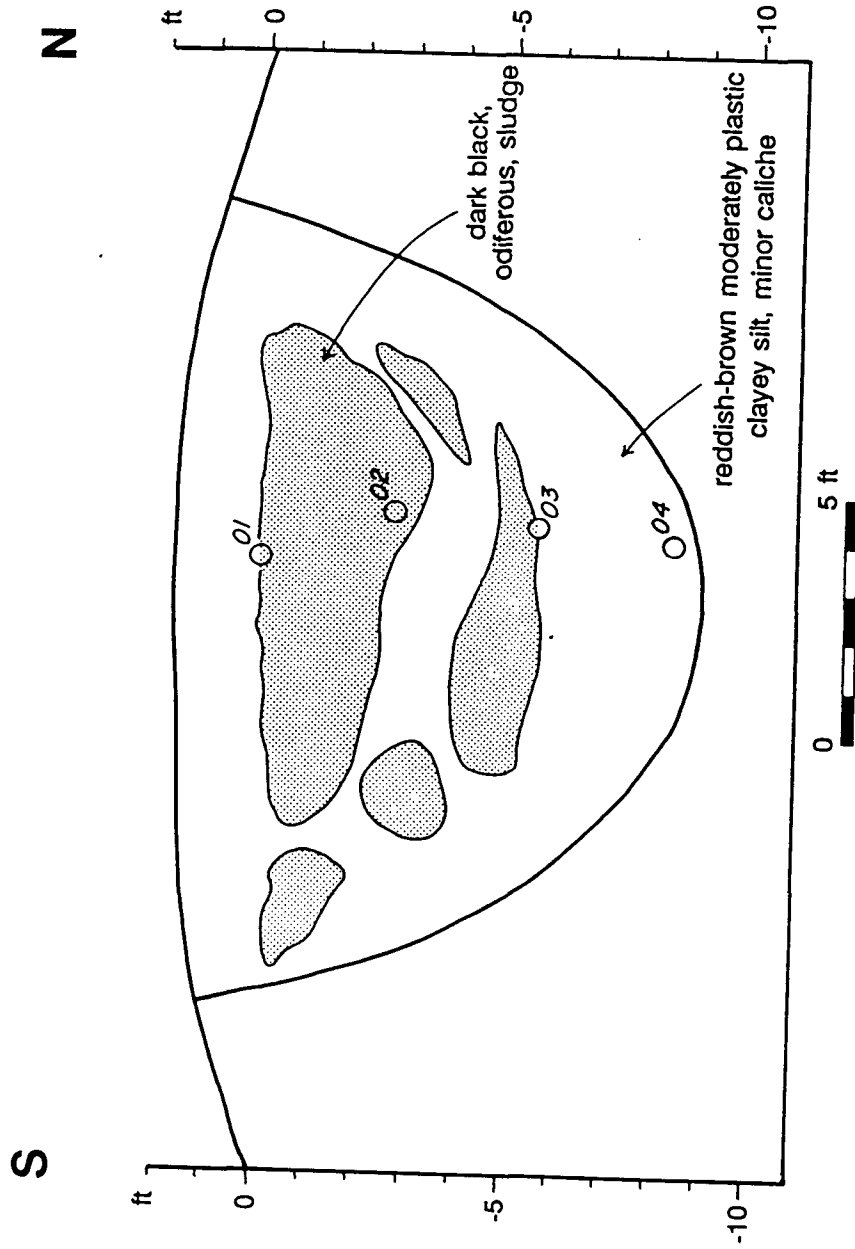
Figure 5.15 Three-Mile Ditch, Trench Cross Section NMD-TR-011, RFI Phase I Report, Navajo Refining Company, October 1990.
