REPORTS

Mariah Associates, Inc. (Mariah) conducted the Resource Conservation Recovery Act (RCRA) facility investigation (RFI) Phase I for Navajo (Navajo) Refining Company, a petroleum refinery located in Artesia, New Mexico. The RFI encompassed three solid waste management units on the refinery site: 1) the Truck Bypass Landfarm, 2) the Three-Mile Ditch and Eagle Creek, and 3) the evaporation ponds. The purpose of the Navajo RFI Phase I was to determine the nature and extent of hazardous waste or constituent releases from solid waste management units (SWMUs) and to provide rationale for proposal of a RFI Phase II investigation.

The Navajo refinery (U.S. Environmental Protection Agency [EPA] ID No. NMD 048918817) located in Artesia, New Mexico, is regulated under the RCRA and the Hazardous and Solid Waste Amendments (HSWA). One of the major provisions of HSWA (Section 3004-6) requires corrective action for releases of hazardous waste

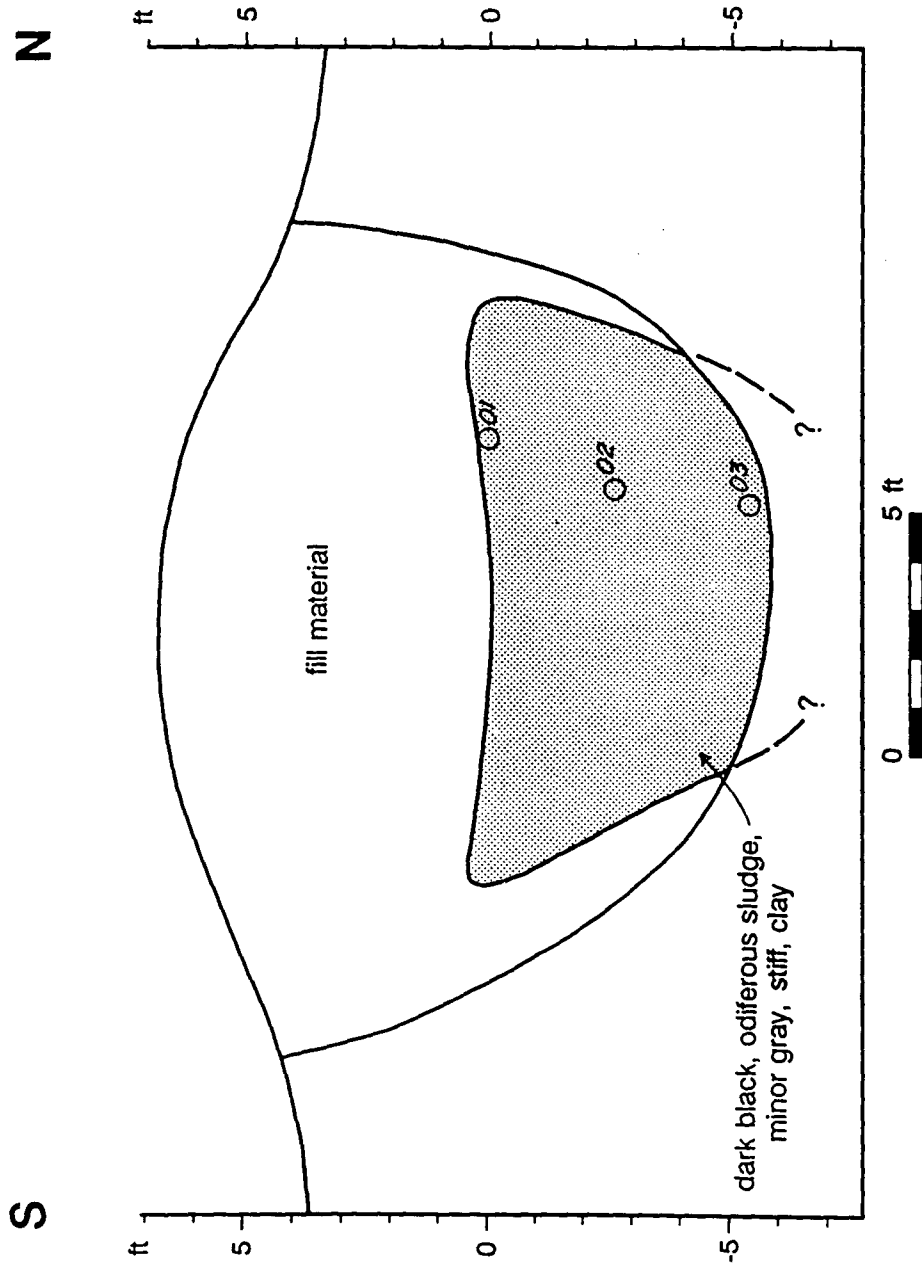
Figure 5.16 Three-Mile Ditch, Trench Cross Section NMD-TR-012, RFI Phase I Report, Navajo Refining Company, October 1990.

Localization of significantly large volumes of sludge appears to be controlled by several factors. Trenches NMD-TR-011, NMD-TR-012, and NMD-TR-013 contained sludge to the deepest levels. These trenches are located nearest the ditch terminus and probably result from wastewater backup into the evaporation ponds. Sufficient

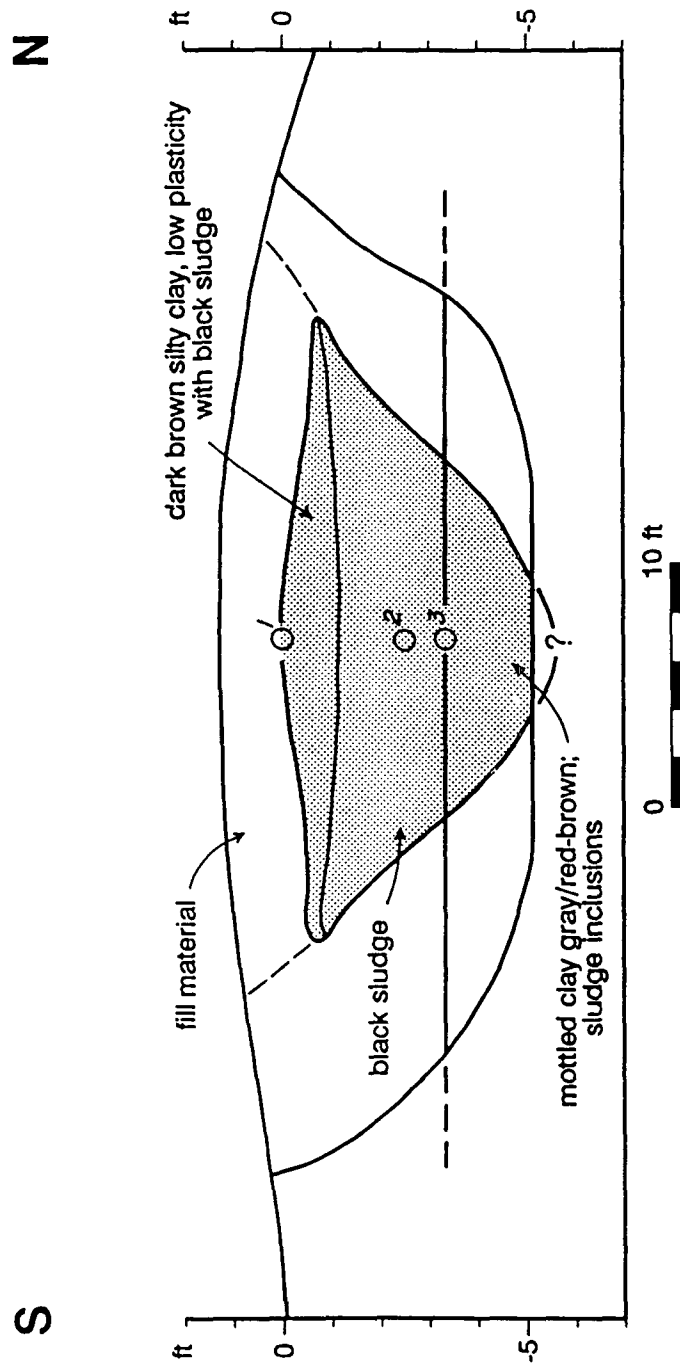
Figure 5.17 Three-Mile Ditch, Trench Cross Section NMD-TR-013, RFI Phase I Report, Navajo Refining Company, October 1990.

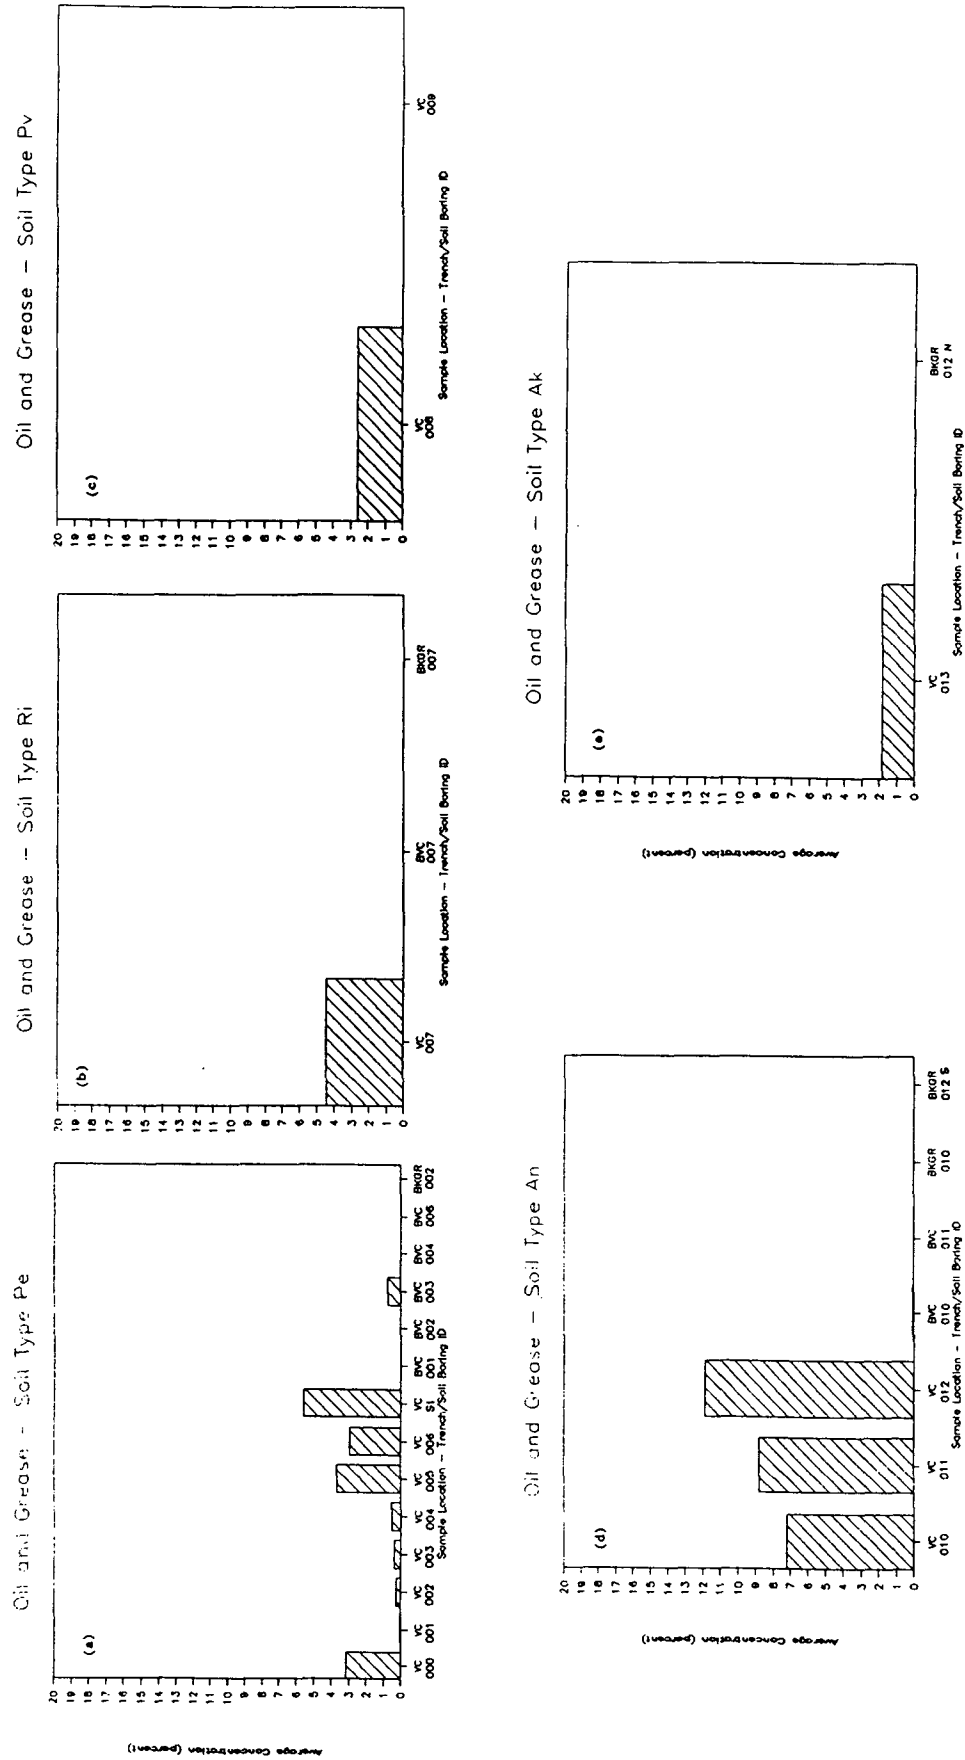
Figure 5.27. Three-Mile Ditch Soils Analytical Results - Metals Comparison of Visibly Contaminated (VC), Below Visibly Contaminated (BVC), and Background (BKGR) Metals Concentrations - Oil and Grease RFI Phase I Report, Navajo Refining Company, October, 1990

Oil and grease are generally confined to VC portions of trenches, are present in BVC zones in two cases, and are absent from background soils (Figure 5.27). There was a significant difference in oil and grease concentrations in VC and BVC samples from soil An (Figure 5.27d). Oil and grease levels were highest in trenches S1, 010, 011, and 012, and lowest in trenches 001, 002, 003, and 004.

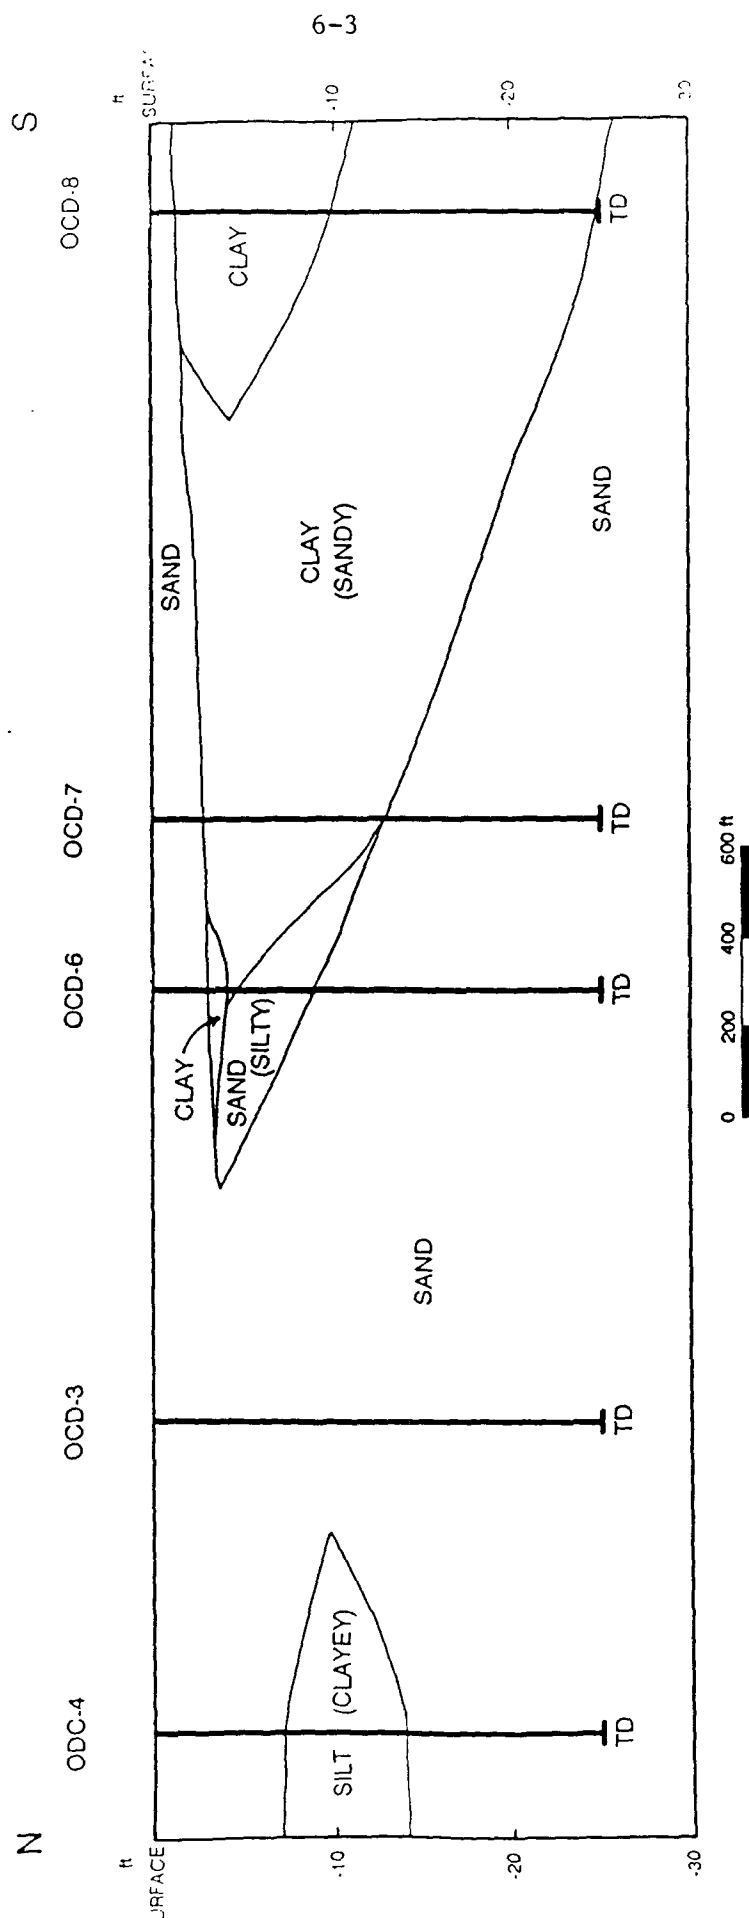
Figure 6.1 Evaporation Ponds, North-South Cross Section, RFI Phase I Report, Navajo Refining Company, October 1990.

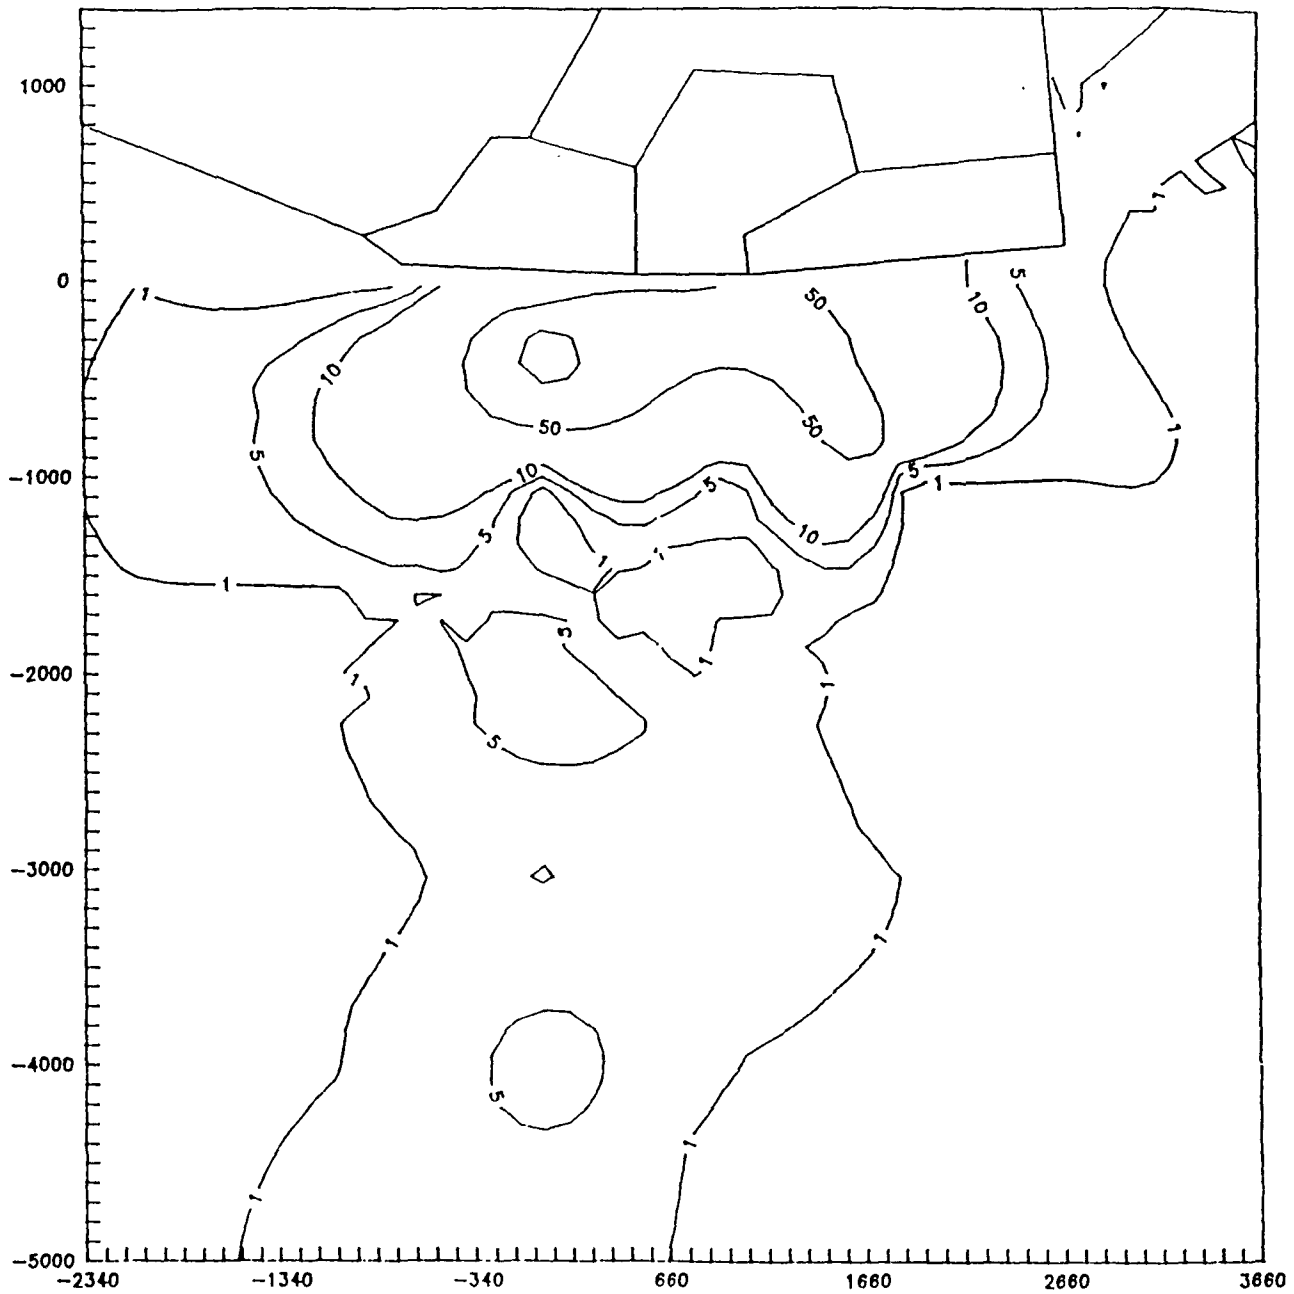
Contoured Toluene Concentrations in Valley-Fill Aquifer
Scales in Feet, Grid Origin is well MW-3
All Concentrations in ug/l

Figure 6.2 Evaporation Ponds, Toluene Concentration Map 1987,
Phase I Report, Navajo Refining Company, October 1990
(Geoscience Consultants Ltd. 1987).

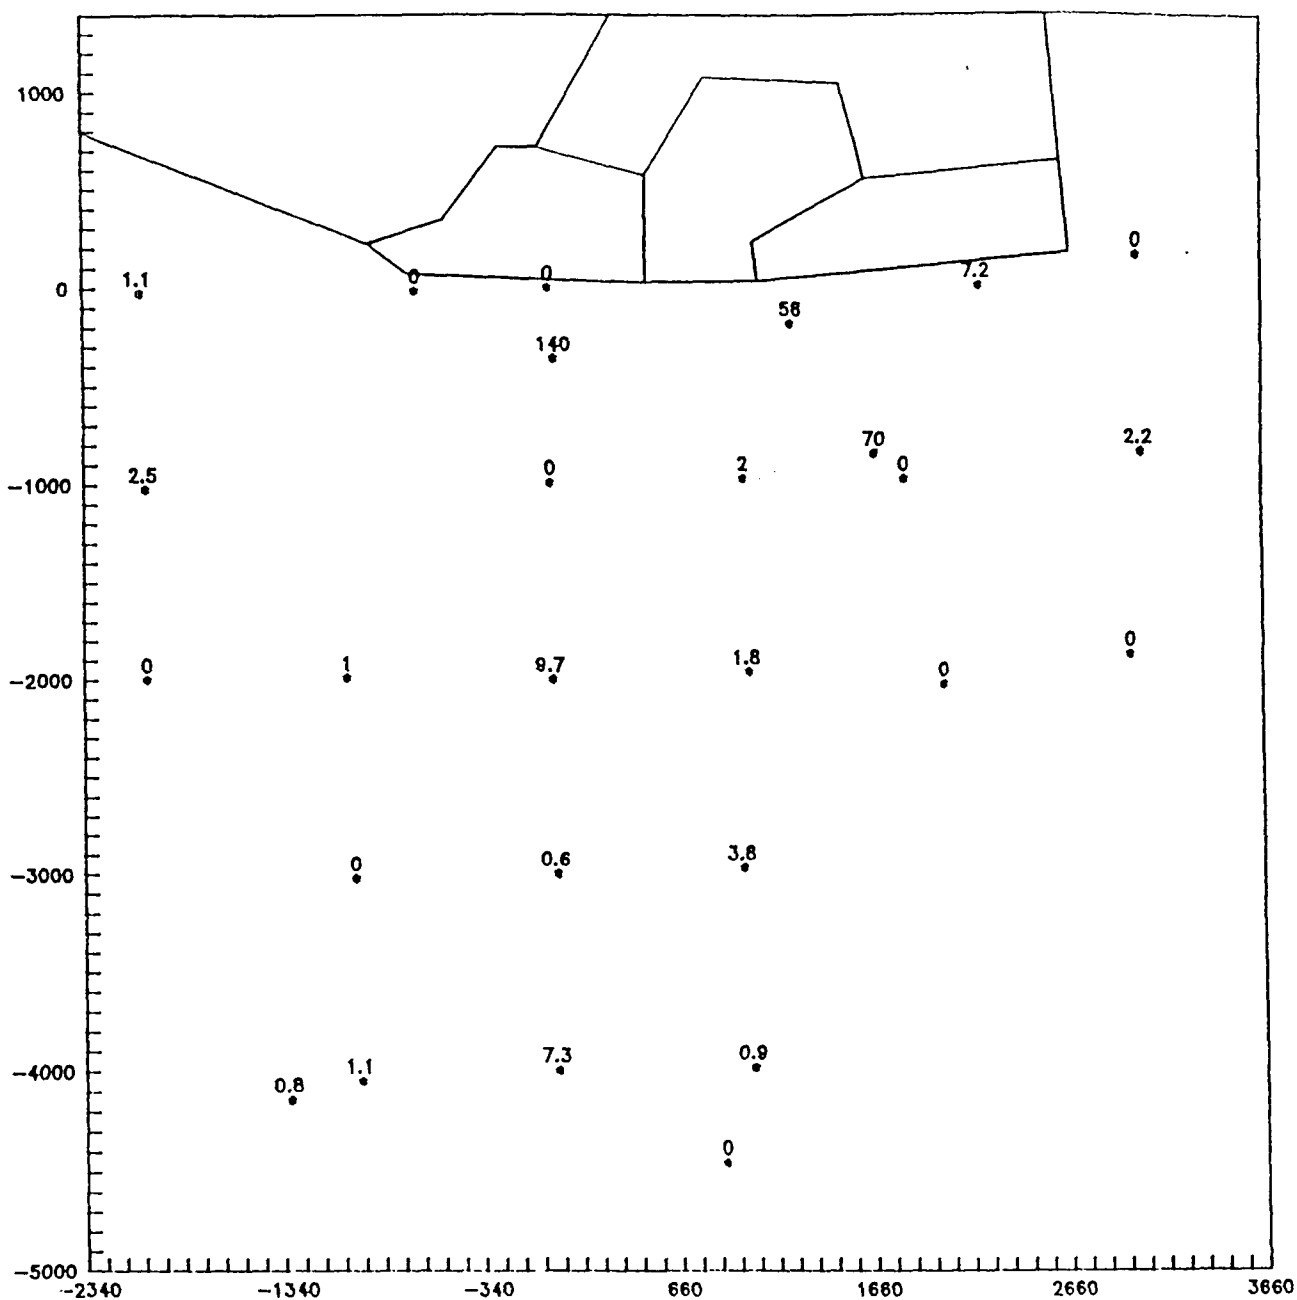
Mapped Toluene Concentrations

Scales in Feet, Grid Origin is well MW-3

1987). Toluene levels have ranged from below detection level (BDL) to 280 ppb (MW-4), ethylbenzene from BDL to 656 ppb (MW-5), and total xylenes from BDL to 992 ppb (MW-4). Low levels of volatile organic compounds were also recorded sporadically in MW-2 and OCD-8. The majority of specific documentation for BTEX plumes is from a one-time sampling event of a piezometer array installed south of the ponds in 1986. Figures 6.2 through 6.7 show the mapped contaminant plumes for the three major contaminants (Geoscience Consultants, Ltd. 1987). Historical volatile groundwater data is compiled in Table 6.1.

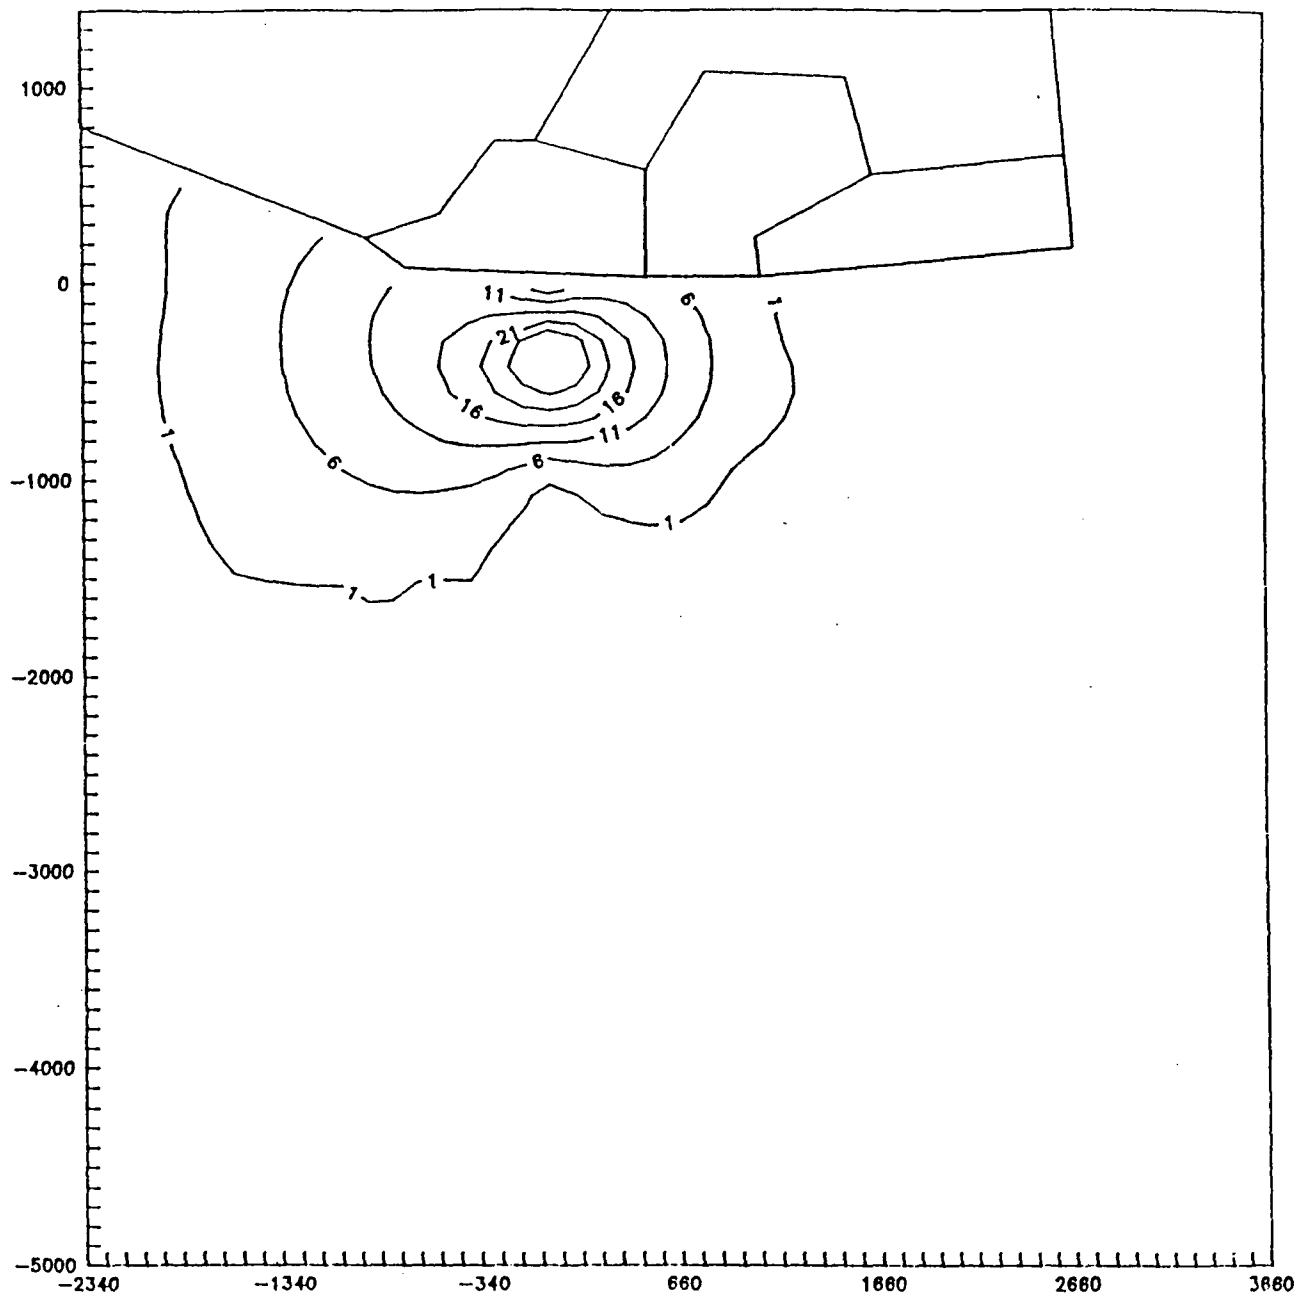
Contoured Ethylbenzene Concentrations in Valley-Fill Aquifer
Scales in Feet, Grid Origin is well MW-3
All Concentrations in ug/l

Figure 6.4 Evaporation Ponds, Ethyl Benzene Concentration Map
1987, Phase I Report, Navajo Refining Company, October
1990 (Geoscience Consultants Ltd. 1987).

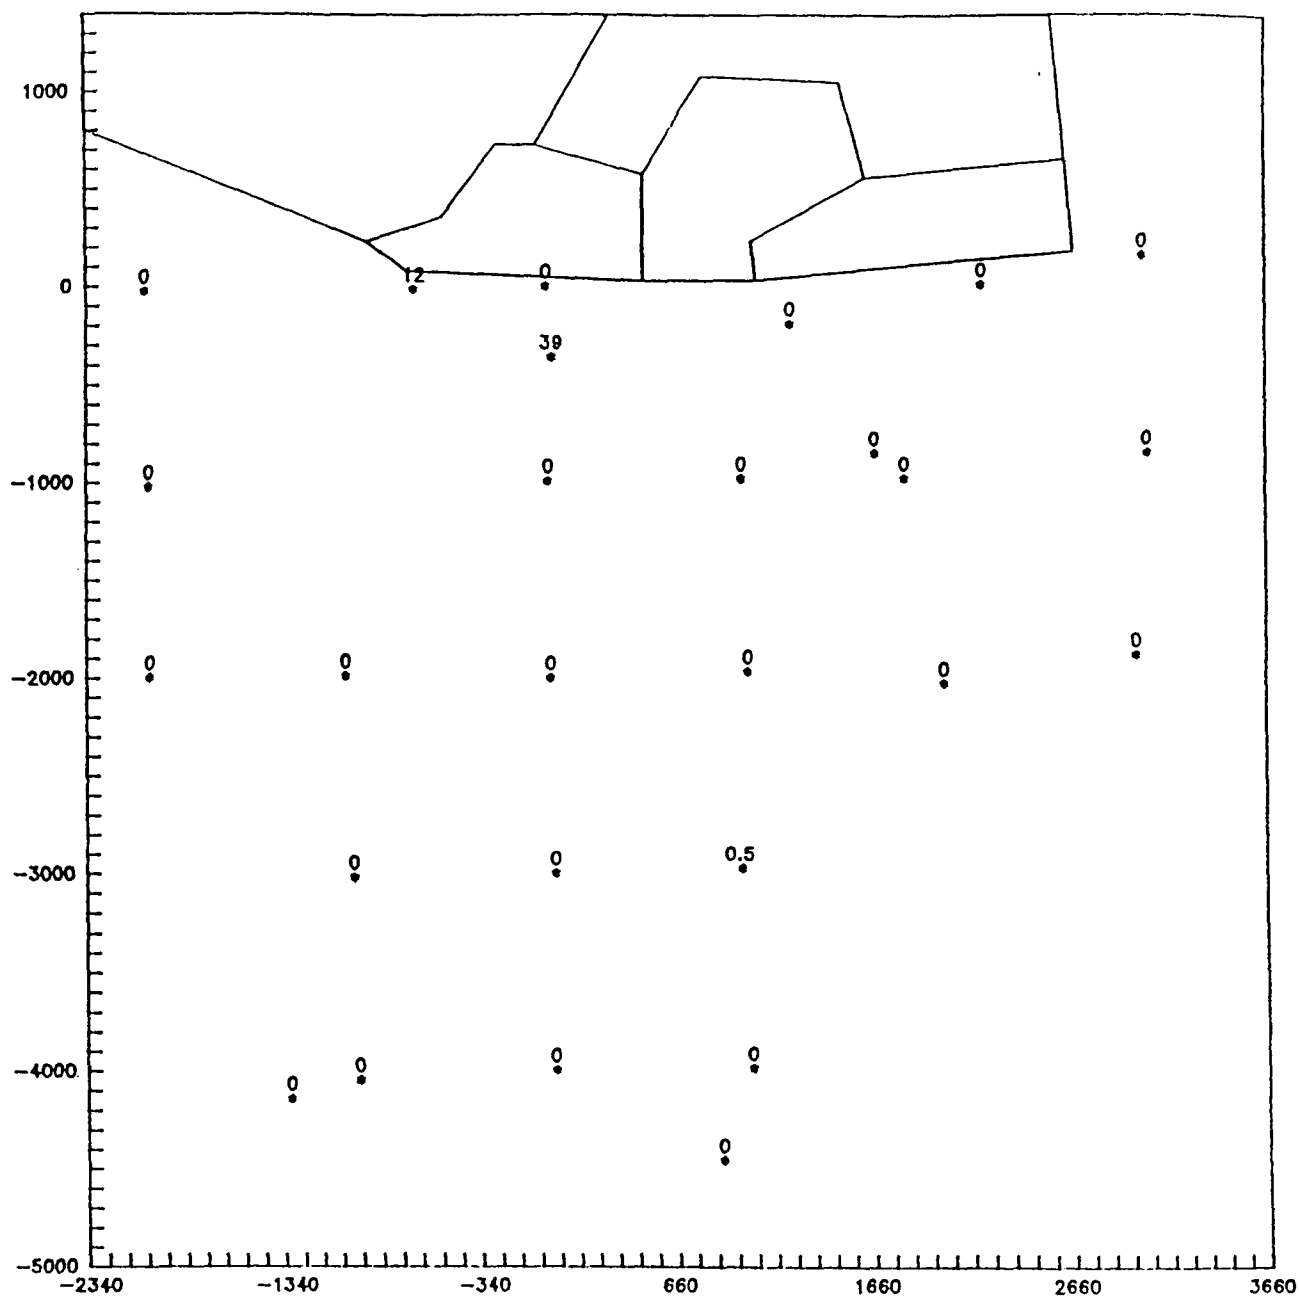
Mapped Ethylbenzene Concentrations

Scales in Feet, Grid Origin is well MW-3

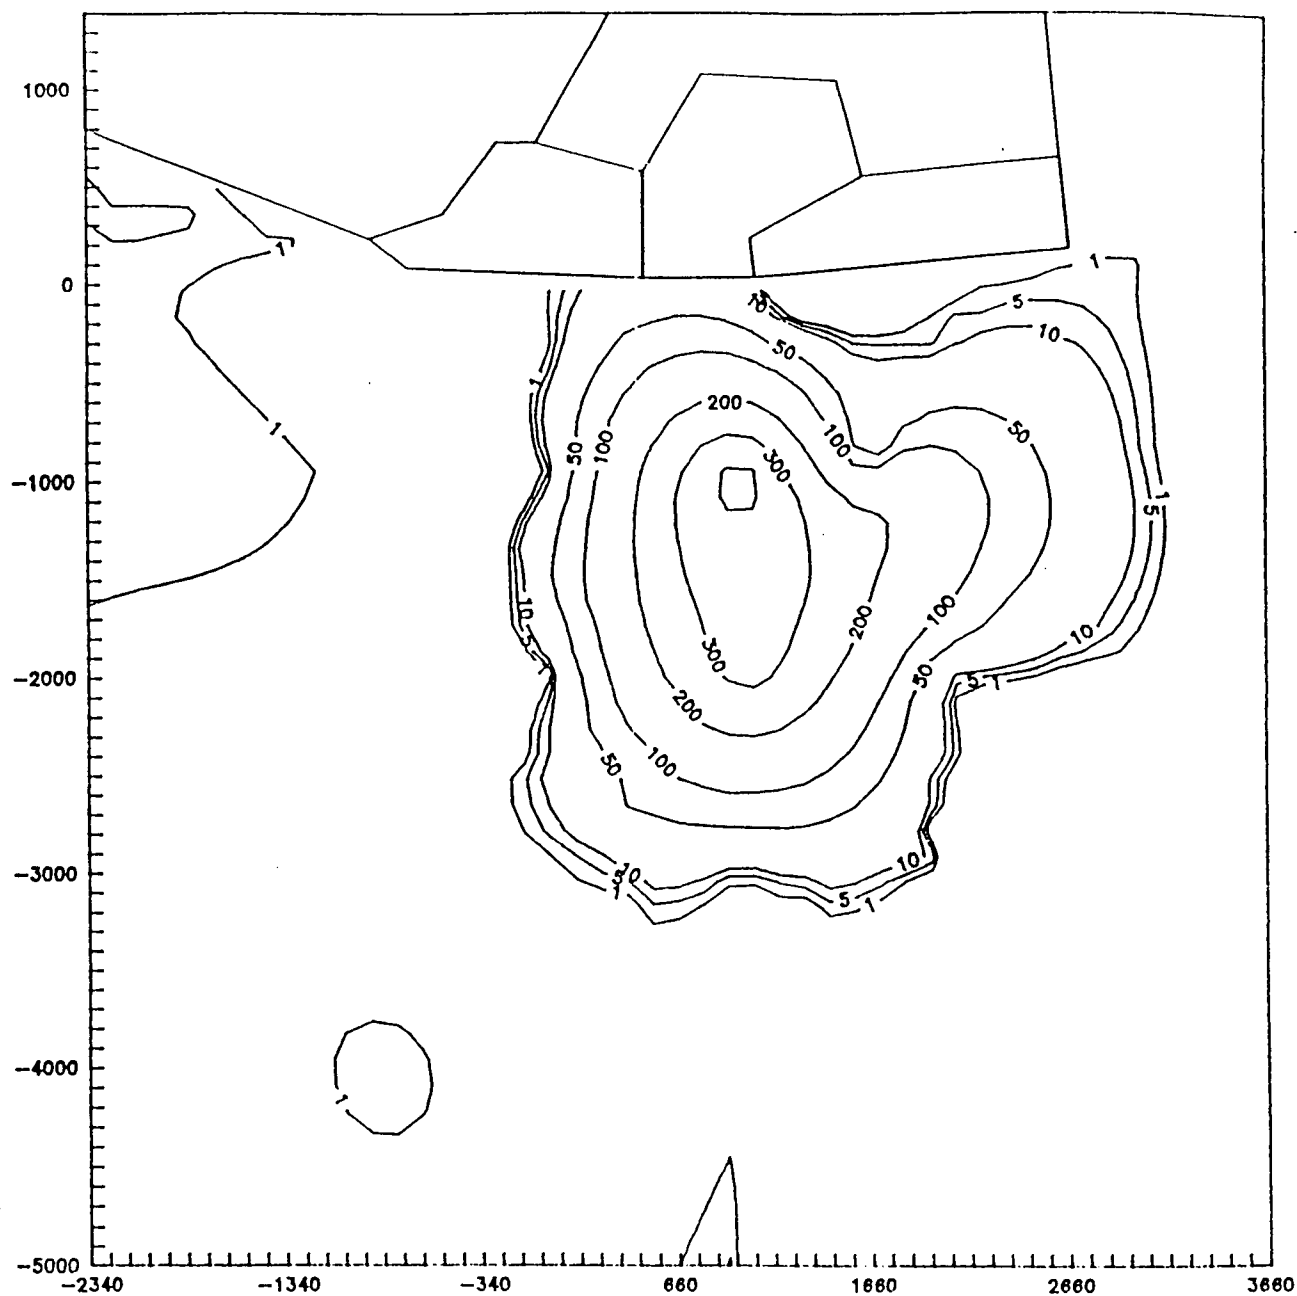
Contoured Xylene Concentrations in Valley-Fill Aquifer
Scales in Feet, Grid Origin is well MW-3
All Concentrations in ug/l

Figure 6.6 Evaporation Ponds, Xylene Concentration Map 1987,
Phase I Report, Navajo Refining Company, October 1990
(Geoscience Consultants Ltd. 1987).

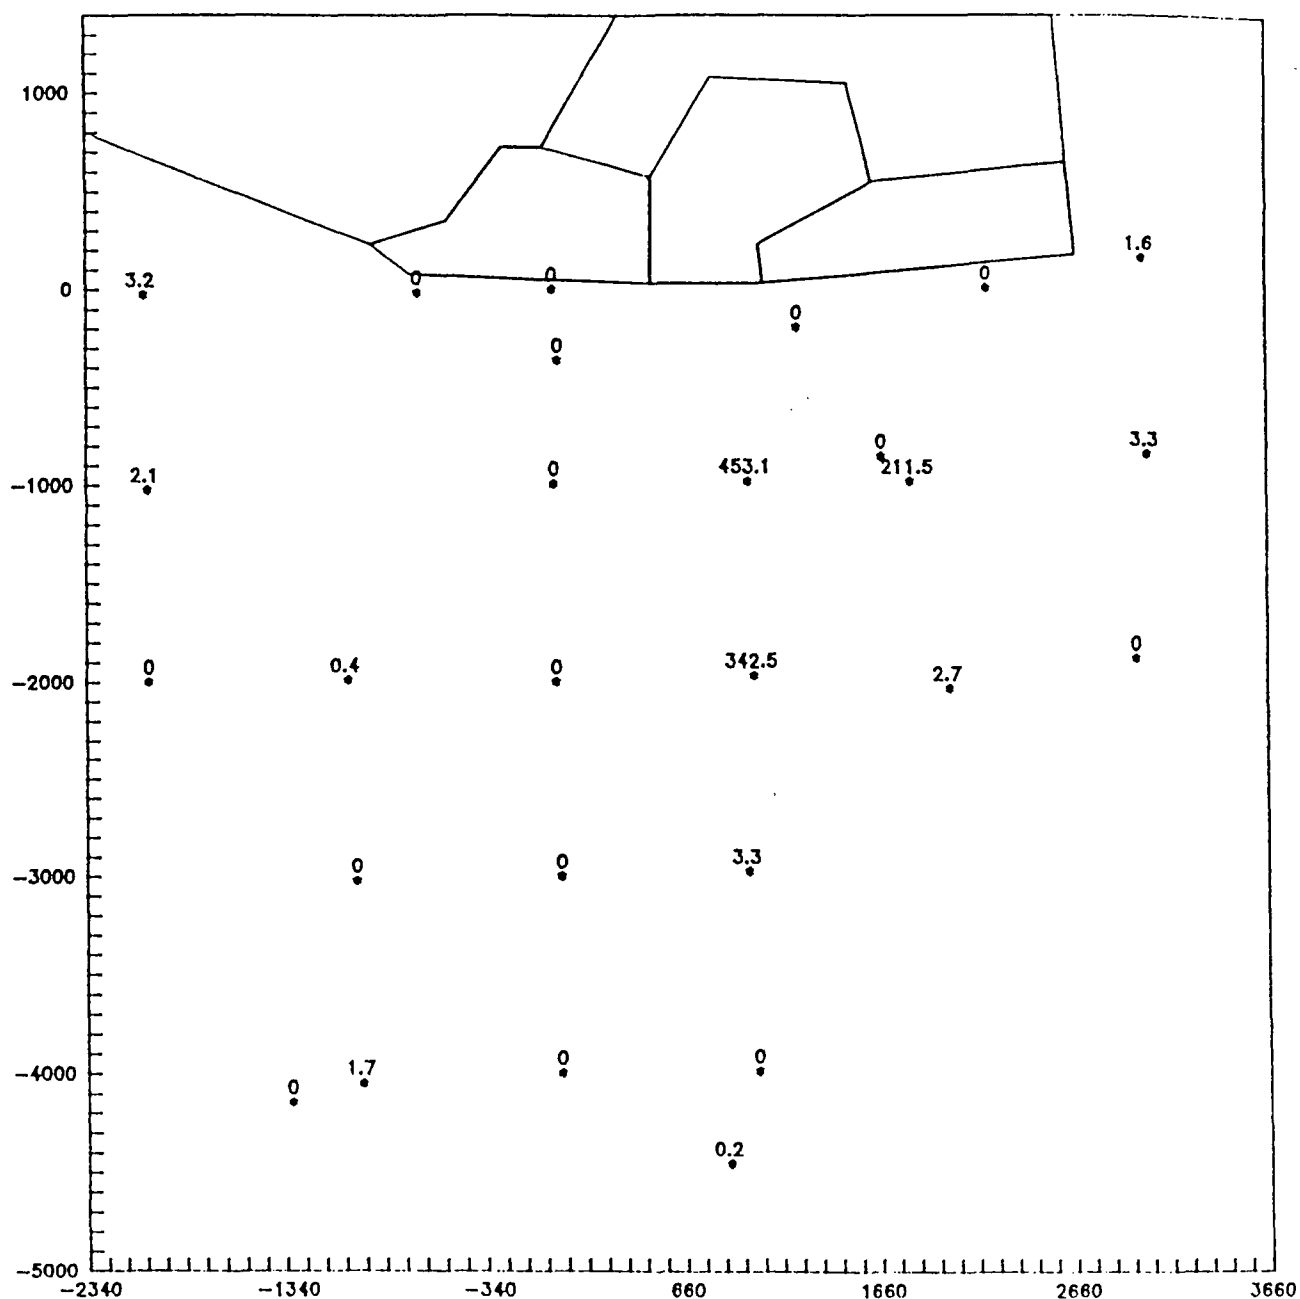
Mapped Xylene Concentrations

Scales in Feet, Grid Origin is well MW-3

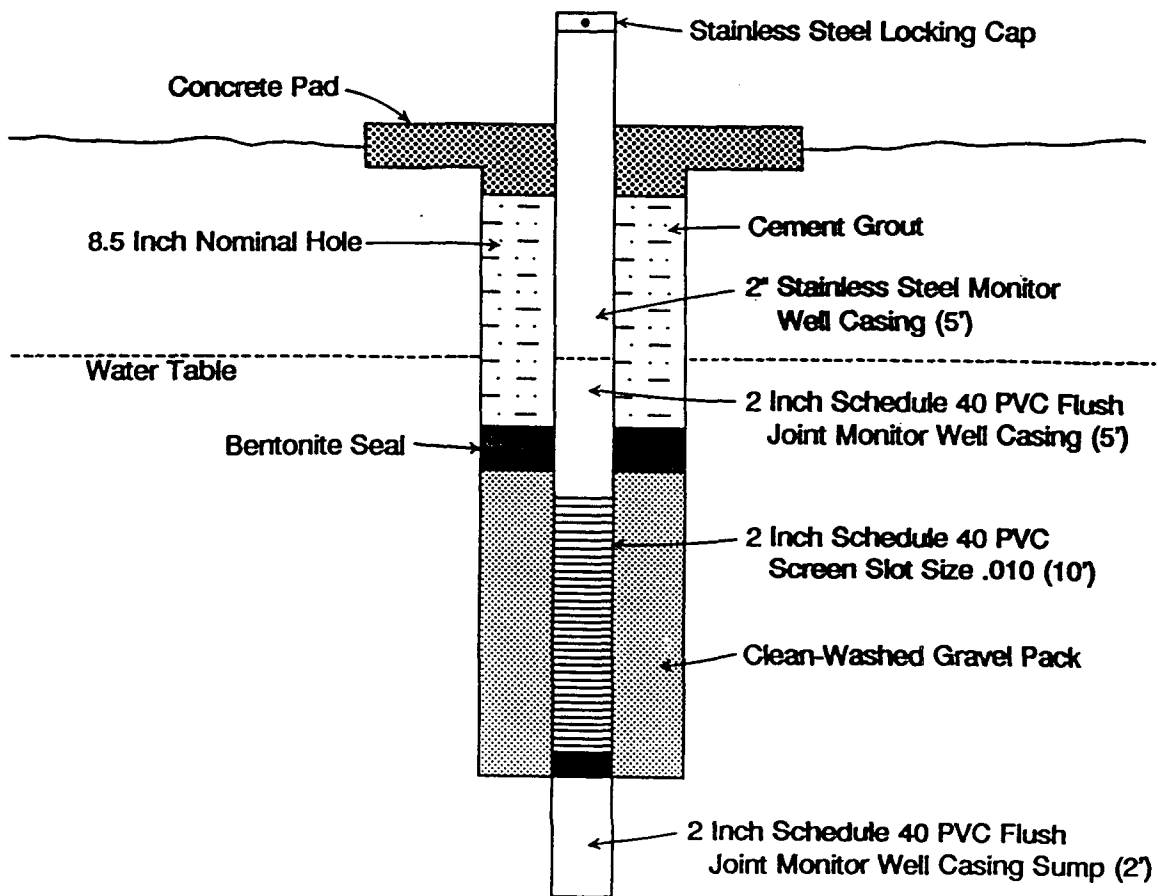
Figure 6.8 Evaporation Ponds, EPA-1 Construction Details Phase I Report, Navajo Refining Company, October 1990.

EPA-1 encountered primarily silty clays and silty sands to a depth of 19 ft. The top of the saturated soil zone is

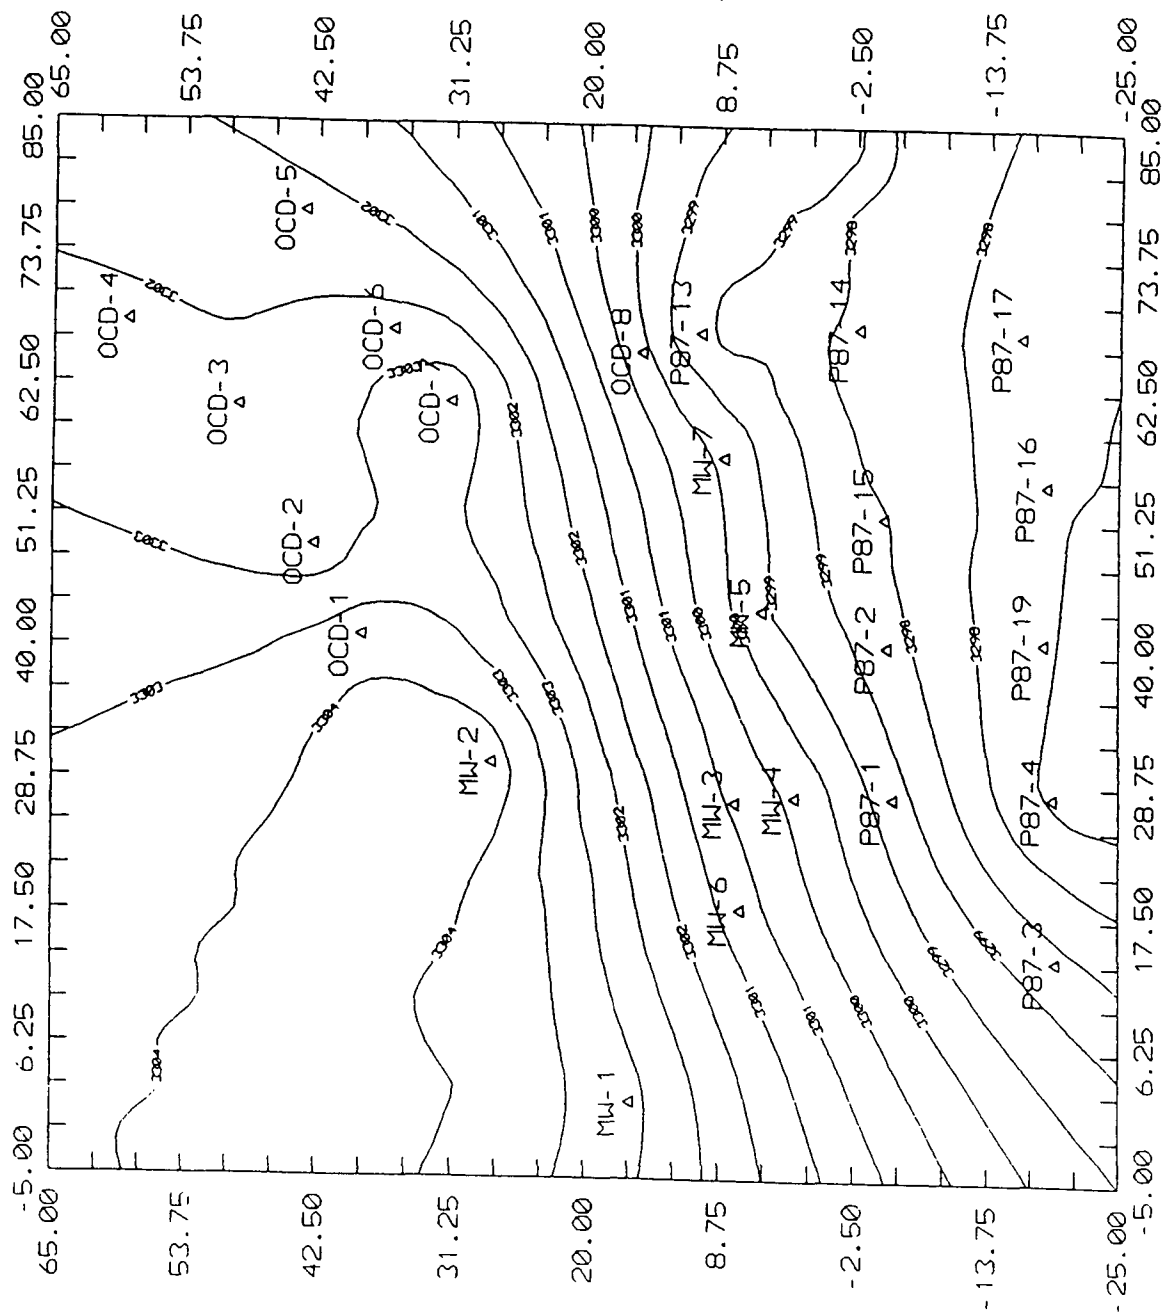
Figure 6.10 Evaporation Ponds, Water Table Surface, July 1990, Phase I Report, Navajo Refining Company, October 1990.

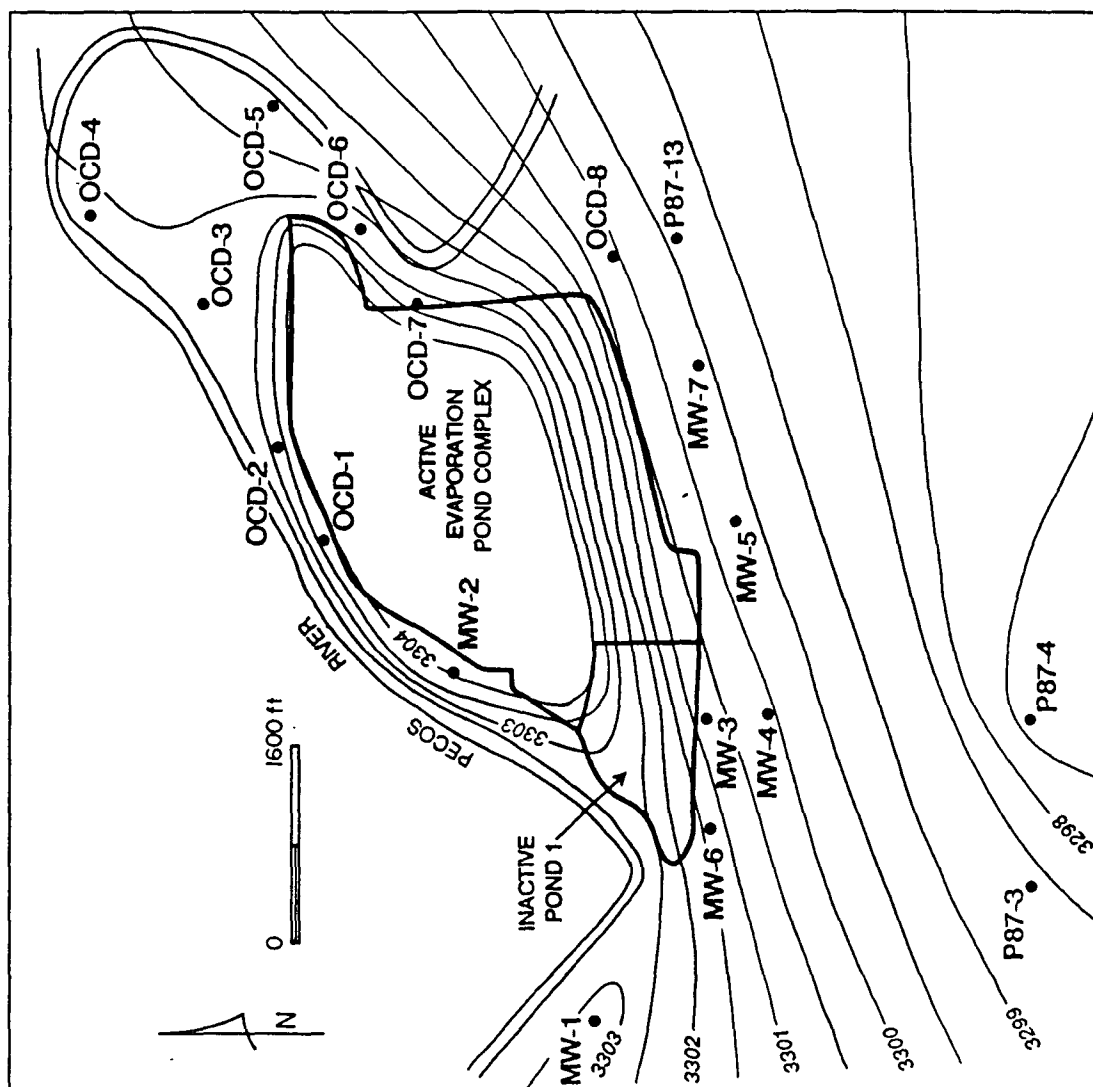
Figure 6.12 Evaporation Ponds, Water Table Surface Interpretation Map, July 1990, RFI Phase I Report, Navajo Refining Company, October 1990.

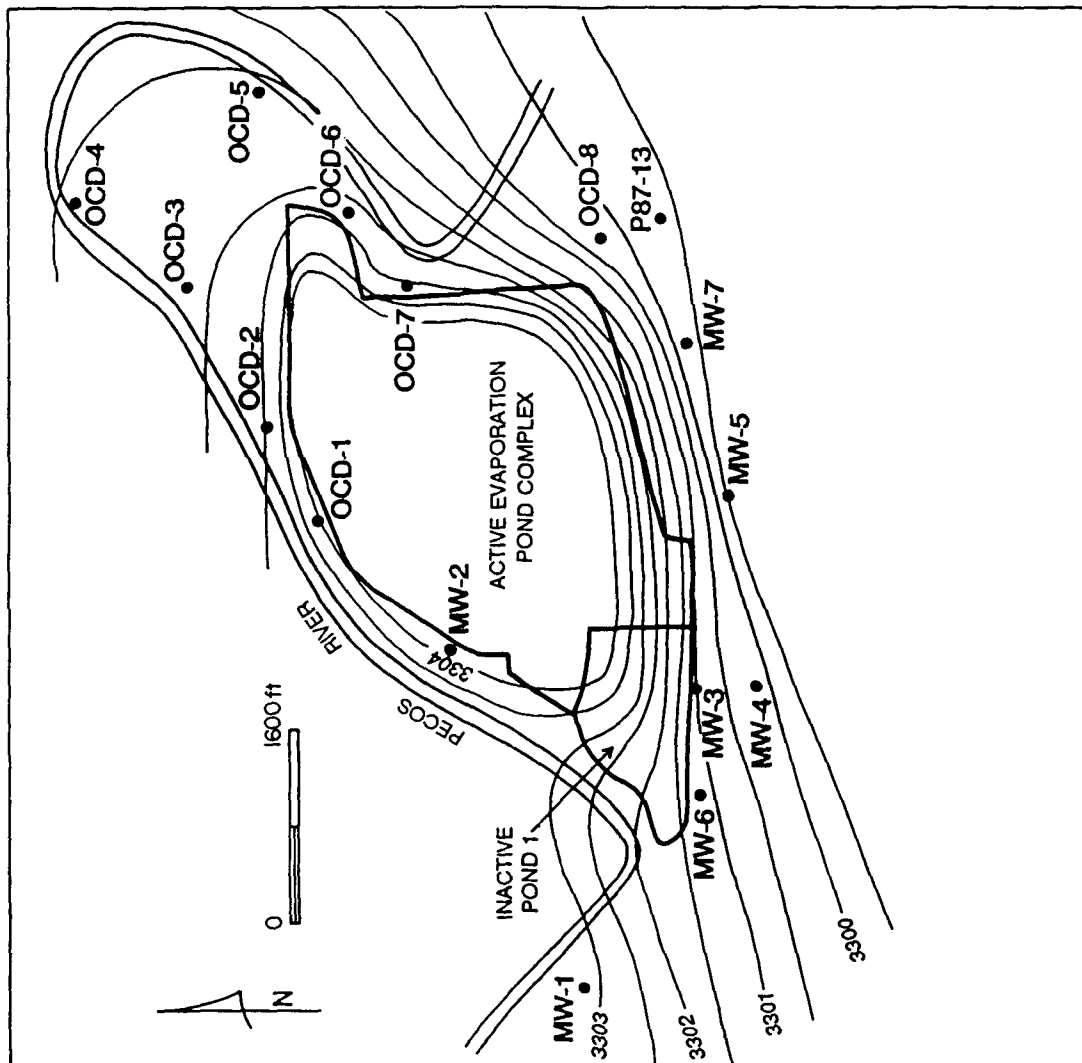
Figure 6.13 Evaporation Ponds, Water Table Surface Interpretation Map, September 1990, RFI Phase I Report, Navajo Refining Company, October 1990.

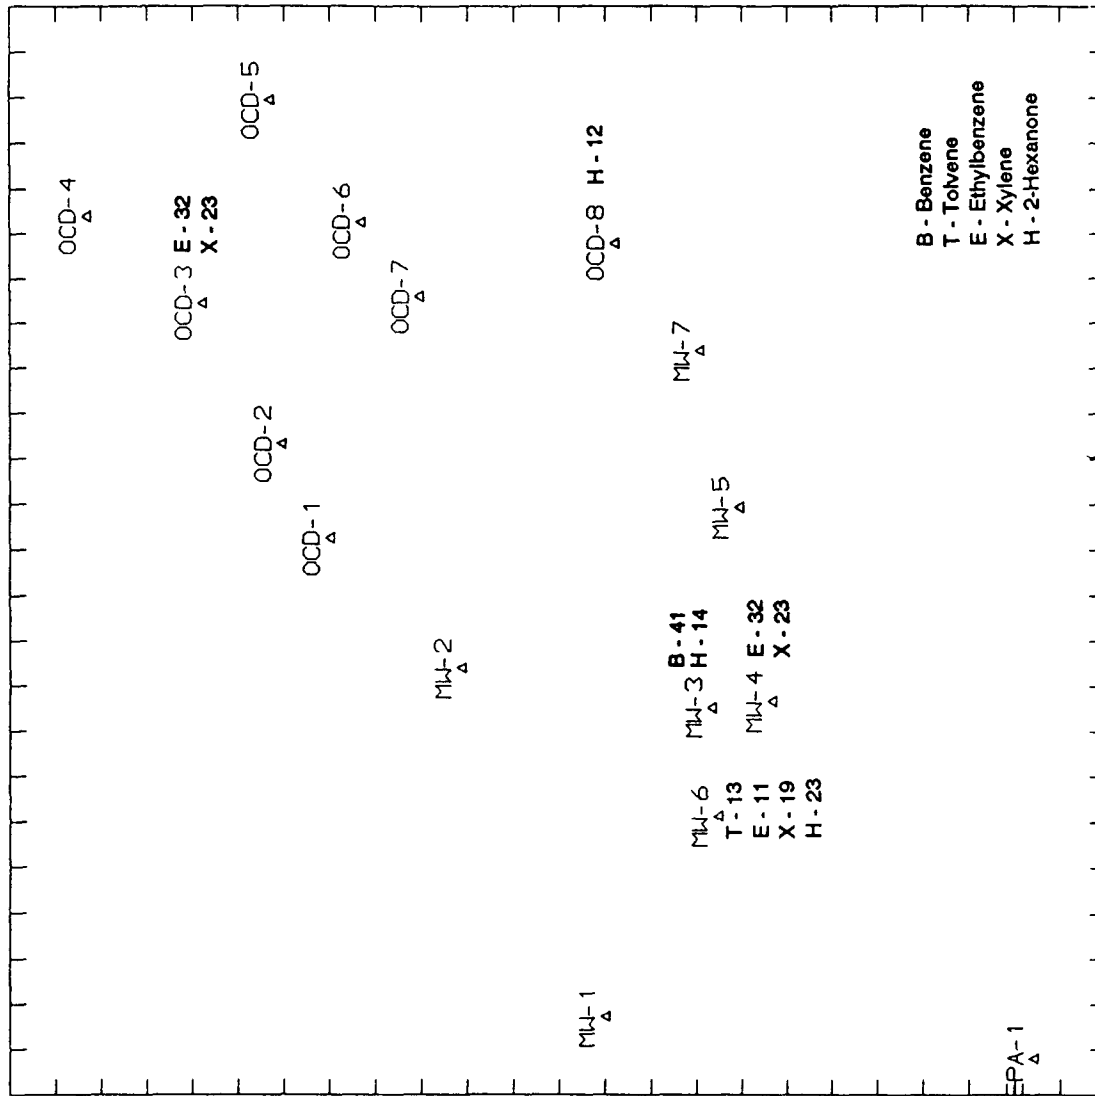
Figure 6.14 Evaporation Ponds, Ground Water Volatiles Concentration Map, September 1990, RFI Phase I Report, Navajo Refining Company, October 1990.
