REPORTS

Mariah Associates, Inc. (Mariah) conducted the Resource Conservation Recovery Act (RCRA) facility investigation (RFI) Phase I for Navajo (Navajo) Refining Company, a petroleum refinery located in Artesia, New Mexico. The RFI encompassed three solid waste management units on the refinery site: 1) the Truck Bypass Landfarm, 2) the Three-Mile Ditch and Eagle Creek, and 3) the evaporation ponds. The purpose of the Navajo RFI Phase I was to determine the nature and extent of hazardous waste or constituent releases from solid waste management units (SWMUs) and to provide rationale for proposal of a RFI Phase II investigation.

The Navajo refinery (U.S. Environmental Protection Agency [EPA] ID No. NMD 048918817) located in Artesia, New Mexico, is regulated under the RCRA and the Hazardous and Solid Waste Amendments (HSWA). One of the major provisions of HSWA (Section 3004-6) requires corrective action for releases of hazardous waste

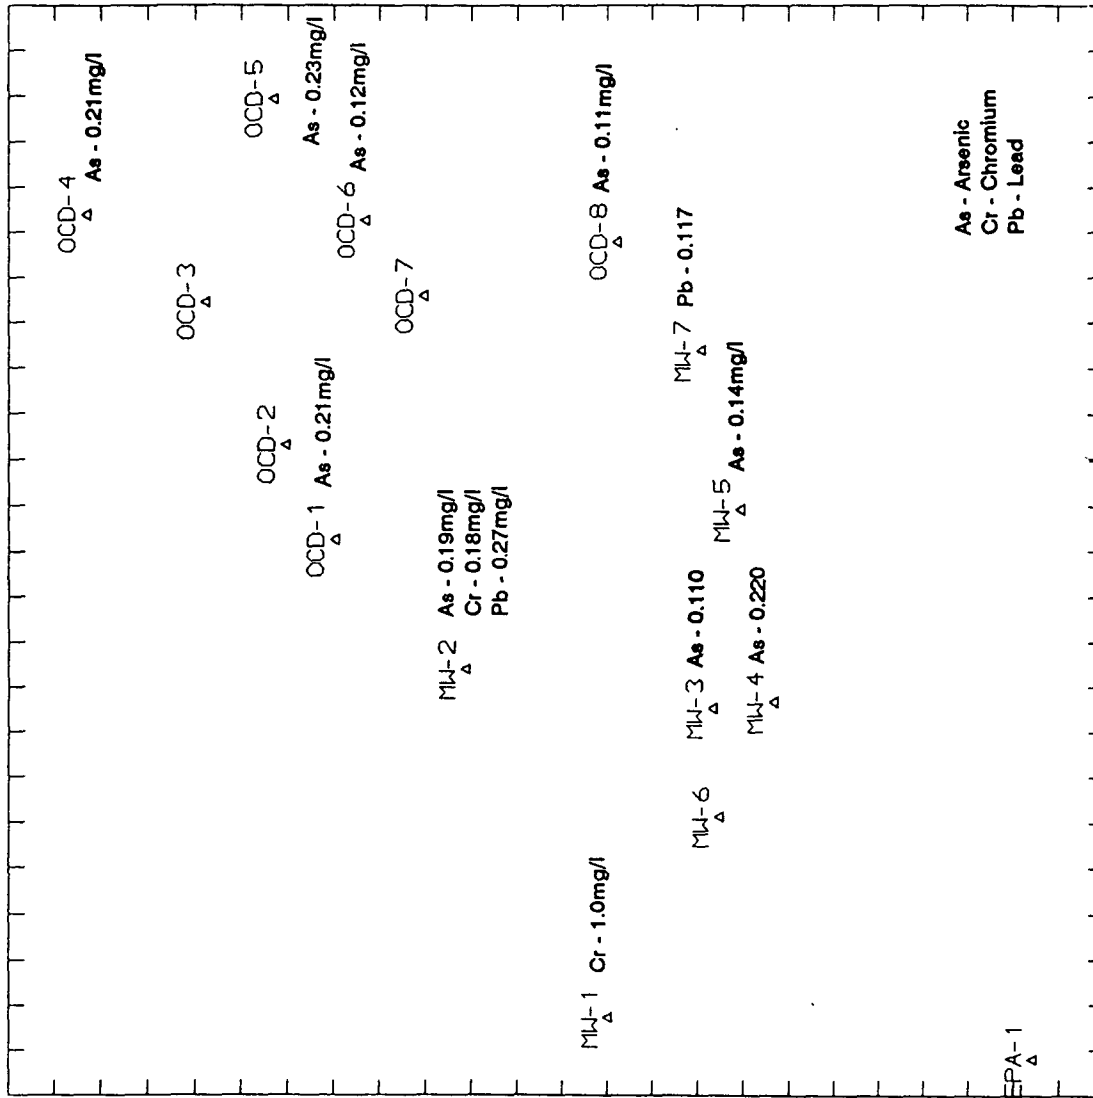
Figure 6.15 Evaporation Ponds, Ground Water Metals Concentration Map, September 1990, RFI Phase I Report, Navajo Refining Company, October 1990.

Metals results from several wells indicate minor chromium and arsenic contamination. Arsenic concentrations ranged from 0.07 mg/lg to 0.27 mg/l in MW-2, MW-3, MW-4, MW-5, MW-6, OCD-1, OCD-2, and OCD-3 during 1986 and 1988 sampling events. A selected group of those wells containing the highest levels were resampled in 1989. Arsenic concentrations were considerably lower ranging from below detection limit to 0.087 mg/l. OCD-1 and OCD-2 contained 0.061 mg/l and 0.076 mg/l chromium when sampled in 1989. Chromium results from the 1988 sampling event were below the detection limit. Metals ground water data are compiled in Table 6.3.

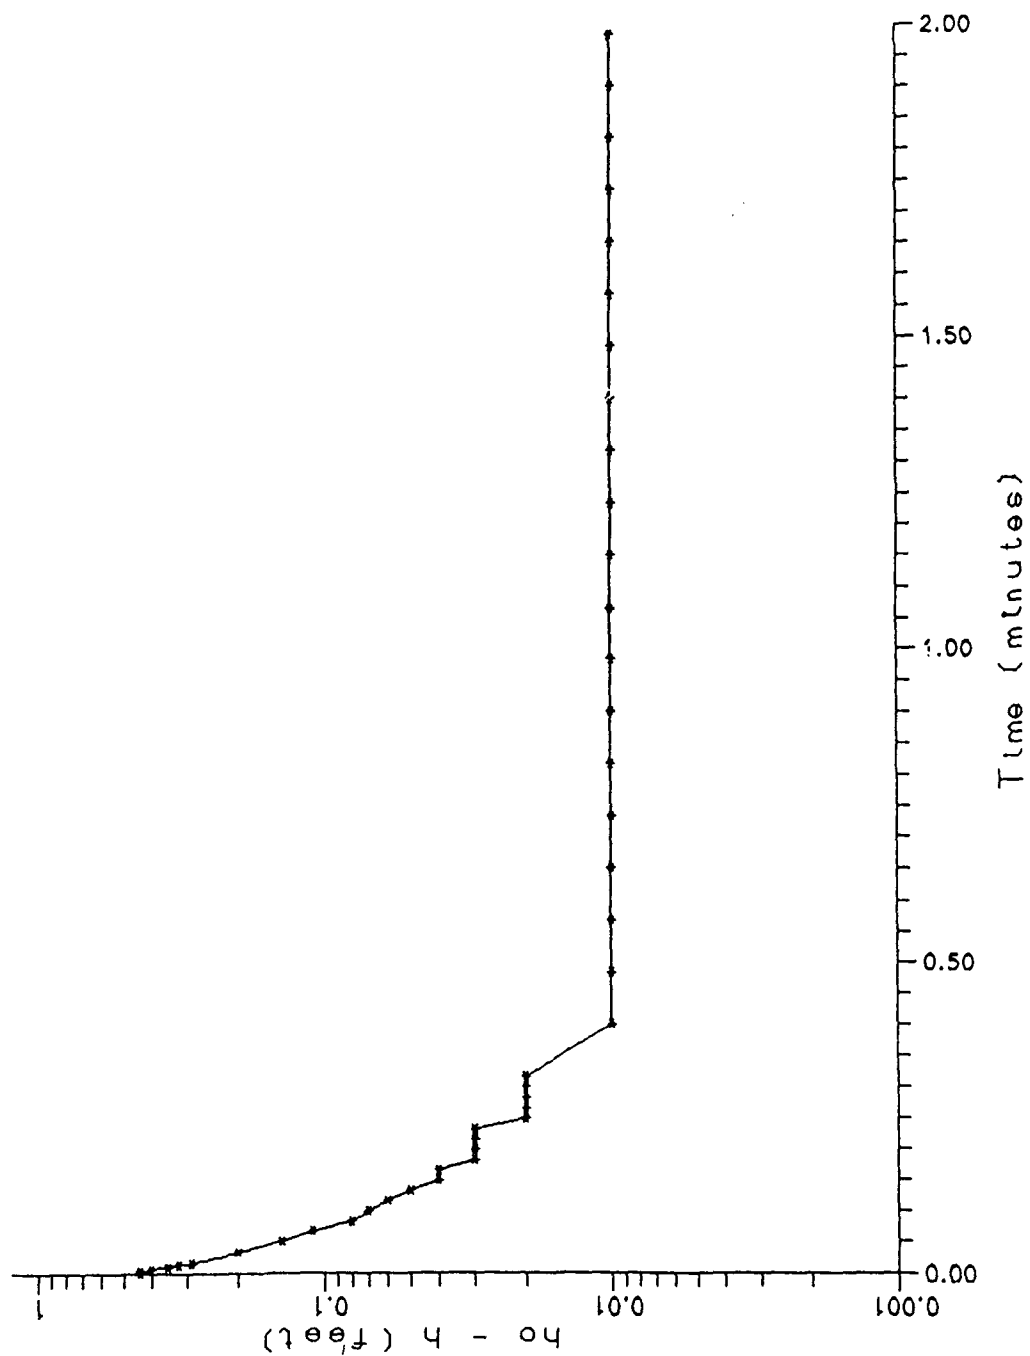
Figure 6.16 Evaporation Ponds, Aquifer Response Curve, MW-4, Test-1, Phase I Report, Navajo Refining Company, October 1990.

The time increments measured during the tests were normalized to account for the initial period where drawdown values fluctuated due to turbulence created when the slug was withdrawn. The test data were plotted on semilogarithmic graph paper (water level change versus time), and a "best fit" line was constructed through the points (Figures 6.16-6.22).

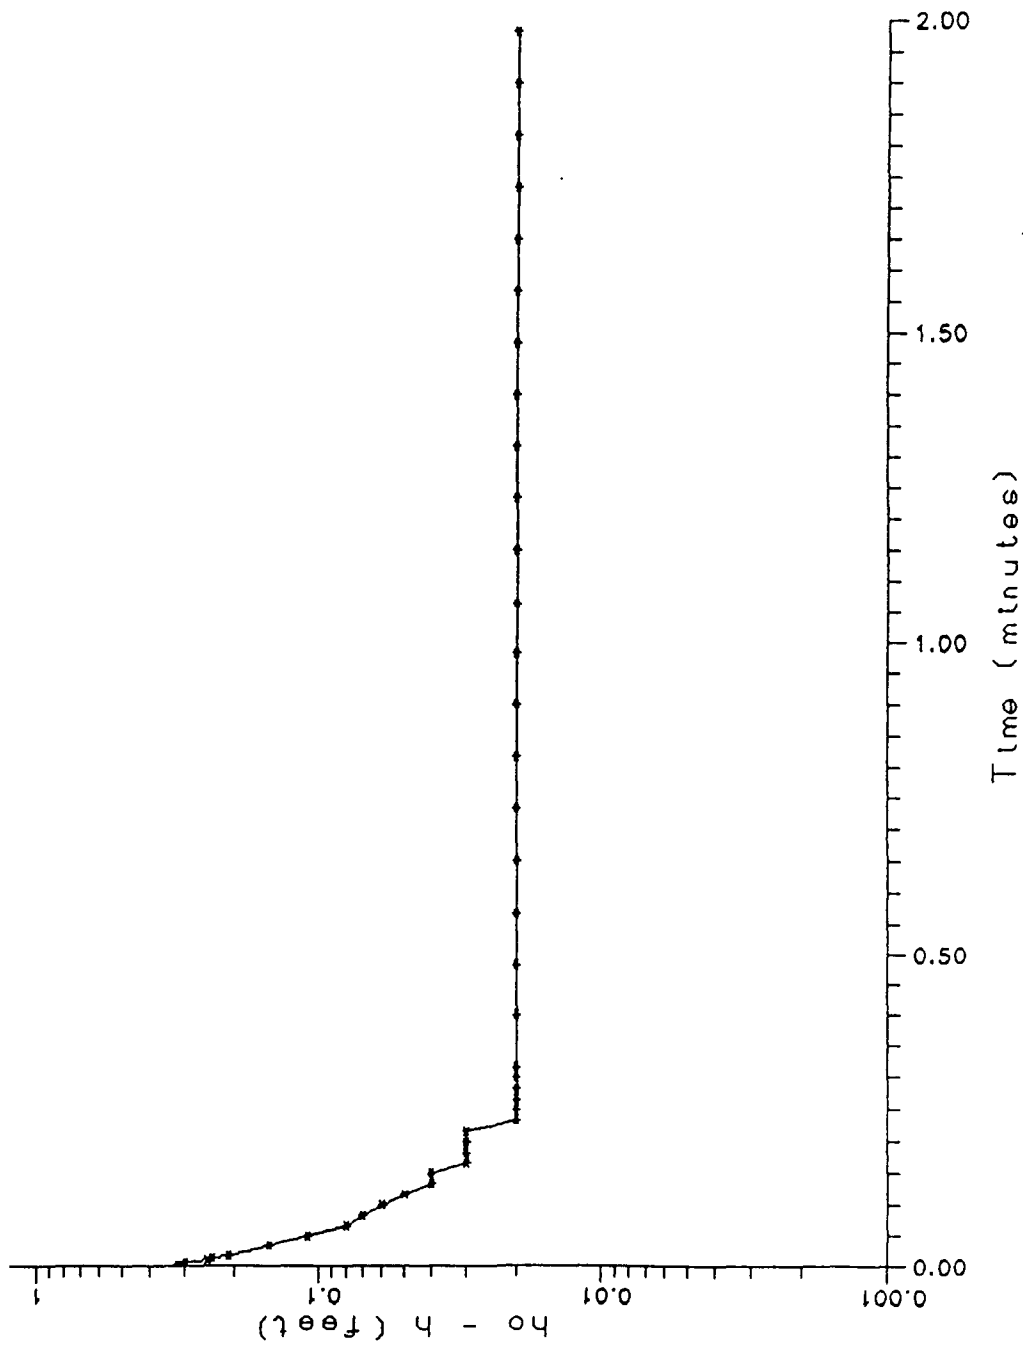
Figure 6.17 Evaporation Ponds, Aquifer Response Curve, MW-4, Test-2, Phase I Report, Navajo Refining Company, October 1990.

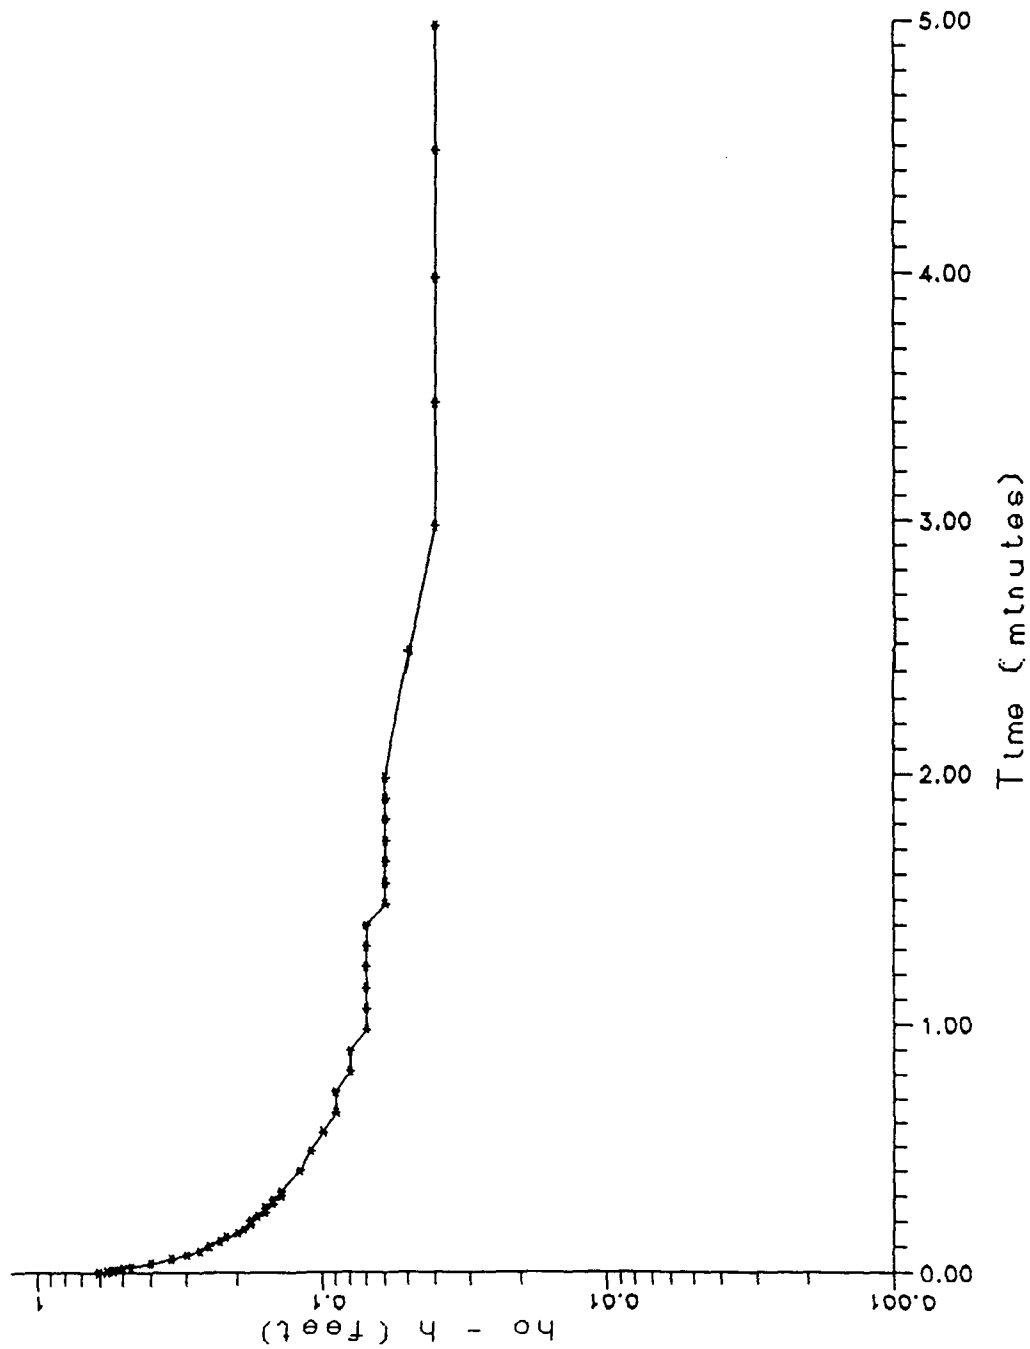
Figure 6.18 Evaporation Ponds, Aquifer Response Curve, MW-6, Test-1, Phase I Report, Navajo Refining Company, October 1990.

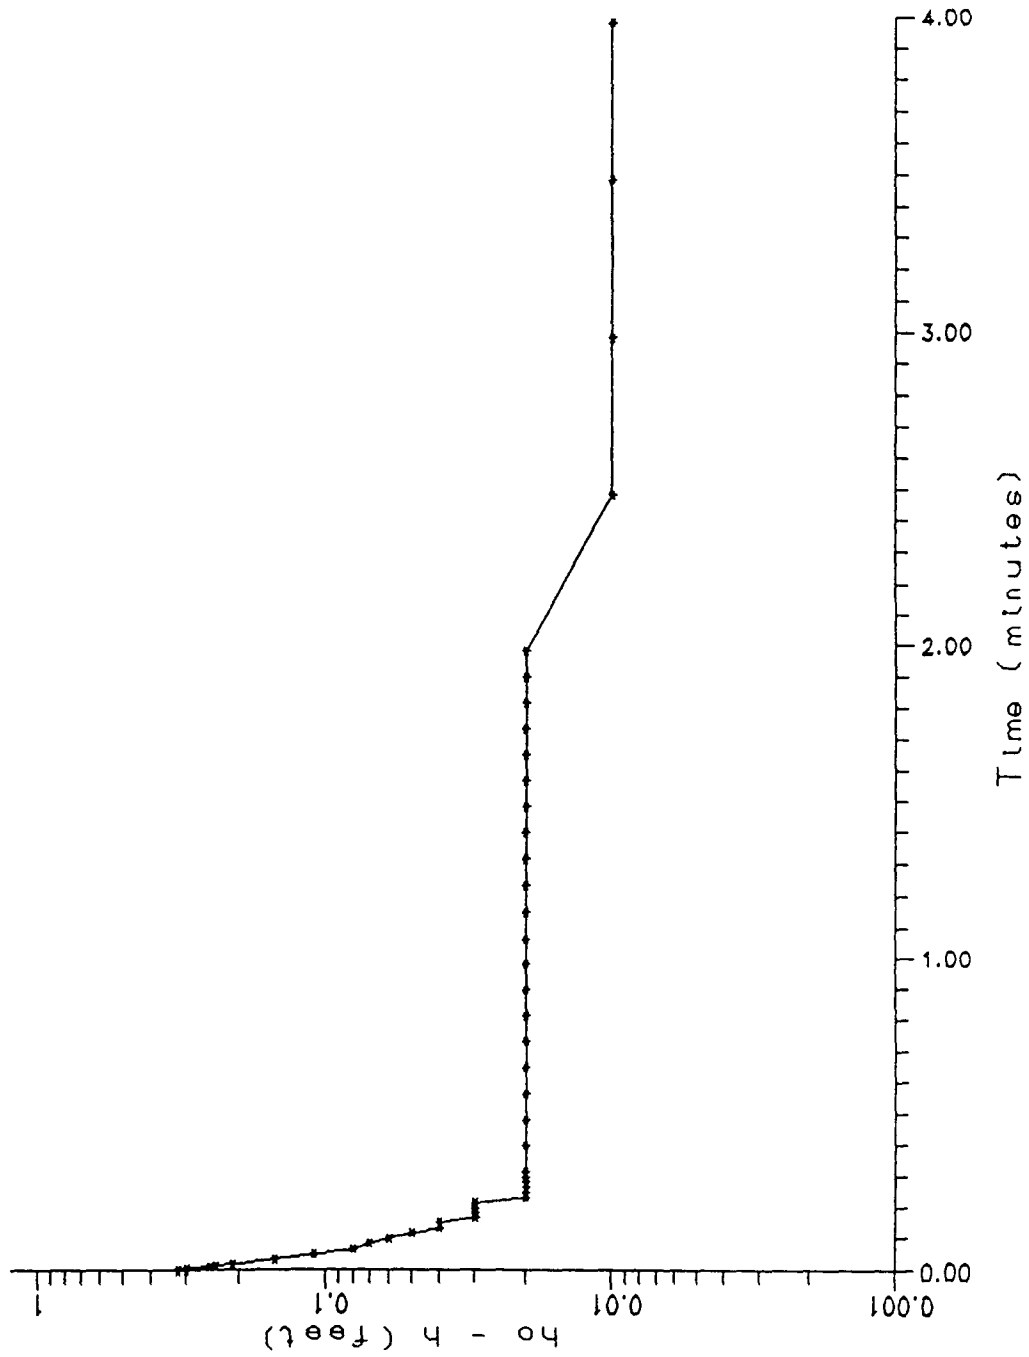
Figure 6.19 Evaporation Ponds, Aquifer Response Curve, MW-6, Test-2, Phase I Report, Navajo Refining Company, October 1990.

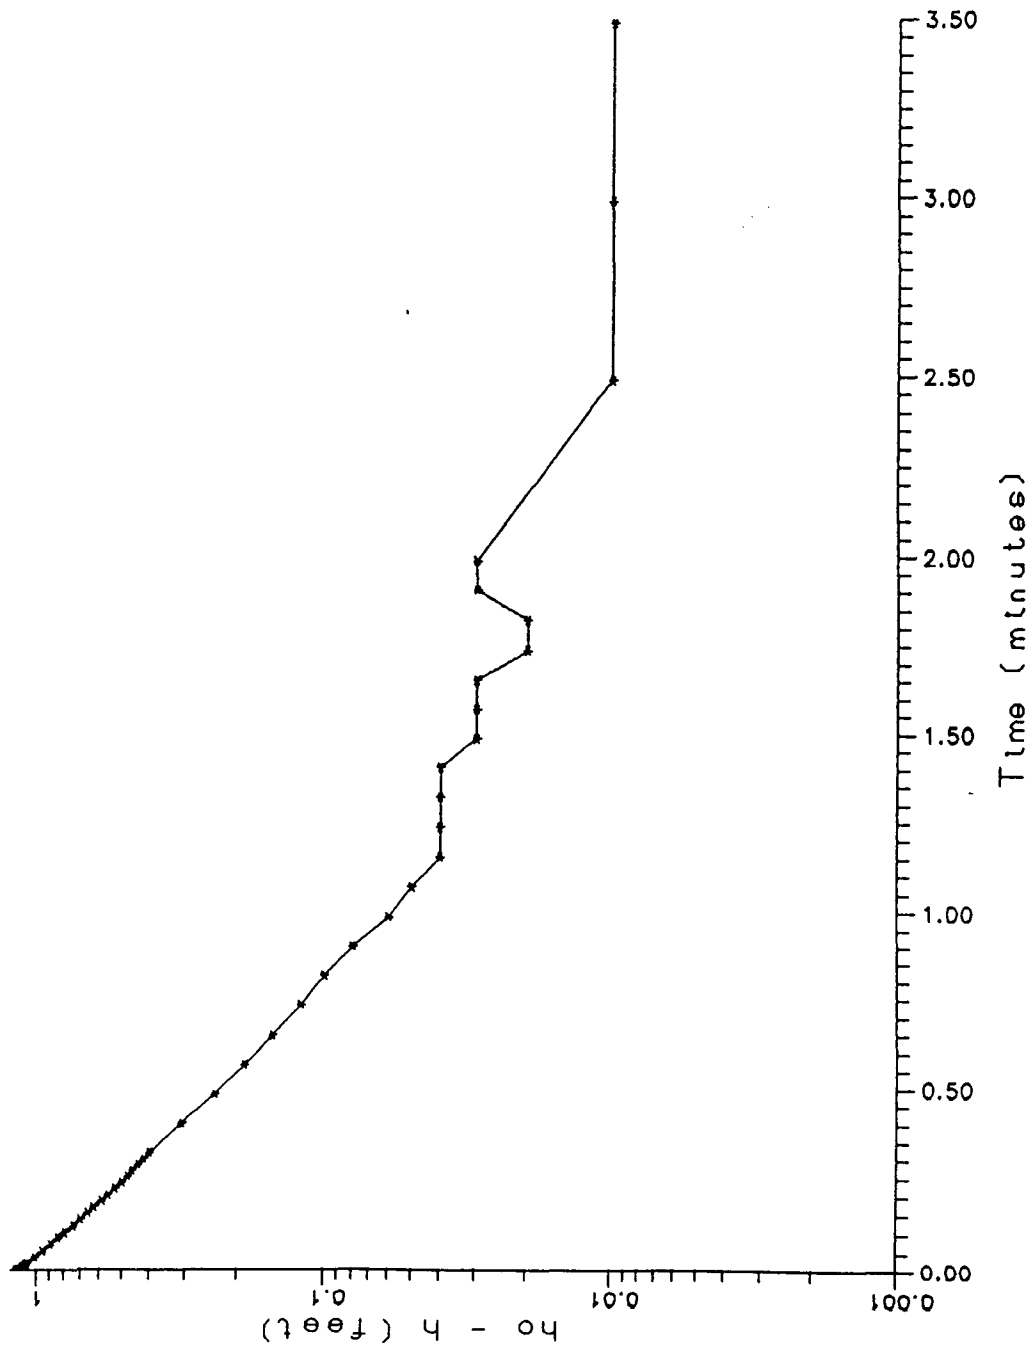
Figure 6.20 Evaporation Ponds, Aquifer Response Curve, OCD-3, Test-1, Phase I Report, Navajo Refining Company, October 1990.

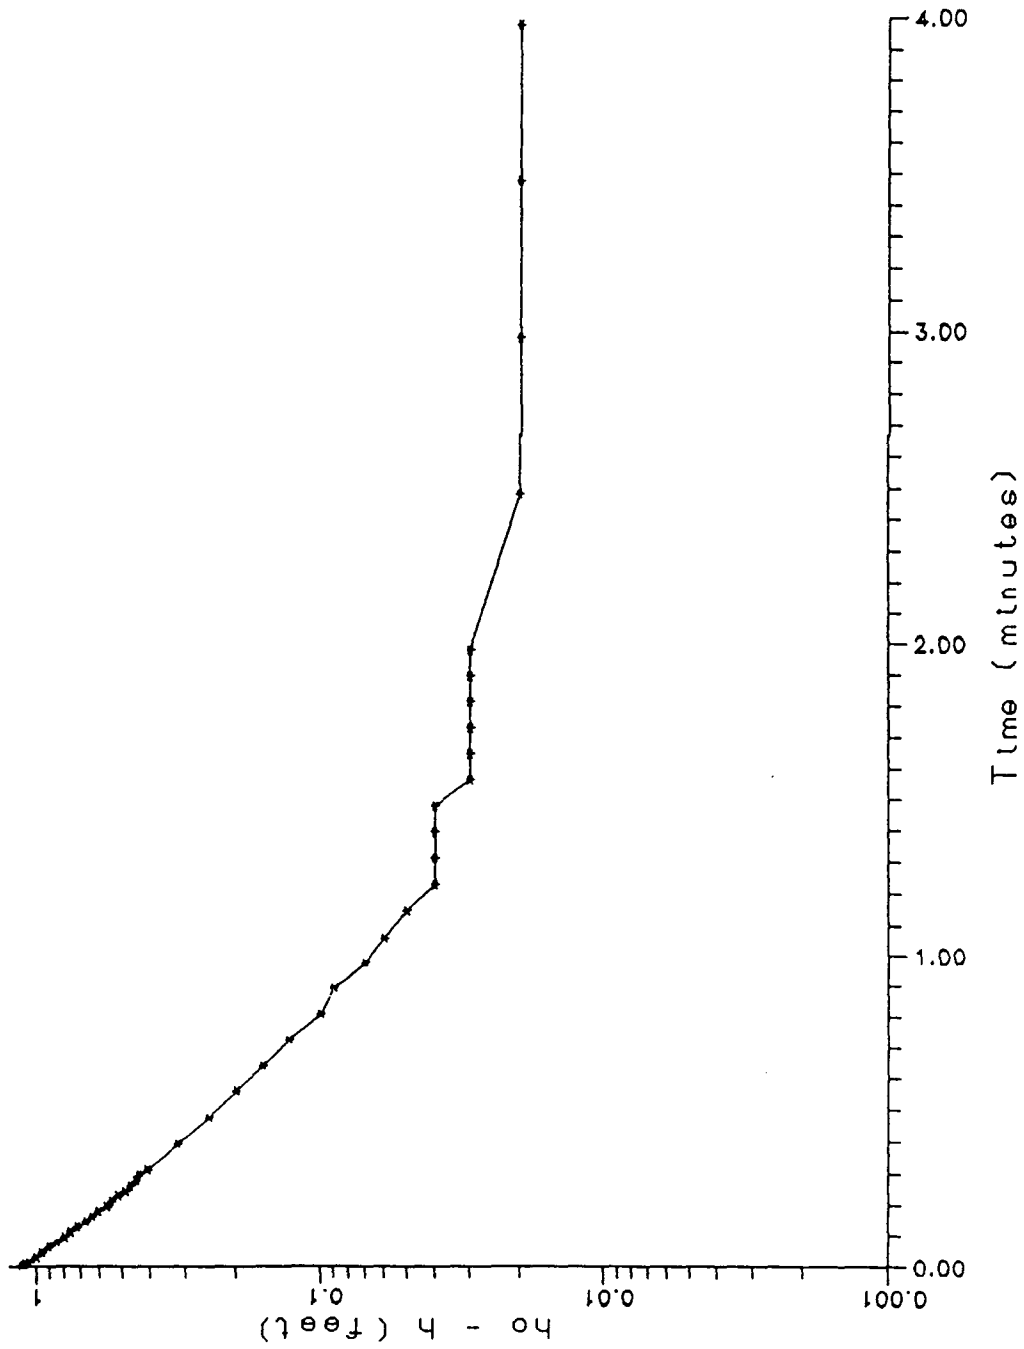
Figure 6.21 Evaporation Ponds, Aquifer Response Curve, OCD-3, Test-2, Phase I Report, Navajo Refining Company, October 1990.

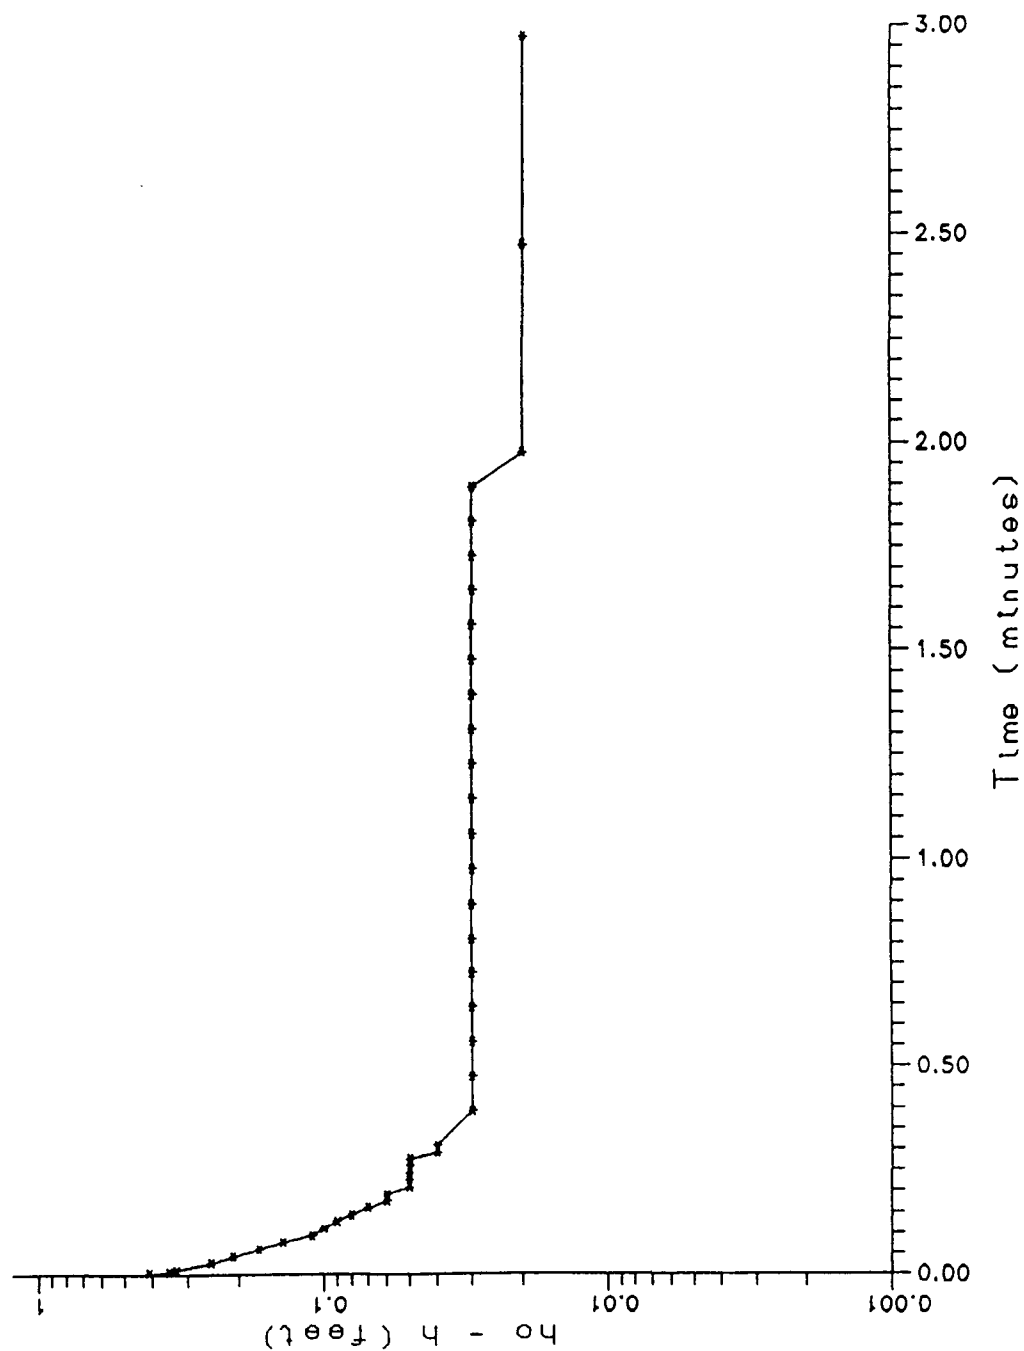
Figure 6.22 Evaporation Ponds, Aquifer Response Curve, EPA-1, Test-1, Phase I Report, Navajo Refining Company, October 1990.
