WORK PLANS

SUPPLEMENT TO BLOOMFIELD REFINERY DISCHARGE PLAN APPLICATION, SITE INVESTIGATION AND ABATEMENT PLAN CMS

September 2002

**RE: Corrective Measures Study (Site Investigation and Abatement Plan)
Giant Refining Company, Bloomfield Refinery
EPA ID# NMD089416416
HWB-GRCB-01-001**

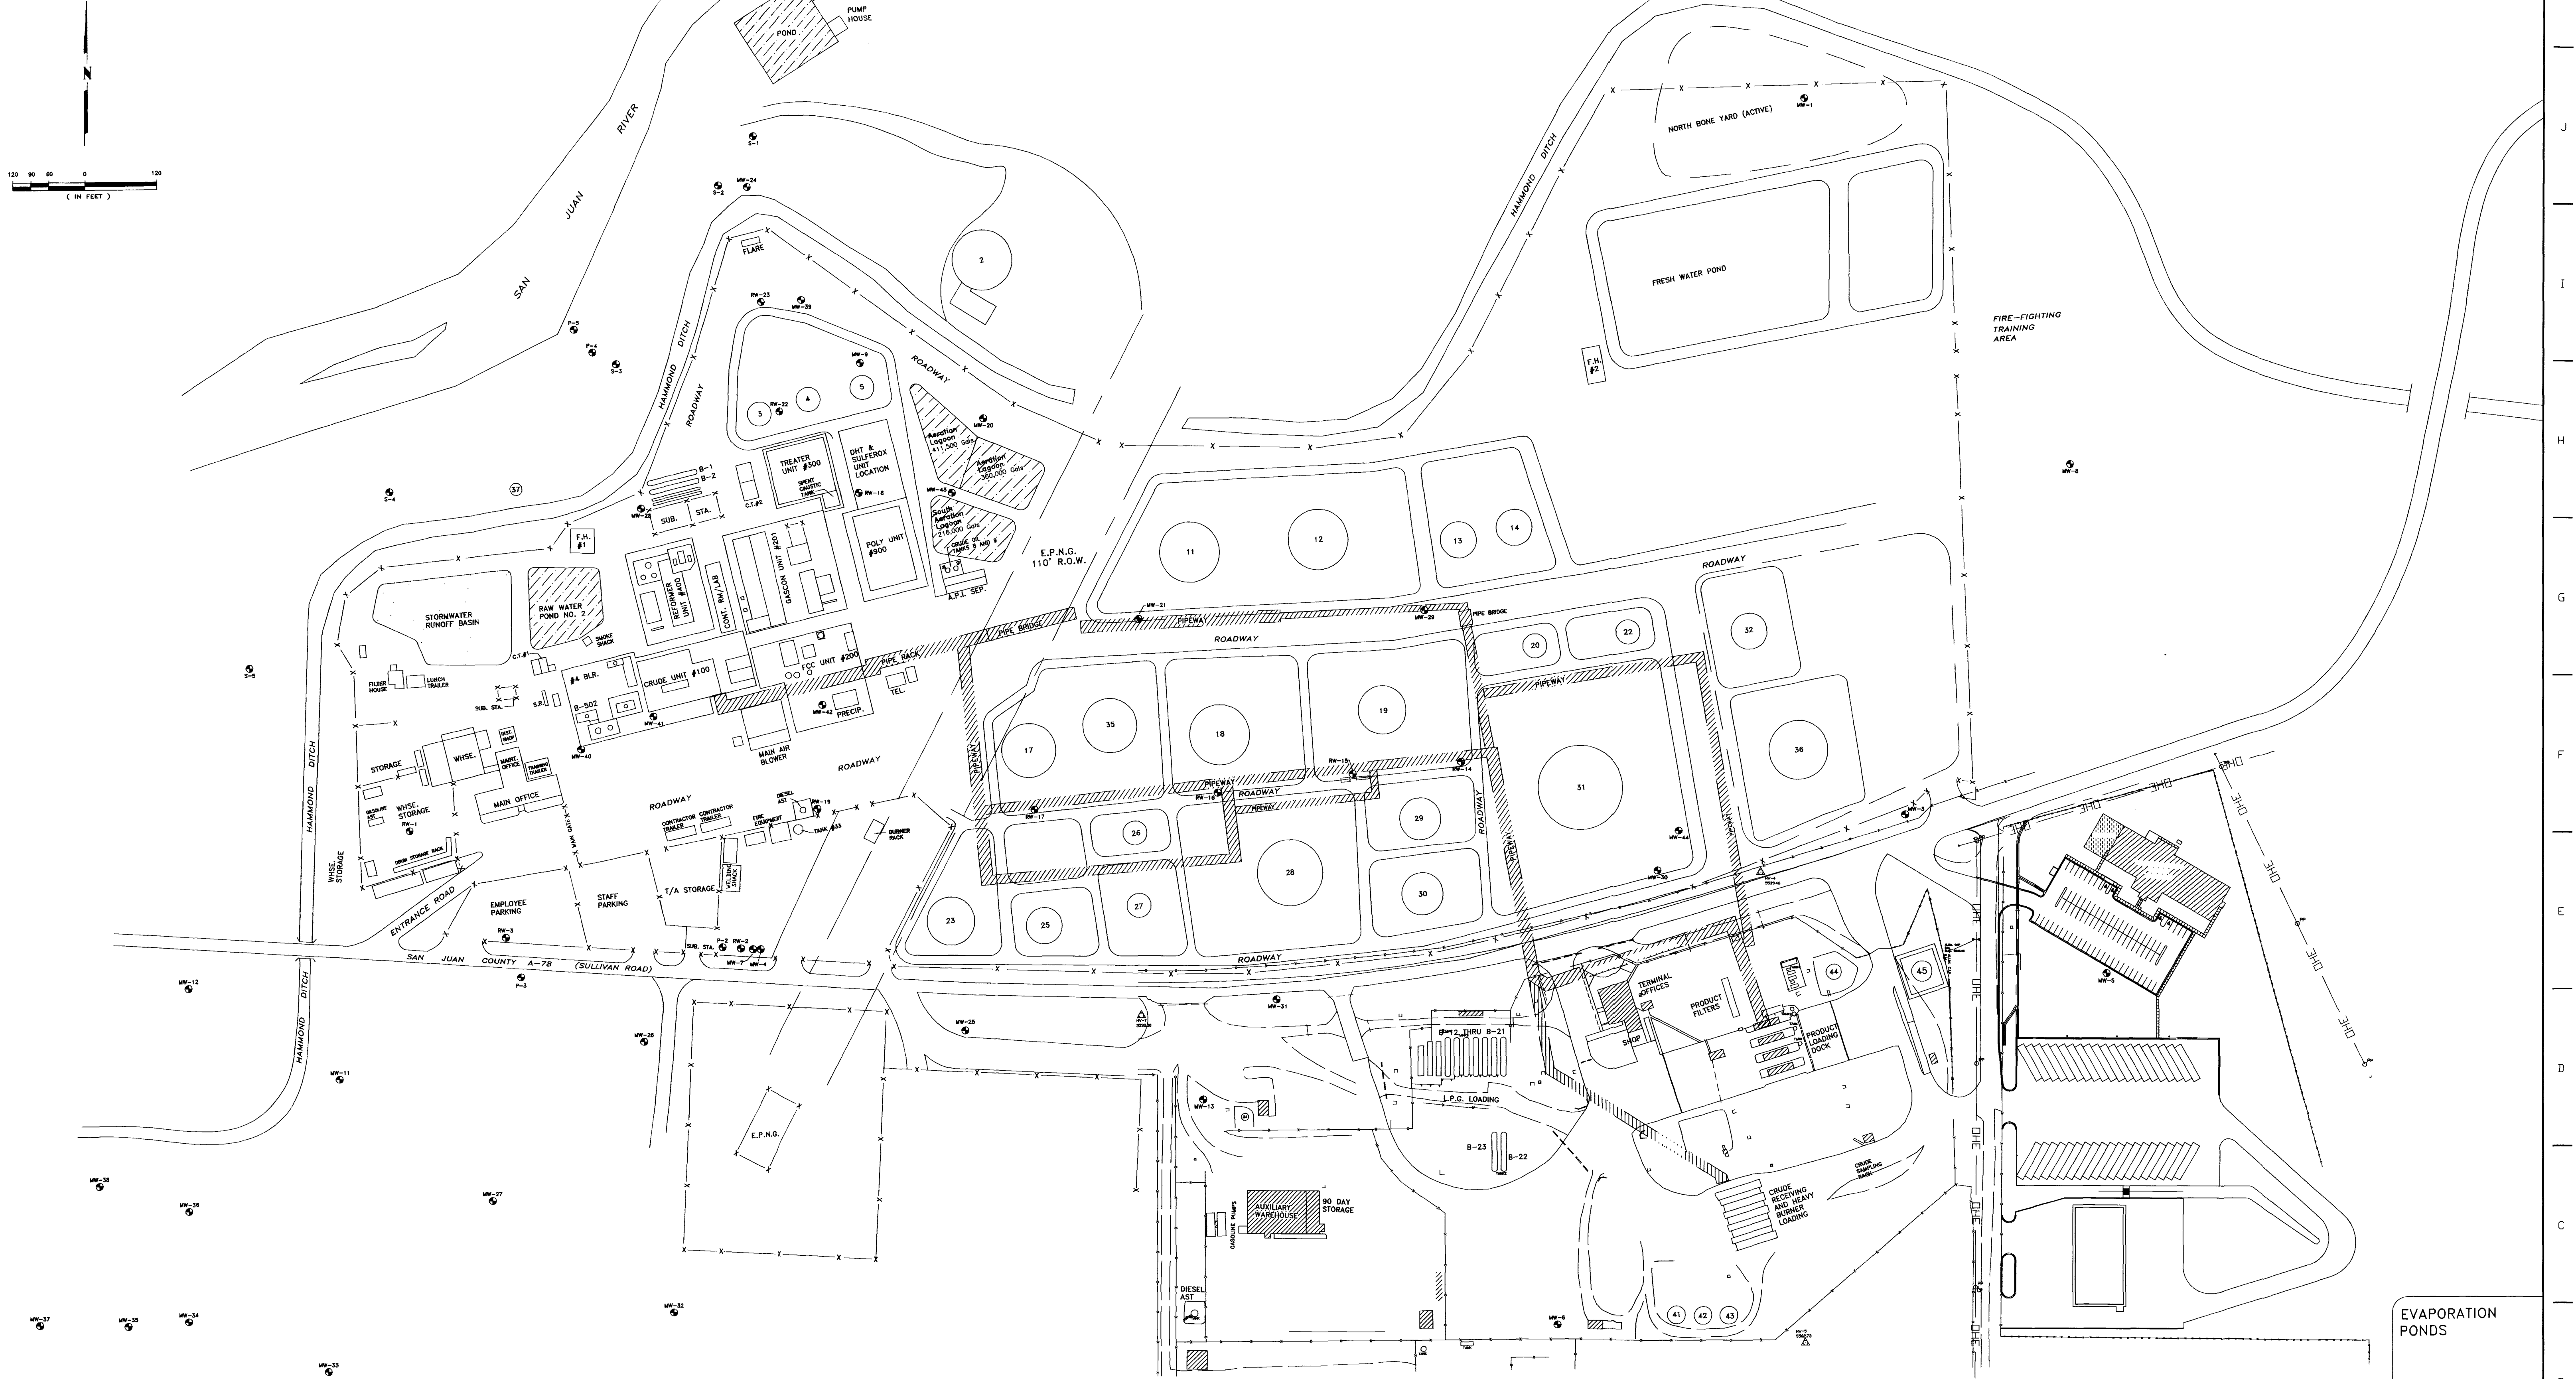
Attachment 1 includes a facility site map with monitoring well locations, labeled process units, above-ground storage tanks, and other refinery and terminal features. This map is provided in both 11" by 17" and 24" by 36" (D) sizes. The D size has been included because so much information is being presented that some information may not be legible in the reduced version. In addition, an 8 1/2" by 11" copy of an October 9, 1997 satellite image of the facility has been included for reference. This image may also be found at: <http://terraservert.homeadvisor.msn.com/image.asp?S=10&T=1&X=1171&Y=20327&Z=13&=2>.

Attachment 1 includes a facility site map/site plan with monitoring well locations, labeled process units, above-ground storage tanks, and other refinery and terminal features. This map is provided in both 11" by 17" and 24" by 36" (D) sizes. The D size has been included because with the amount of information that is being presented some information may not be legible in the reduced version. In addition, an 8 ½" by 11" copy of an October 9, 1997 USGS aerial photograph of the facility has been included for reference. This image may also be found on the internet at:

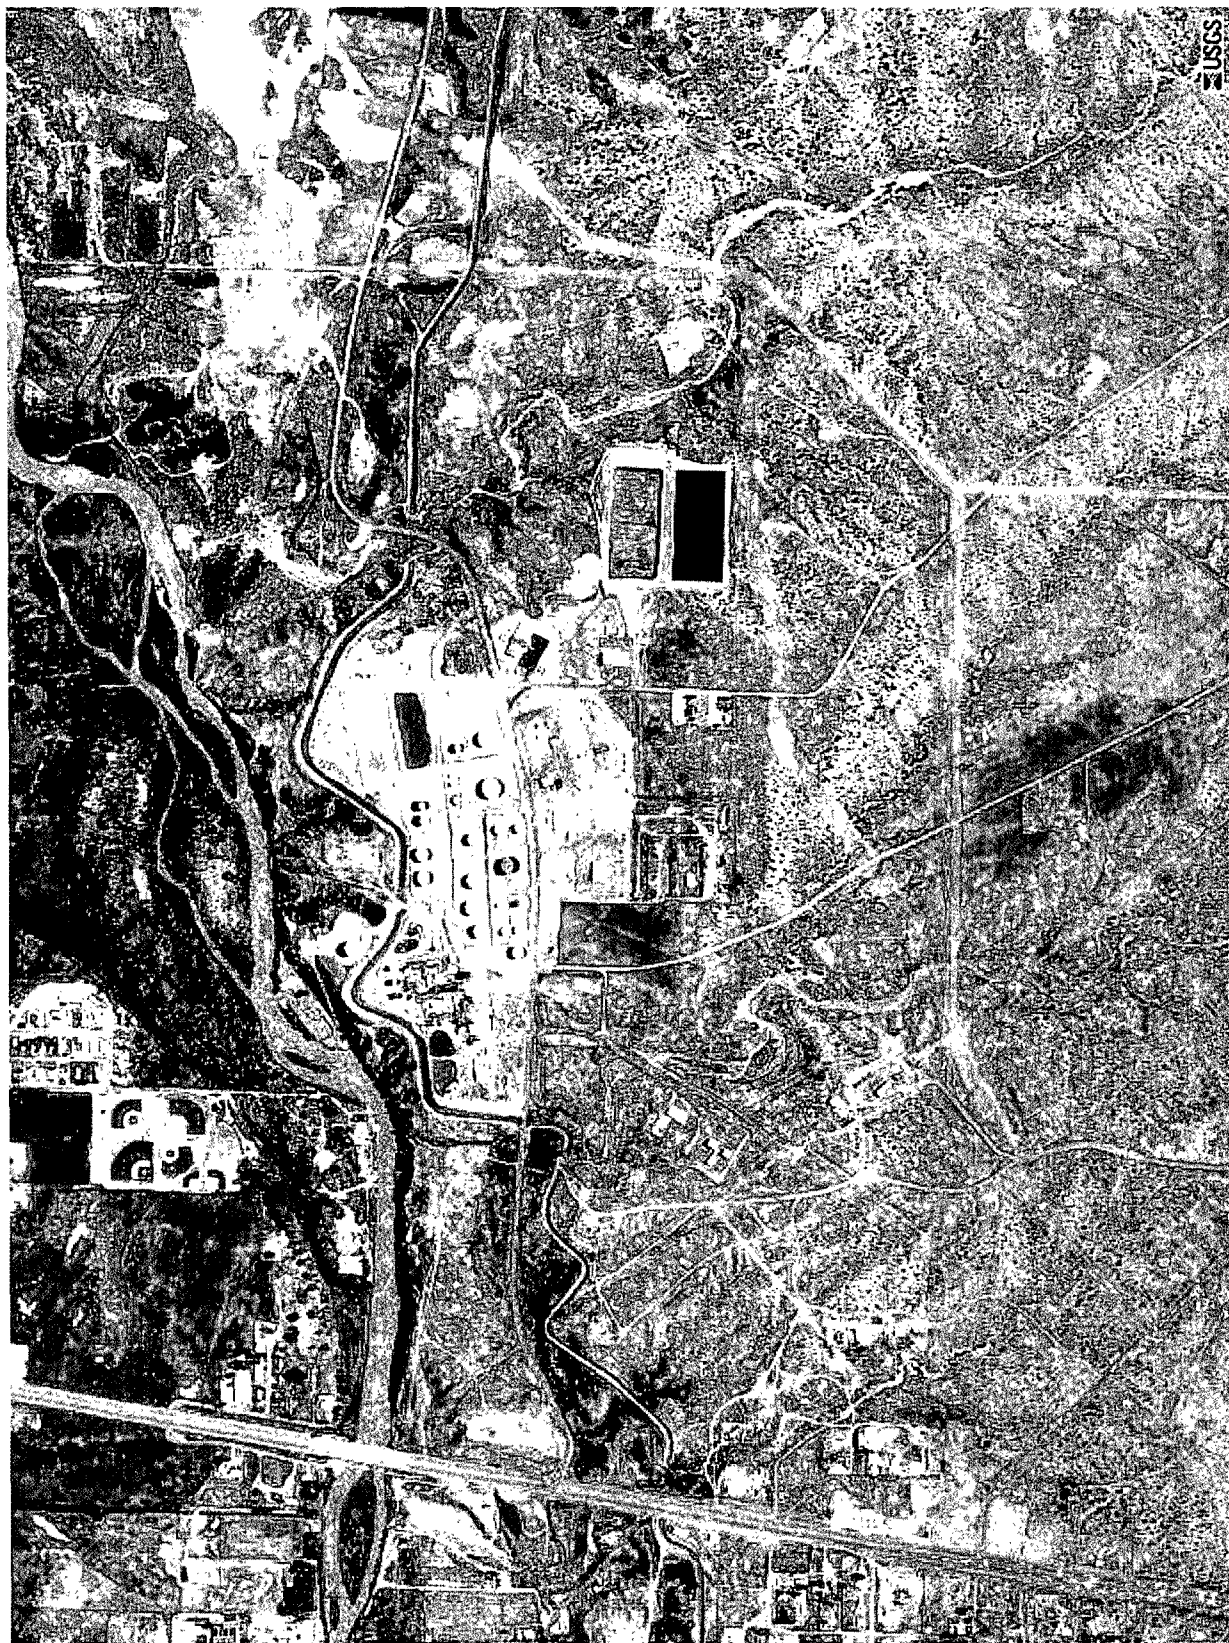
October 9, 1997
Bloomfield Refinery USGS Aerial Photograph

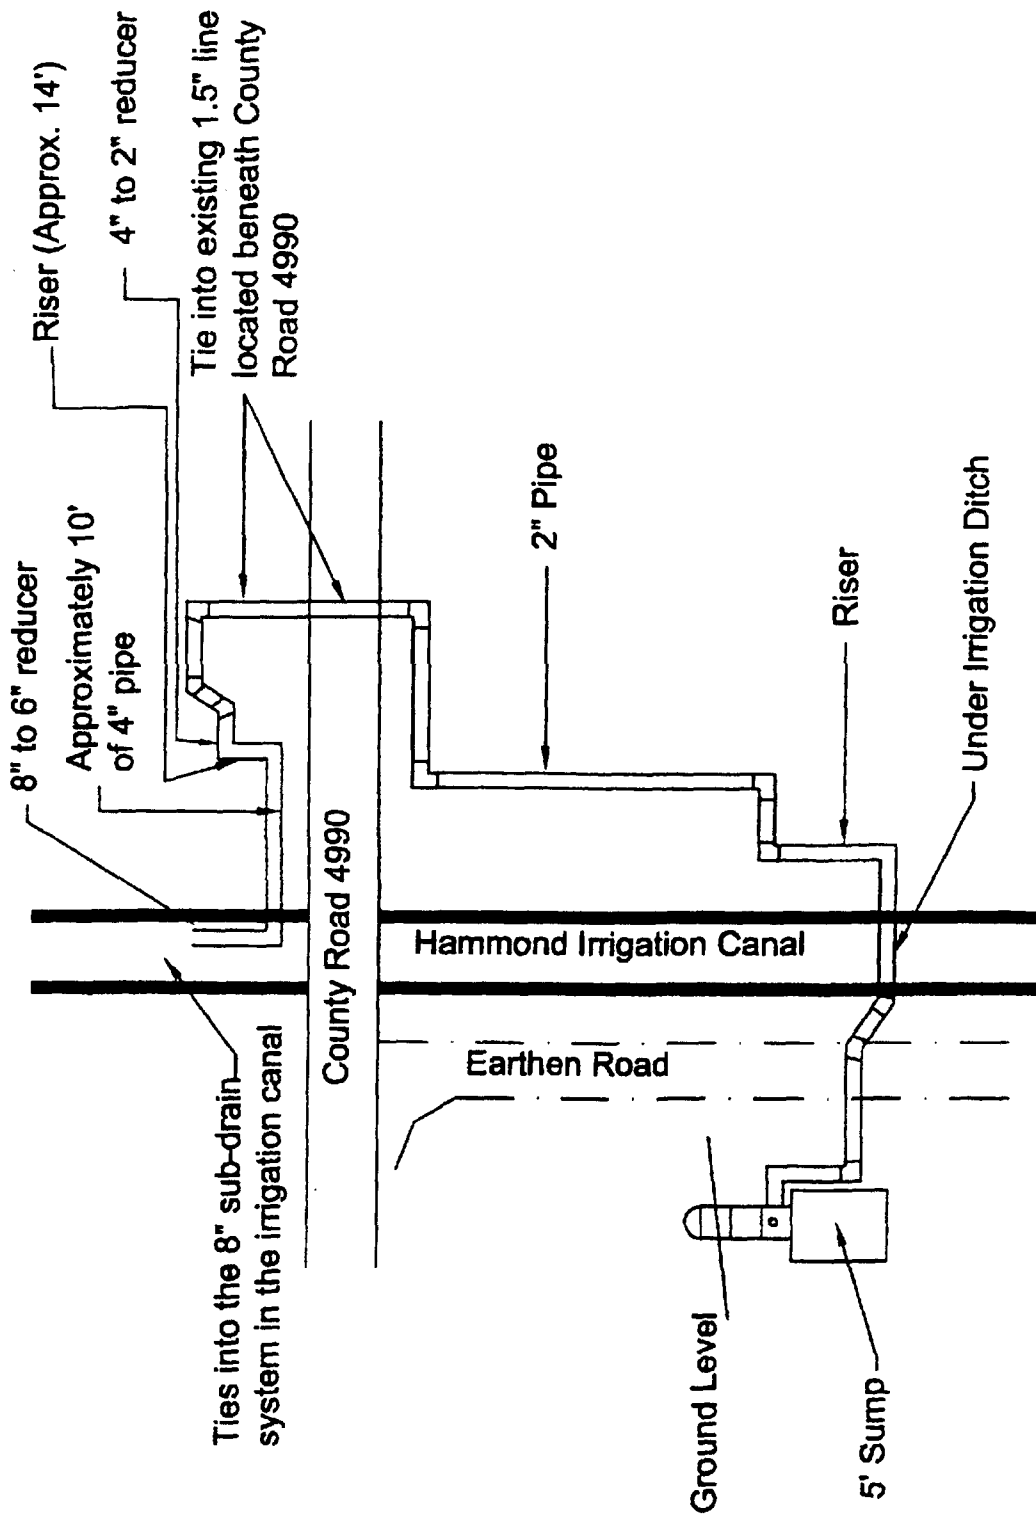
The 8" sub-drain north of CR 4990 receives the groundwater from the south collection system. From the sub-drain an 8" to 6" reducer is used. At the next 90° (detailed on the side view) a 6" to 4" reducer followed by a 4" line approximately 10' in length is used. A 4" riser approximately 14' in height brings the line to the elevation needed to connect to the existing 1.5" line. A 4" to 2" reducer followed by a 2" line connects the 4" riser to the 1.5" line beneath the road.

6019 Jefferson NE Albuquerque, New Mexico 87113	South Collection System - Side View Figure No. 2 Date Drawn: 8 July 2002 Drawn By: RJT Checked By: LW
---	---	--

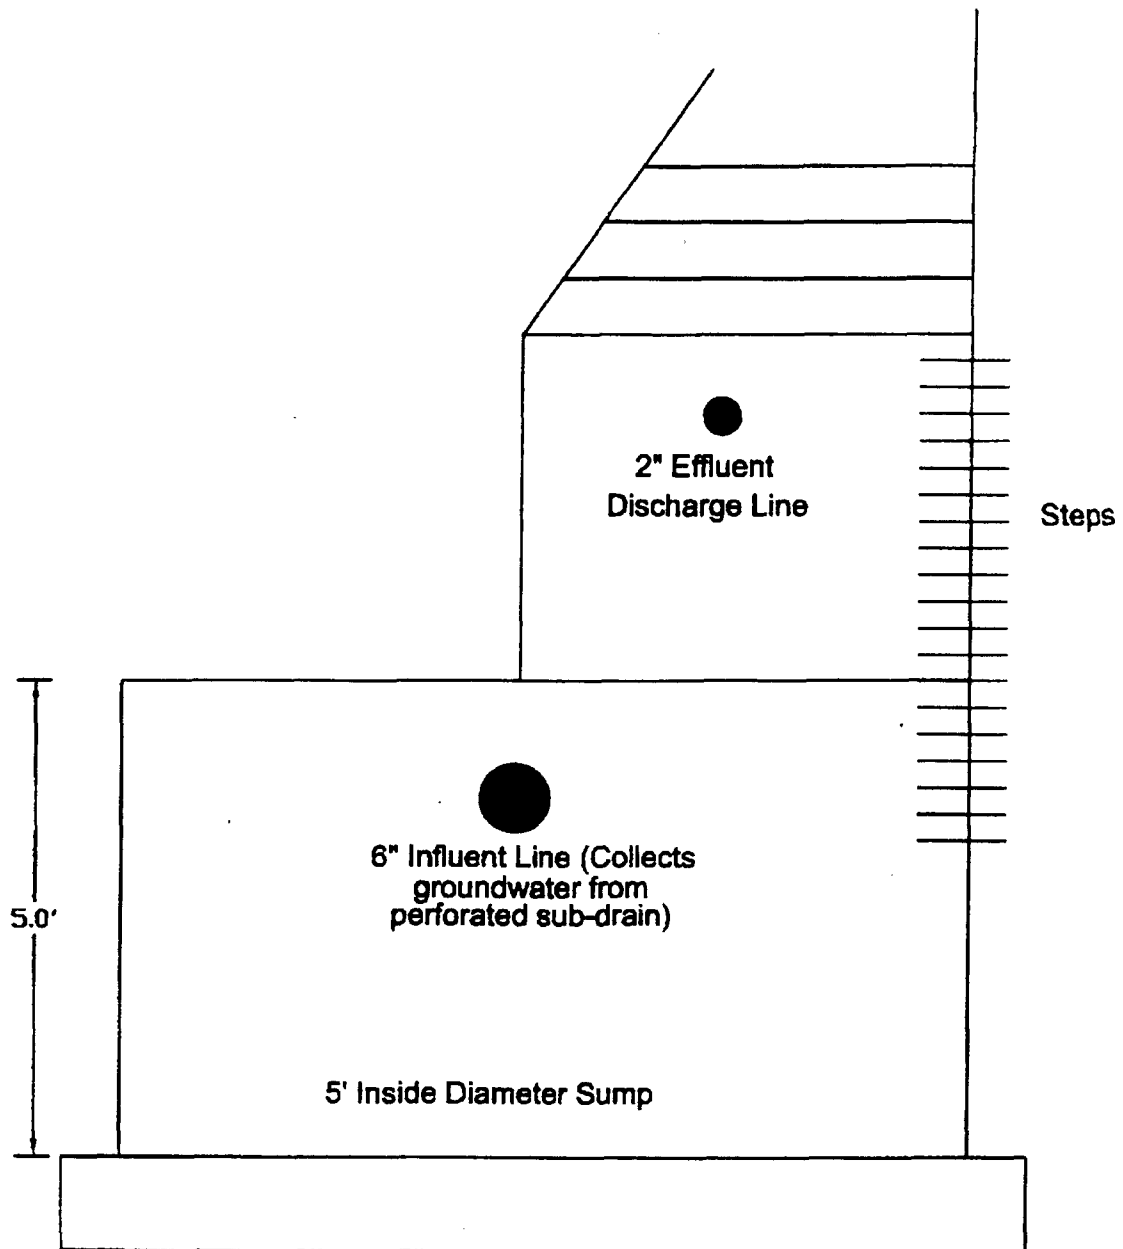
The tank collects groundwater from the two 8" influent lines connected to the perforated sub-drain beneath the irrigation canal. The water is pumped to a 4" welded steel line beneath the road canal, and up the embankment south of the tank.

Giant Groundwater Collection System Bloomfield, New Mexico AMEC Project No. 2-517-000001	amec 5515 Jefferson NE Albuquerque, New Mexico 87113	North Collection System	Figure No. 4
		Date Drawn: 9 July 2002 Drawn By: RJT Checked By: LDW

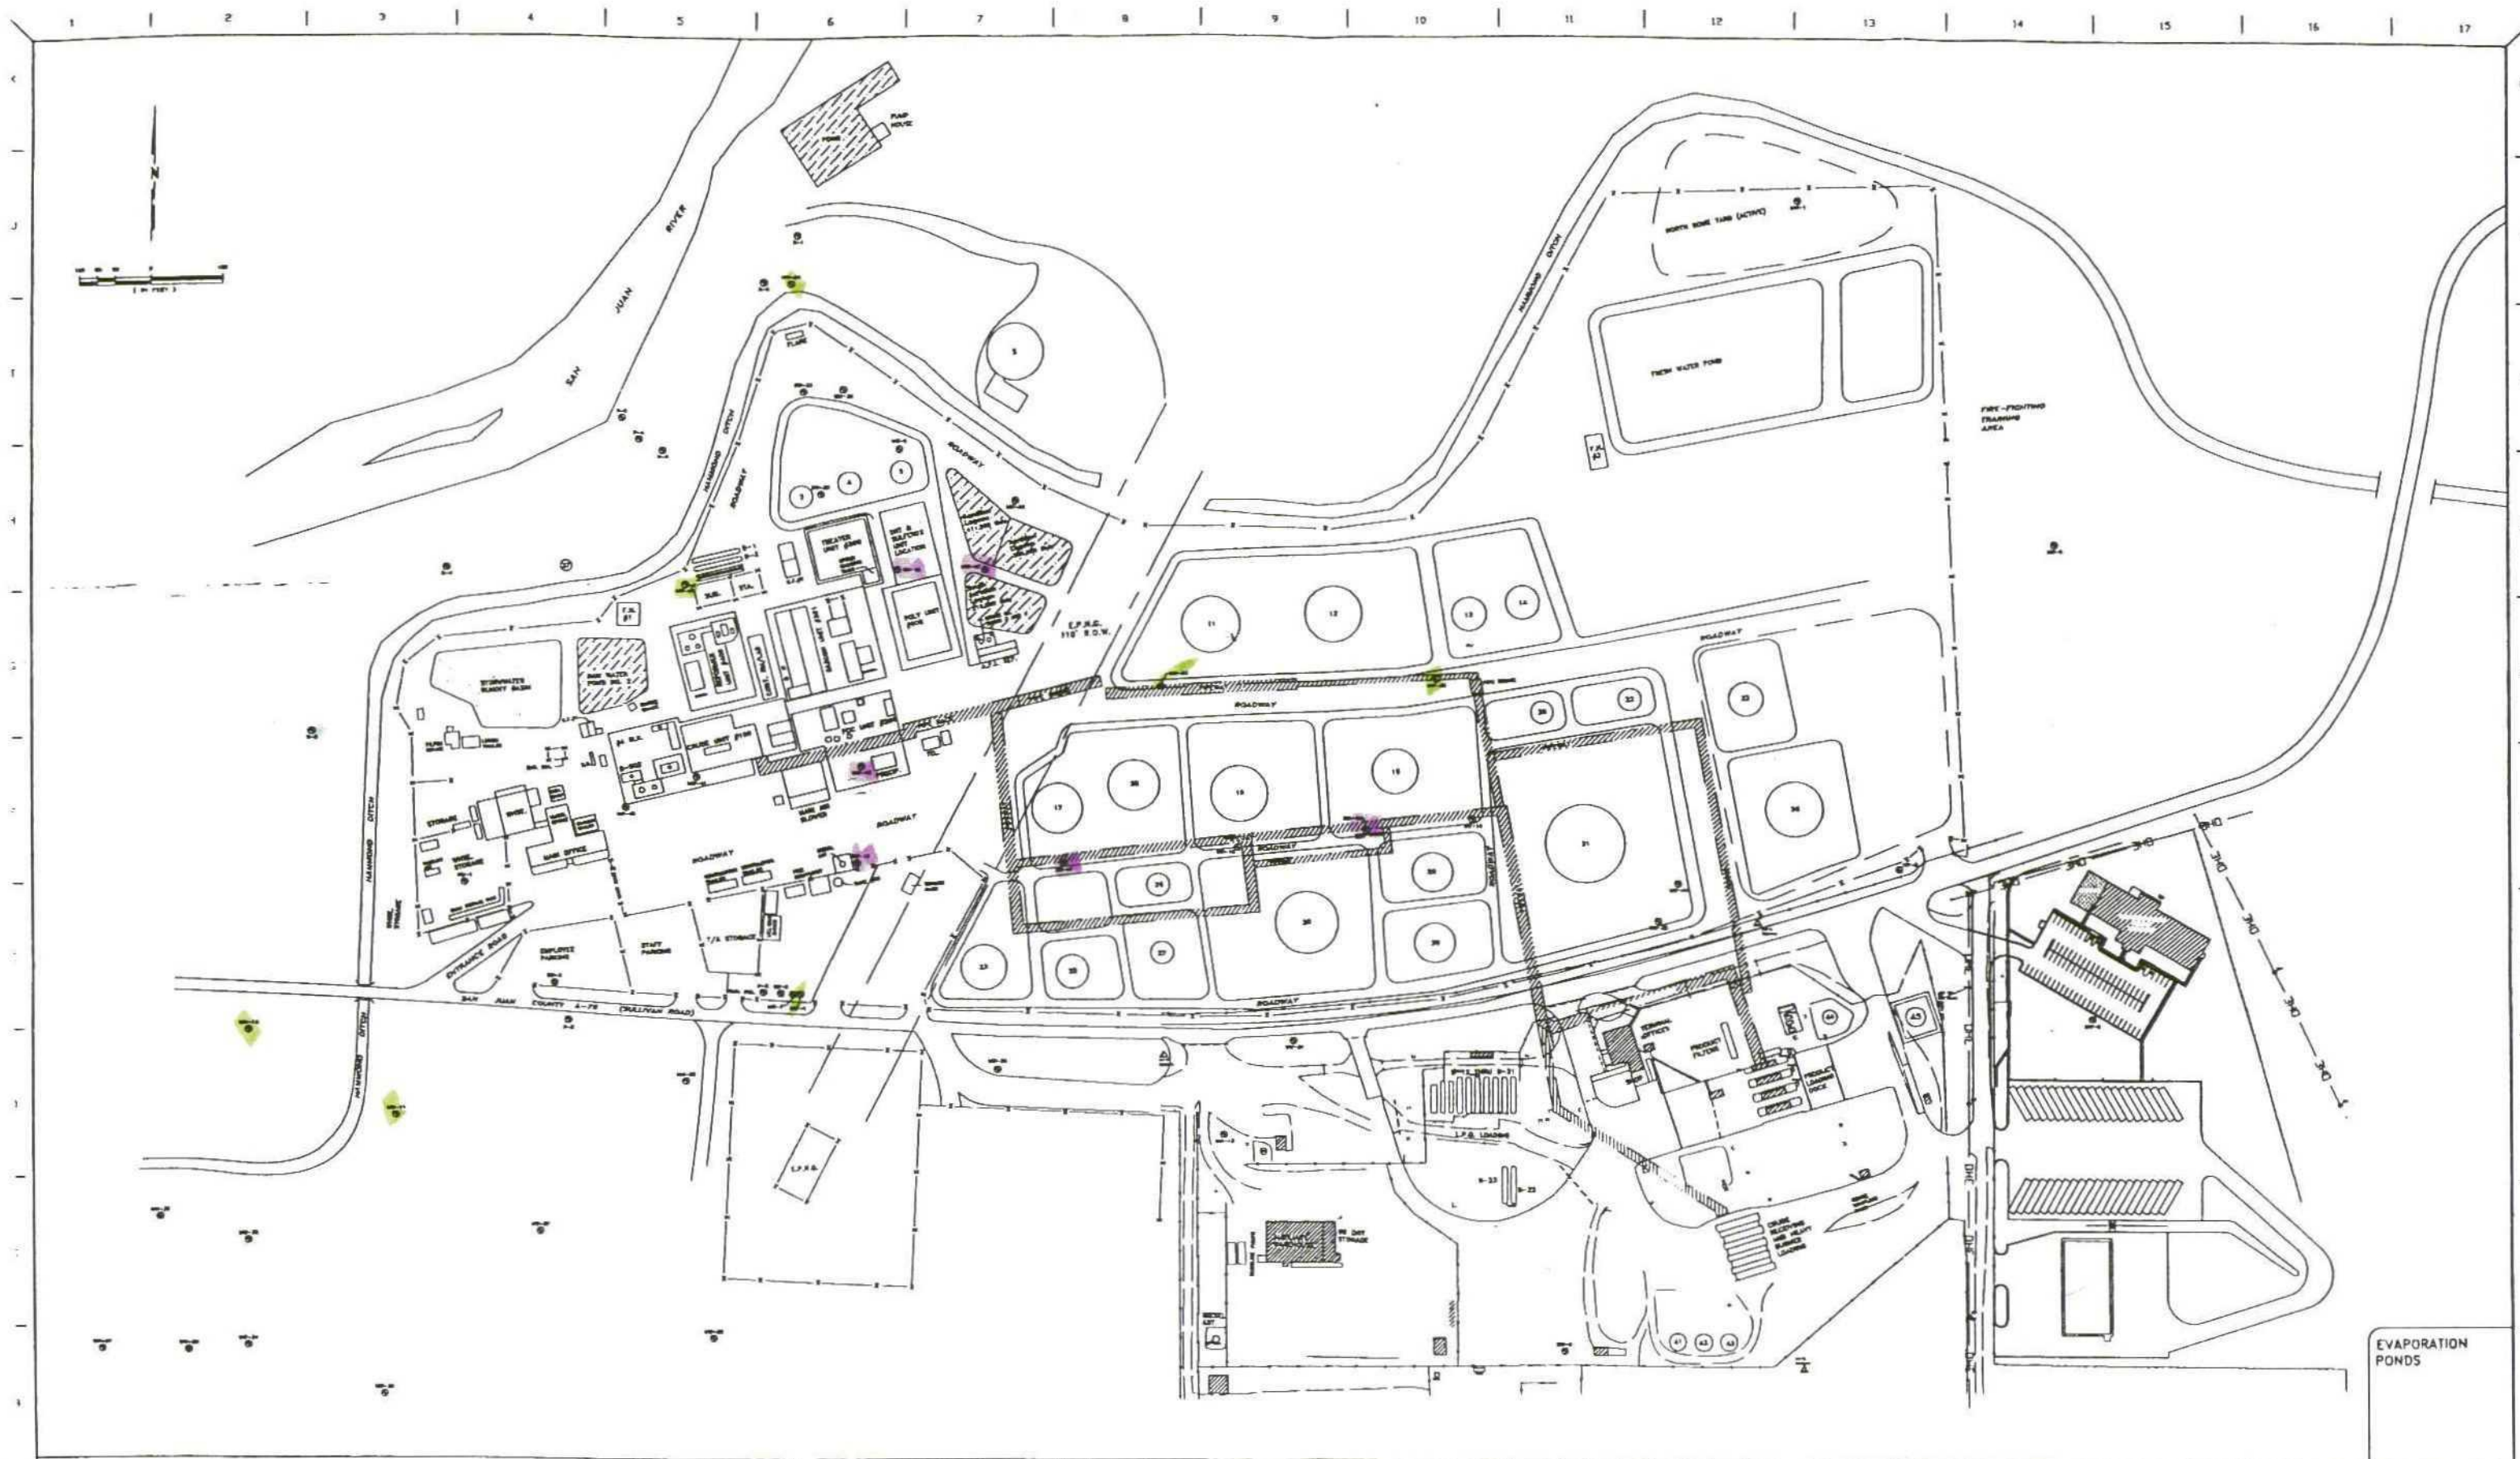
Water/product level measurements for the monitoring wells, recovery wells, and seeps were taken by refinery personnel throughout 2002. The results of these measurements are presented as part of this attachment in both tabular and graphic form.

An individual site plan has not been included for each monitoring event. However, the tabulated data from all sampling events have been graphed showing the ground water levels across the site.

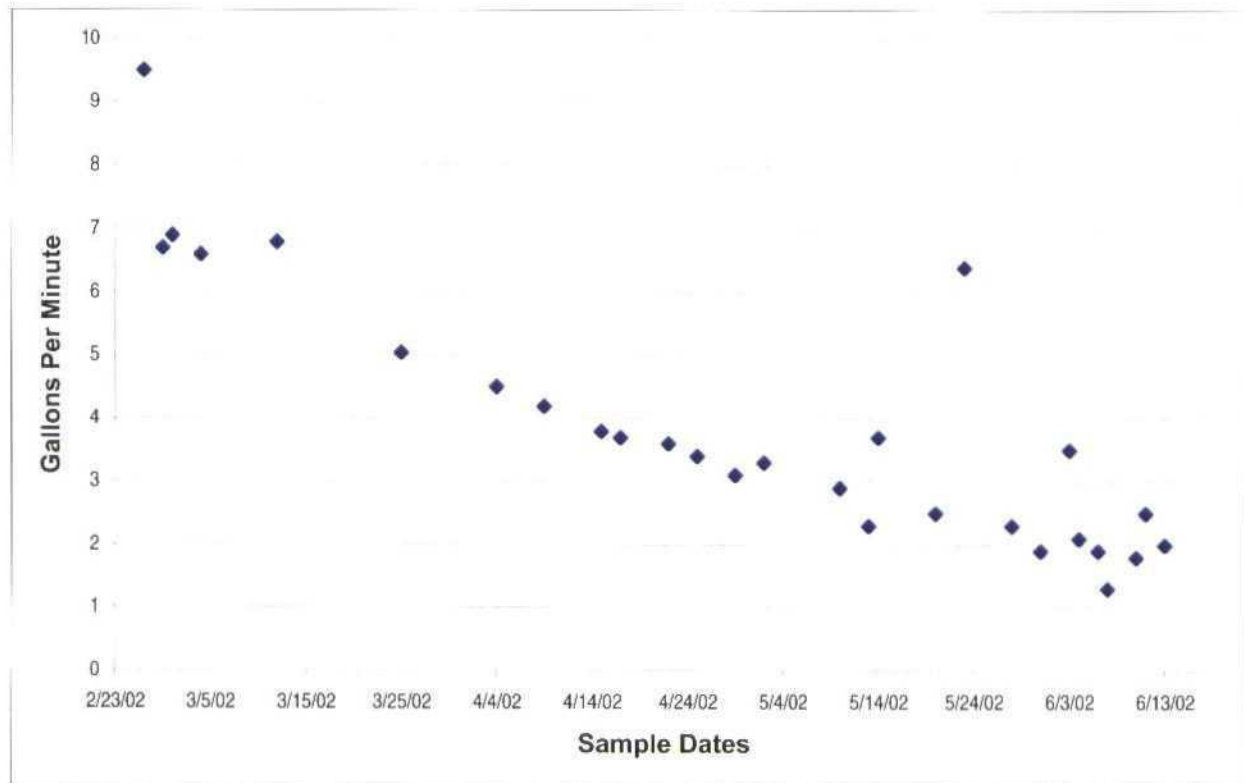
Recovery Rates from Hammond Ditch French Drain into Tank 37

BRC does not measure the volume and/or flow rate of water removed from the recovery wells. This water and the water recovered from the Hammond Ditch French Drain join process water in the API Separator; therefore, there is no method to provide product recovery rates from these sources individually.

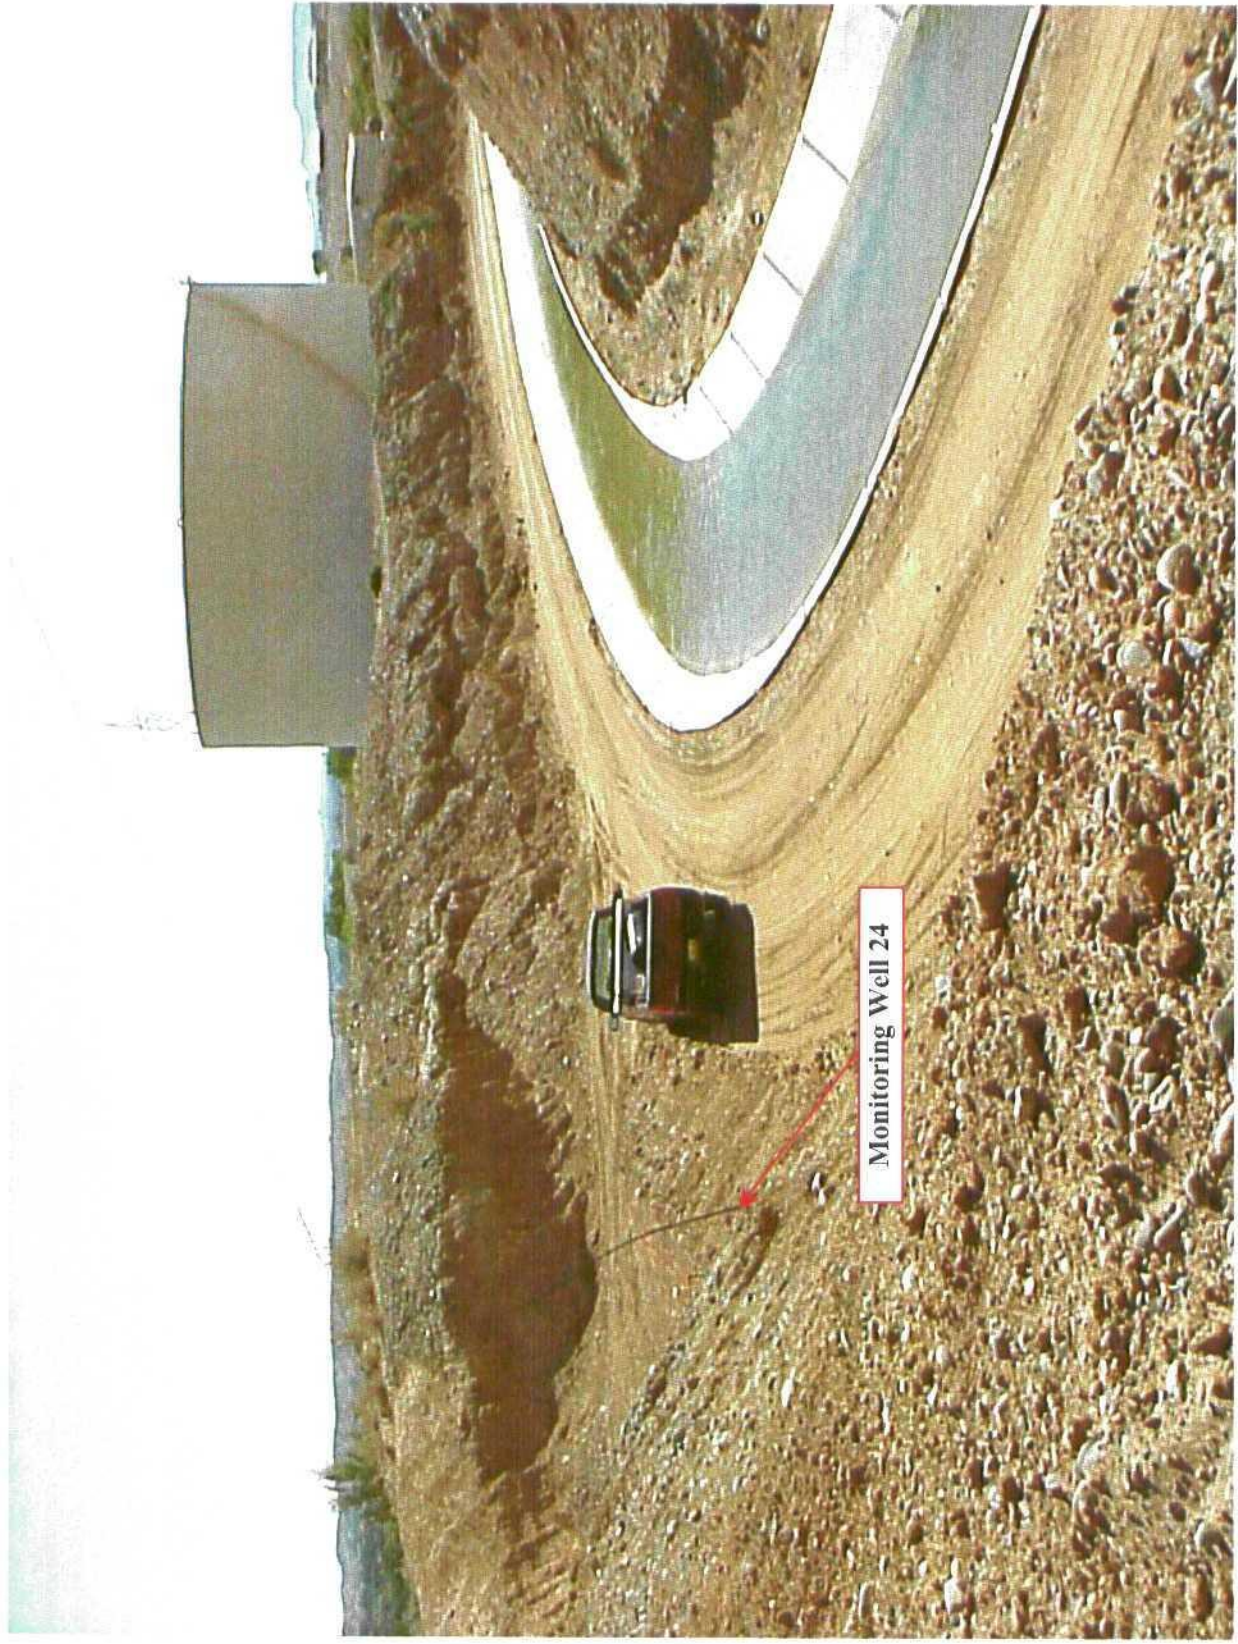
Monitoring Well 24 and Hammond Ditch (Lined)

One new monitoring well is proposed downgradient of the Hammond Ditch to monitor the effectiveness of the Hammond Ditch French Drain. BRC will also continue to monitor the downgradient seeps along the bluff, MW24, and the points at the sheet piling. Attachment 3 includes water level information on the seeps and monitoring wells downgradient of Hammond Ditch.

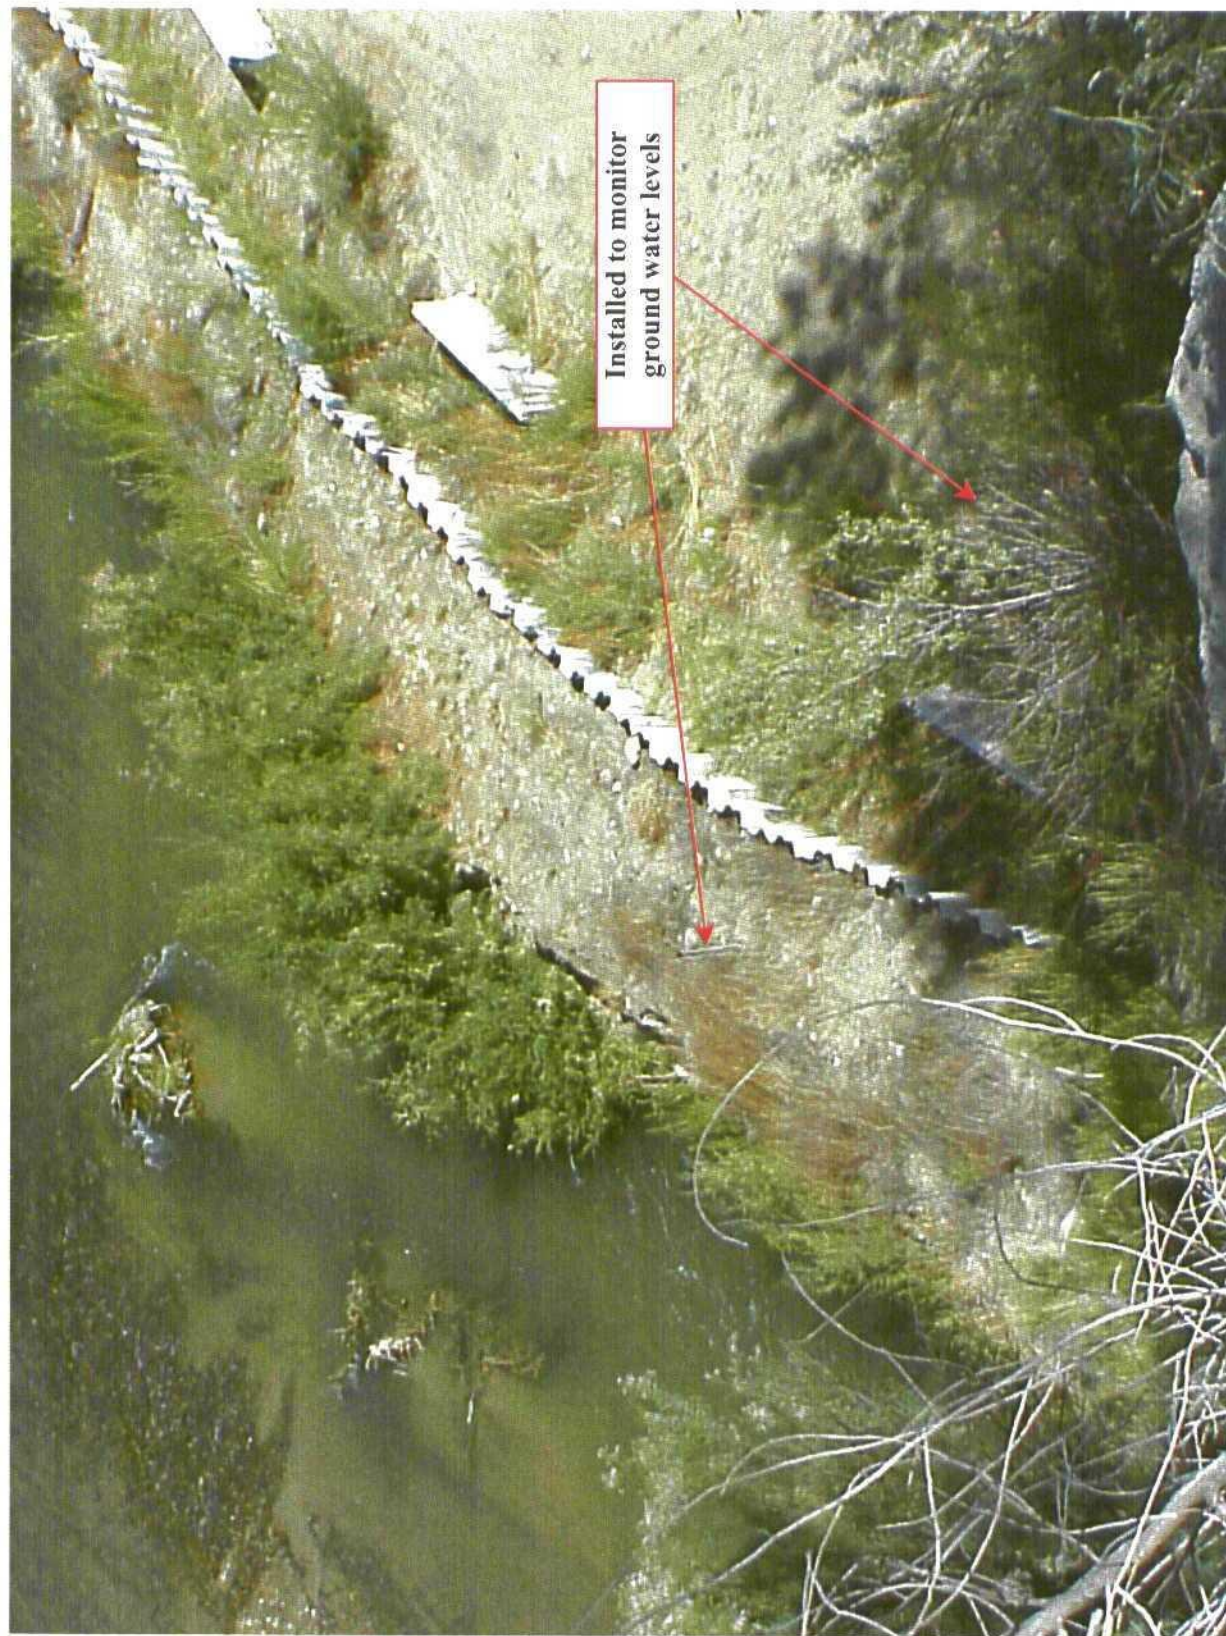
San Juan River Sheet Piling and Slurry Wall with Monitoring Points

Sheet pilings and a bentonite clay slurry wall have already been installed between the western edge of the gravel bar and the San Juan River. This barrier was constructed after some SPH was observed at the seeps along Jackson Terrace. The base of the slurry wall was placed within the low permeability Nacimiento Formation that underlies the more permeable sand and gravel. The sheet pilings are located just behind the slurry wall, only 5 to 10 feet from the river's edge, and extend to the water make-up ponds. Both barriers will be left in place so they will continue to prevent any seepage of SPH into the San Juan River.

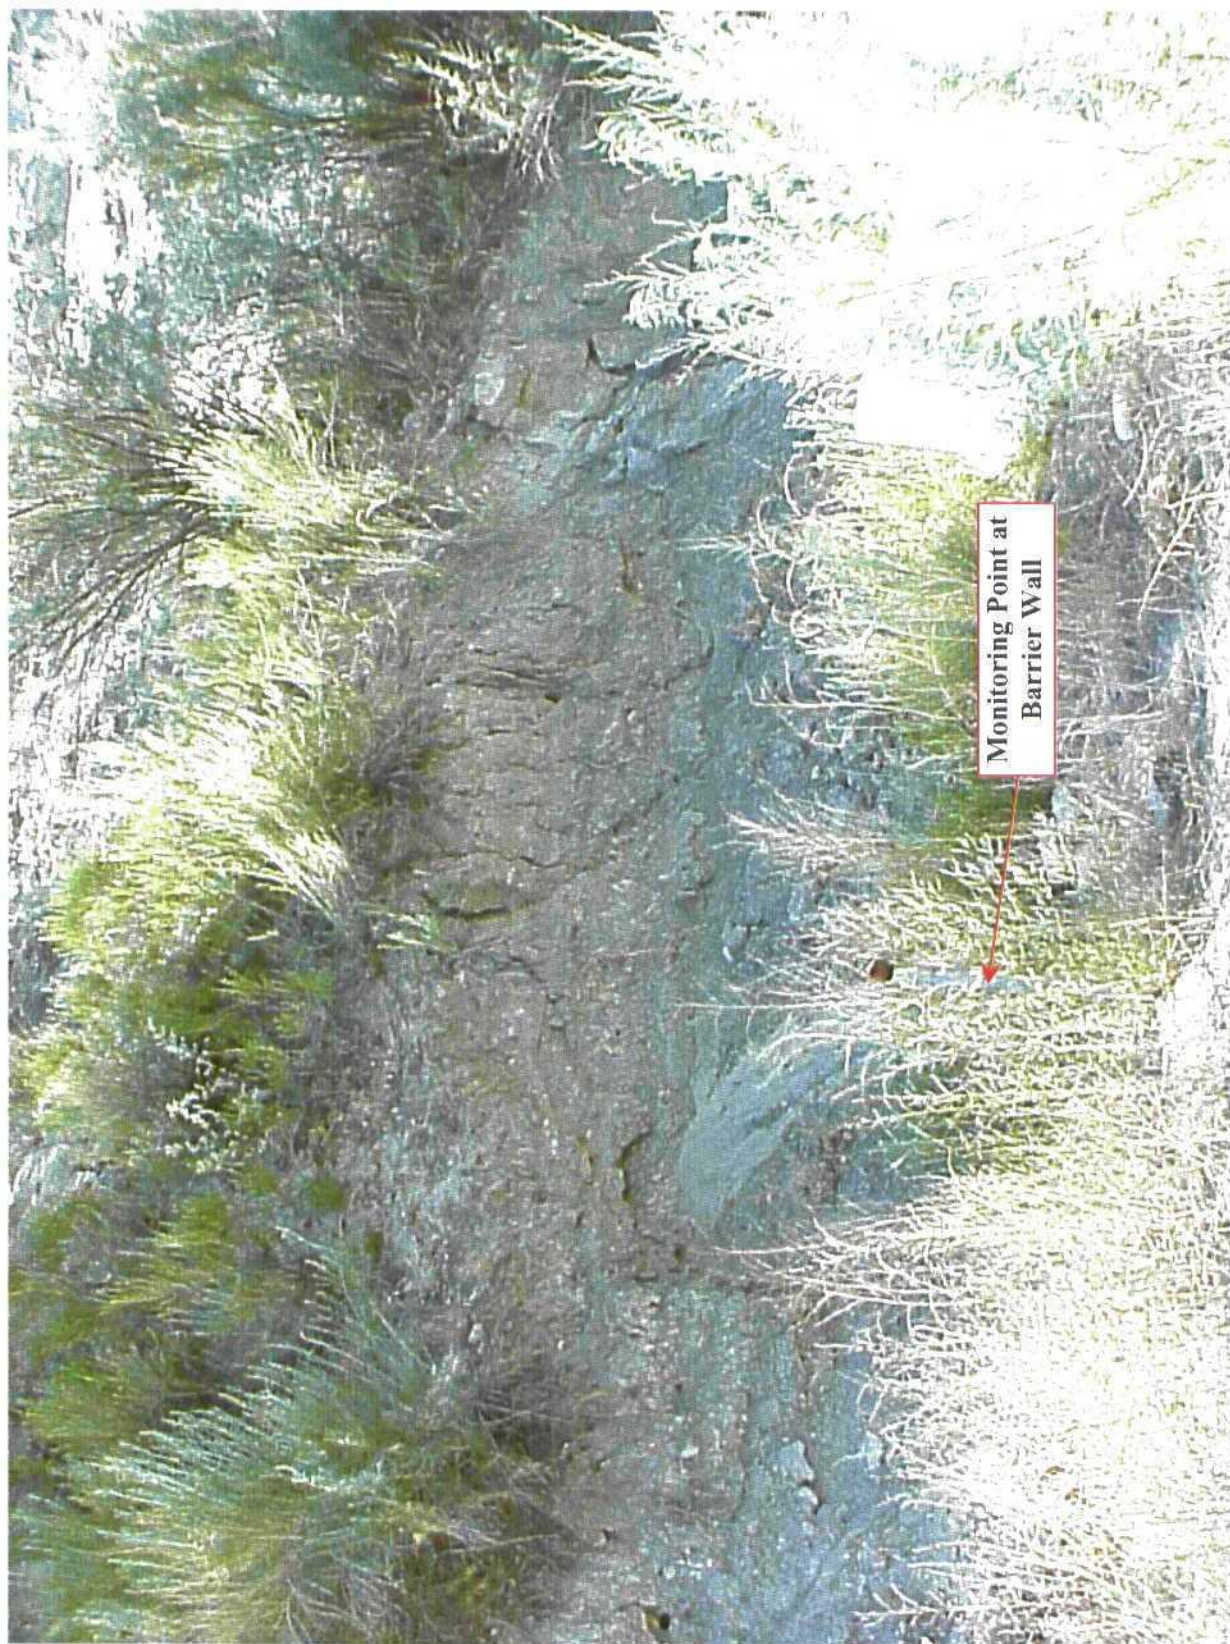
Close-up of Monitoring Point Adjacent to Sheet Piling

For SPH containment, the effectiveness of the hydraulic barrier between the San Juan River and the alluvial sediments will be monitored with two permanent piezometers installed in drive-point wells. Semiannually refinery personnel will measure water levels and SPH thickness in each of the two piezometers. If contaminants are observed in the piezometers on the San Juan River side of the barrier, refinery personnel will collect San Juan River samples around the perimeter of the barrier for total benzene, toluene, ethyl benzene, xylene, (BTEX) and naphthalene. Additionally, at regular intervals, inspections will be conducted by refinery personnel on Seeps 2 and 3 for product.
