WORK PLANS

SUPPLEMENT TO BLOOMFIELD REFINERY DISCHARGE PLAN APPLICATION, SITE INVESTIGATION AND ABATEMENT PLAN CMS

September 2002

**RE: Corrective Measures Study (Site Investigation and Abatement Plan)
Giant Refining Company, Bloomfield Refinery
EPA ID# NMD089416416
HWB-GRCB-01-001**

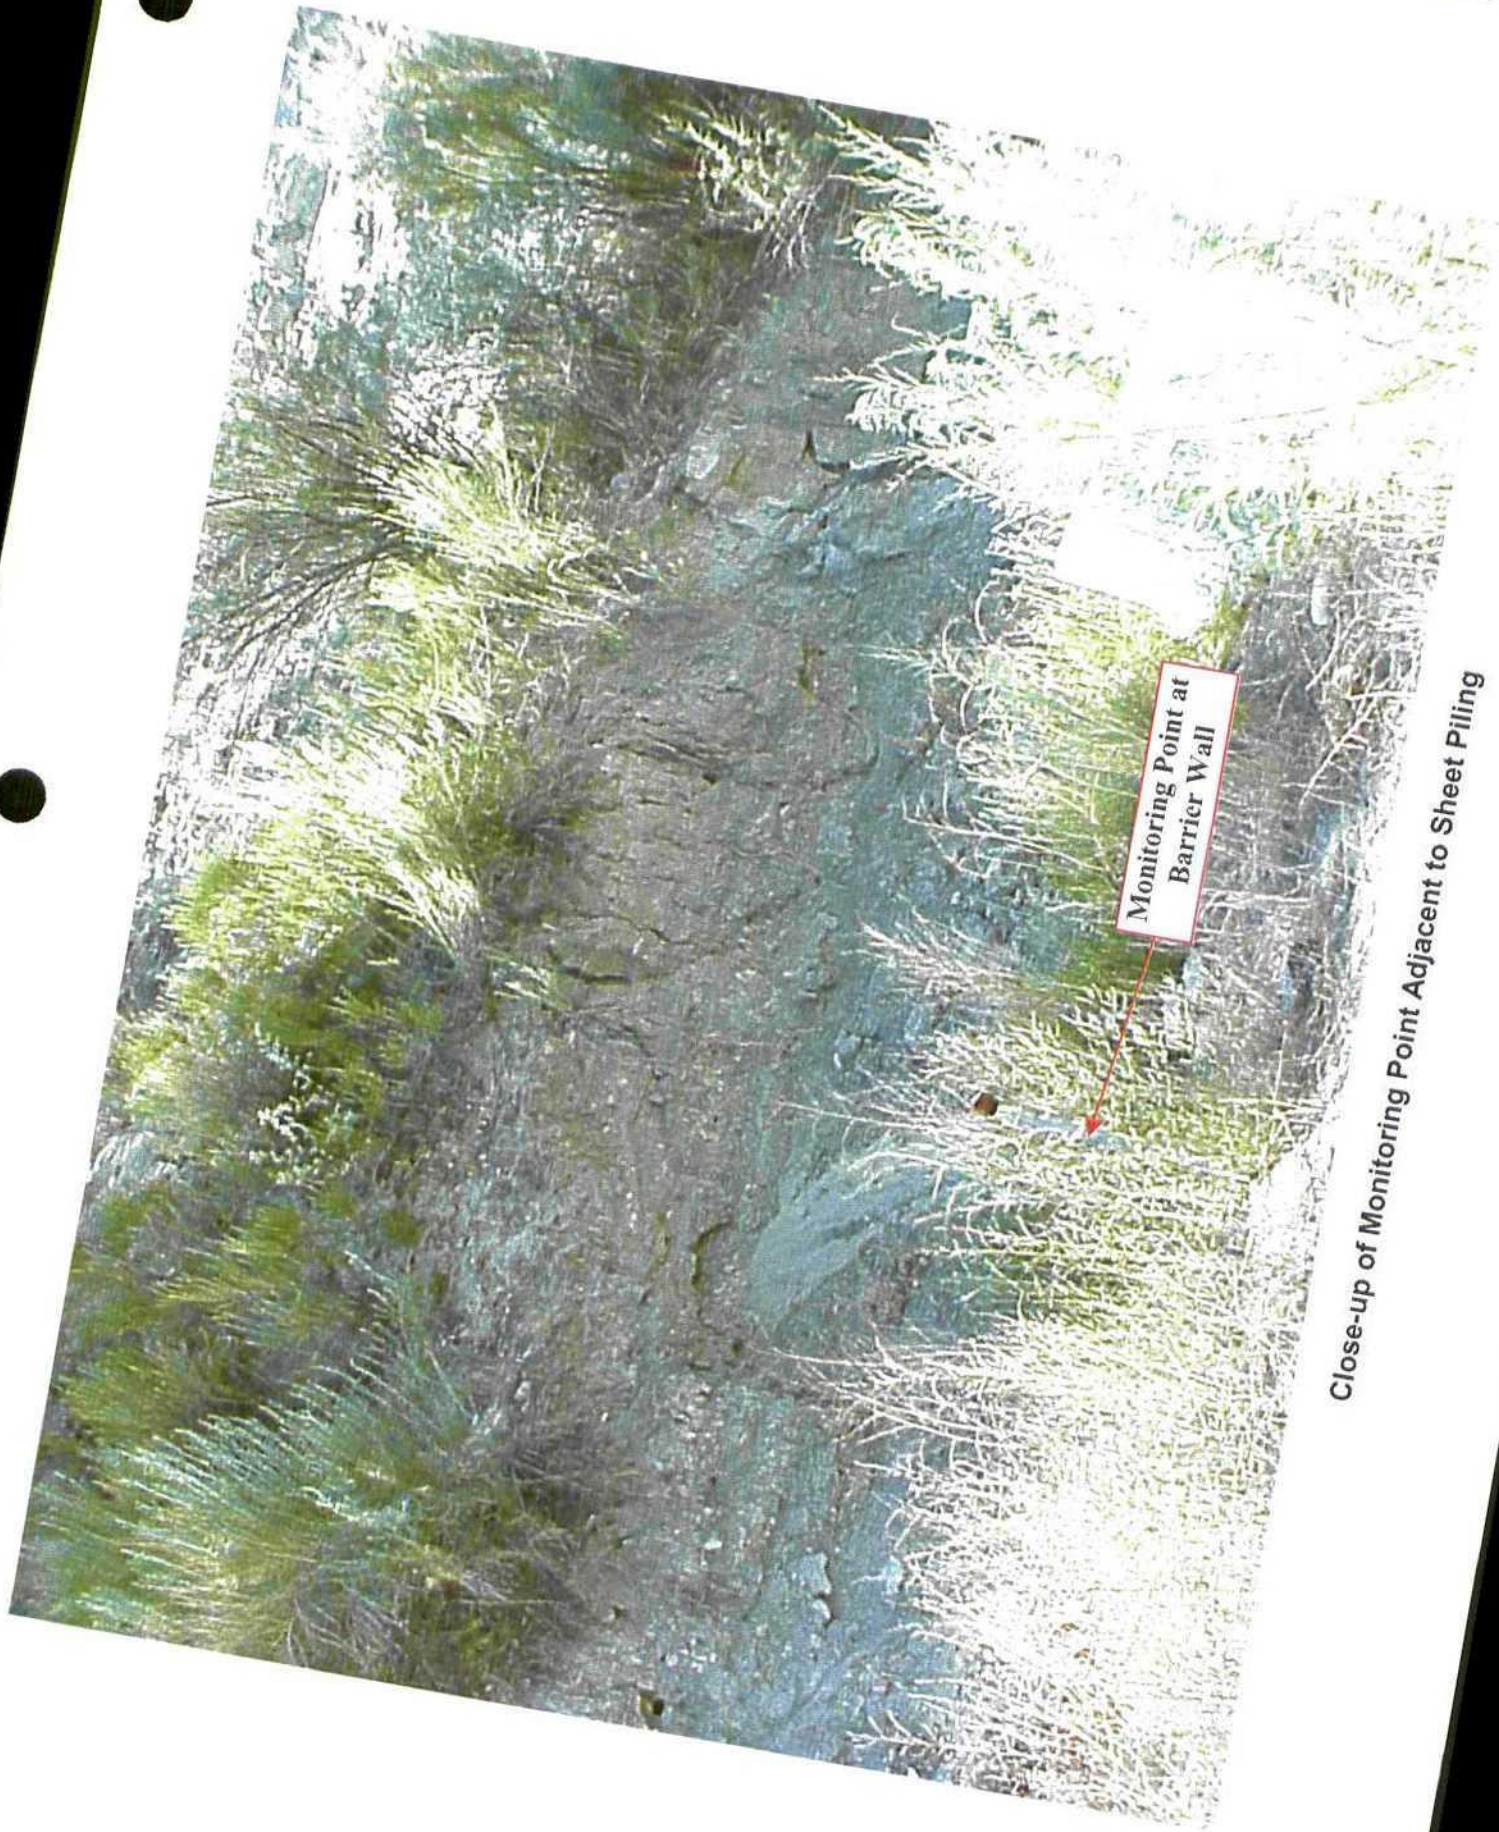
Close-up of Monitoring Point Adjacent to Sheet Piling

This attachment includes two 8 ½" by 11" copies of photographs of the monitoring points at the San Juan River sheet piling and an 11" by 17" copy of a site plan with these points highlighted. These monitoring points are also mapped in the site plan provided in Attachment 1. The Monitoring and Sampling Work Plan (Attachment 6) identifies the plan for the requested sampling at these points.

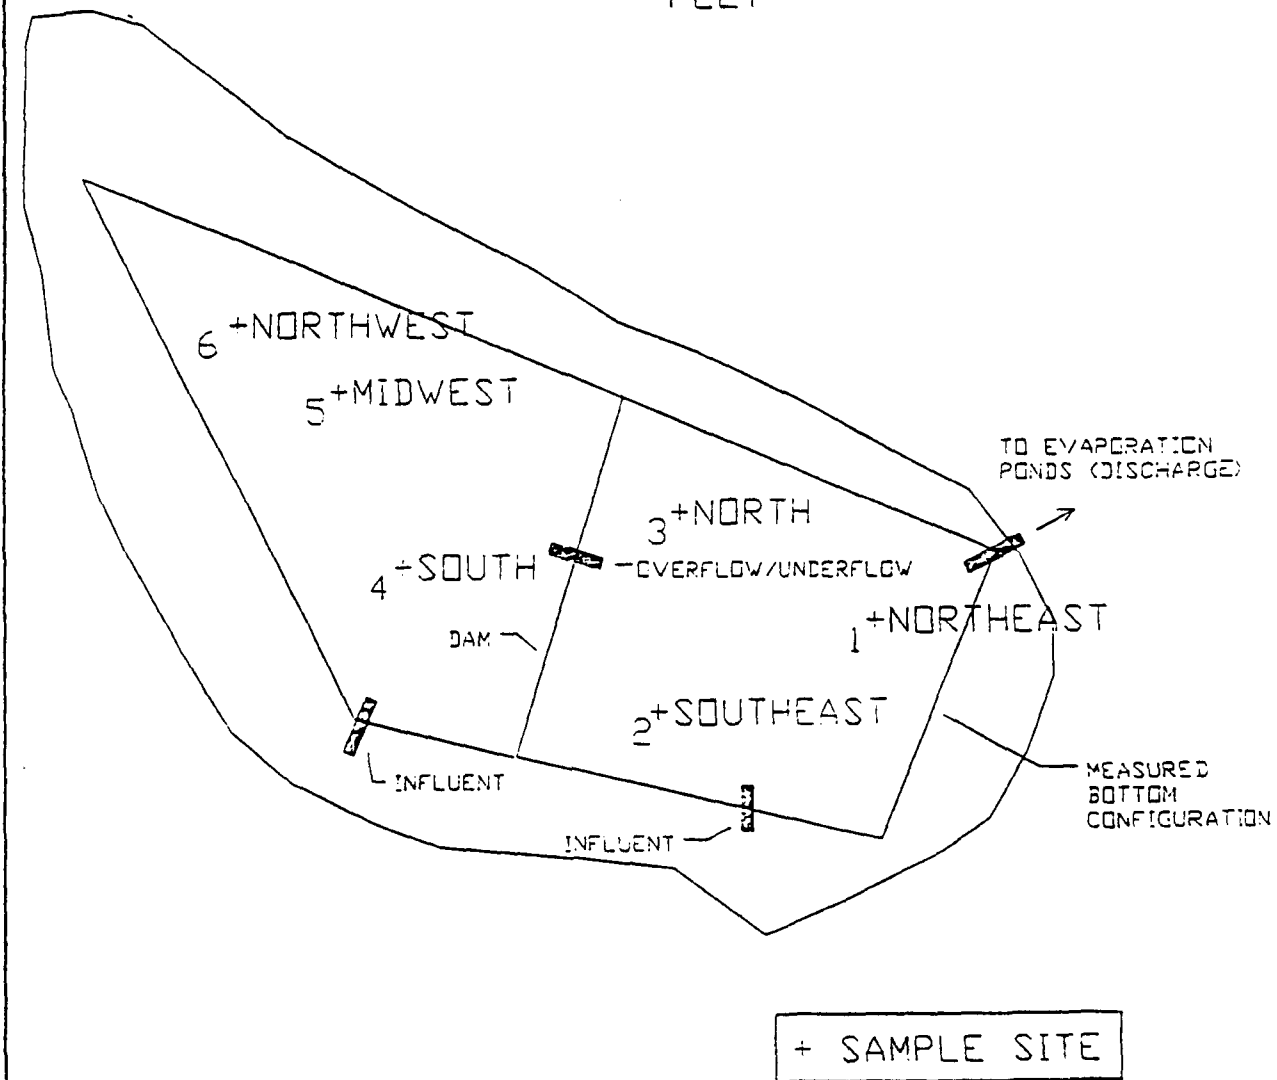
FIGURE 3 SOUTH API POND

In the south API wastewater pond, a single grab sample collected in the top 6 inches near the influent end of the pond was analyzed for the "Skinner List" of compounds expected to be present in petroleum refinery wastes. This list and the analytical methods being used are presented in Table 1. None of the "Skinner List" constituents were present at detectable concentrations in this sample.

The analytical data presented in Appendix B indicates no appreciable residual contamination in the top 12 inches immediately beneath the ponds. Based on this finding, and the removal of material from the ponds as documented in Appendix A, closure of the API wastewater ponds should be deemed complete.

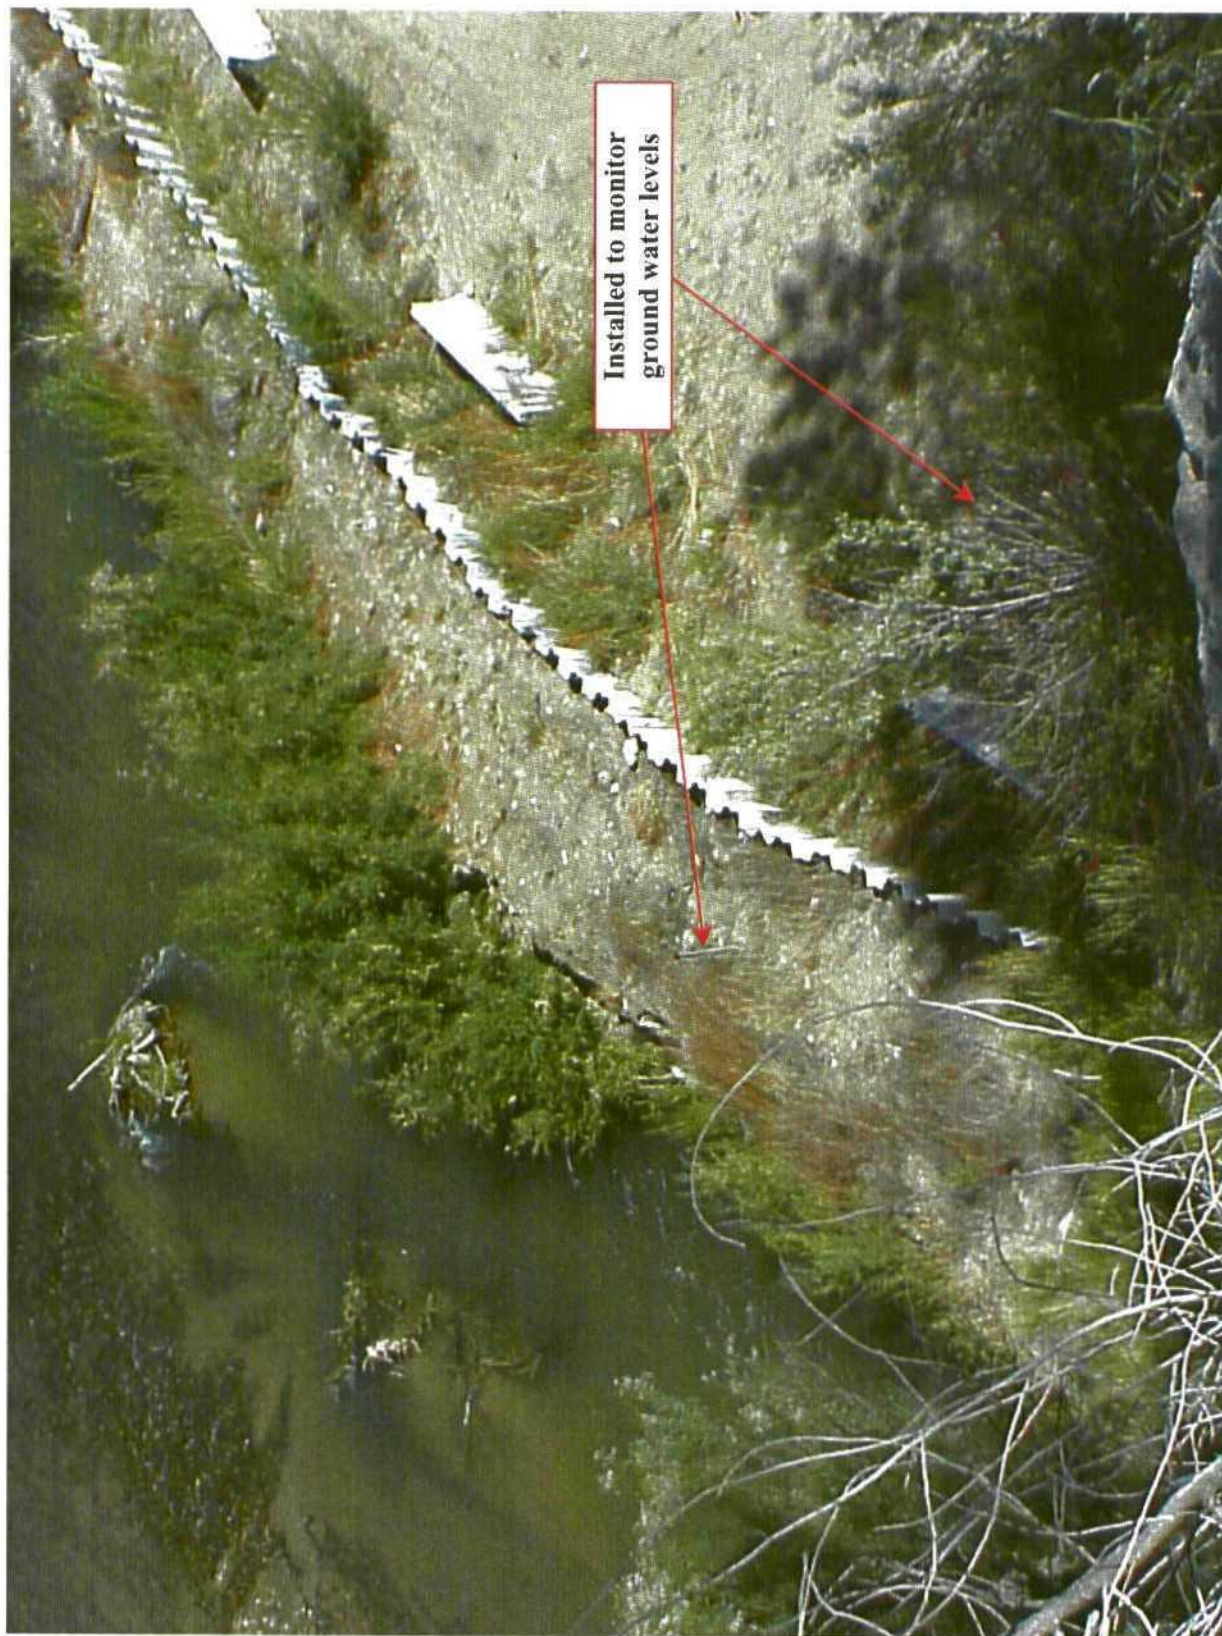
San Juan River Sheet Piling and Slurry Wall with Monitoring Points

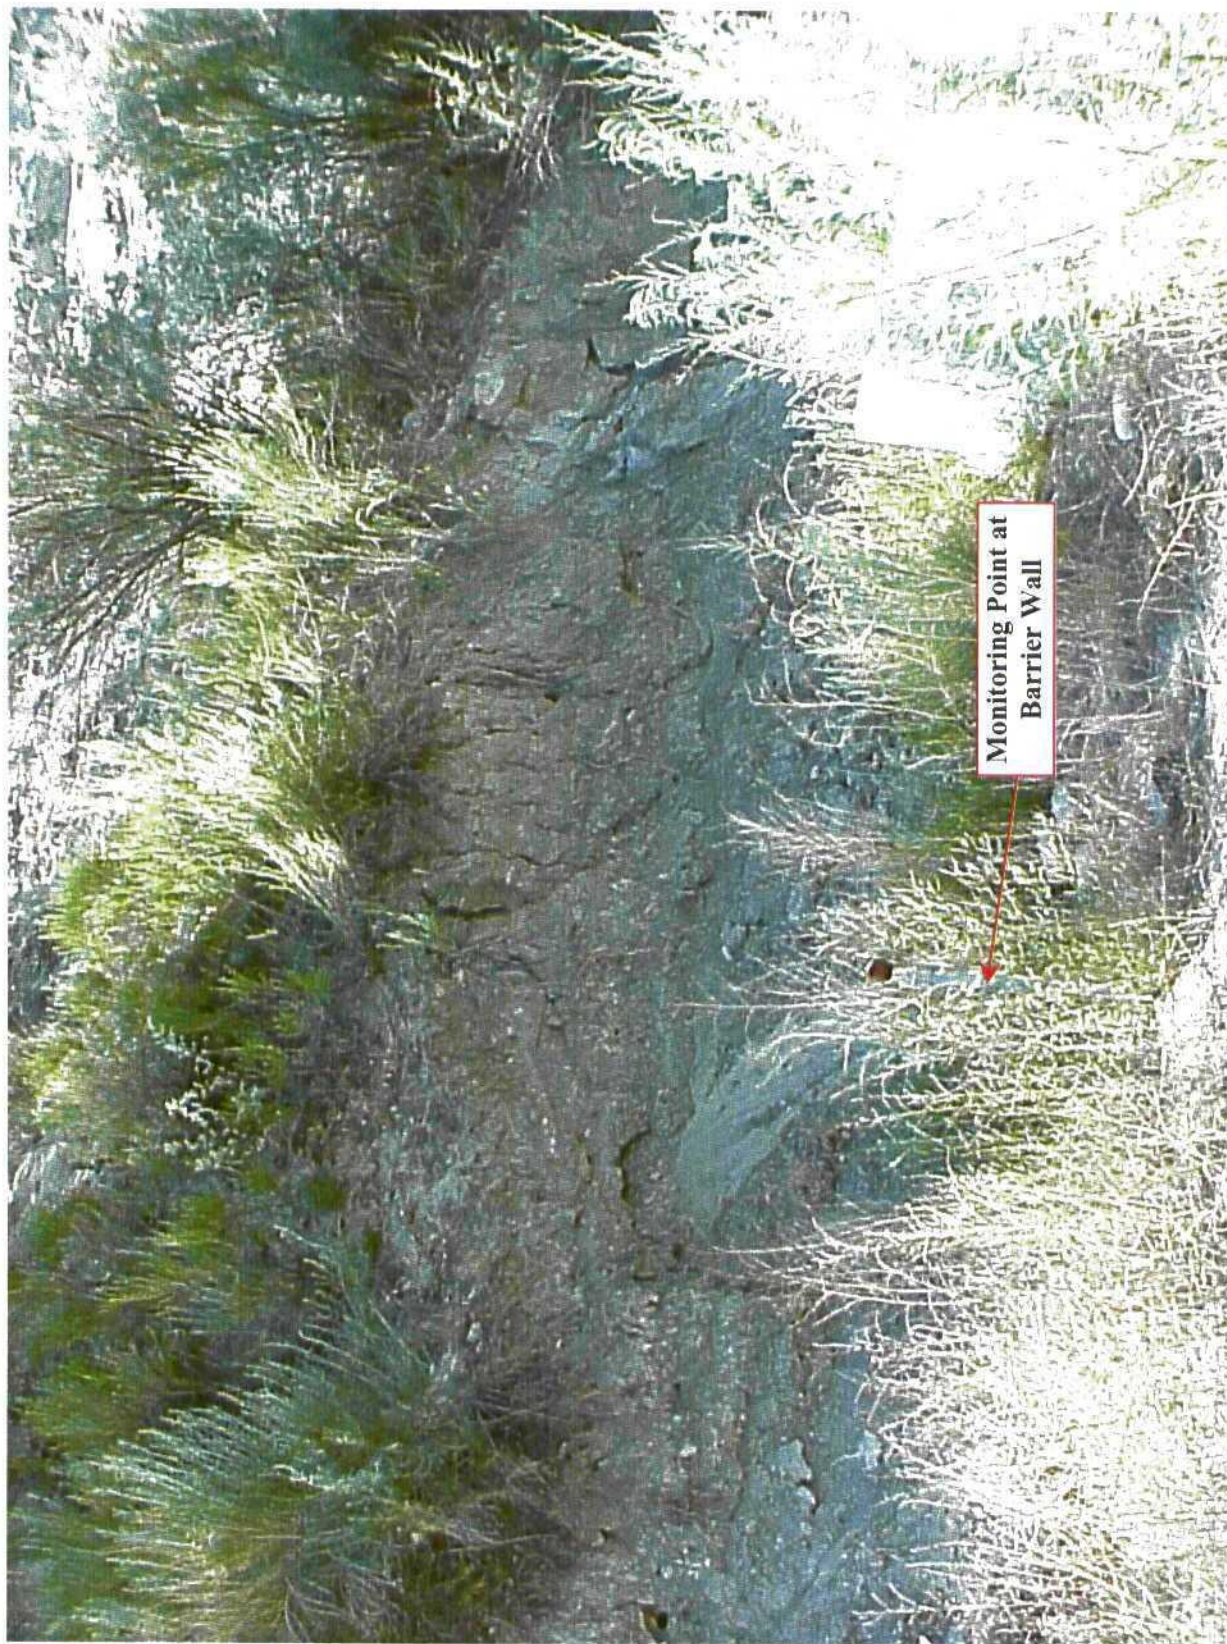
Close-up of Monitoring Point Adjacent to Sheet Piling

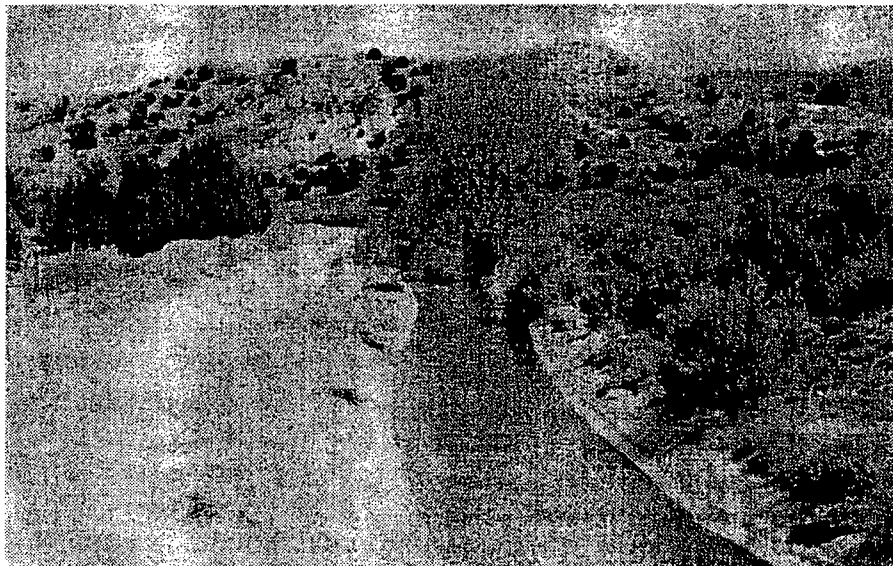
Existing lined section in foreground, unlined in background.

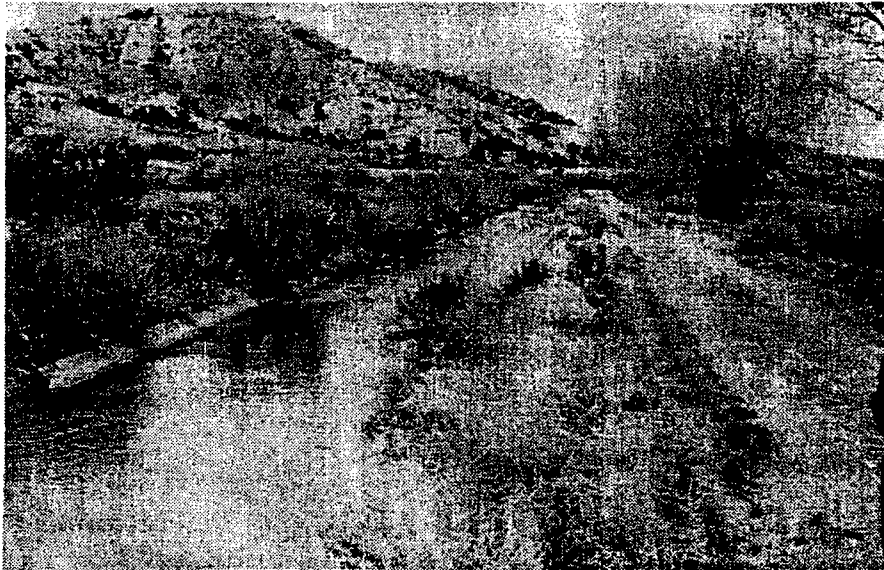
Existing lined portion of Main Canal with rabbitbrush, willows, and cottonwoods.
