IR-426-23

**RICE OPERATING COMPANY  
JUNCTION BOX FINAL REPORT**

## BD jct. M-26

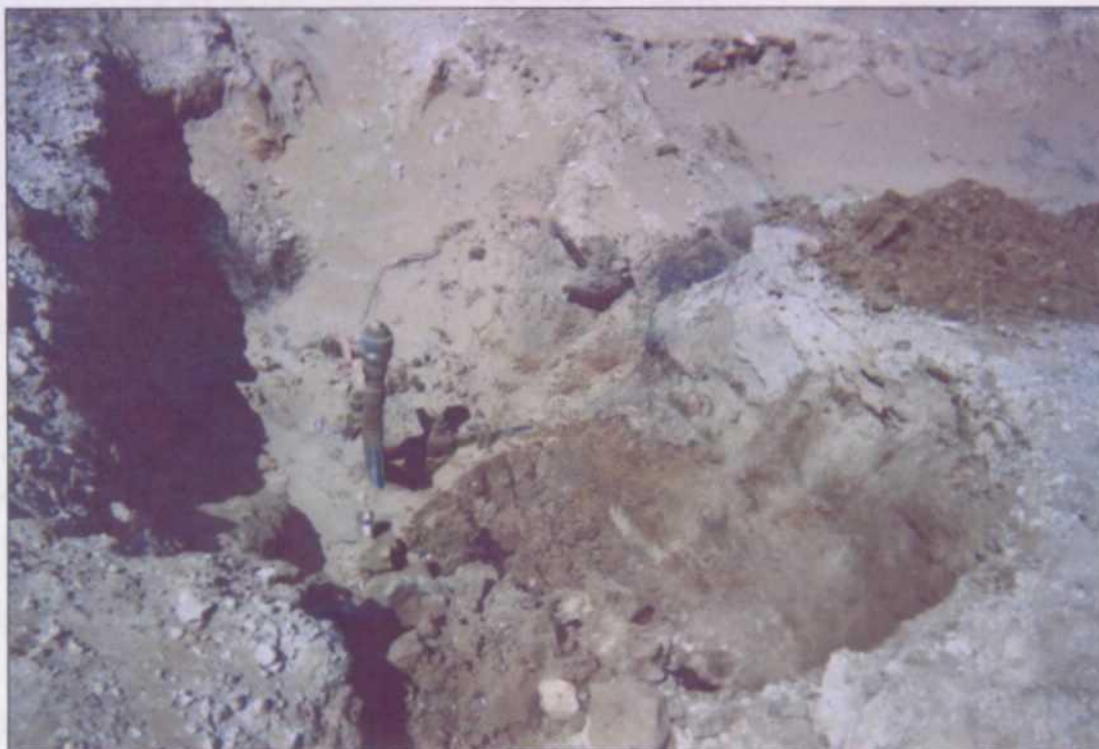
Before Excavation, After NORM Removal

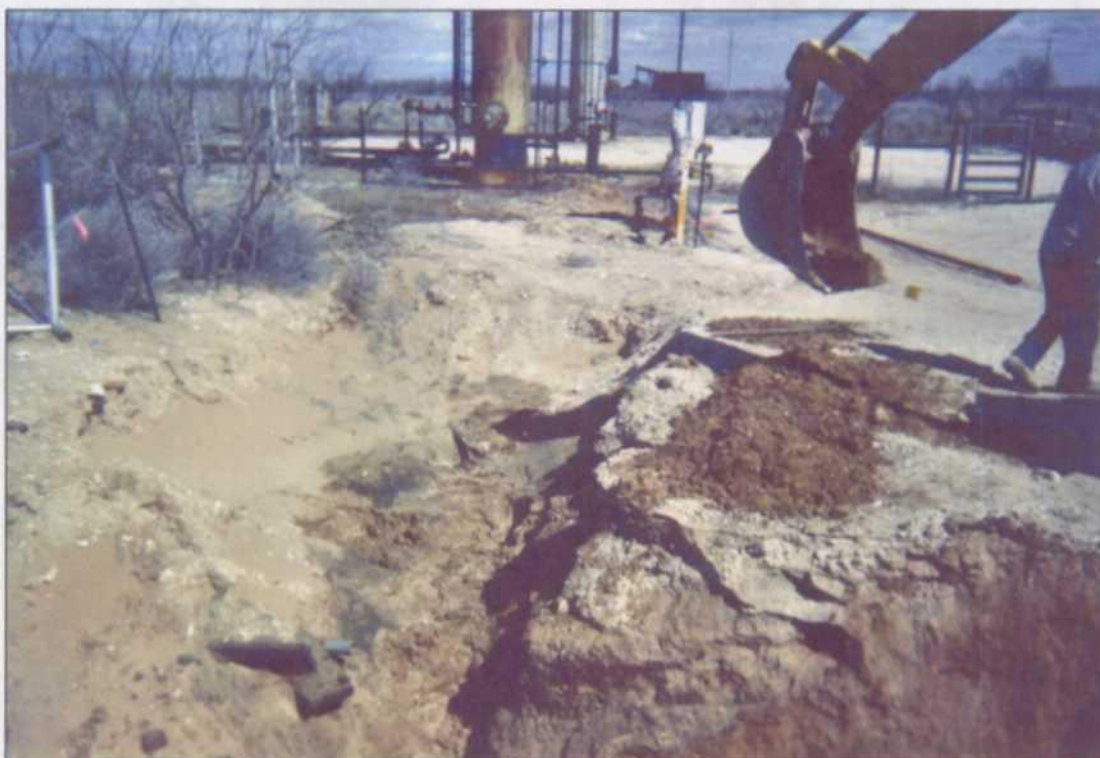
Beginning Impact Excavation

**General Description of Remedial Action:** This junction was located about 20' south of an active production facility. The site was delineated vertically and laterally producing a 24' x 25' x 10' excavation as space allowed. Chloride impact exhibited a significant decline with depth. TPH was below NMOCD guidelines. A 1' compacted clay barrier was installed at the bottom to hinder vertical migration of residual impact. The excavated soil was land farmed on location and then backfilled into the clay-lined hole. A water-tight junction box has been built over this location.

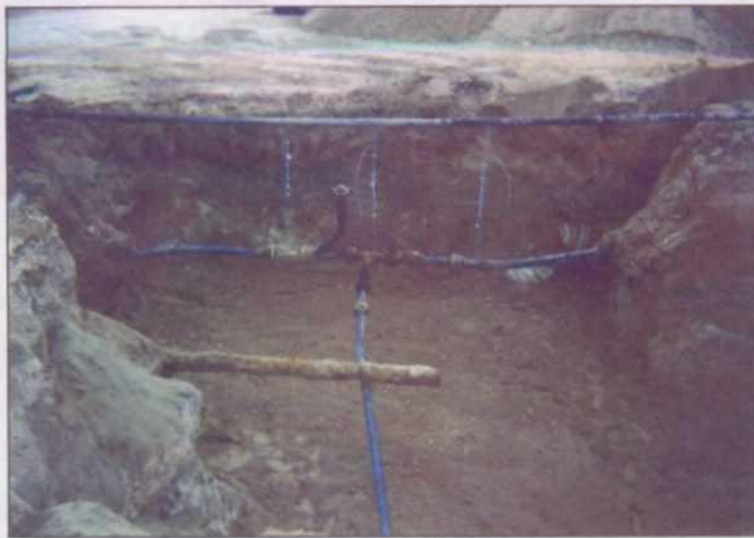
Impact Excavation

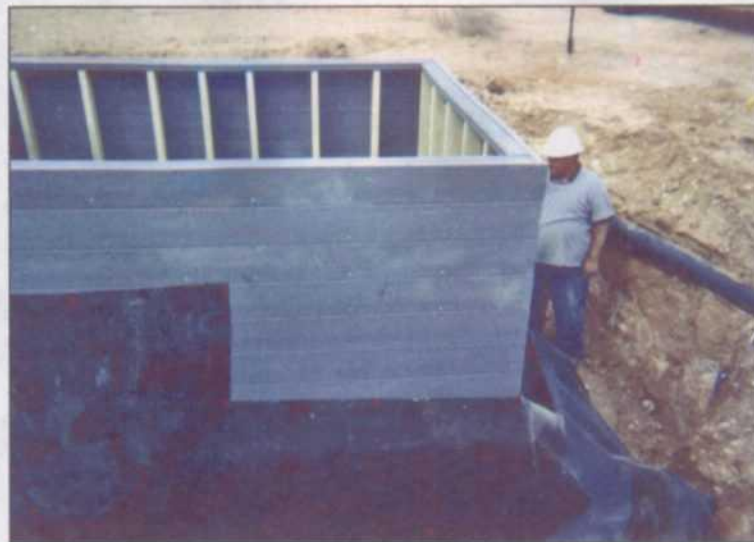
Box Construction With Plastic Liner

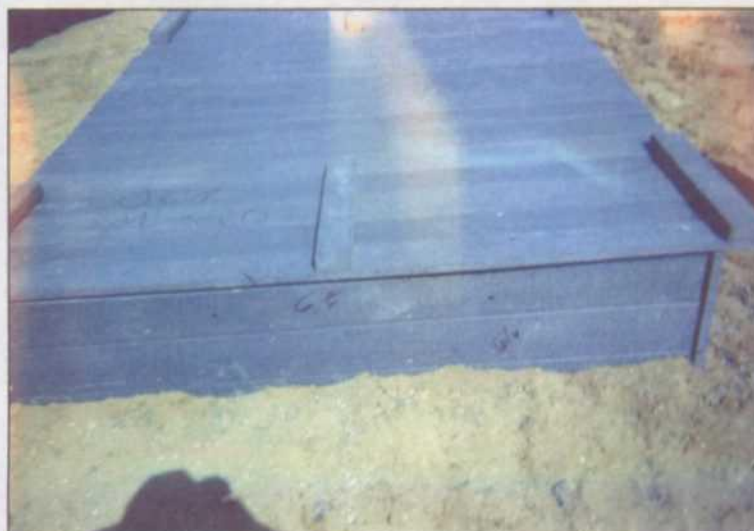
Completed New Junction Box
