# FINAL REPORT

**RICE OPERATING COMPANY  
JUNCTION BOX FINAL REPORT**

| SWD SYSTEM | JUNCTION | UNIT | SECTION | TOWNSHIP | RANGE | COUNTY | BOX DIMENSIONS - FEET | | |
|---|---|---|---|---|---|---|---|---|---|
| Blinebry-Drinkard | K-17 | K | 17 | 21 S | 37 E | Lea | under construction | | |

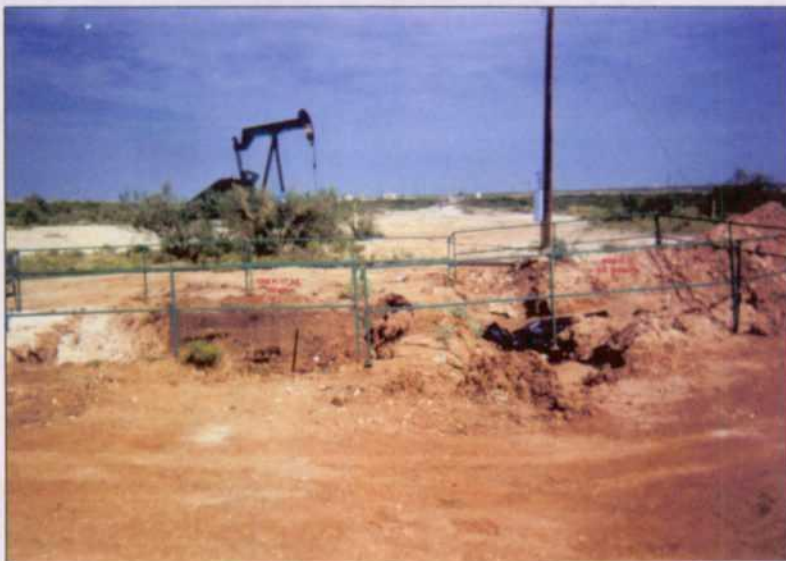
After NORM Removal

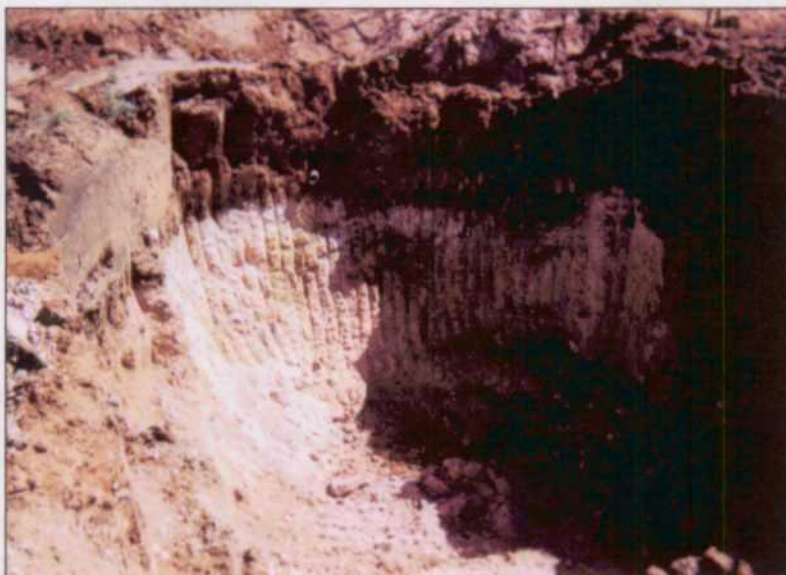
**General Description of Remedial Action:** The soil directly below the junction box was visibly TPH-impacted to 10 ft BGS. ROC conducted a soil bore at the location on 9/9/02 and found that chloride impact started to dissipate around 75 ft. At 100 ft, returns tested 450 ppm chlorides but no water was ever encountered. A 30' x 30' area was excavated down to 12 ft to completely remove visible TPH. A 1 ft clay liner was installed at 12 ft. The excavated soil was landfarmed on location until the soil field tested a composite of 1710 ppm TPH. The soil was then backfilled into the excavation and contoured to control water flow and mimic the natural contours of the landscape. Any remaining hydrocarbons will naturally attenuate. A water-tight junction box has been built at the location.

Impact Excavation

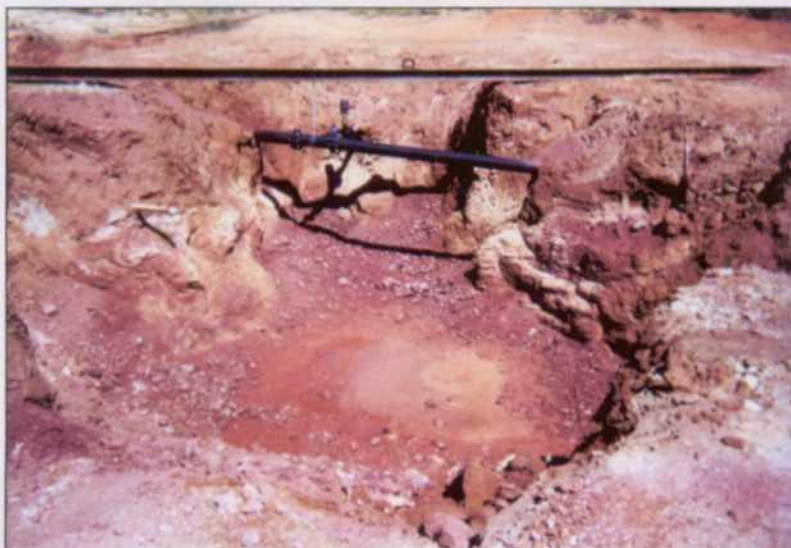
Clay Liner in Excavation
