# DISCLOSURE REPORT

**RICE OPERATING COMPANY  
JUNCTION BOX CLOSURE REPORT**

## BD jct. F-29-1 (North)

**Project:** Jct. F-29-1

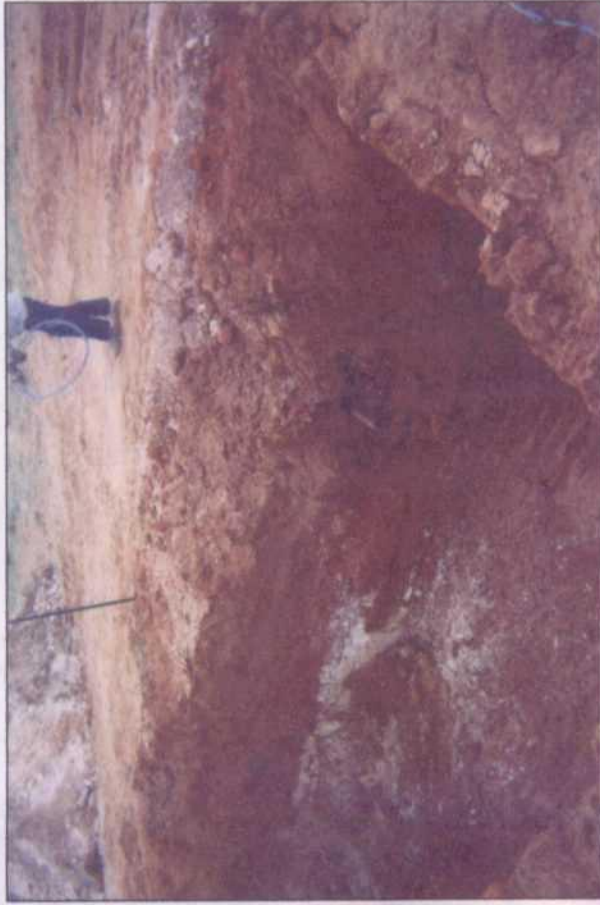
Excavation—March 2003

General Description of Remedial Action: This is the northernmost box of two that were next to each other. The junctions have been eliminated and a new watertight box has been built over a new junction 150 ft north of this one. A bottom composite of the 20 x 10 x 6 ft deep excavation yielded TPH concentrations well below NMOCD guidelines and chloride was minimal considering the depth to groundwater. The excavation has been backfilled and contoured to the surrounding terrain. The disturbed surface is expected to natural to productive capacity at a normal rate.

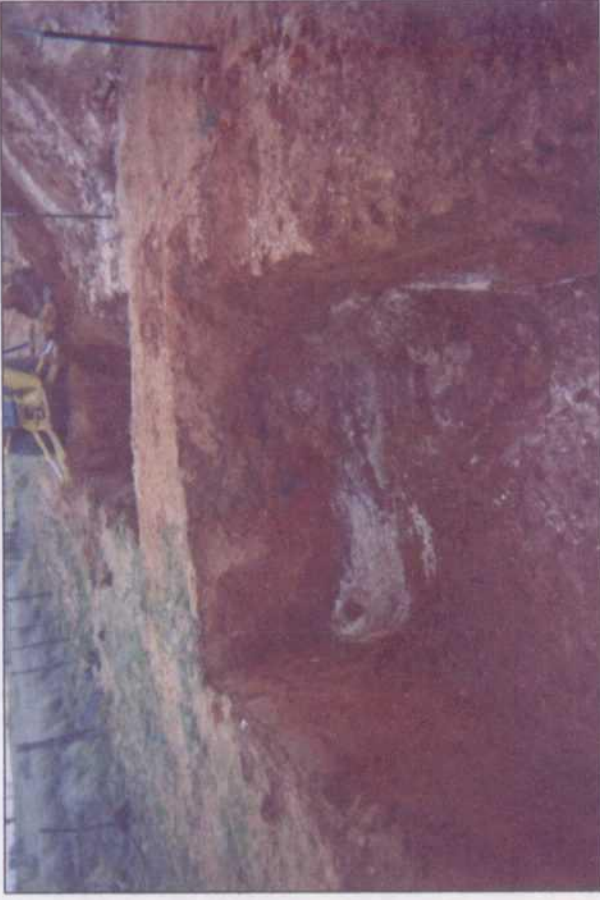
Final Excavation (F-29-1 in foreground)—March 2003

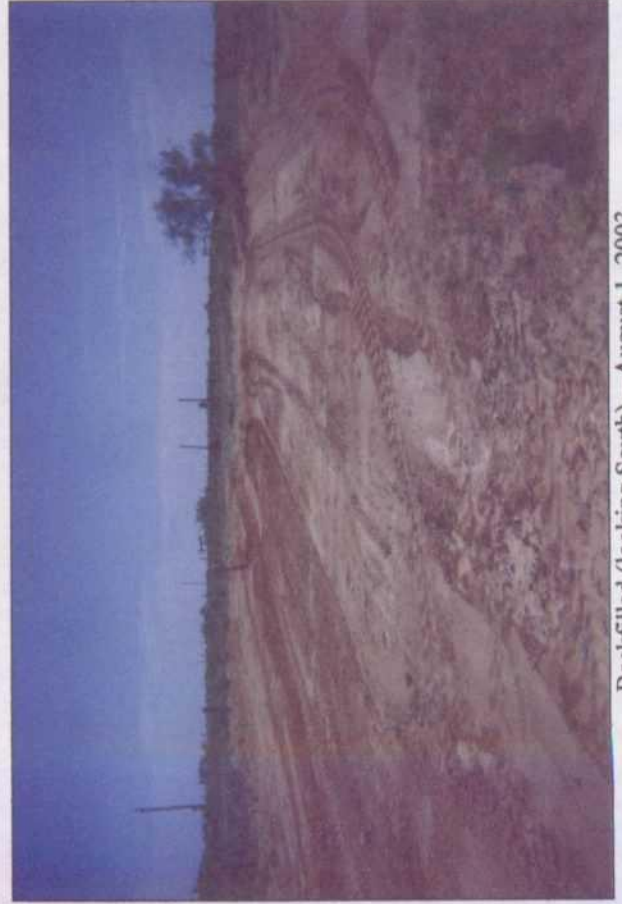
Backfilled (looking South)—August 1, 2003

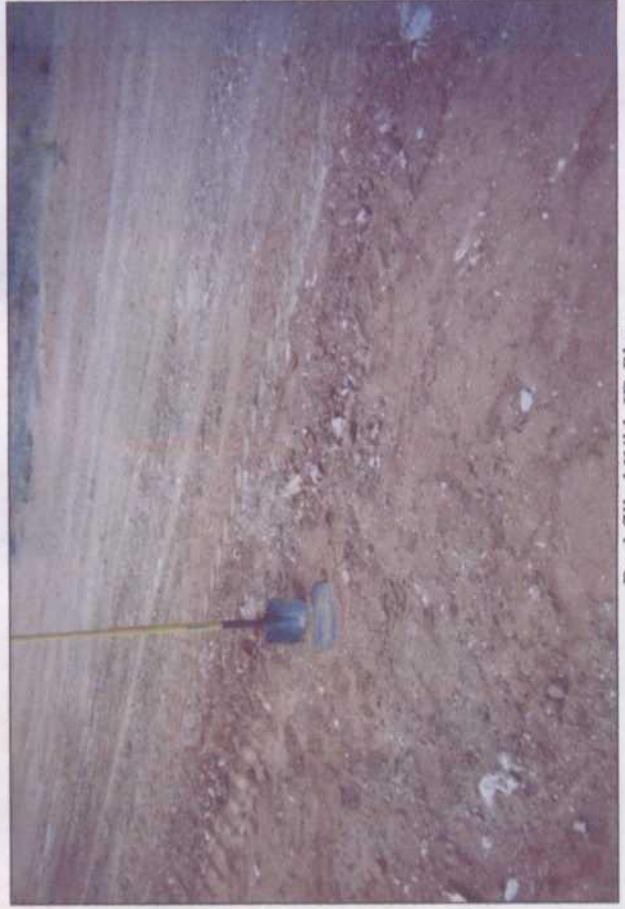
Backfilled With ID Plate
