1R - 449

The Final Closure Report for Dynegy Midstream Services, L.P. Site #55 (OCD Case #1R0449) is attached, along with the corresponding table, photos, and laboratory analysis.

**Re: Final Closure Report, OCD Case # 1R0449**  
**Dynegy Midstream Services, L.P., Unit Letter H (SE/4, NE/4), Section 19, Township 22**  
**South, Range 38 East, Lea County, New Mexico**  
**Latitude: North 32°, 22.677'; Longitude: West 103°, 05.706'**

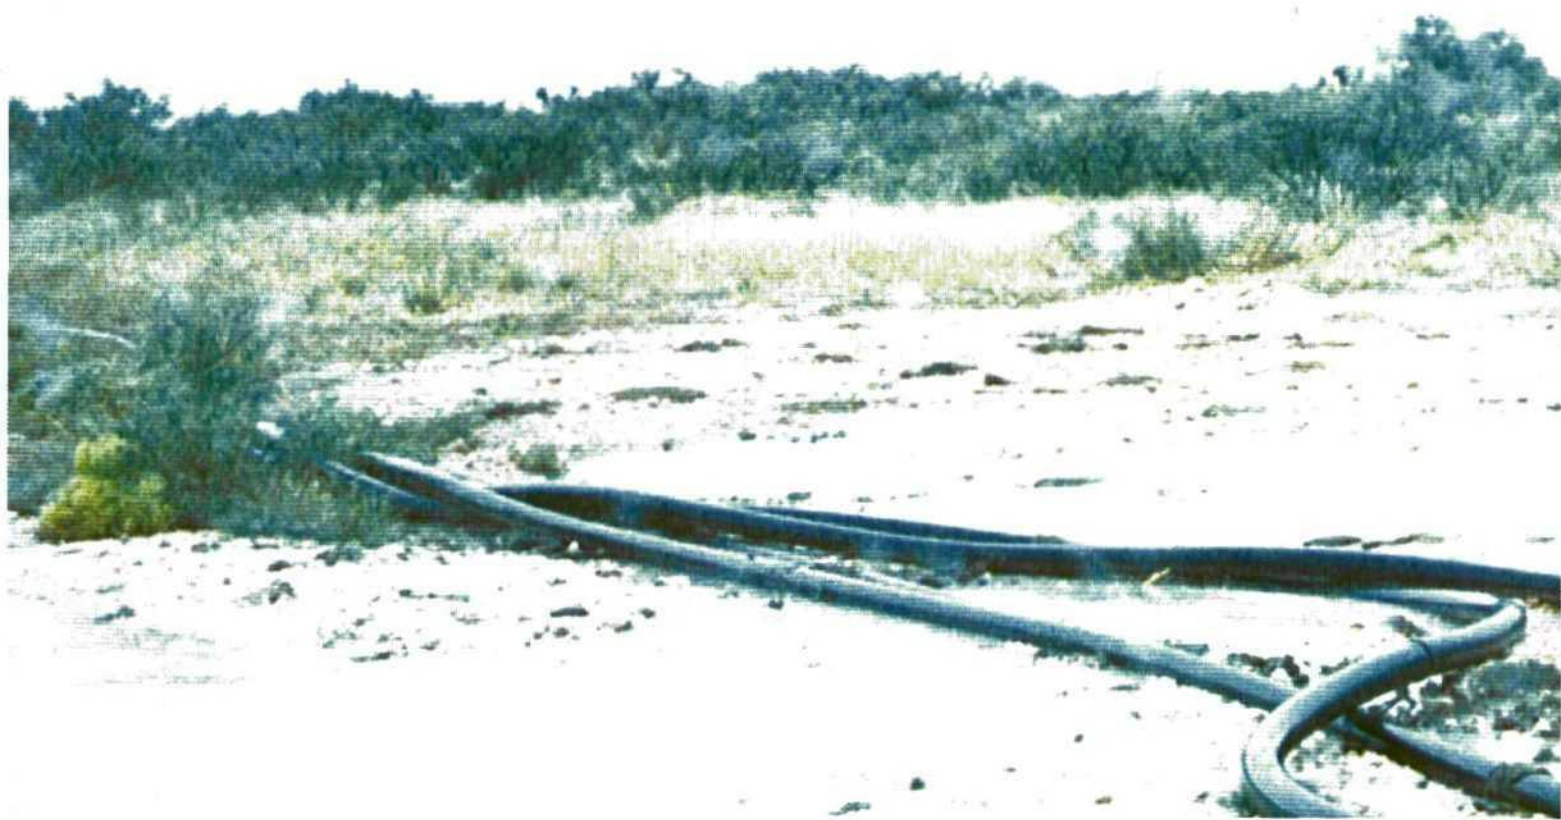
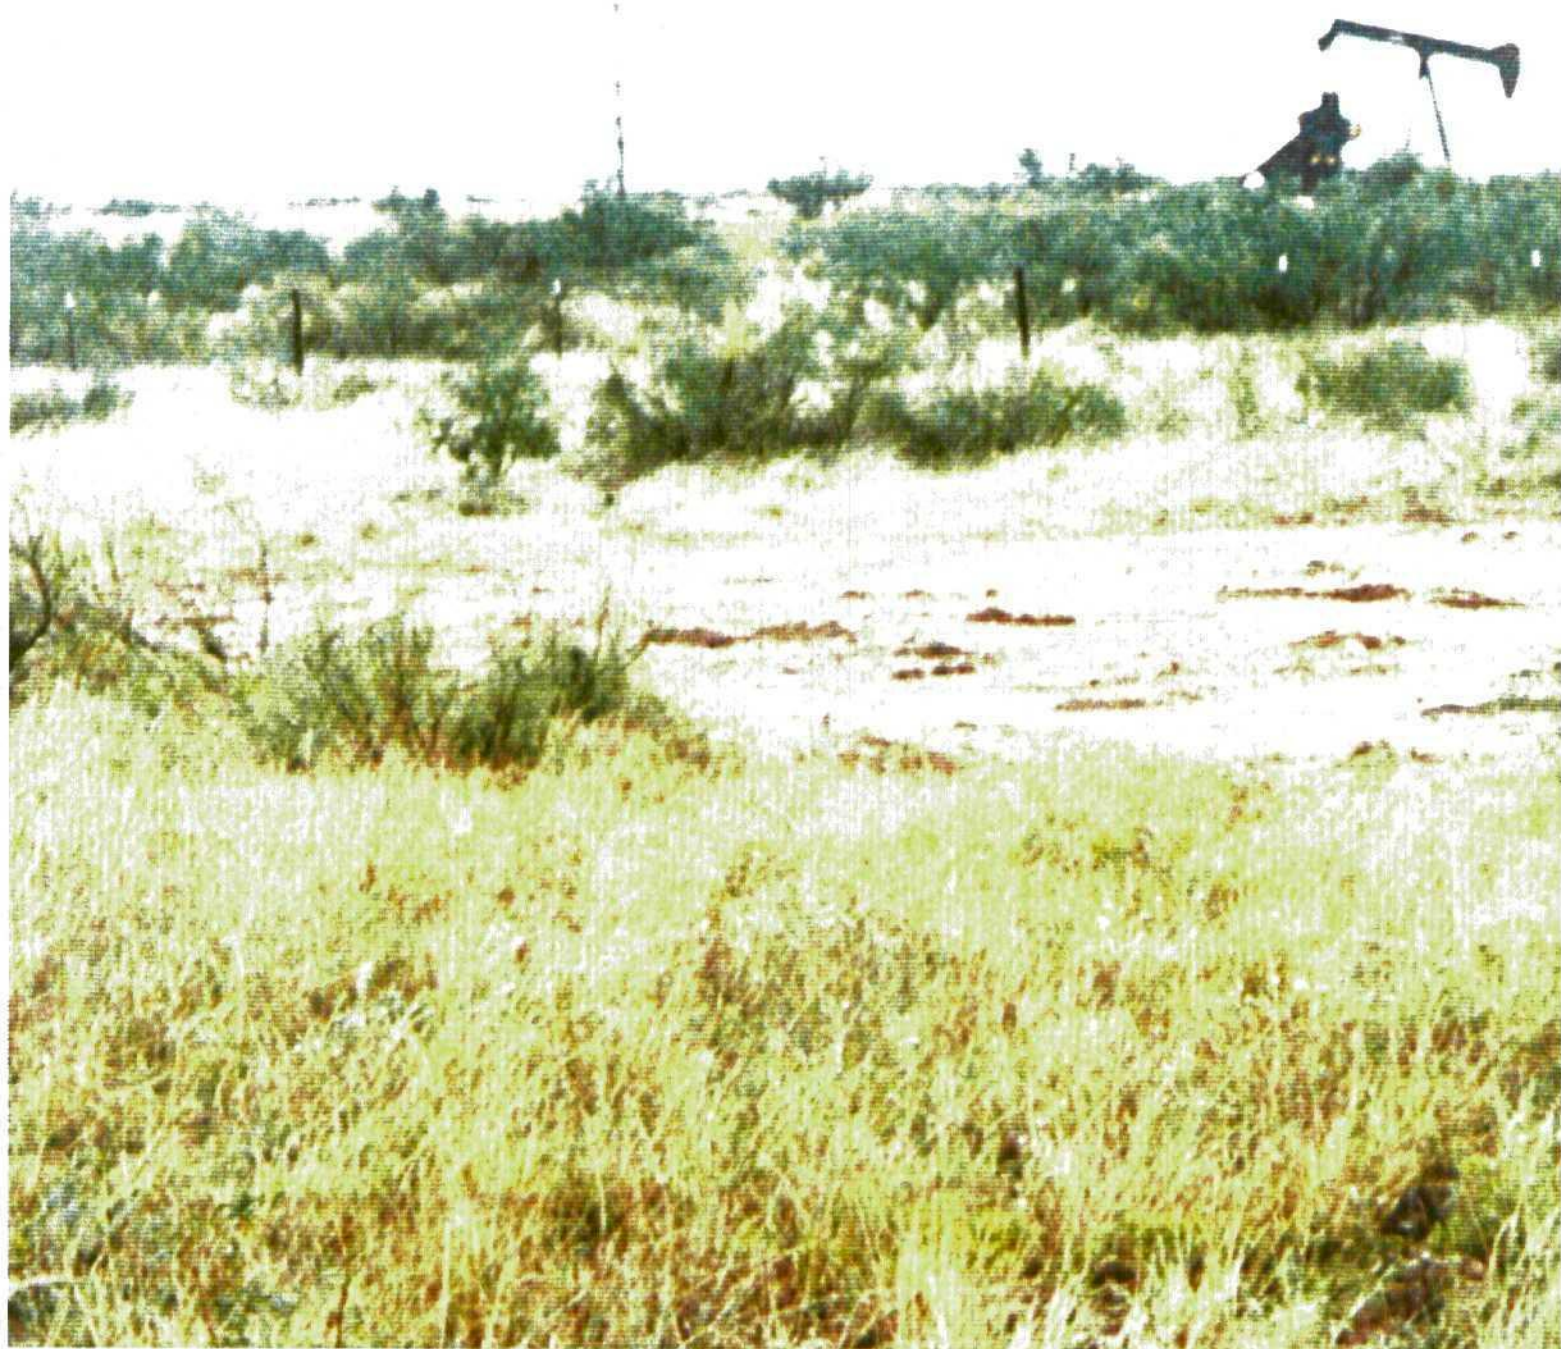
As analytical results from composite samples of the spoil pile reported TPH concentrations below 5,000 ppm (1,810.5 mg/kg and 2,010.6 mg/kg), the excavation was backfilled with a combination of excavated and clean soil on September 15, 2005. Photographs are attached that show Site #55 upon completion of all remediation activities.
