3R - 397

Project Name AZTEC PIPE YARD
Project Number 66037606

**El Paso Field Services Company
Sampling Plan for the Sunland Construction Co. Yard
(Formerly EPFS Aztec Pipeline Yard)**

Sunland Construction Co.
(Former El Paso Field Services Co. Aztec Pipeline Yard)
816 Aztec Blvd. NE
Aztec, NM 87410

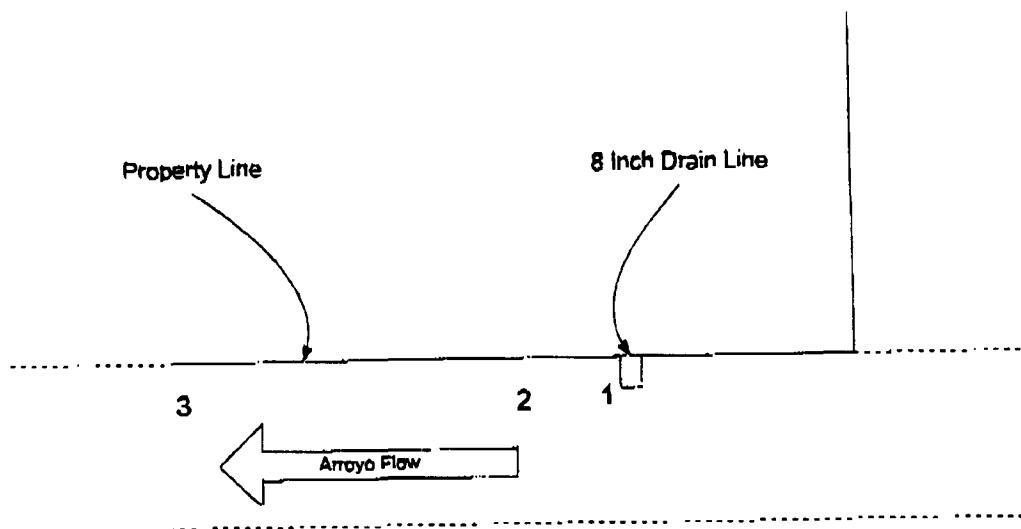
Proposed Sample Points:

Using the services of a third party contractor, collect a total of six (6) soil samples from three (3) locations within the arroyo (see attached diagram). All samples will be collected by using a hand auger. Sample Point #1 will be below the wash rack drain line and 4 inches down stream, sample Point #2 will be 2 feet downstream from the center of the drain line, and Sample Point #3 will be 10 feet downstream from the center of the drain line.

- #1 - Below and 4 inches downstream from the center of the drainline
- #2 - 2 feet downstream from the center of the drainline
- #3 - 10 Feet downstream from the center of the drainline
