Incident ID	NRM2003760594
District RP	
Facility ID	
Application ID

Release Notification

Site Name	Becknell State Com 001H	Site Type	Tank Battery
Date Release Discovered	January 22, 2020	API# (if applicable)	30-025-41298

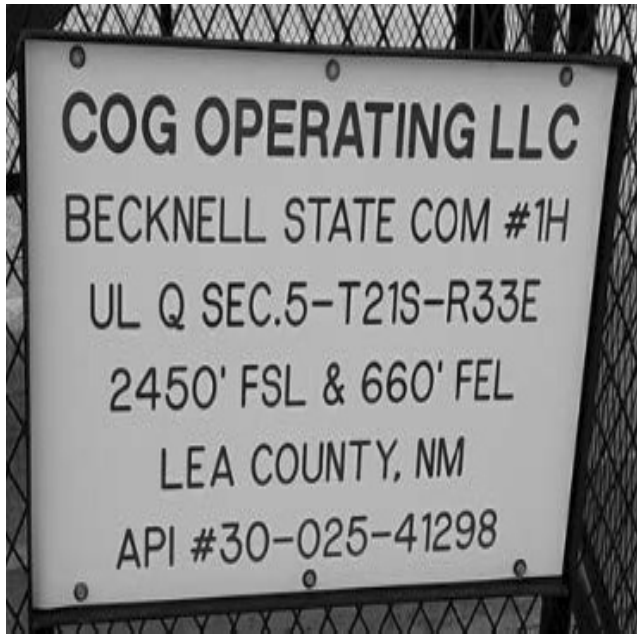
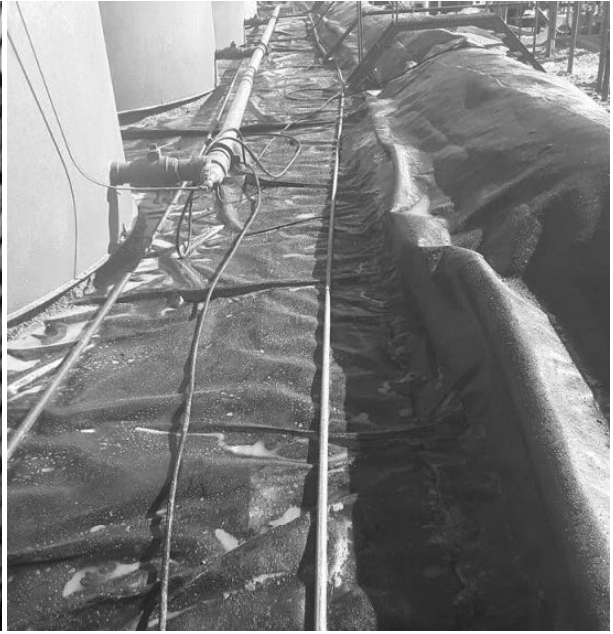
The release was caused by a tank overflow.
The release occurred within the lined facility. A vacuum truck was dispatched to remove all freestanding fluids. Concho will have the spill area evaluated for any possible impact from the release.
