Release Notification

Site Name South Blanco State 36 #006	Site Type Oil Well Site
Date Release Discovered 11/22/2019	API# (if applicable) 30-045-27639

South Blanco State 36 #006
30-045-27639
Summary of Events

South Blanco State 36 #006
SB One (5) point Composite Sample Map

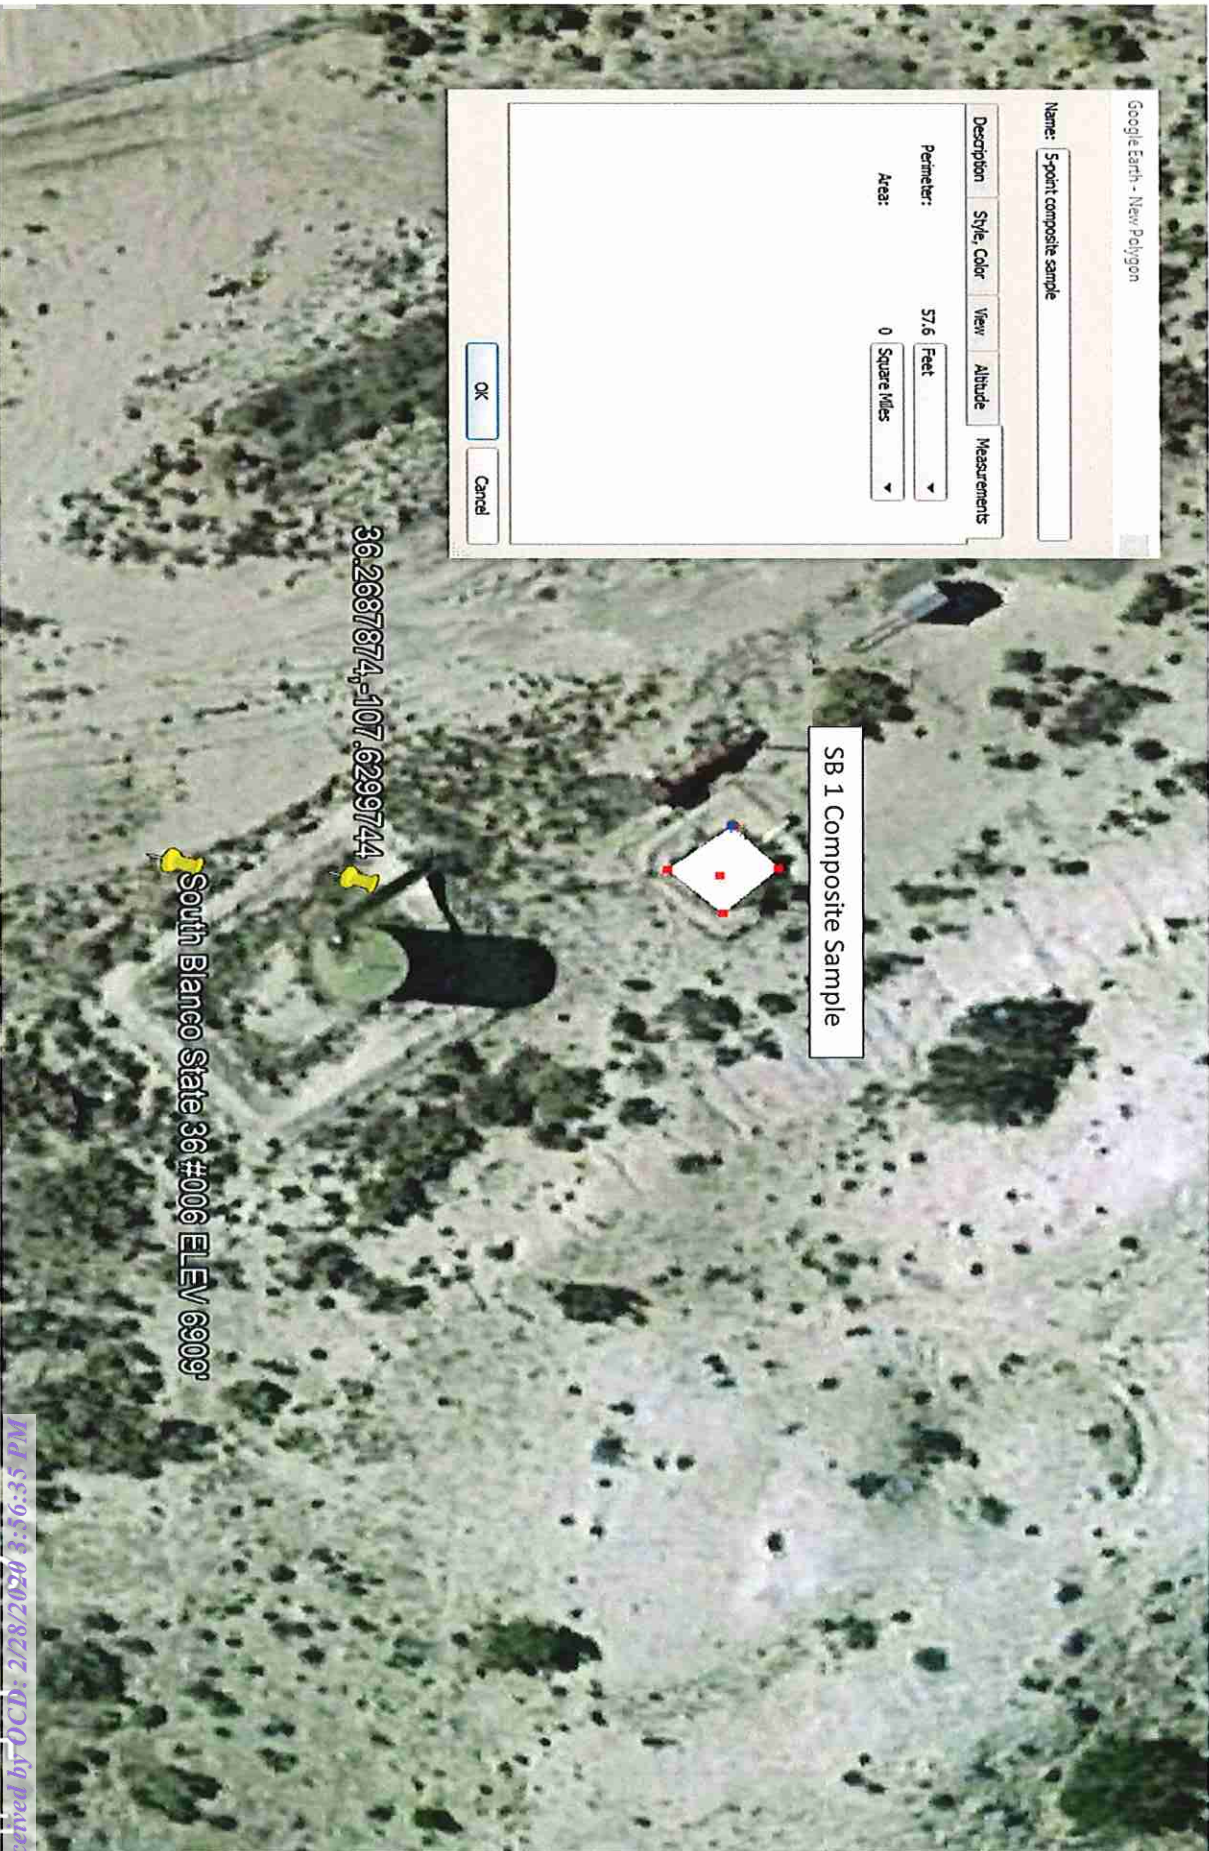
Sitting Criteria South Blanco State 36 #006

See attached Water Report
