**RE: Closure Request
James Ranch Unit 48 Battery
Remediation Permit Numbers 2RP-1142 and 2RP-2556
Eddy County, New Mexico**

LT Environmental, Inc. (LTE), on behalf of XTO Energy, Inc. (XTO), presents the following Closure Request report detailing site assessment, soil sampling, and excavation activities at the James Ranch Unit (JRU) 48 Battery (Site) in Unit M, Section 12, Township 22 South, Range 30 East, in Eddy County, New Mexico (Figure 1). The purpose of the site assessment, soil sampling, and excavation activities was to address impacts to soil after two separate releases of crude oil and/or produced water at the Site.

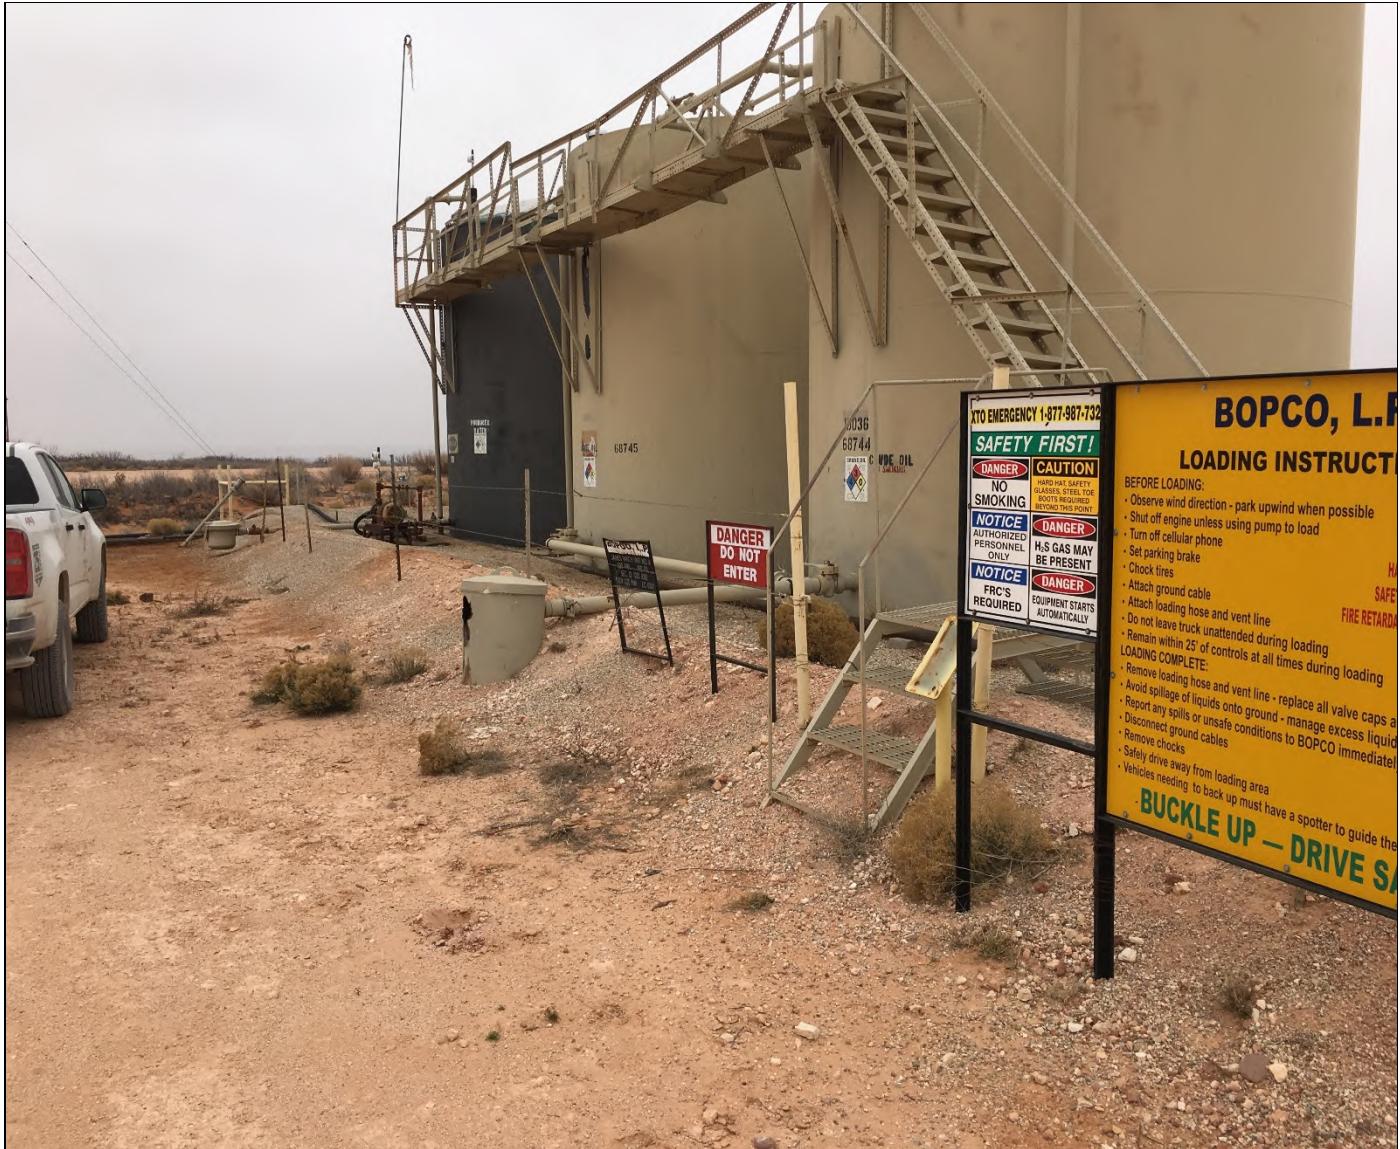
View facing northwest of earthen berm around tank battery.

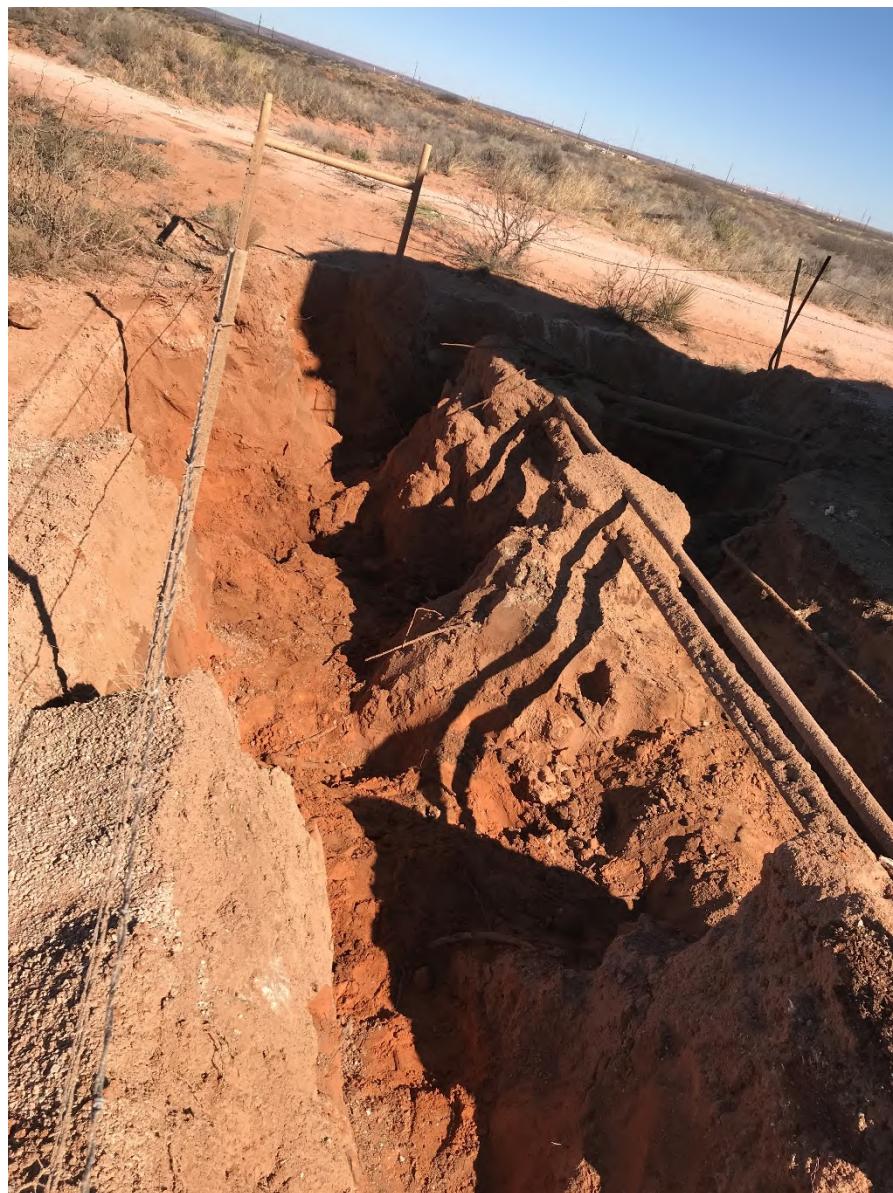
View facing west of initial excavation activities.

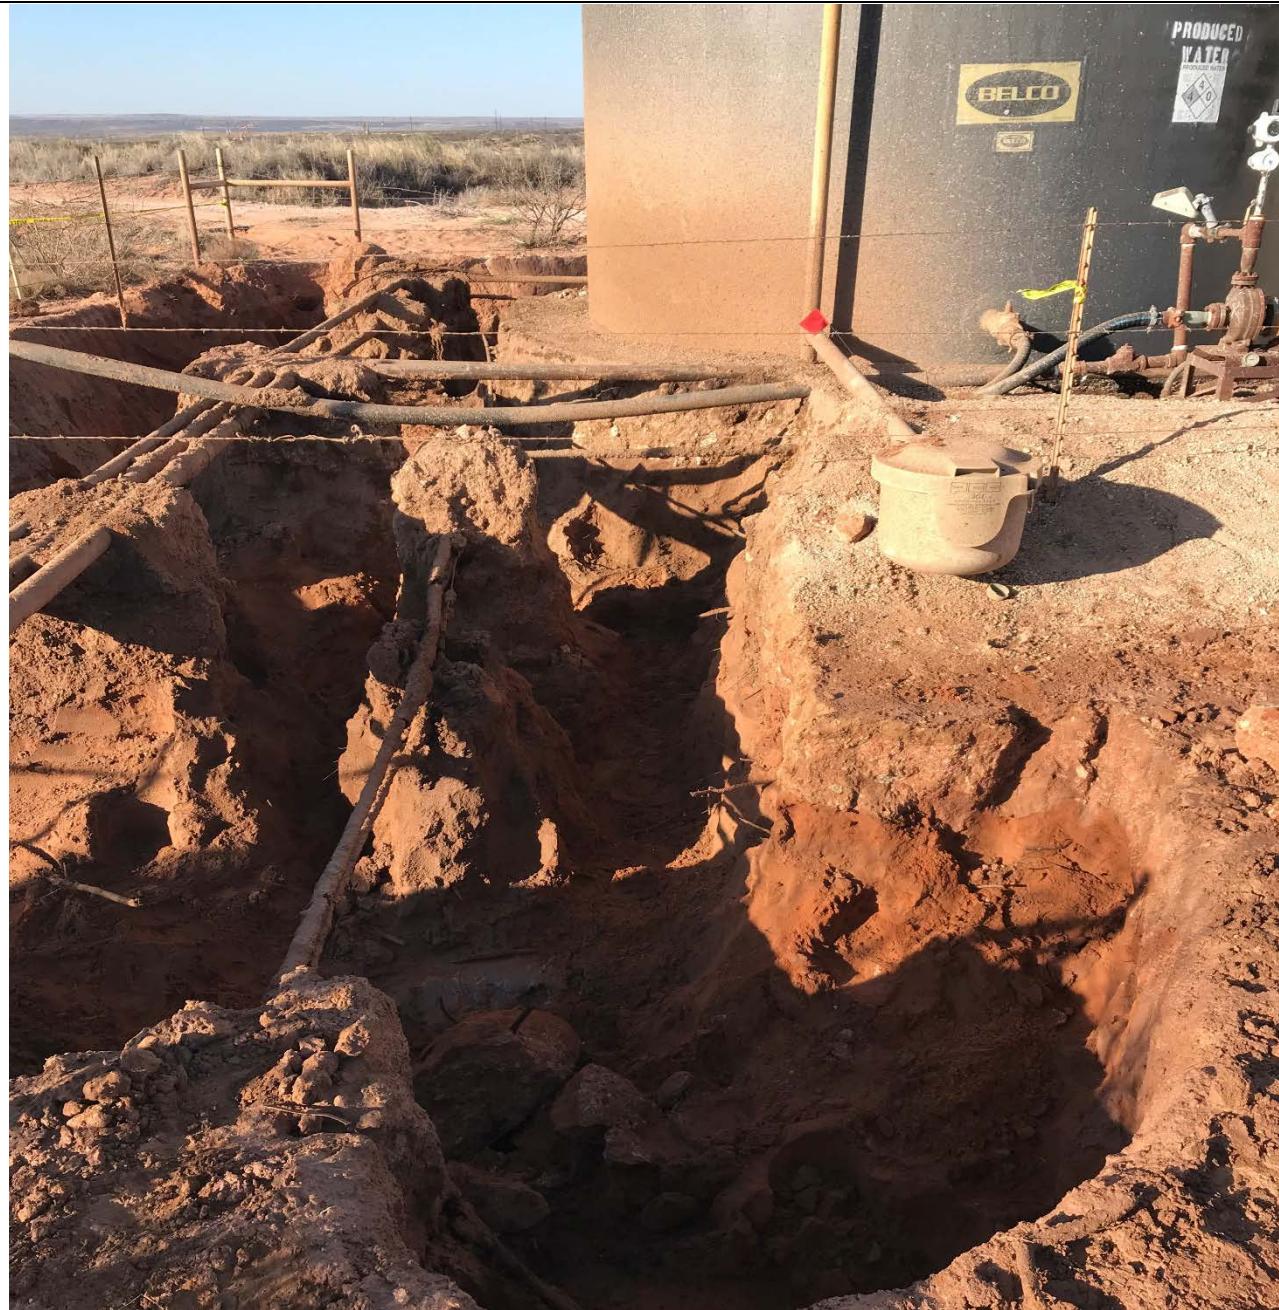
View facing north of initial excavation activities.

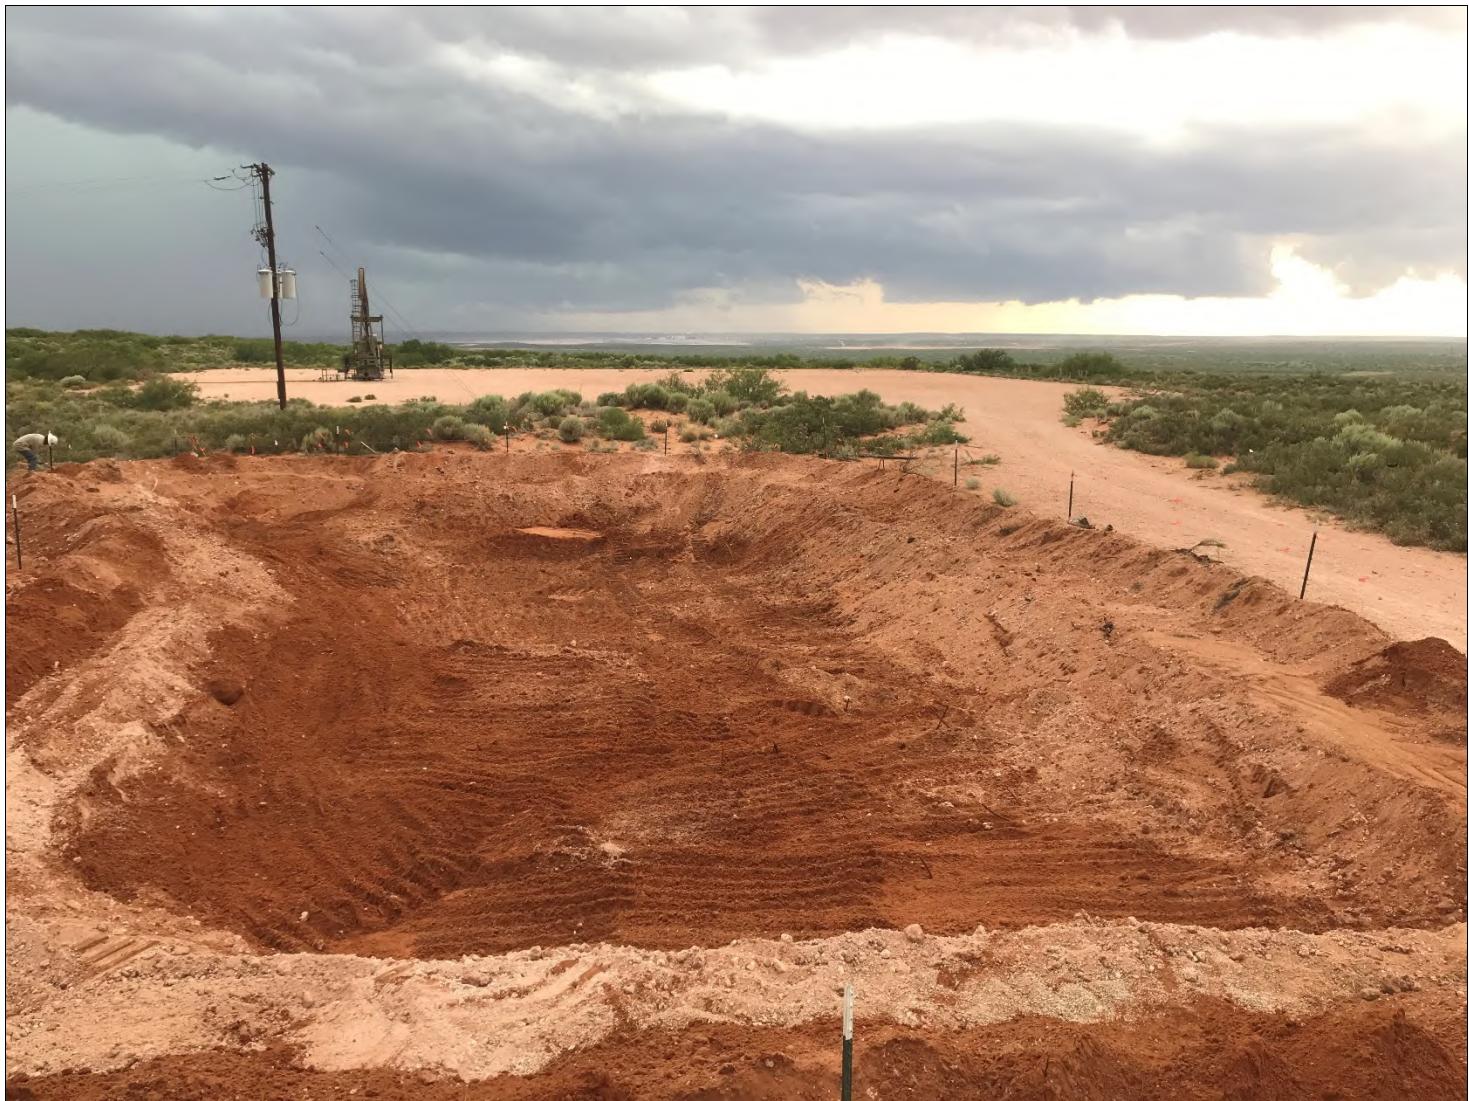
View facing west post tank battery removal.

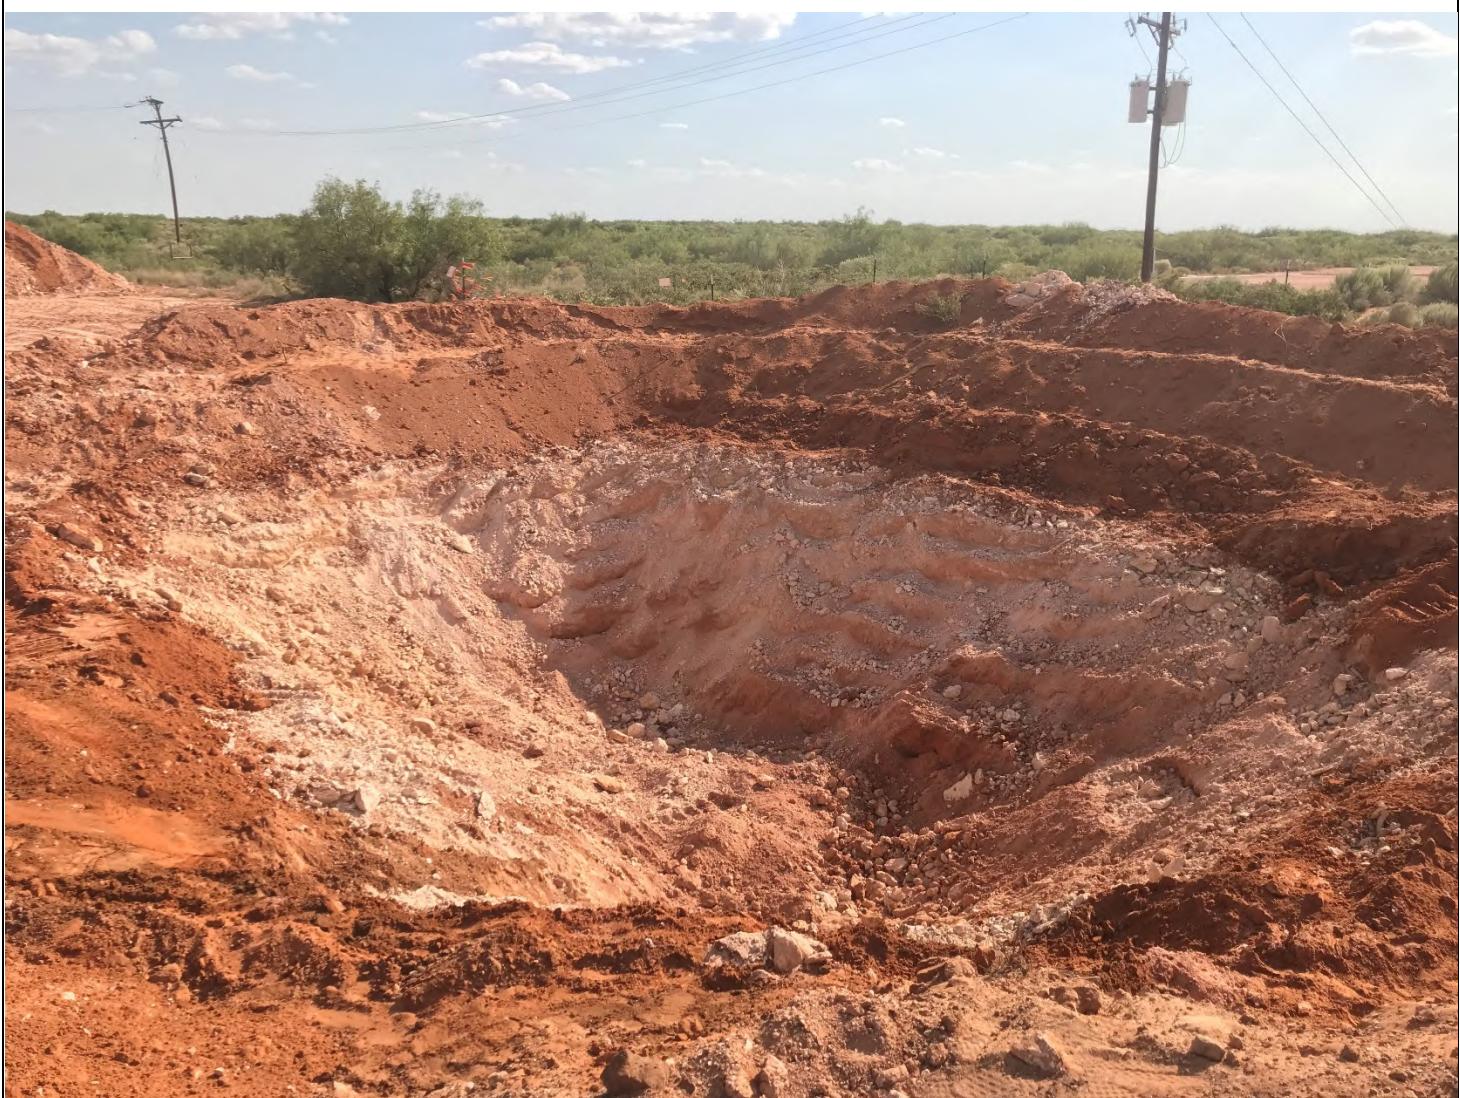
View facing southwest of the open excavation.
