Proposed Alternative Method Permit or Closure Plan Application

BP AMERICA PRODUCTION COMPANY
SAN JUAN BASIN, NORTHWEST NEW MEXICO

BELOW-GRADE TANK CLOSURE PLAN

Gallegos Canyon Unit #219E
API No. 3004525449
Unit Letter H, Section 21, T28N, R12W

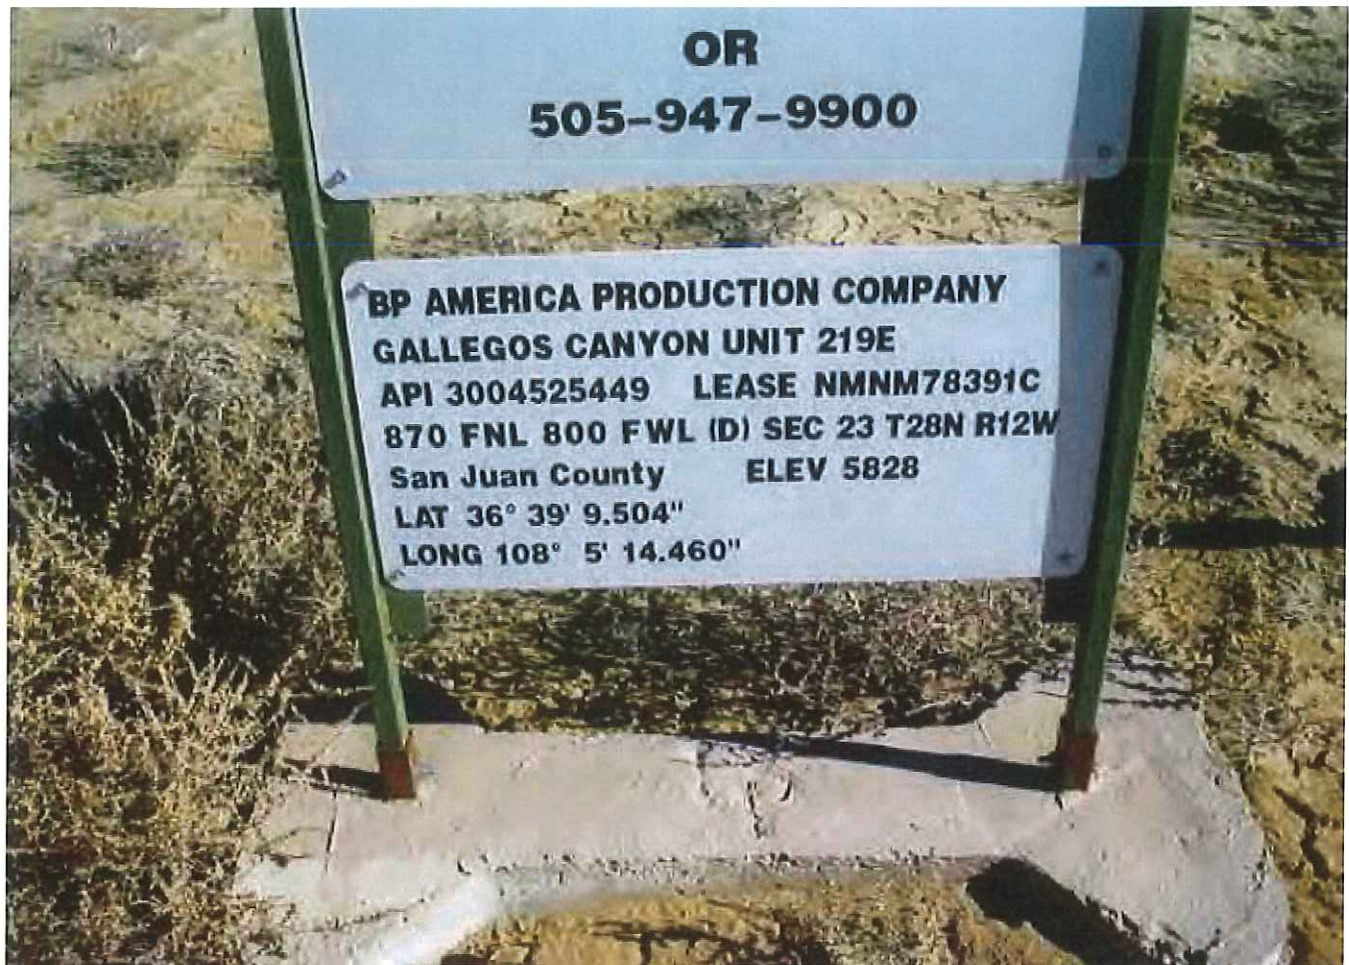
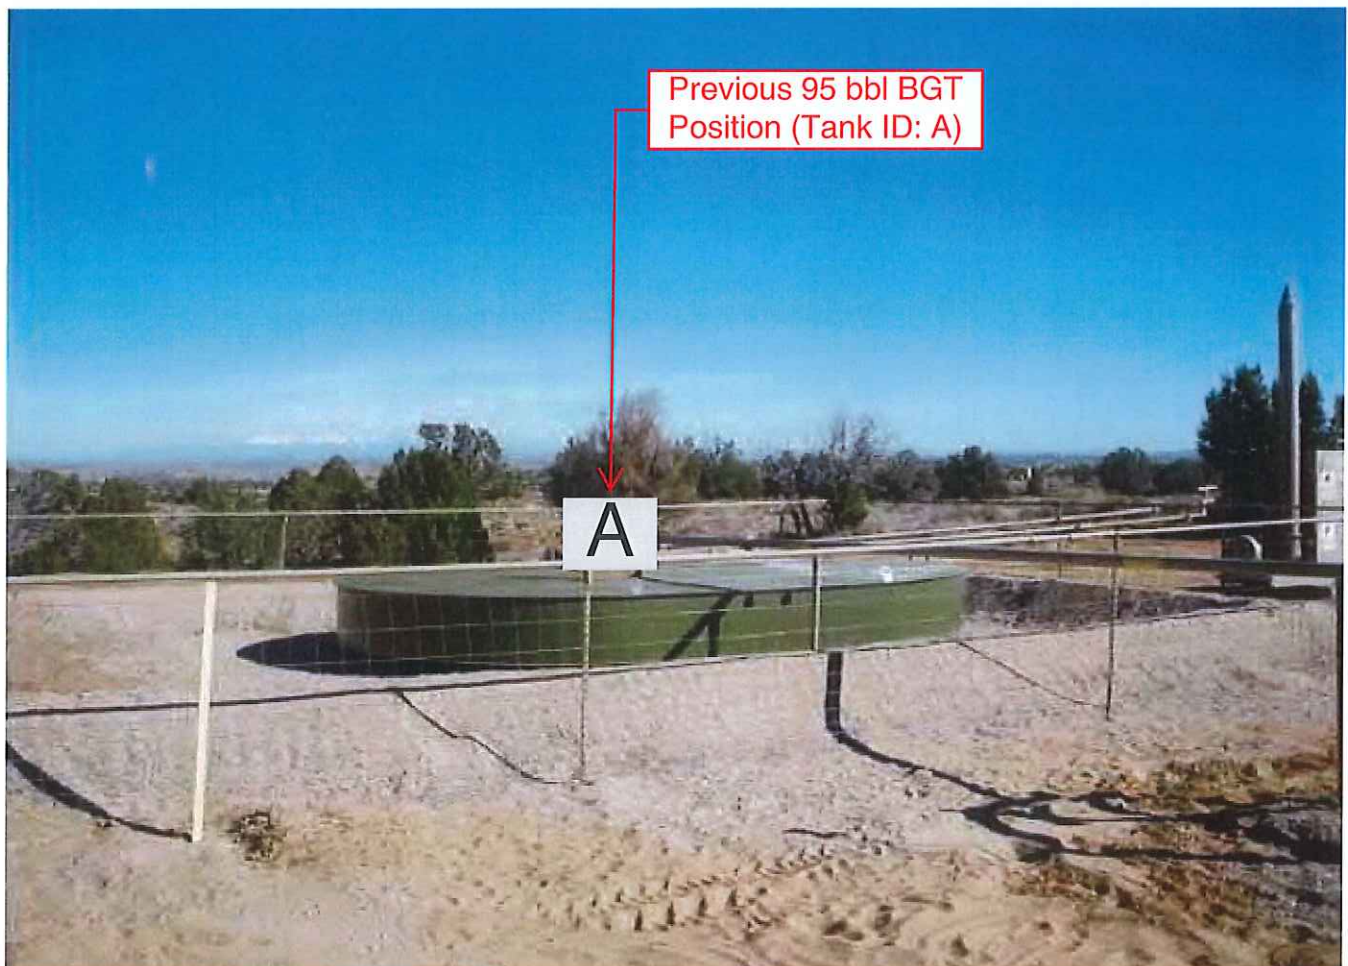
SITE OBSERVATIONS: APPARENT EVIDENCE OF A RELEASE OBSERVED AND/OR OCCURRED: YES <u>NO</u> EXPLANATION: _____ EQUIPMENT SET OVER RECLAIMED AREA: <u>YES</u> / NO EXPLANATION - 105 BBL SHALLOW LOW PROFILE ABOVE-GRADE TANK TO BE SET ATOP BGT POSITION. OTHER: _____	LOST INTEGRITY OF EQUIPMENT: YES <u>NO</u> EXPLANATION - _____
---	--

The area has been backfilled and will be reclaimed once the well has been plugged and abandoned.
