## **Red Hills West State 16 W2 CTB (RP-4254) Corrective Action Plan**

**Release Date: April 14, 2016**

**Unit D, Section 16, Township 26S, Range 32E**

**RE: Corrective Action Plan  
ConocoPhillips Red Hills West State 16 W2 CTB (RP-4254)**

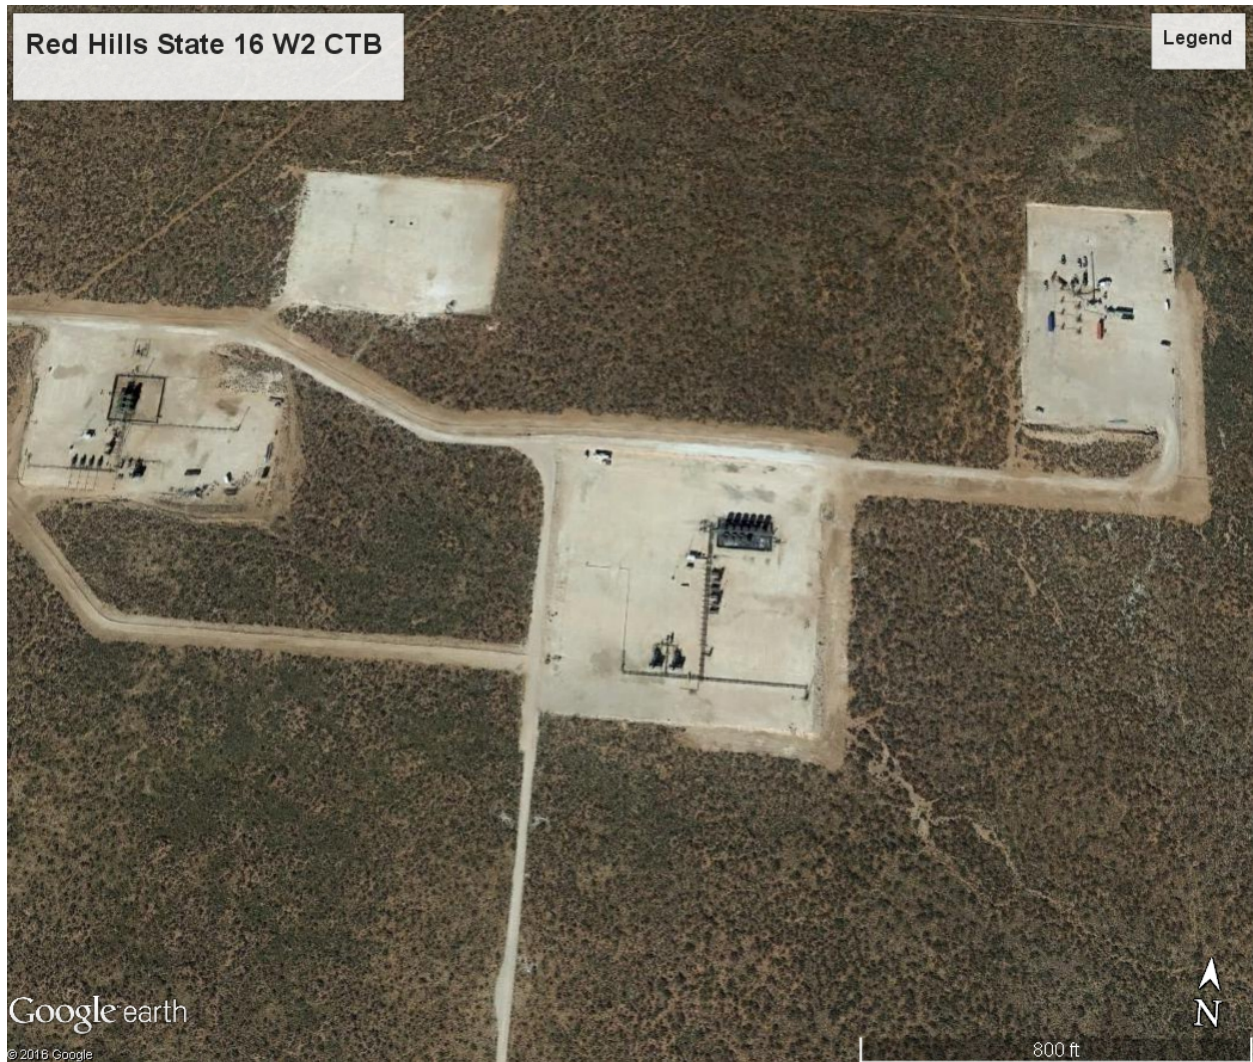
# Figure 1 – Site Map

COP personnel were on site to visually assess the release on April 15, 2016. The release was mapped and photographed (Appendix B). Based on the assessment, the release will be excavated down 6 inches bgs. Once the excavation is completed, a composite field screening sample from the bottom of the excavation will be taken and field tested for chlorides and organic vapors. If the field screening indicates that the composite will not achieve chloride, Gasoline Range Organics (GRO), Diesel Range Organics (DRO) and BTEX readings below regulatory standards, the excavation will be deepened until confirmation sampling (from three discrete samples collected from the excavation bottom) indicates that all constituents are below regulatory standards. The confirmation samples will be taken to a commercial laboratory to confirm that chloride, GRO, DRO and BTEX readings are below regulatory standards.

All excavated soils will be taken to a NMOCD approved facility for disposal. Clean soil will be imported to the site to serve as backfill and contoured to the surrounding location. A sample of the backfill soil will be taken to a commercial laboratory to confirm that the chloride reading is below regulatory standards.

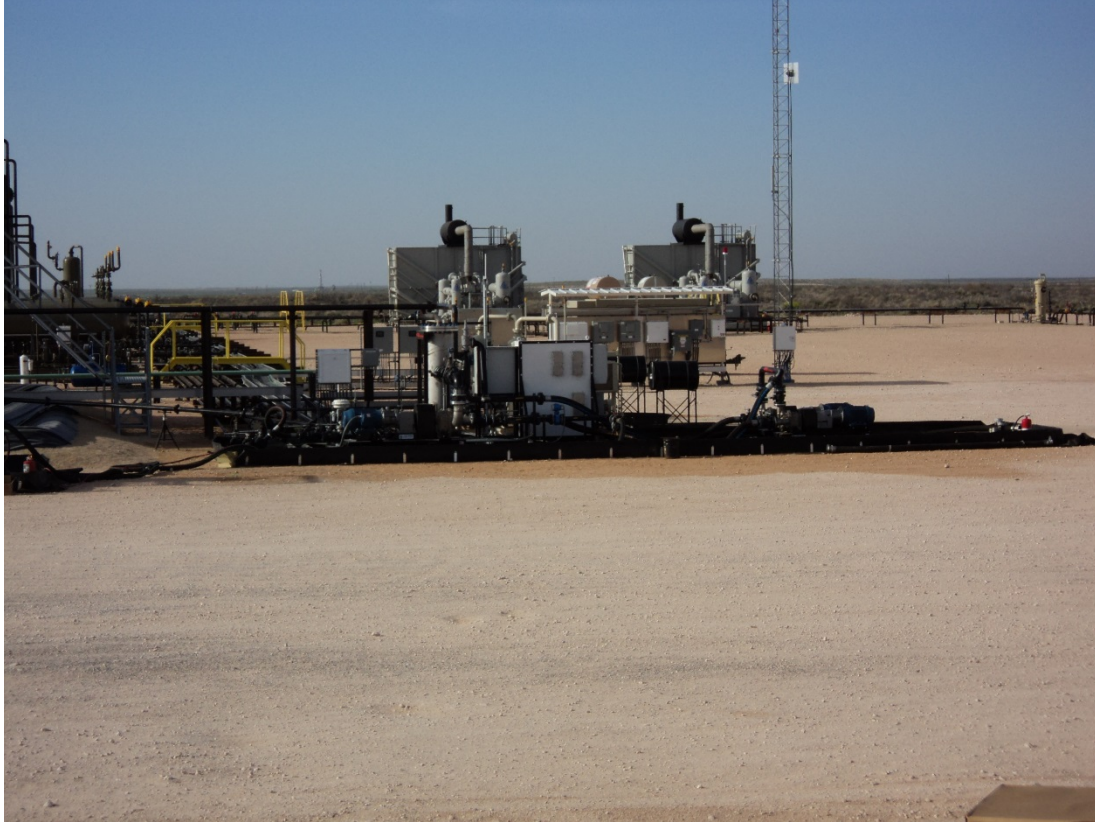
A 25 BBL Produced Water release occurred on the ConocoPhillips Red Hills W2 CTB located in Lea County, New Mexico. During de-oiler operations our MSO noticed steam coming from the pumps on the de-oiler skid. Upon closer inspection noticed that water that was leaking from one of the hoses. The water was leaking into the containment but some of the water was splashing out onto the ground. MSO contacted de-oiler operators then shut down the pumps. Once the pumps were off and the area deemed safe, the water hauler on location recovered the produced water in containment. The leak resulted in approximately 20 BBLs of produced water spilled to lined containment (with all recovered) and 5 BBLs of produced water spilled to ground. Location will be remediated in accordance with NMOCD and COPC policies with confirmation soil samples.

View looking towards the south of the de-oiler skid (4/15/2016)
