ConocoPhillips

Buck Federal CTB (RP-4275) Corrective Action Plan

NMLC 068281B

RE: Corrective Action Plan ConocoPhillips Buck Federal CTB NMLC 068281B

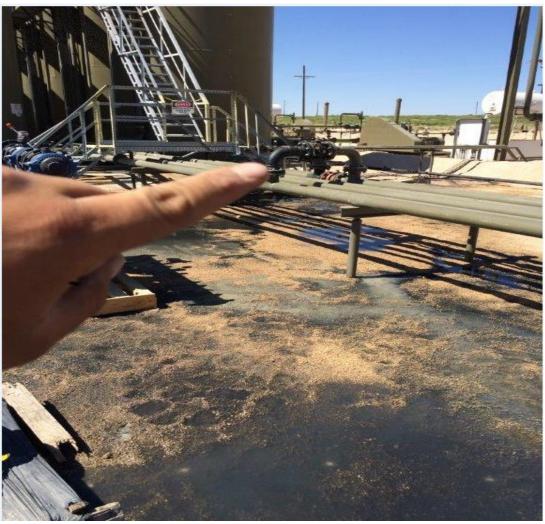
On Wednesday 11, 2016 at 11:00 am, a release of produced water occurred due to a faulty valve resulting in the release of 6 BBLs of produced water with 5 BBLs of water recovered. Immediate action was to shut down and replace the valve. NMOCD was notified of the release on May 12, 2016, and an initial C-141 was submitted (Appendix A).

View looking towards the South (5/11/2016)

COP personnel were on site to visually assess the release on May 11, 2016. The release was mapped and photographed (Appendix B). Based on the assessment, the release will be excavated down 6 inches bgs. Once the excavation is completed, a Composite sample from the bottom of the excavation will be taken and field tested for chlorides and organic vapors. If the field data indicates that the composite will not achieve chloride, Gasoline Range Organics (GRO), Diesel Range Organics (DRO) and BTEX readings below regulatory standards, the excavation will be deepened until field testing indicates that all constituents from bottom discrete samples (3 discrete samples will be collected) will return values below regulatory standards. The bottom samples will then be taken to a commercial laboratory to confirm that chloride, GRO, DRO and BTEX readings are below regulatory standards.
