## Release Notification and Corrective Action

Name of Company	Devon Energy Production Company	Contact	Randy Gladden, Production Foreman
Address	6488 Seven Rivers Hwy Artesia, NM 88210	Telephone No.	575-513-9463
Facility Name	Rattlesnake Federal Unit #001	Facility Type	Oil
Surface Owner	Federal	Mineral Owner	Federal
		API No	30-025-36928

Rattlesnake Federal Unit 1  
19.5BBLs Oil\_4.6.2017

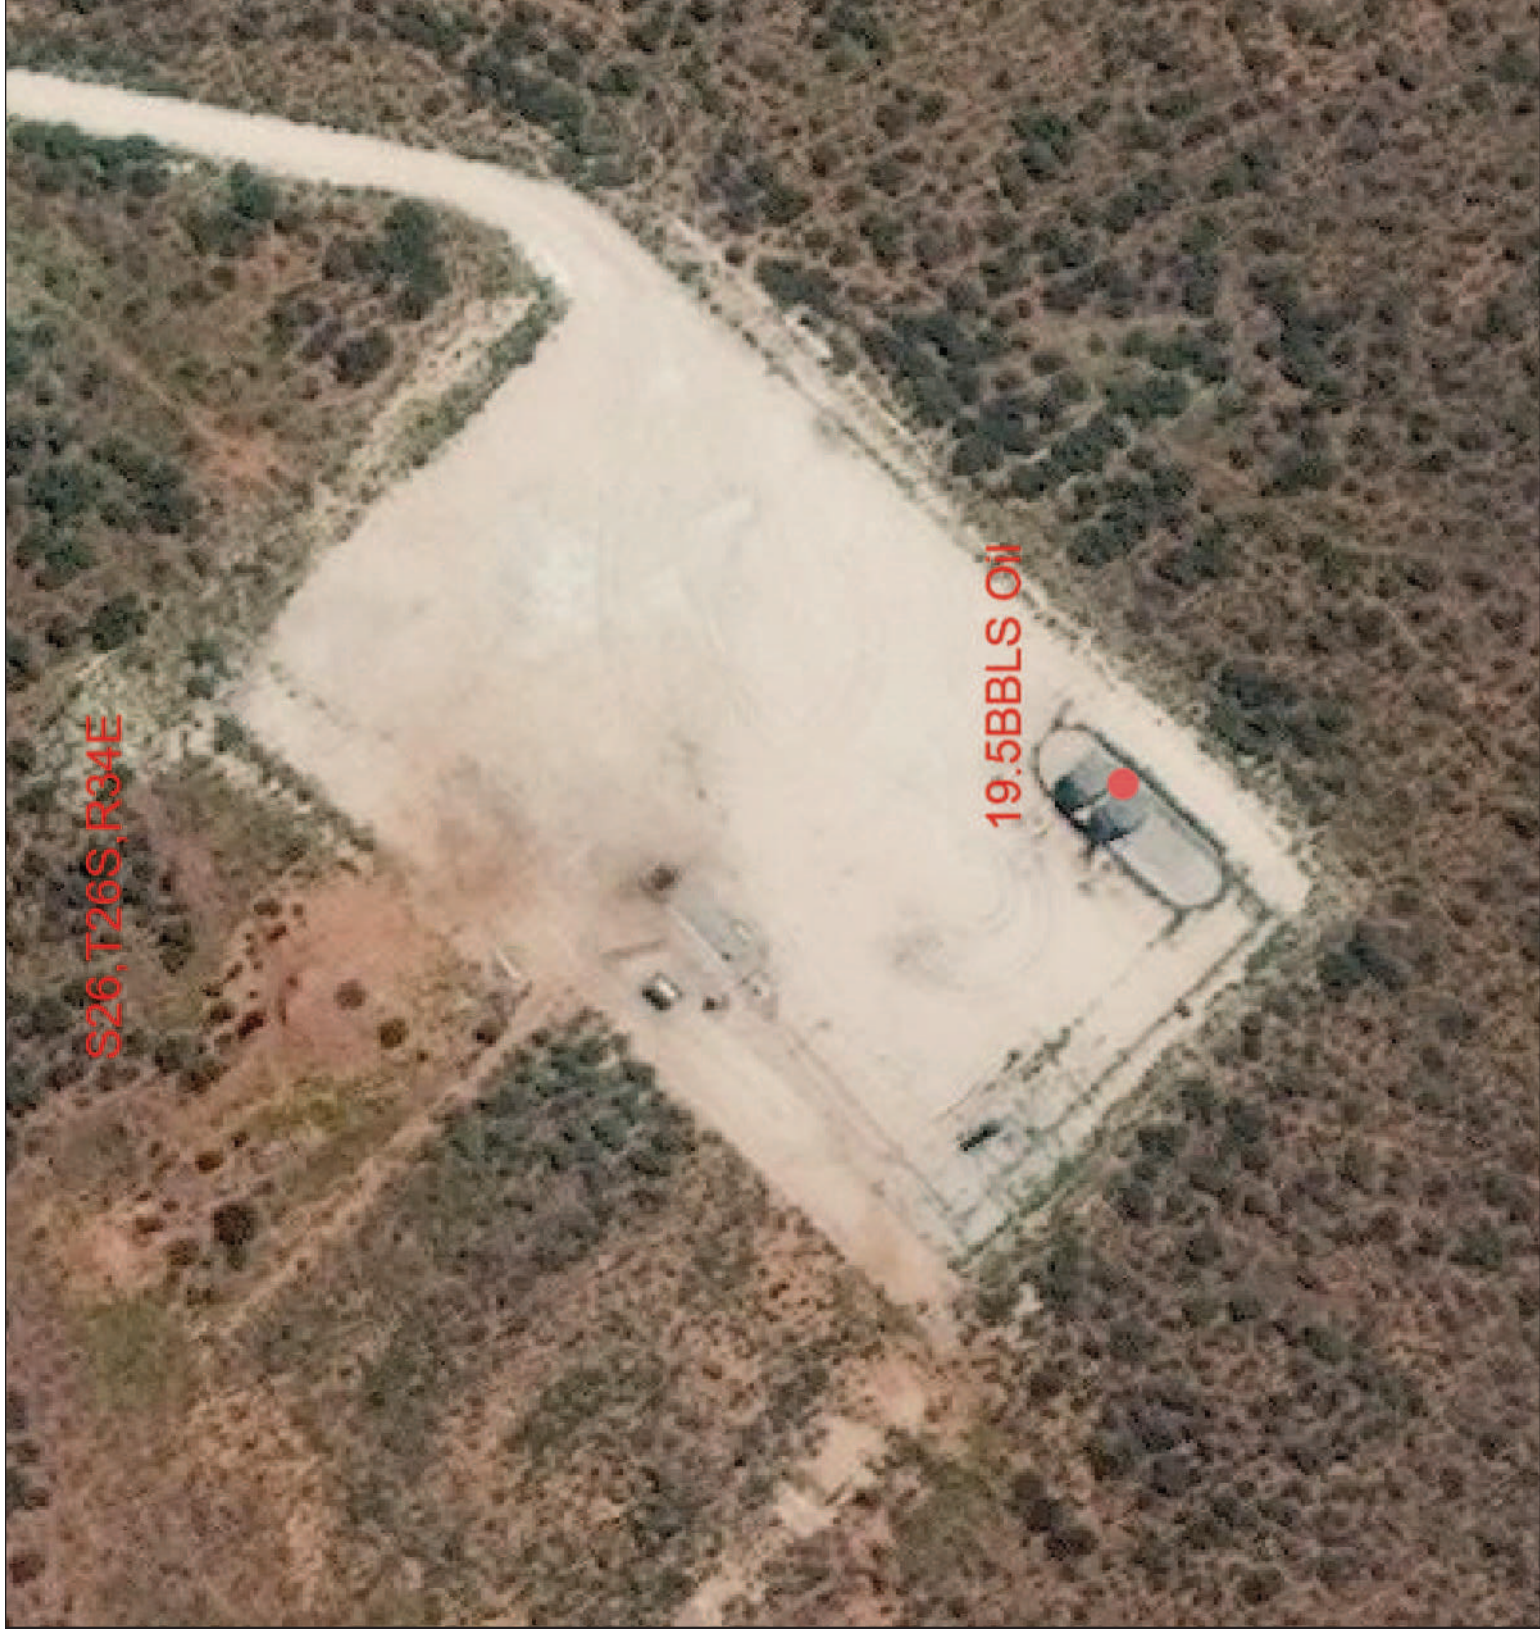
The release originated from a tank which is inside the metal containment as seen on the image that was provided. This is an older facility where the metal containment ring does not have a floor liner installed. The fluids were released from the lower portion of the tank, travelled down the outside of the tank, contacted the ground surface and then travelled across the ground surface until they were absorbed into the ground which allowed for none of the fluids to be recovered. The only fluids that were recovered by the vacuum truck that was dispatched were fluids remaining inside the tank that were below the level where the holes developed.

Please clarify this concern. According to the provided initial C141, no fluid was recovered inside the containment. However, the GIS image indicated that the release was inside a secondary containment. Where did the fluid go?

Attached is the Initial C141 and GIS Image for the 19.5BBL PW release that occurred on 4.6.2017.  
The red dot on the GIS Image represents the approximate origin of release.

A hole was discovered in the bottom of an oil tank which resulted in a release of 19.5BBLS of oil. The total area affected by the release was 70' X 25'. A vacuum truck was called in to remove the remaining fluid from inside the tank. Repairs will be made to the tank.
