From: [Yu, Olivia, EMNRD](#)
To: ["Bob Asher"; Katie Parker](#)
Cc: [Oberding, Tomas, EMNRD](#); [Billings, Bradford, EMNRD](#); agroves@slo.state.nm.us
Subject: RE: Form C-141, Initial/Final Report (Woodstock State Unit #1)
Date: Friday, August 18, 2017 8:08:00 AM
Attachments: image001.png

The 1RP for this incident

4777	8/4/2017	A	EOG Y Resources	Woodstock State Unit #1	30-025- 30700	9S-33E-5P	6/29/2017
-------------	----------	---	--------------------	-------------------------	------------------	-----------	-----------

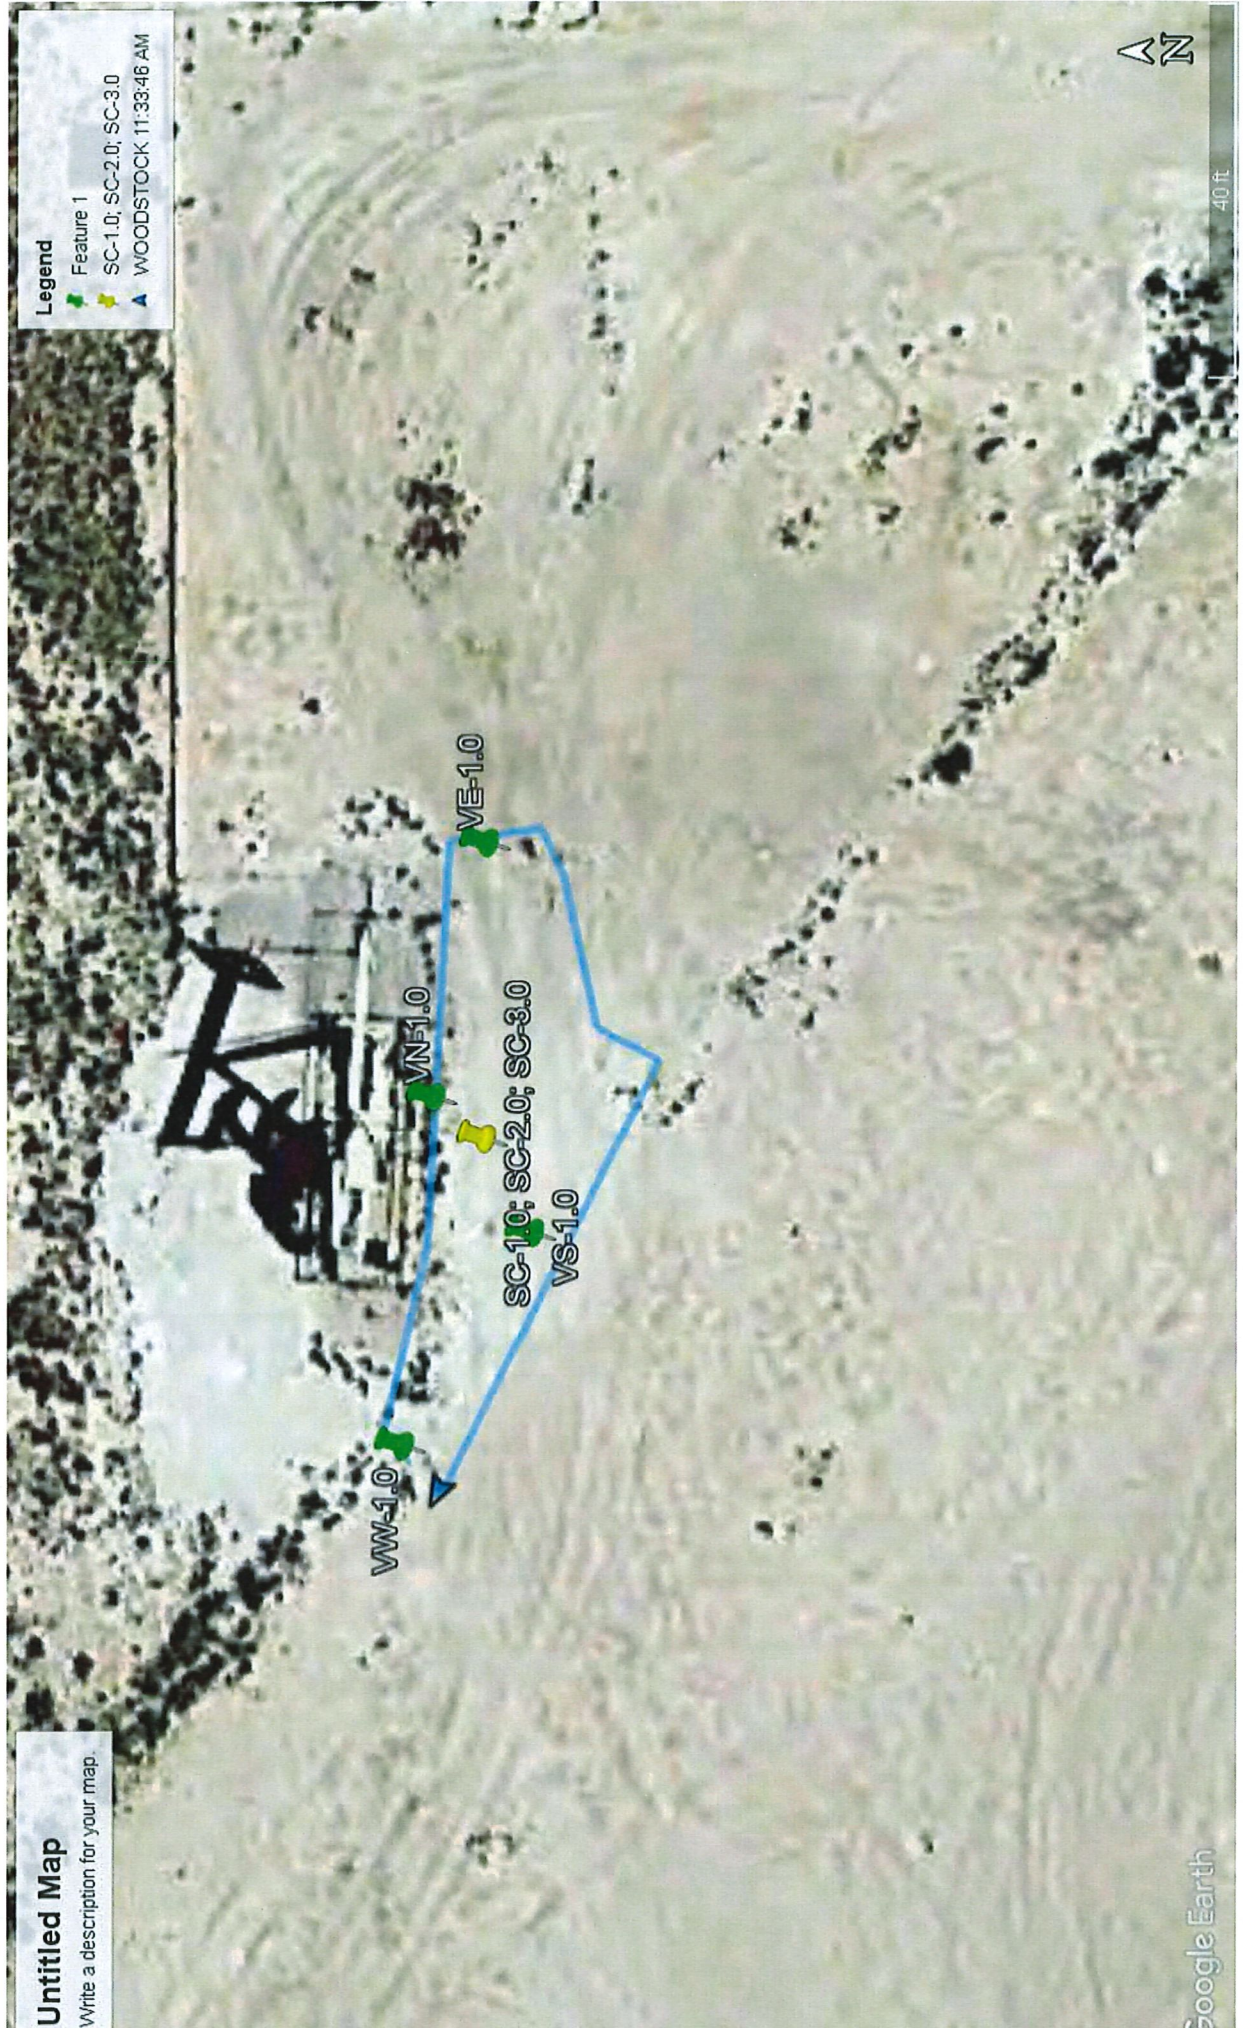
Untitled Map

Thank you for the scaled map with the release area demarcated for 1RP-4777. The pins marked the locations of the sample locations for delineation. Please clarify whether these pins also mark the locations where confirmation samples of sidewalls and bottom will be taken.

Attached is a to scale map with the release area (outlined in blue) and the confirmation sample locations.

SC-1.0; SC-2.0; SC-3.0
