Release Notification and Corrective Action

Name of Company Marathon Oil Permian LLC	Contact Callie Karrigan
Address 5555 San Felipe Street, Houston, Texas 77056	Telephone No. 405-202-1028 (cell) 575-297-0956 (office)
Facility Name: Cave Lion 5 Federal WC 5H	Facility Type Oil and gas production facilities

Type of Release: Fire	Volume of Release: <1 gallon	Volume Recovered: None
Source of Release: Flare	Date and Hour of Occurrence: 02/21/2018 08:15 am	Date and Hour of Discovery 02/21/2018 11:15 am
Was Immediate Notice Given? <input checked="" type="checkbox"/> Yes <input type="checkbox"/> No <input type="checkbox"/> Not Required	If YES, To Whom? Olivia Yu	
By Whom? Callie Karrigan	Date and Hour 02/22/2018 7:20 am	
Was a Watercourse Reached? <input type="checkbox"/> Yes <input checked="" type="checkbox"/> No	If YES, Volume Impacting the Watercourse.

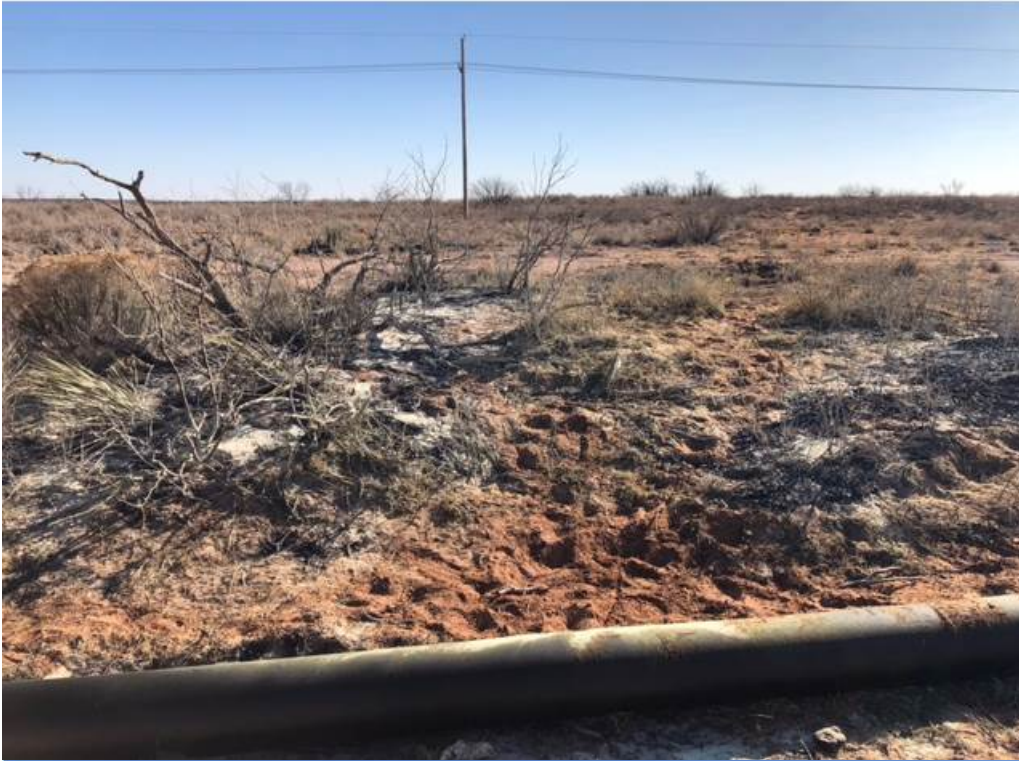
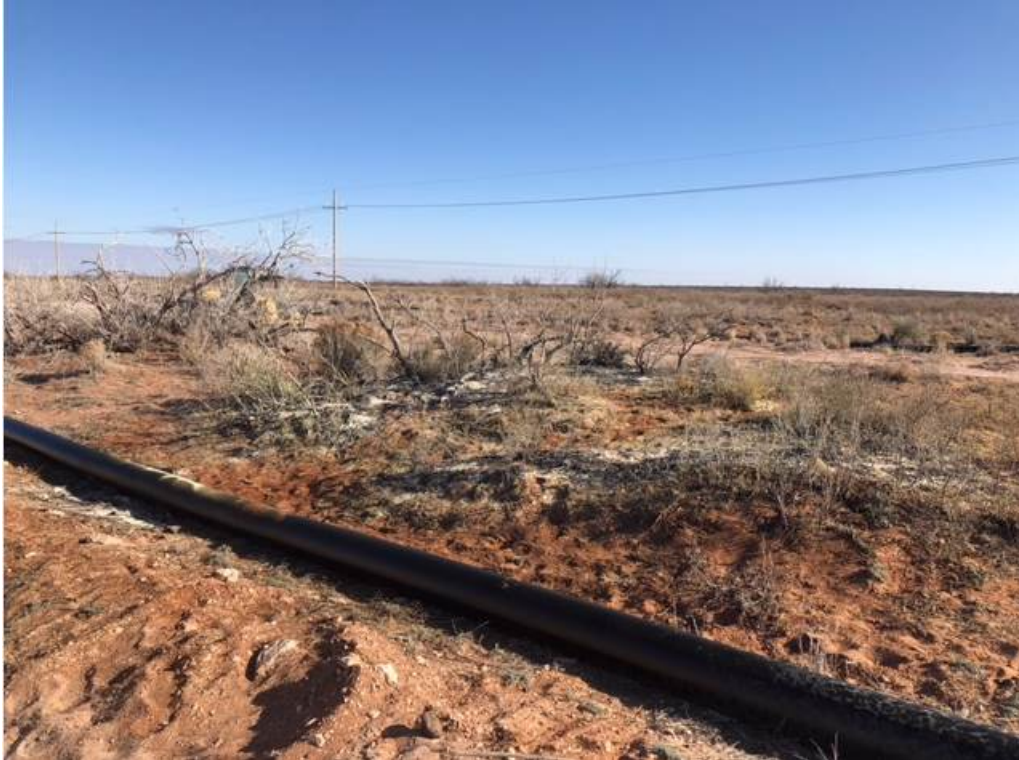
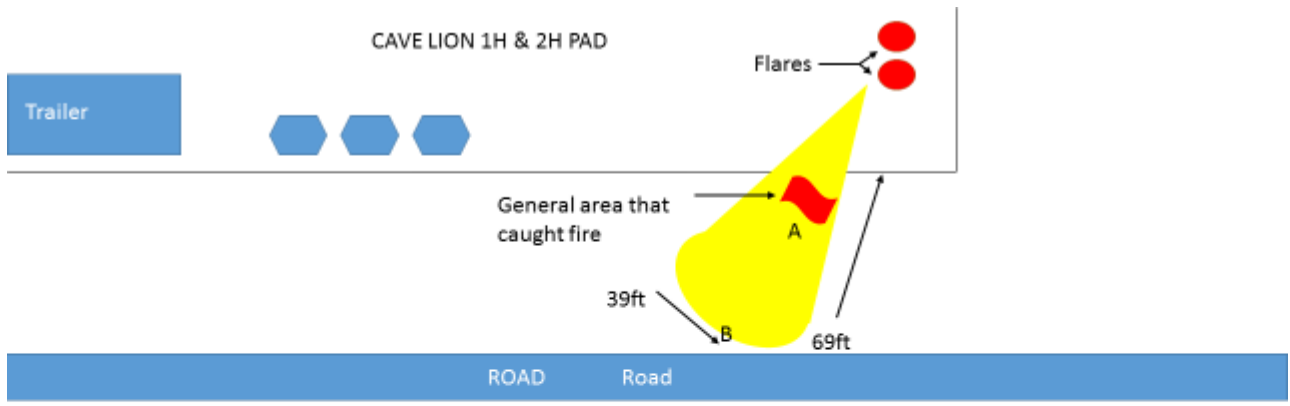
Extent of release

While making repairs to the low pressure separator, the control line for the regulator on the high pressure separator froze and prevented the separator from properly dumping fluid. The operator noticed the fluid buildup and manually dumped the high pressure separator. The lines were defrosted during the manual dump causing the regulator to discharge gas and fluid down the flare line, resulting in a light, overspray mist and starting a small fire. The fire covered two separate areas measuring 9'x24' and 3'x15' before it was extinguished.

Area was lightly raked. Contaminated soils were taken to R360.
