COMPANY NAME: Oxy

SITE NAME: State 33 #2

LEGAL DESCRIPTION: UL F, Section 33, T21S, R35E

Receiving Date: 11/20/09  
Reporting Date: 11/24/09  
Project Owner: OXY  
Project Name: STATE 33 #2  
Project Location: 176

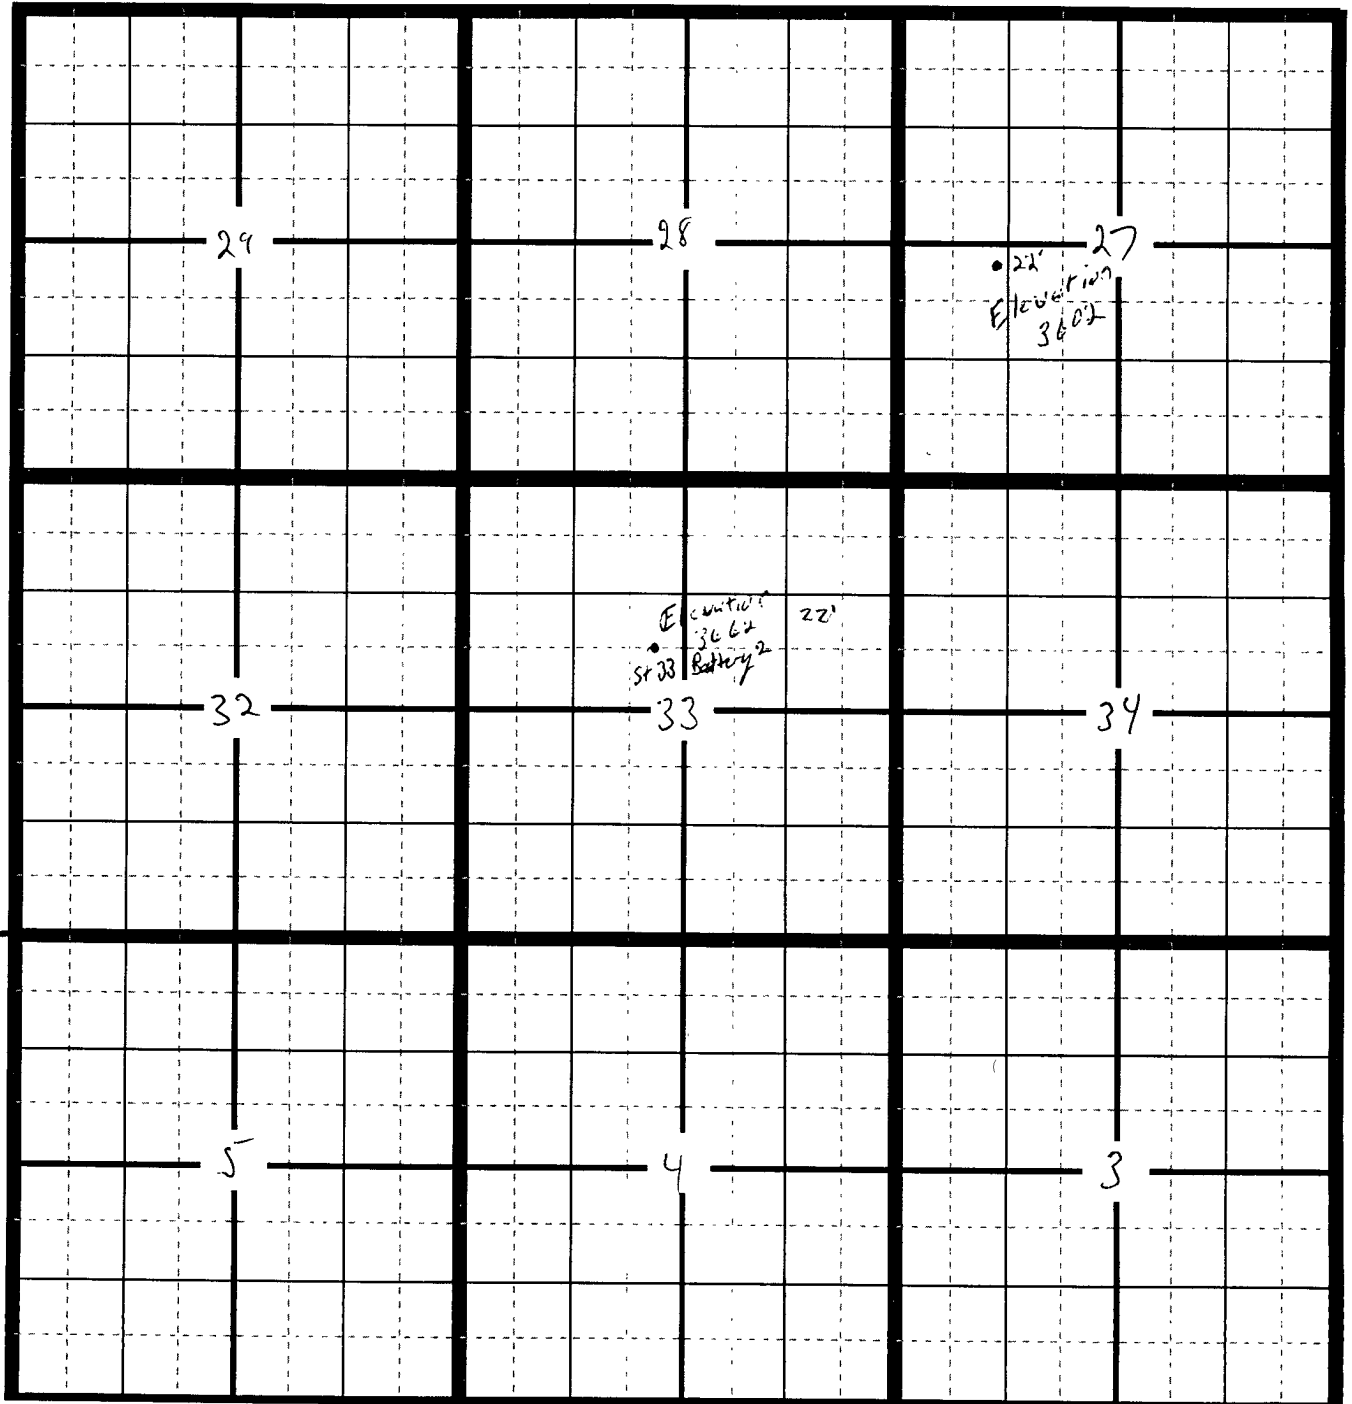
## Groundwater Plot

Oil/Gas Well Name:

R 35E
