Case No  
6507

EXHIBIT NO. 3  
HARVEY E. YATES COMPANY  
STRATIGRAPHIC CROSS SECTION  
A-A'  
#1 HANLAD STATE  
LEA COUNTY, NEW MEXICO  
HORIZONTAL SCALE: 1"=100' VERTICAL SCALE: 1"=100'

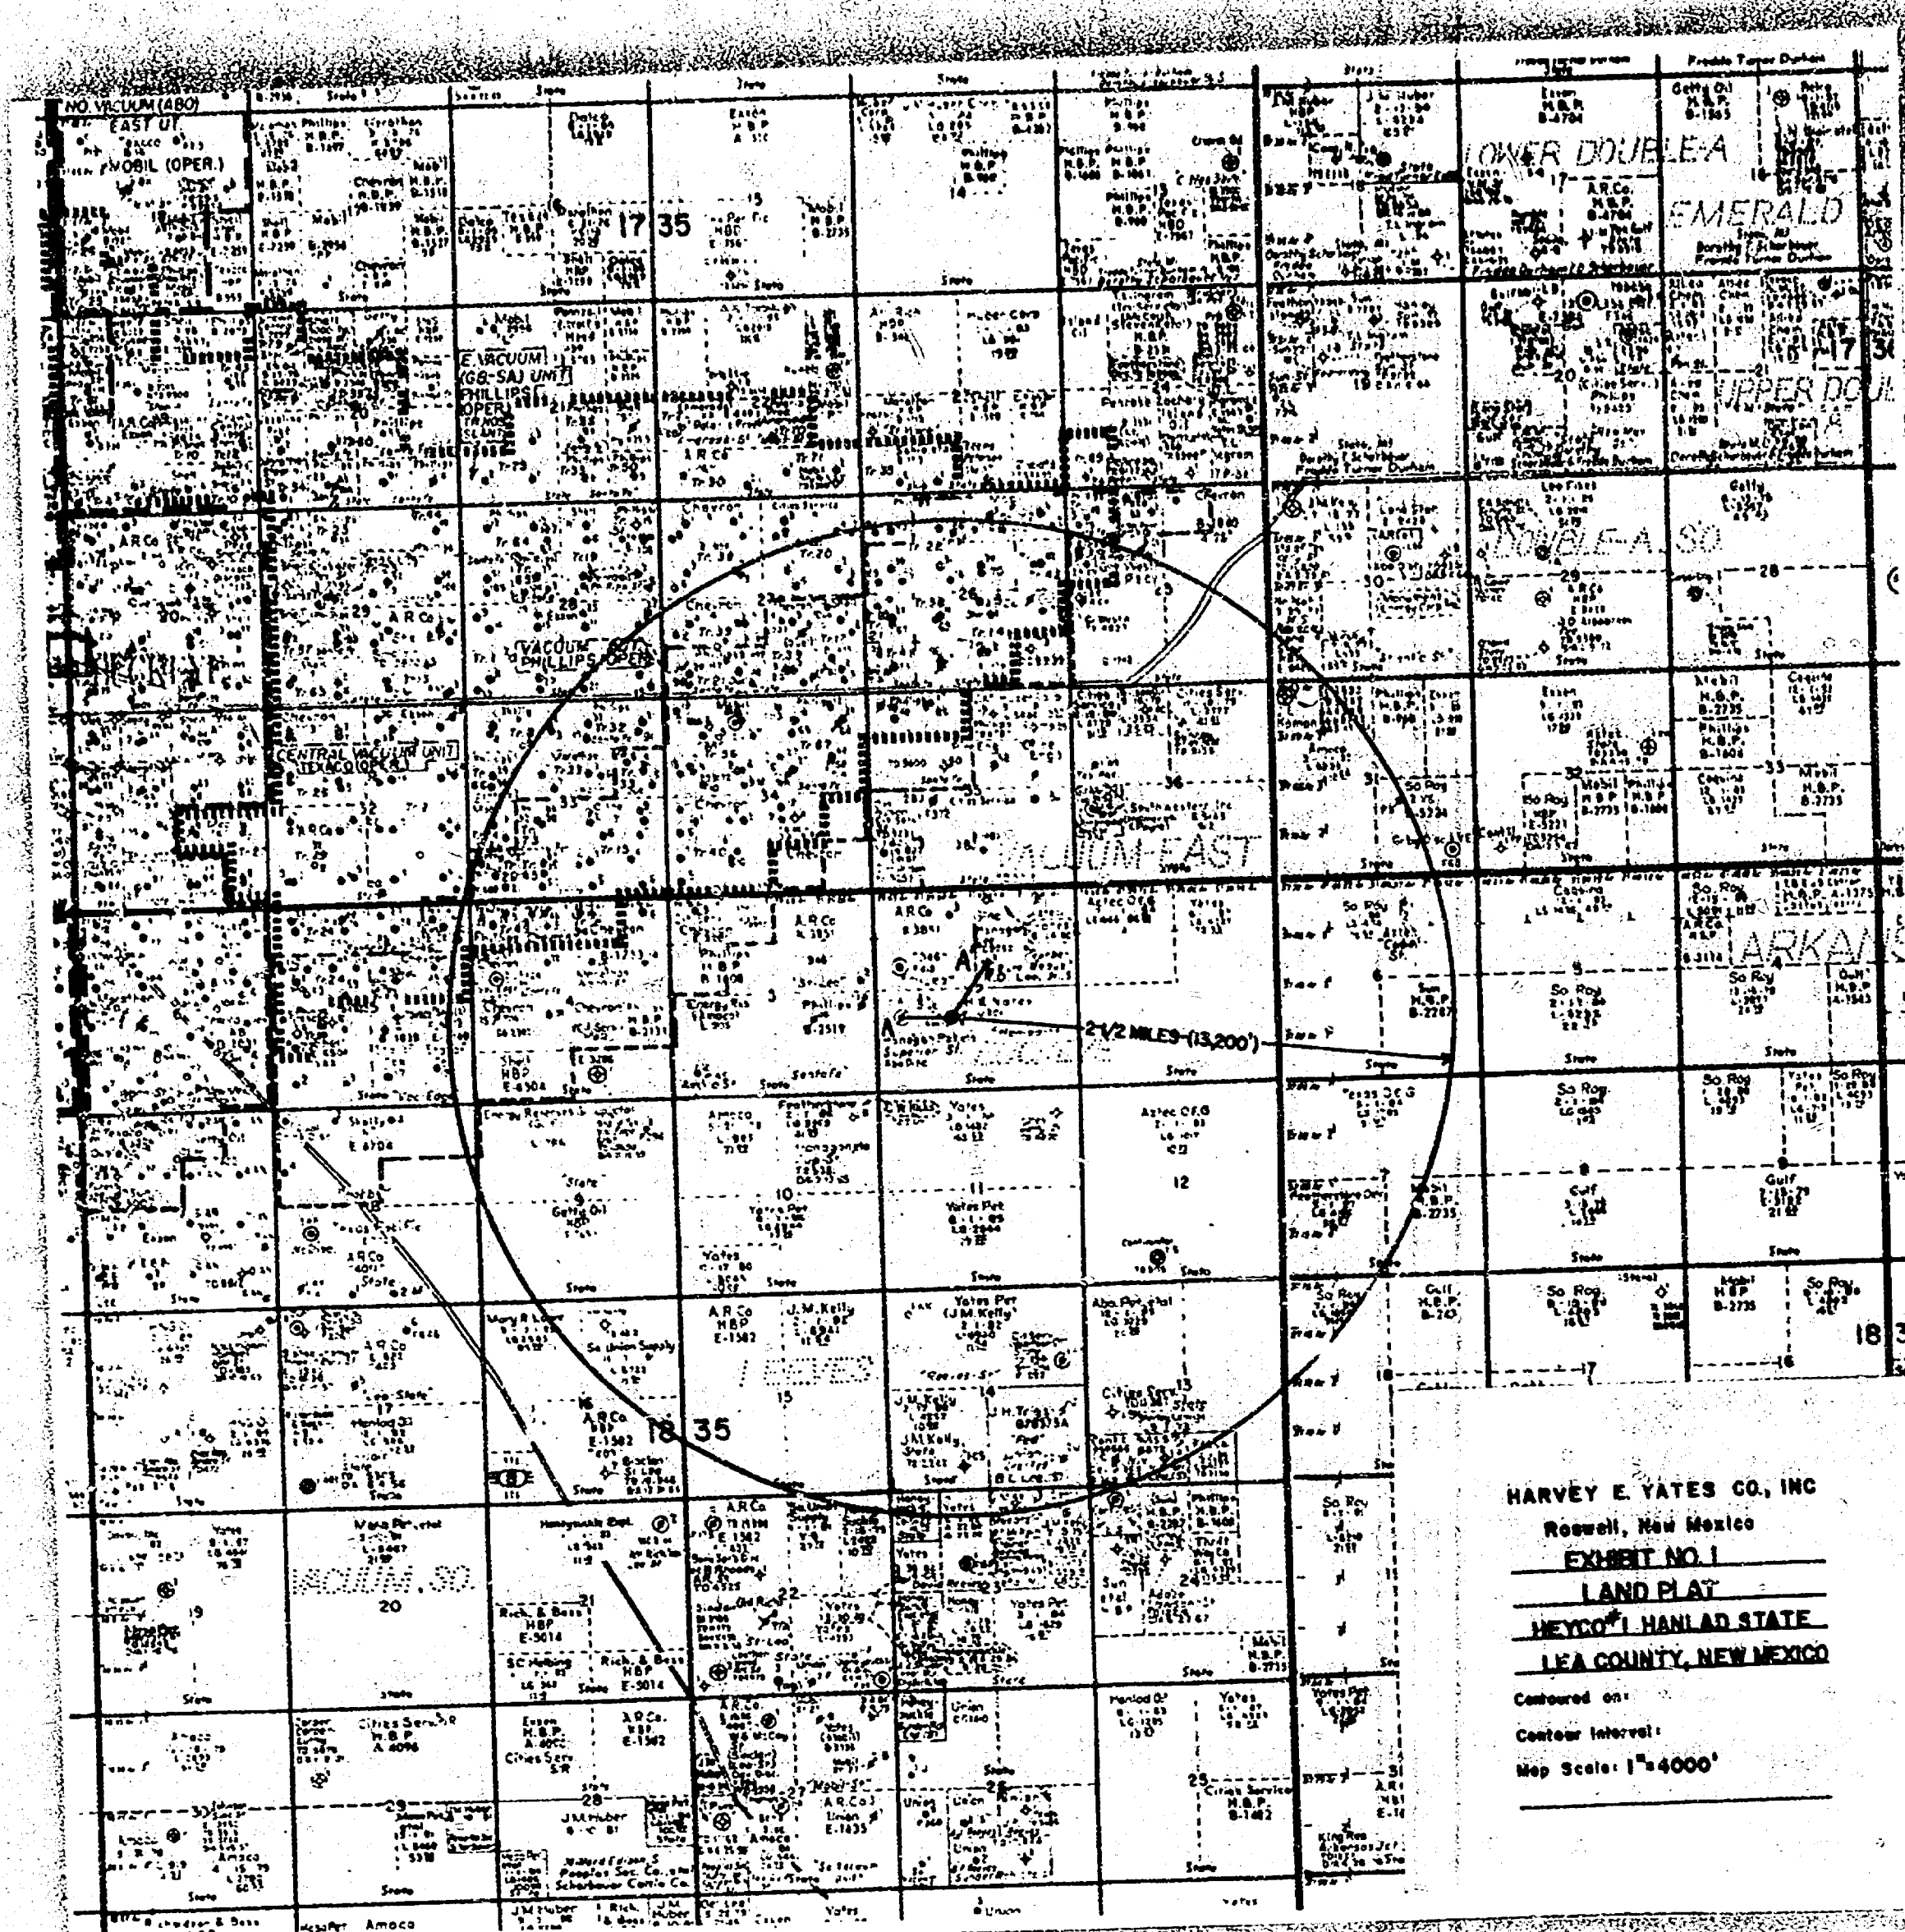
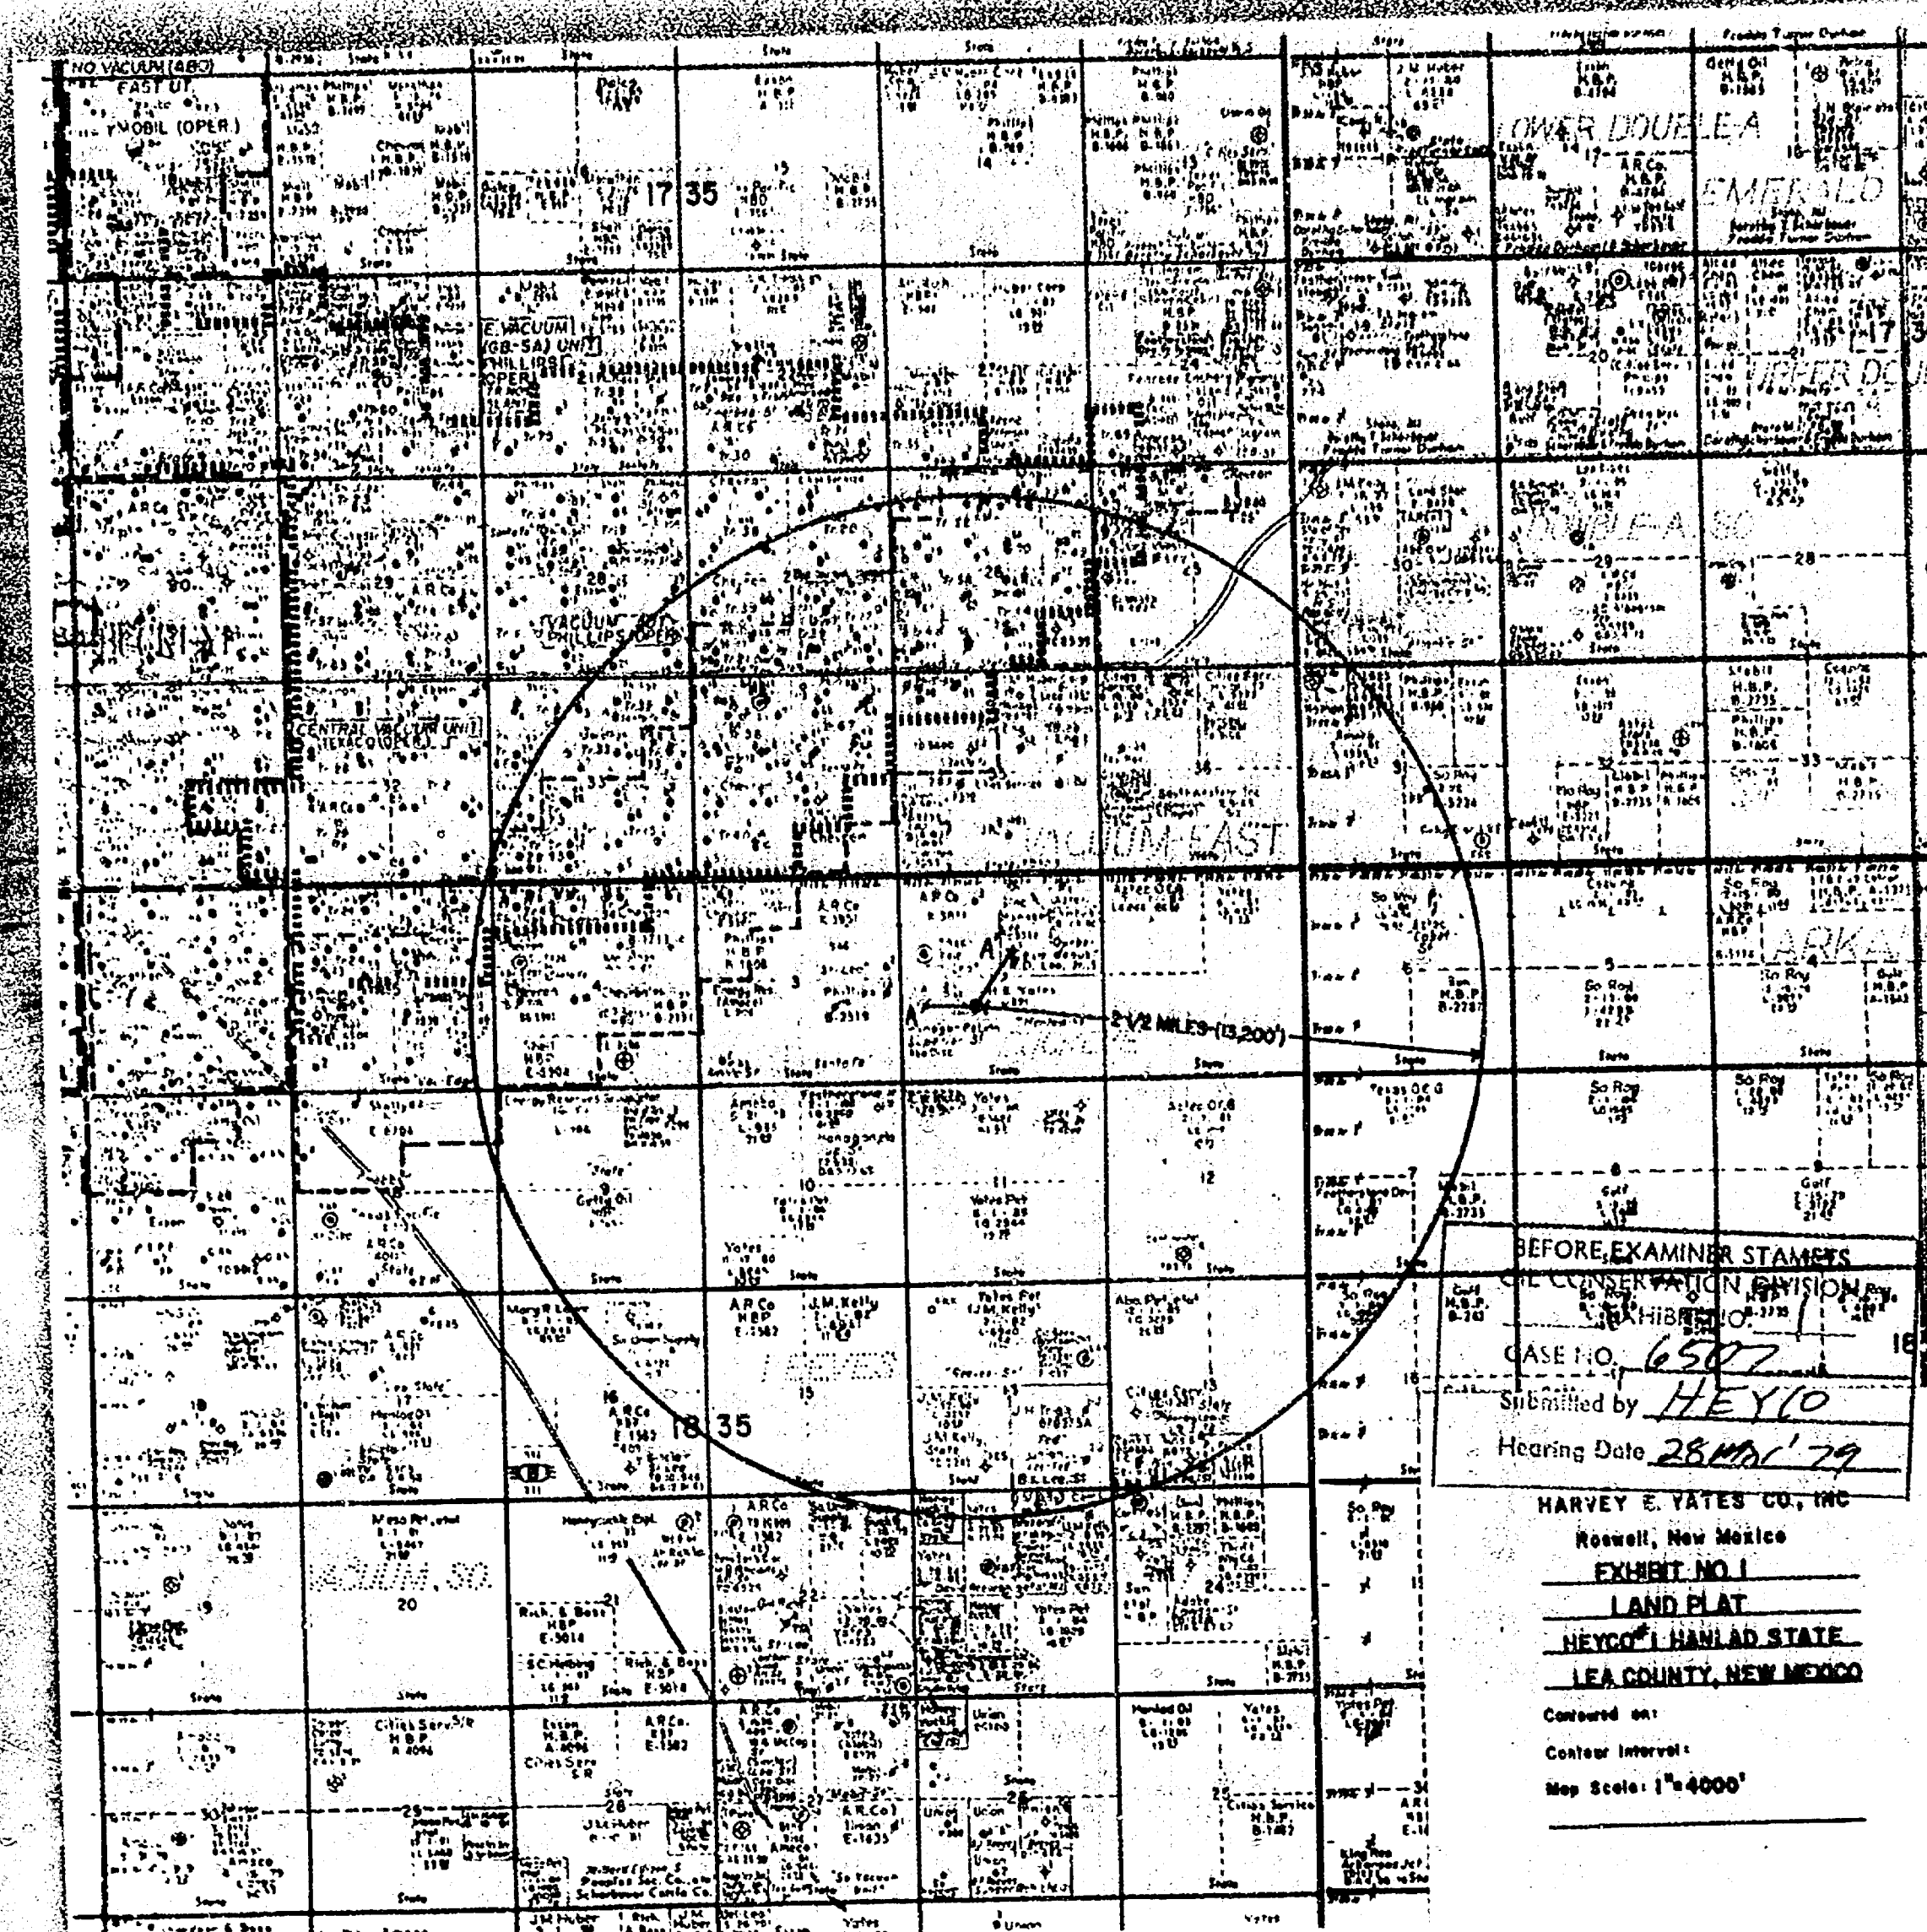
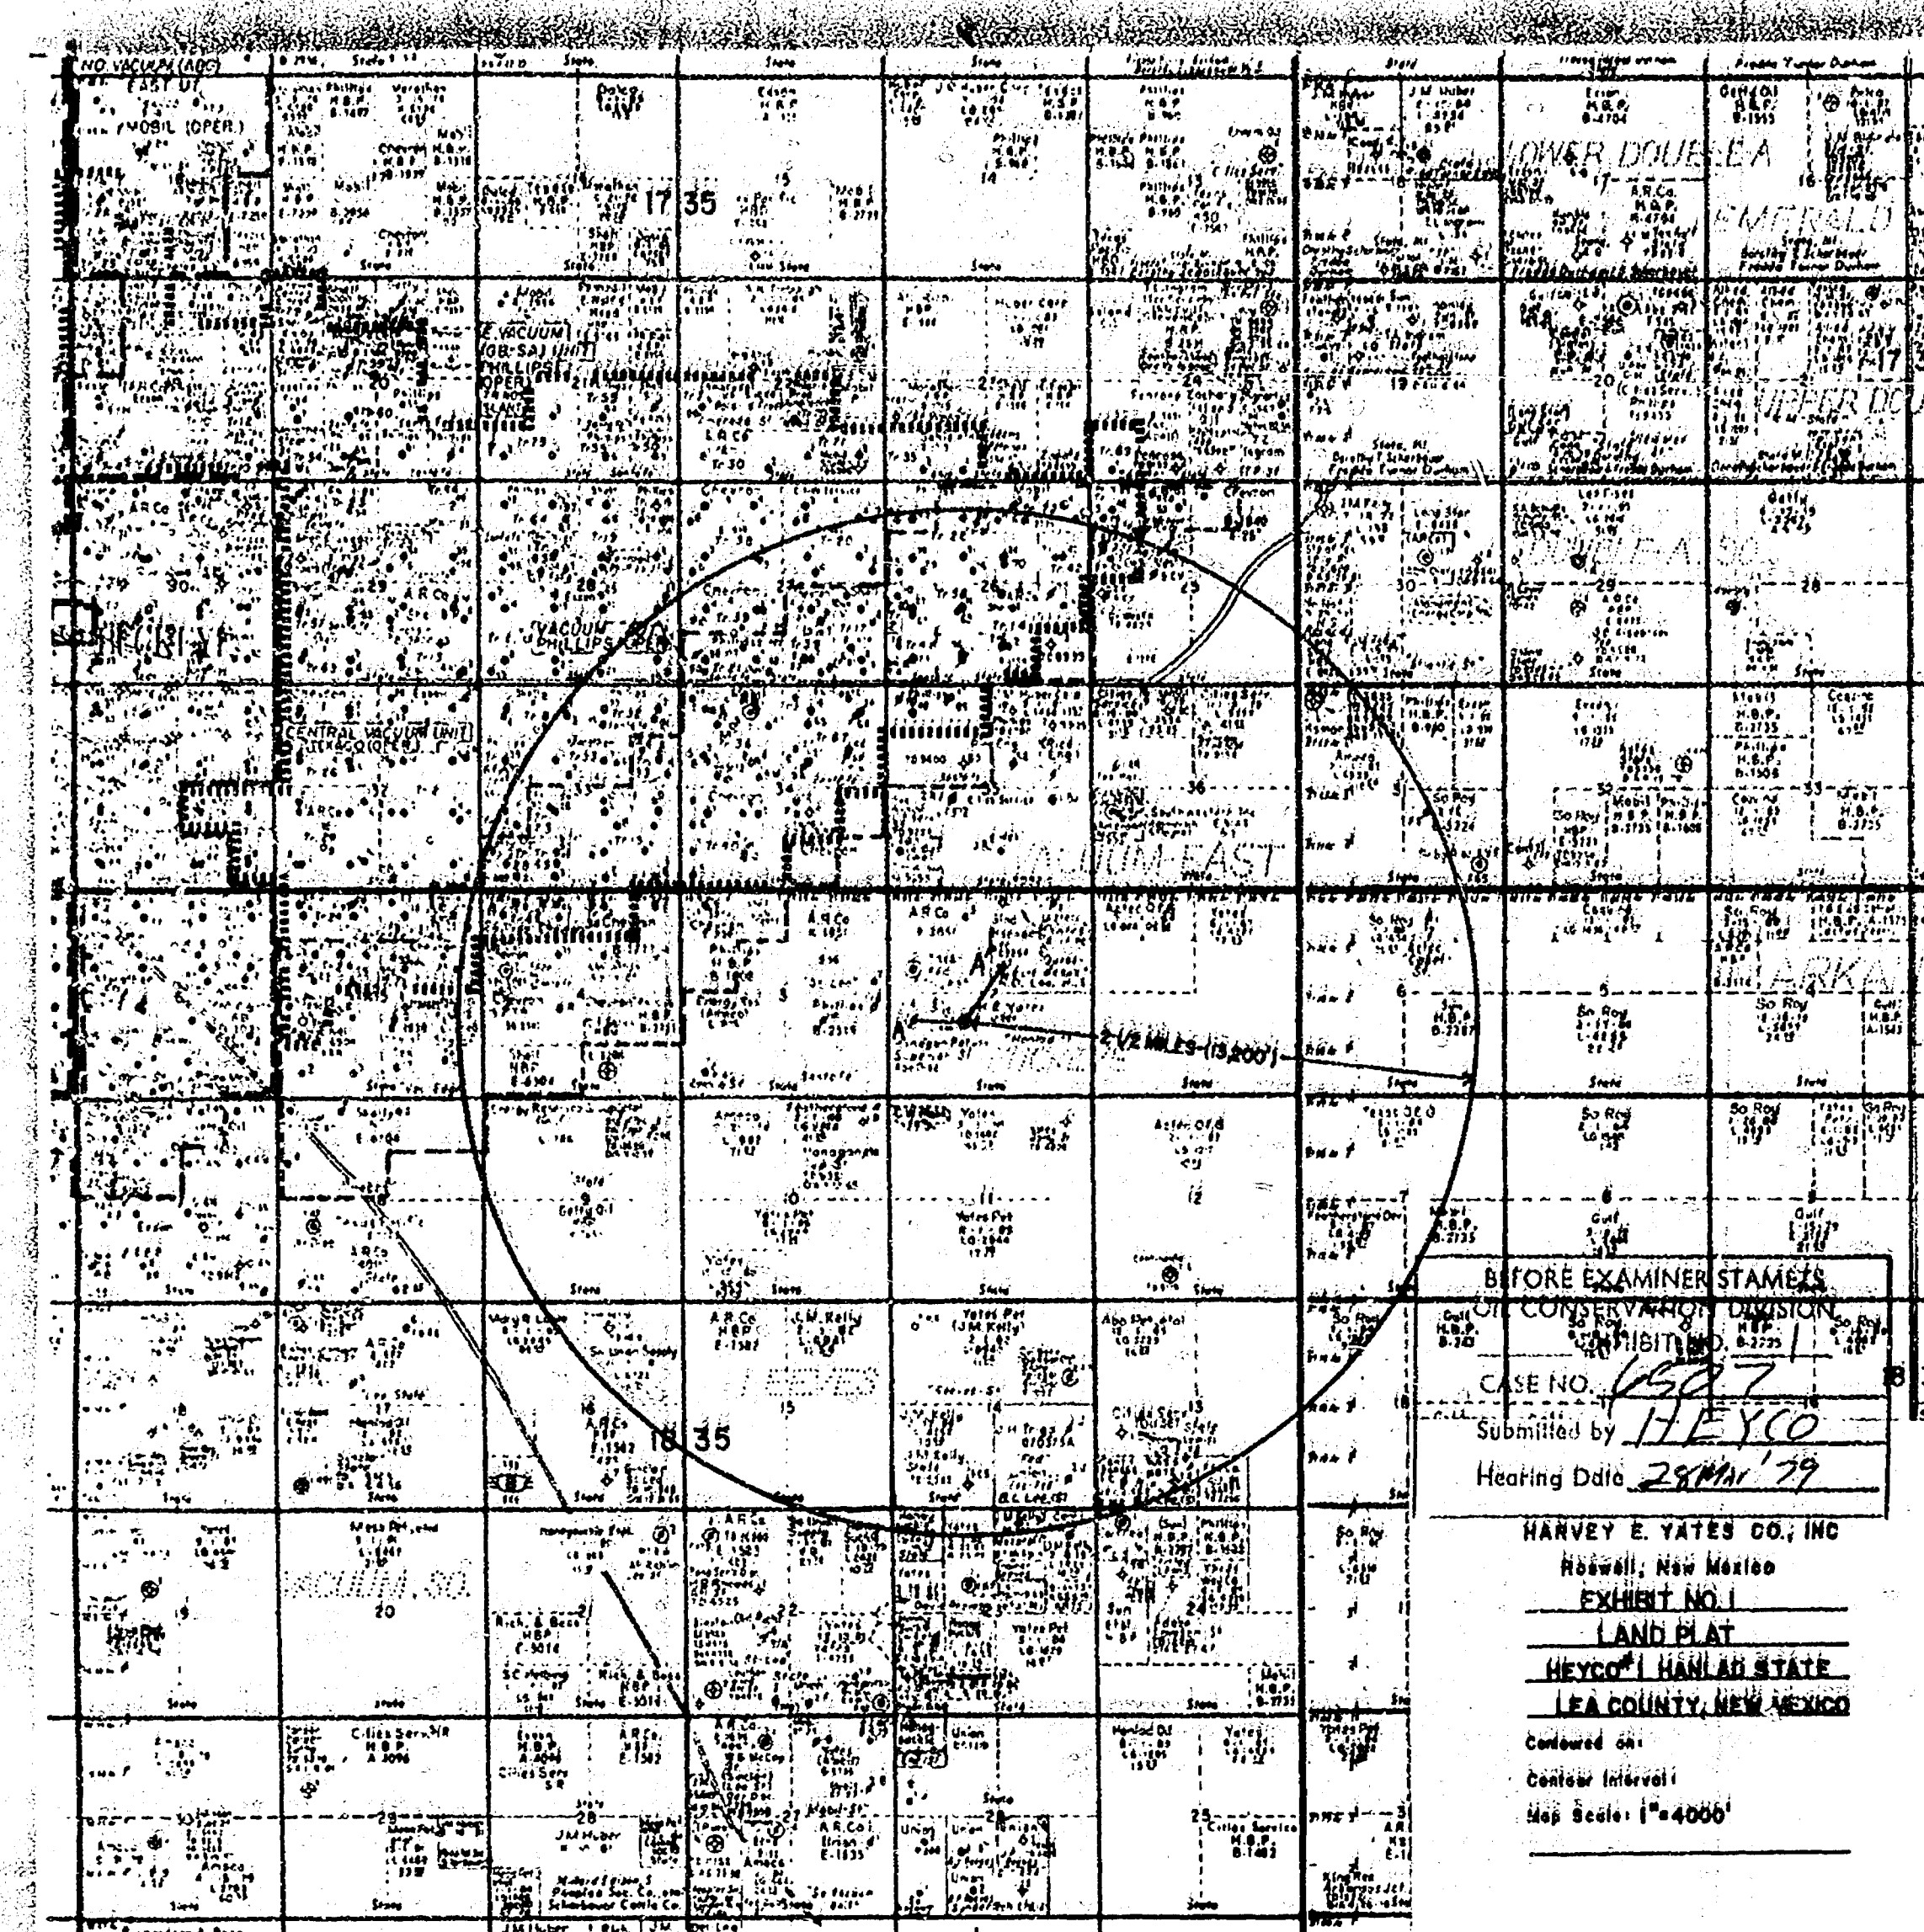
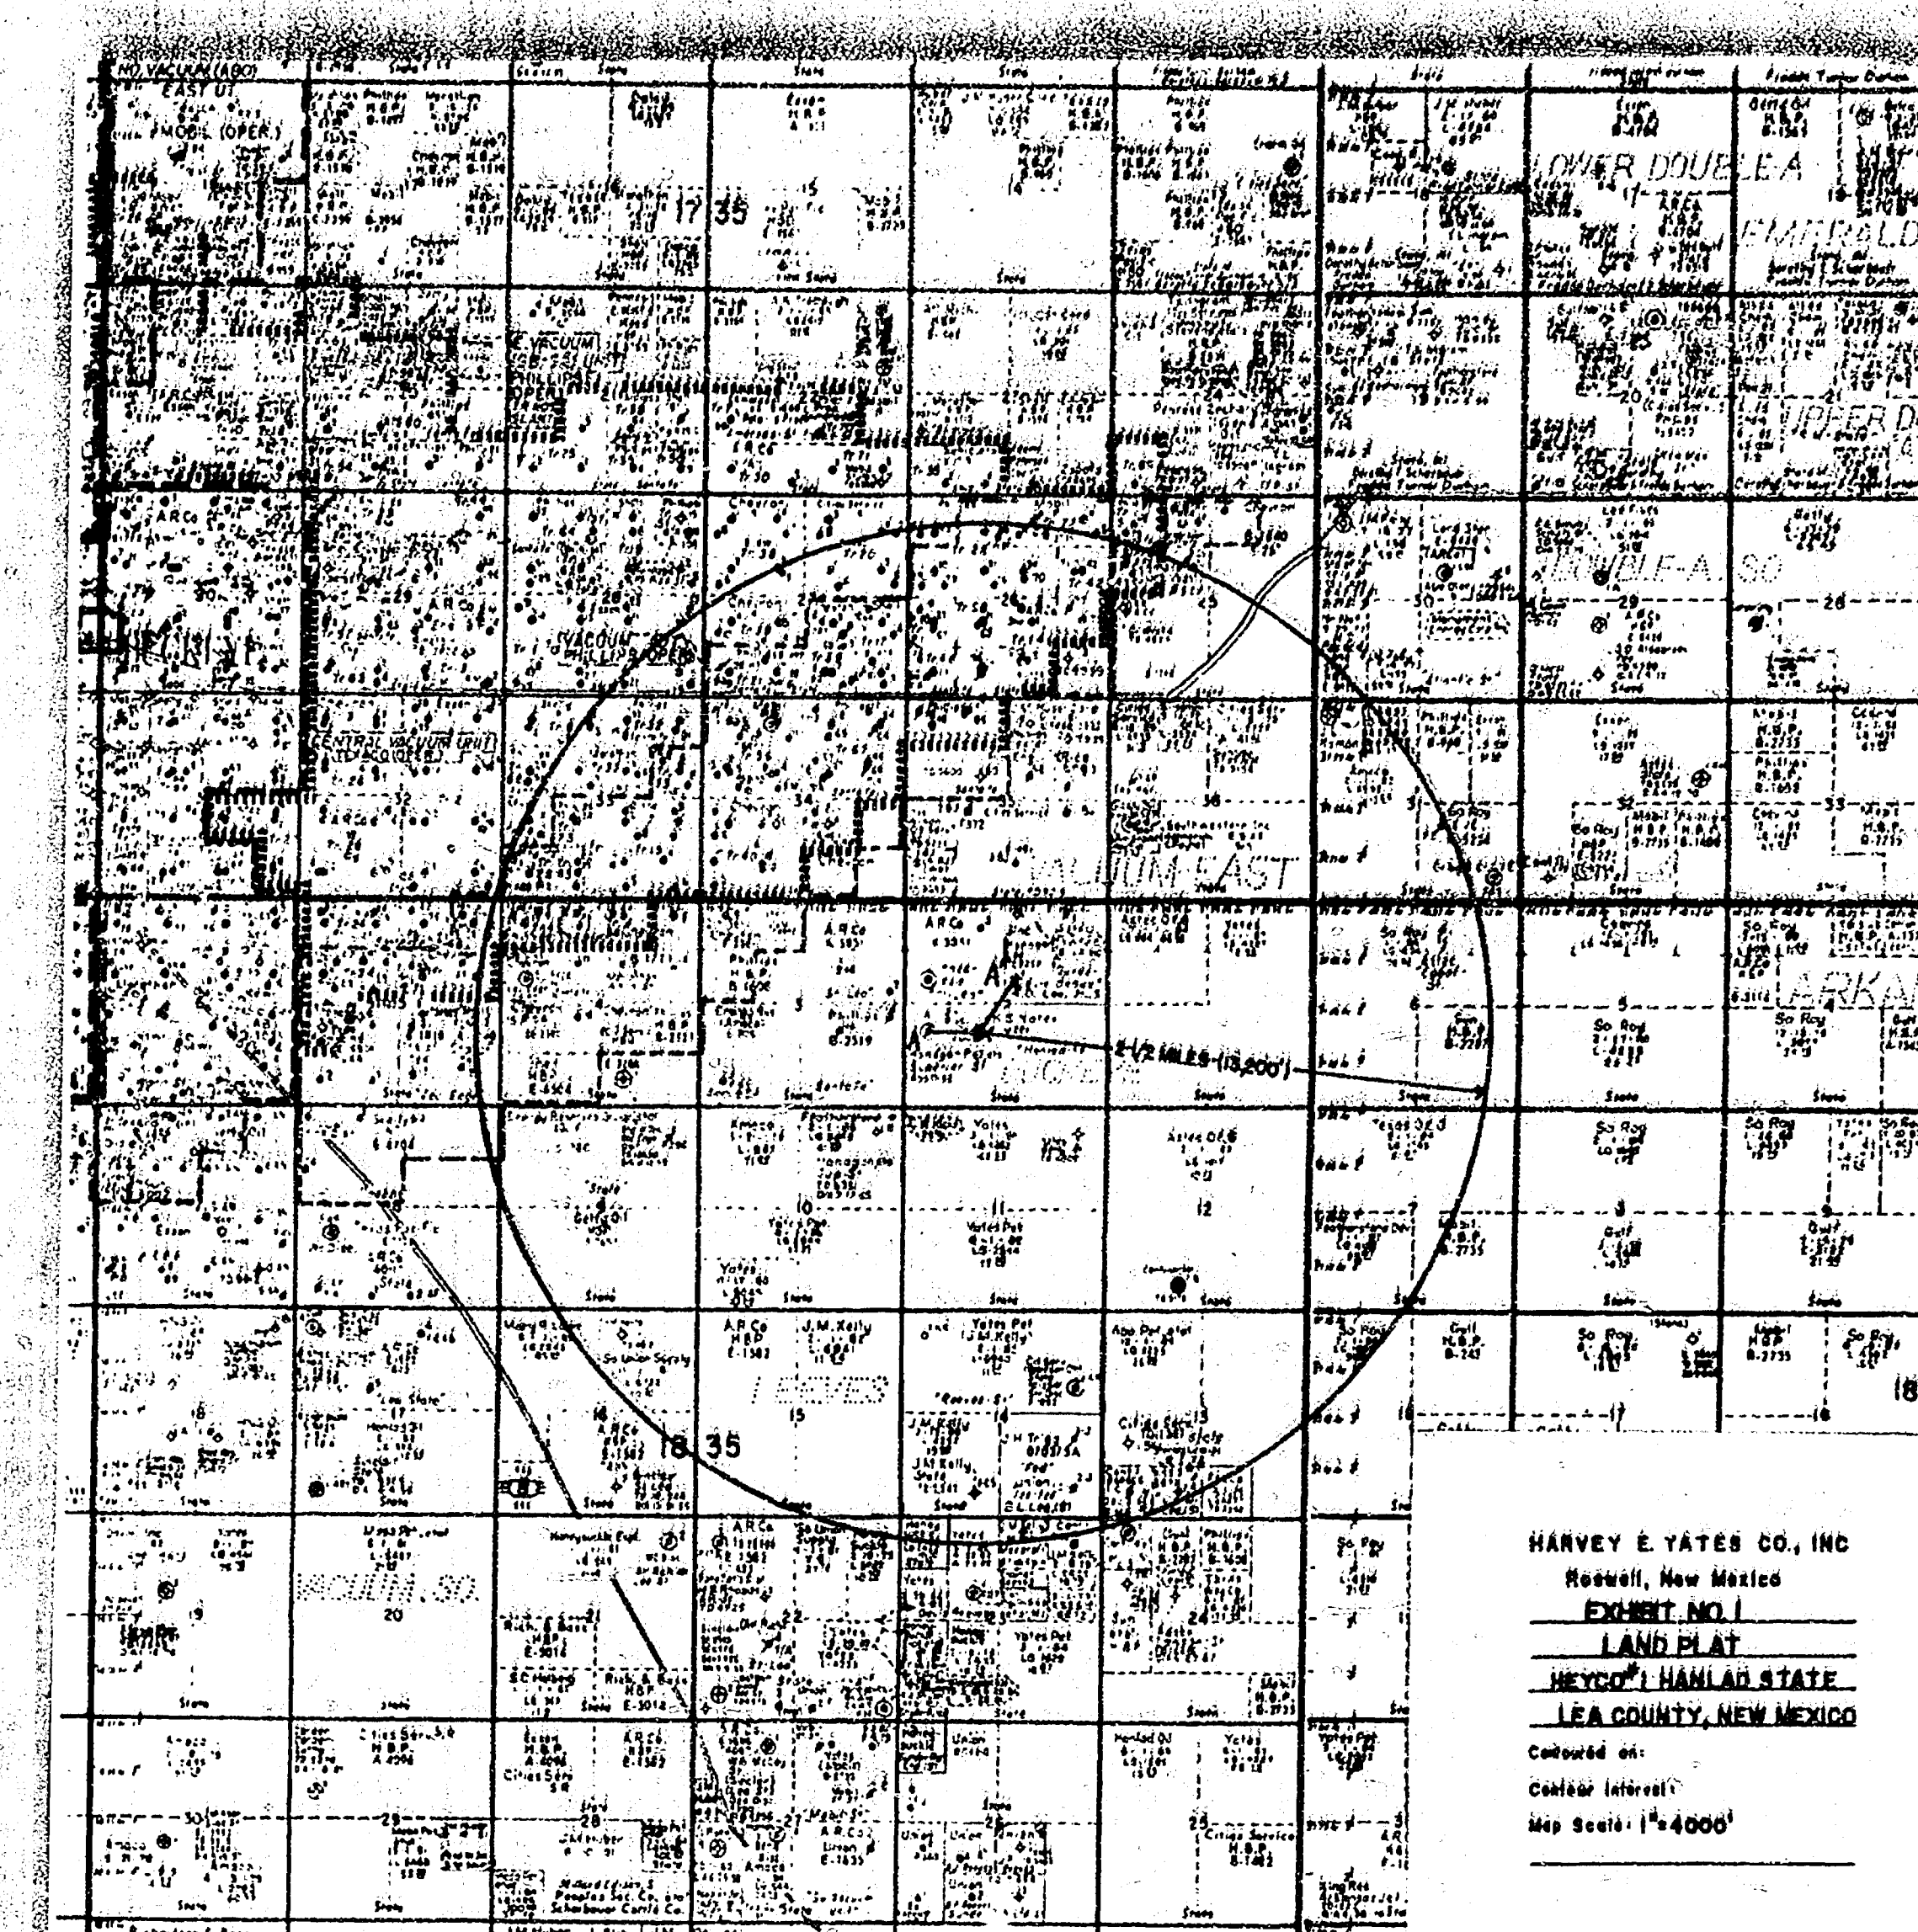
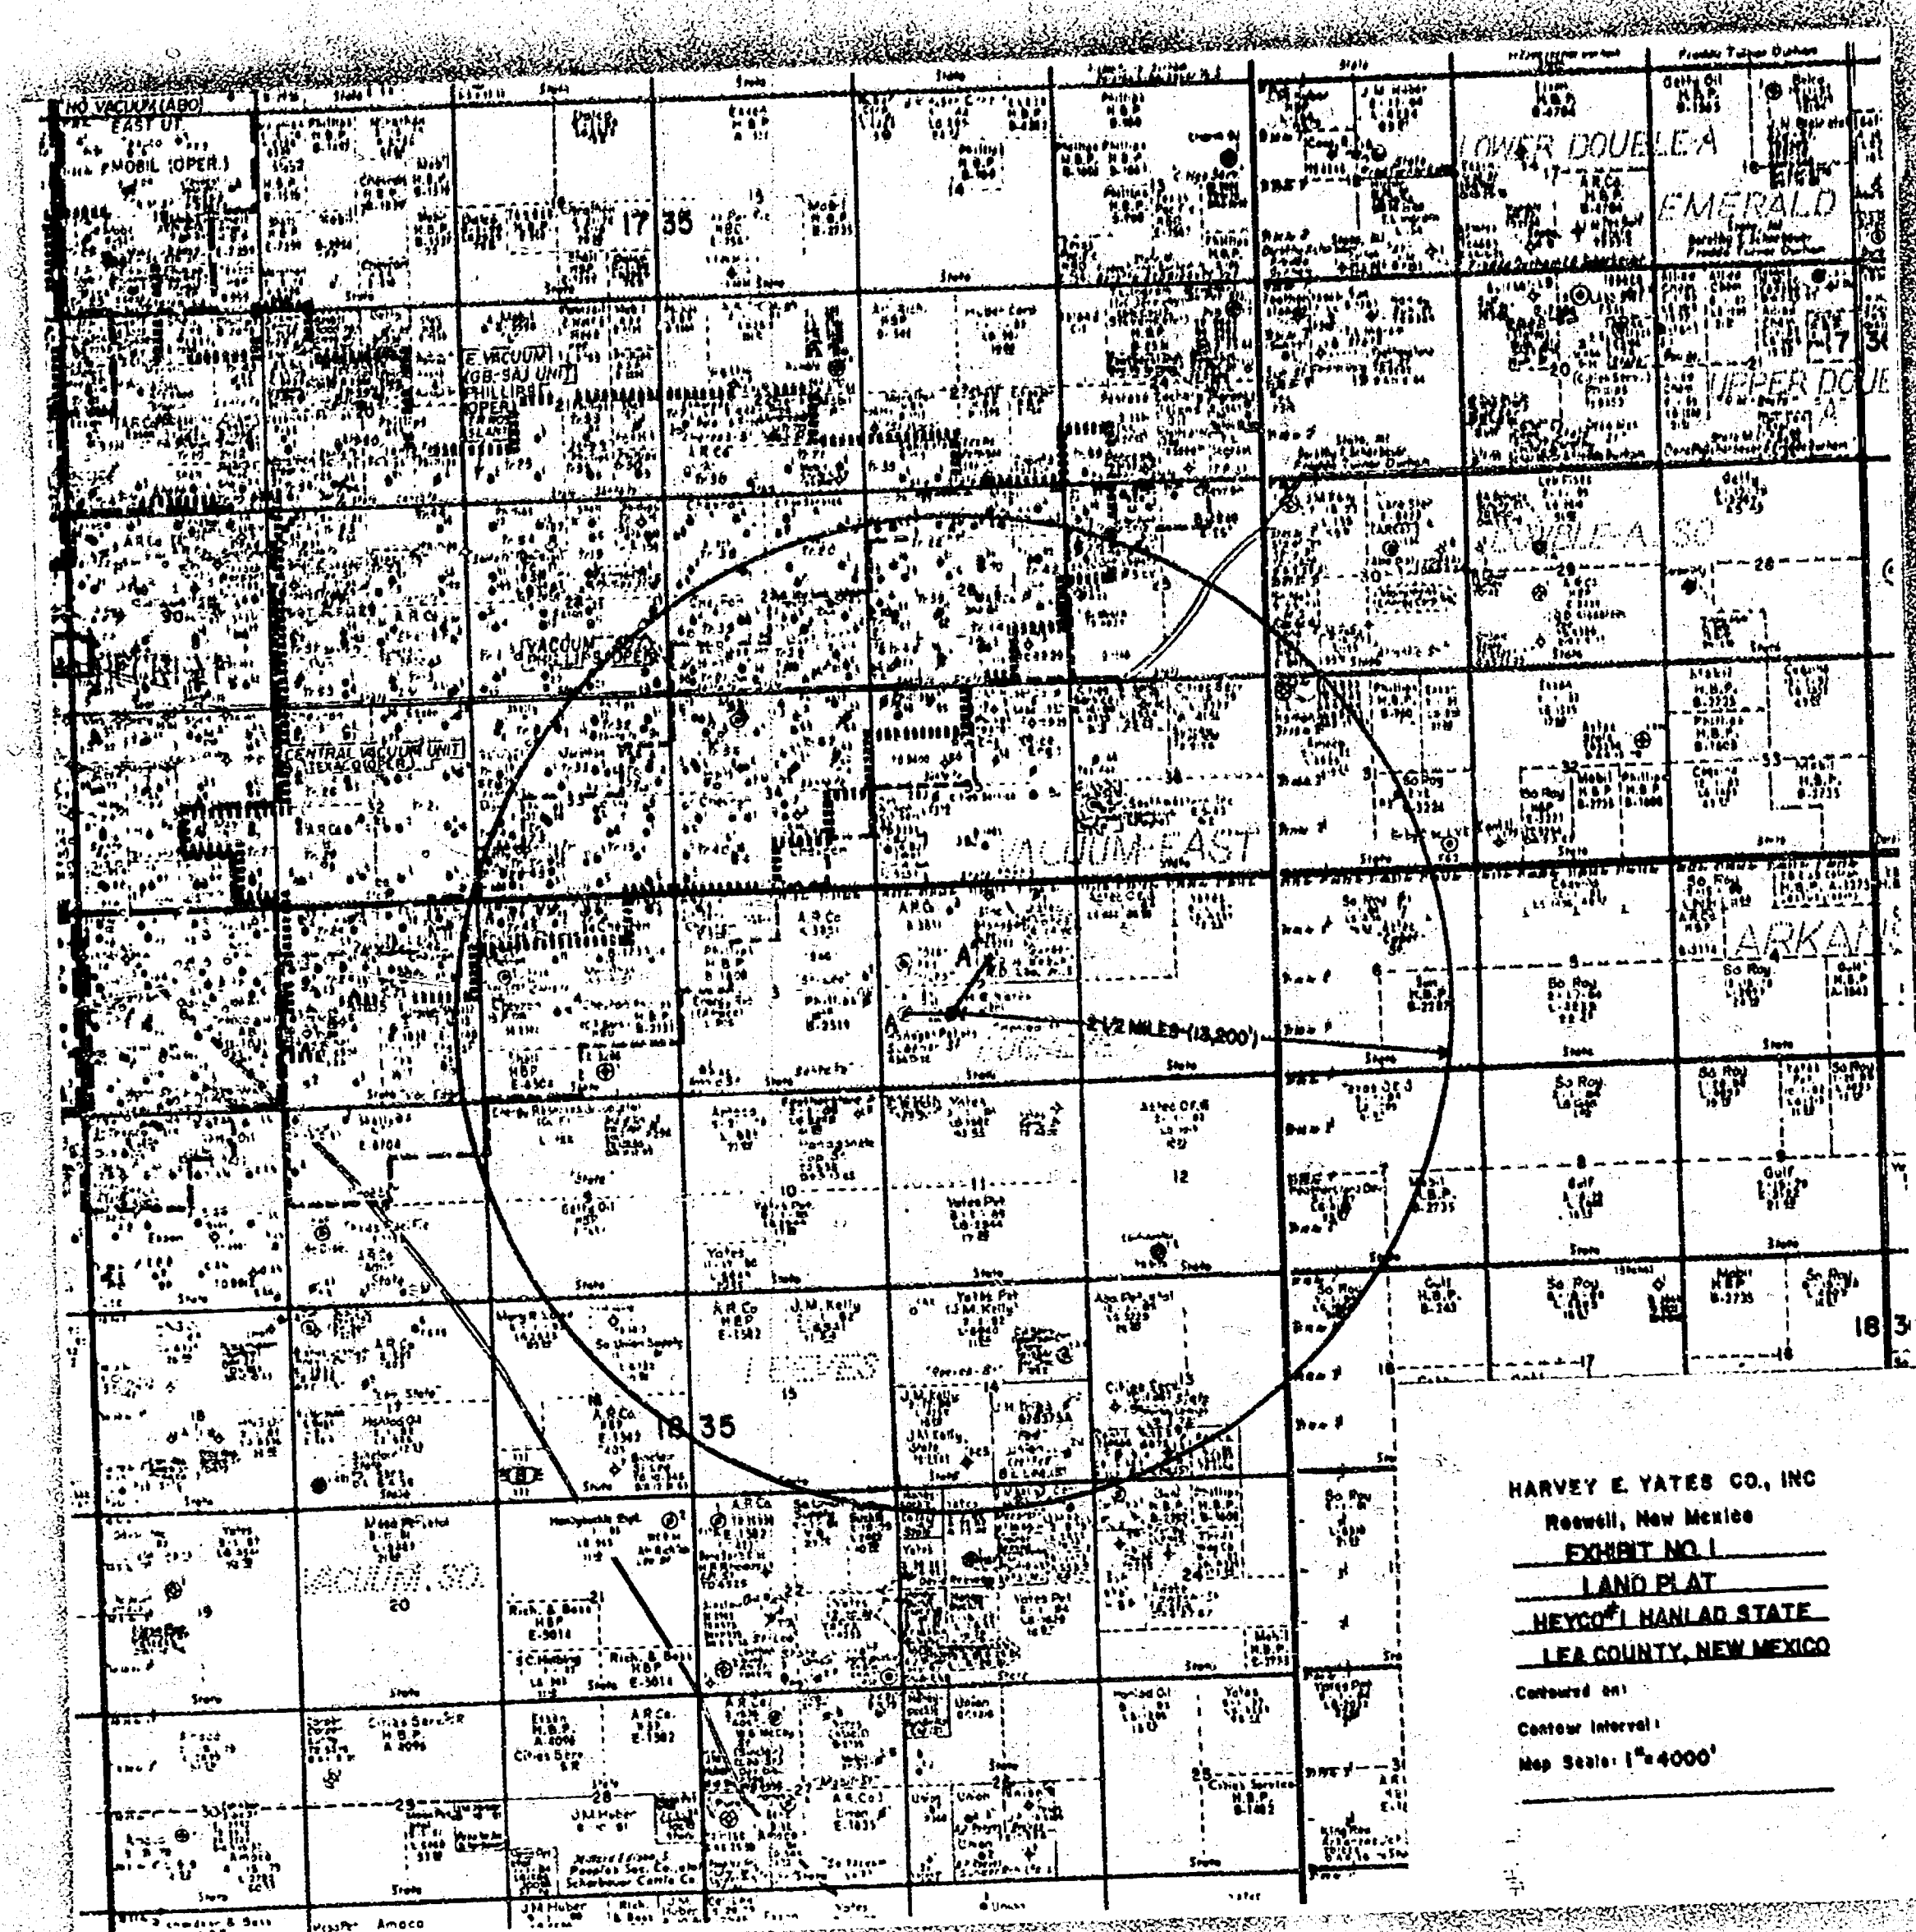
DRY 4105-4248' 00" 1/2" F  
5000 MCM/WT. 20000' 1/2"  
NO 322' 00" 1/2" 1/2" 1/2" 1/2"  
77 000' 00" 1/2" 1/2" 1/2" 1/2"  
HP 2270-2324'

SPUD: 8-15-77 COMP: 9-16-77  
IP: CAOF: 2415 MCF/GPD Prod. thru perfs  
4212-20'

SPUD: 9-9-66 COMP: 10-25-66

DATUM: TOP OF QUEEN
