Case No  
6507

EXHIBIT NO. 3  
HARVEY E. YATES COMPANY  
STRATIGRAPHIC CROSS SECTION  
A-A'  
#1 HANLAD STATE  
LEA COUNTY, NEW MEXICO  
HORIZONTAL SCALE: 1"=100' VERTICAL SCALE: 1"=100'

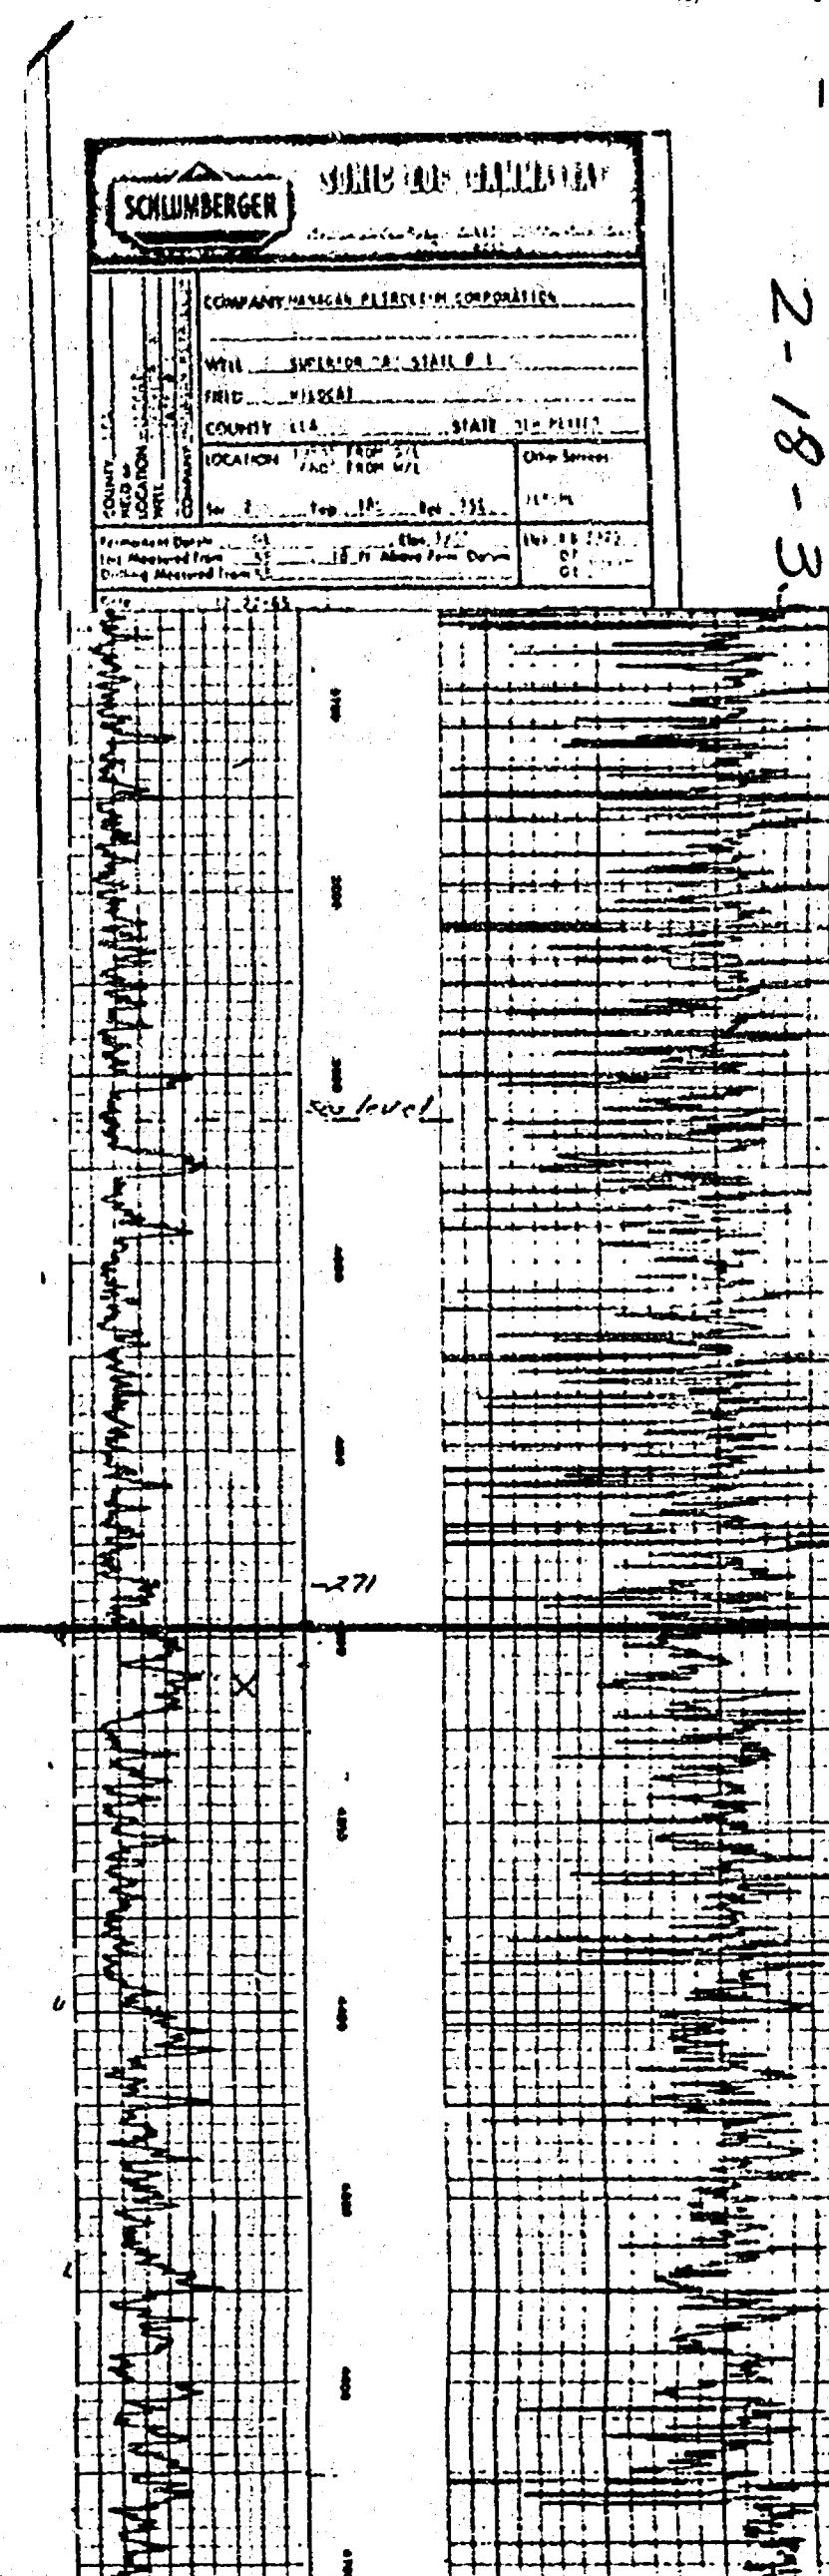
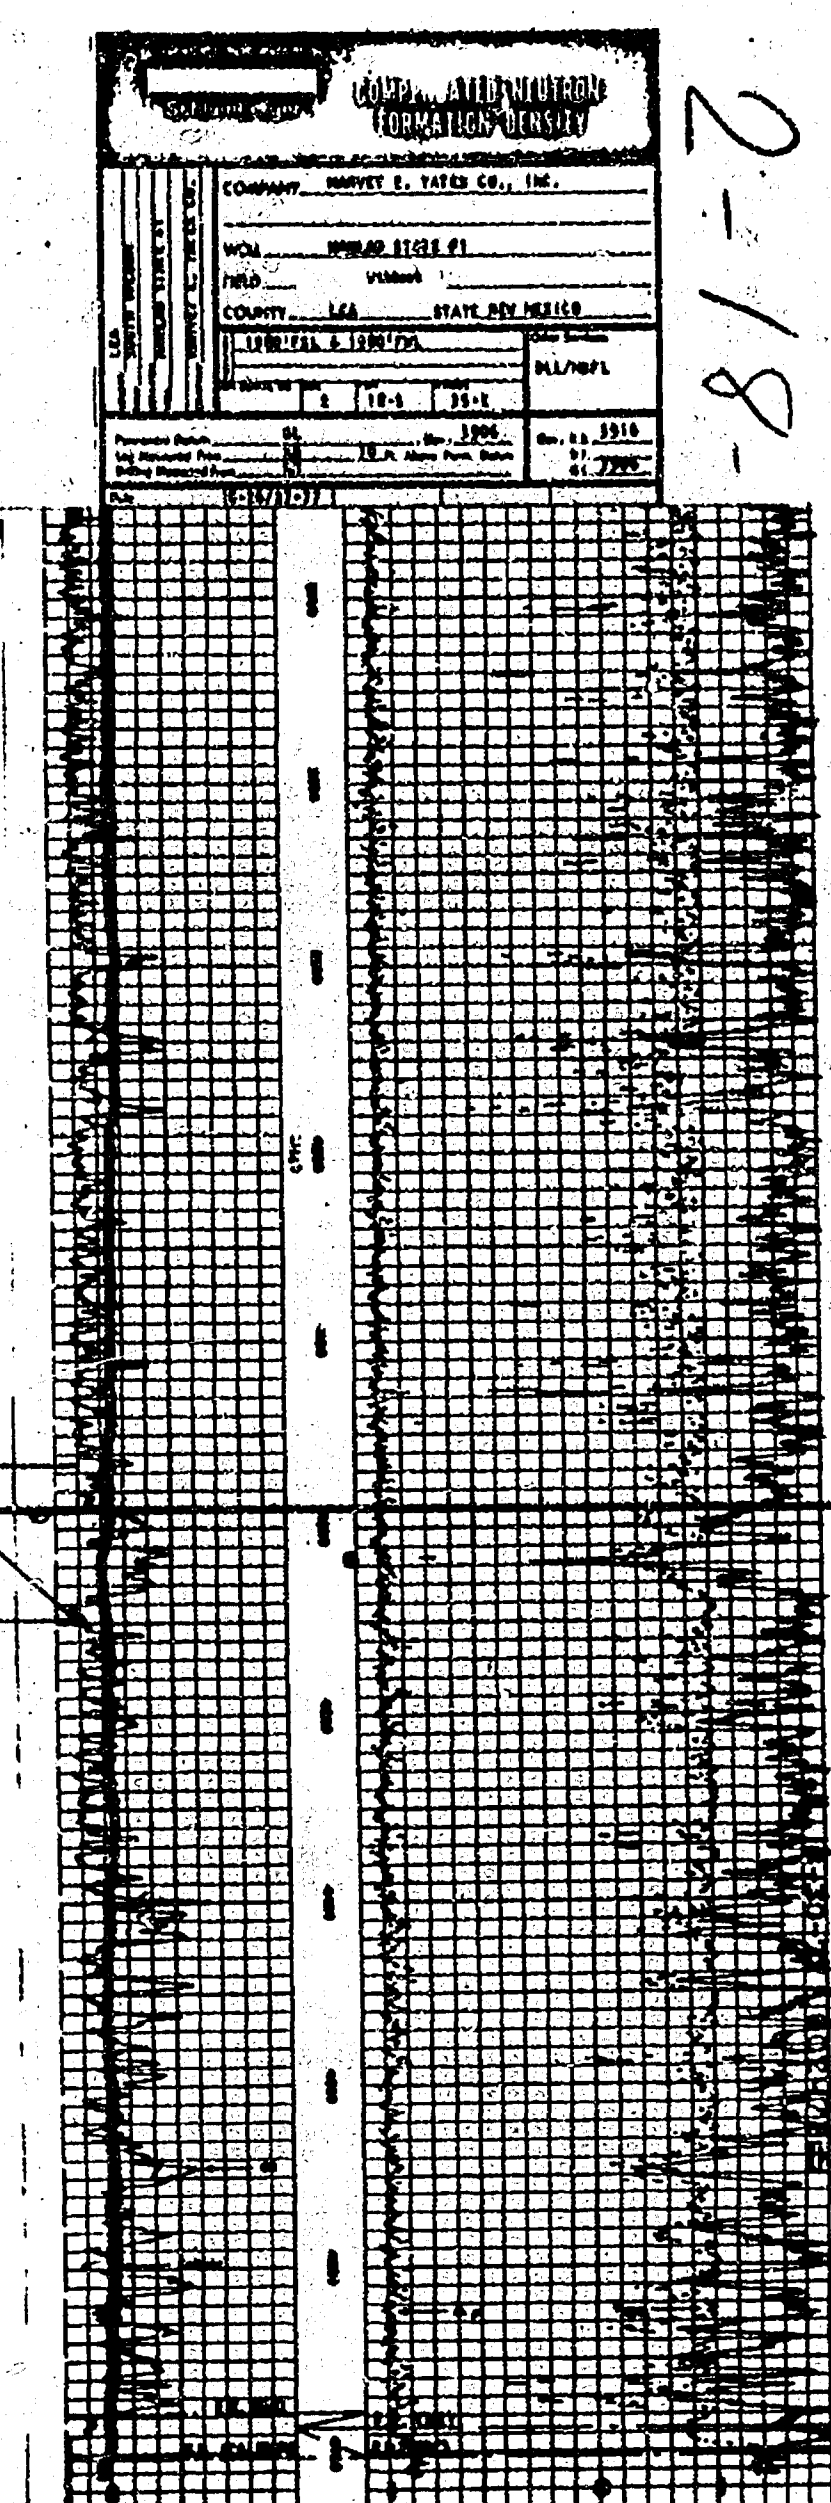
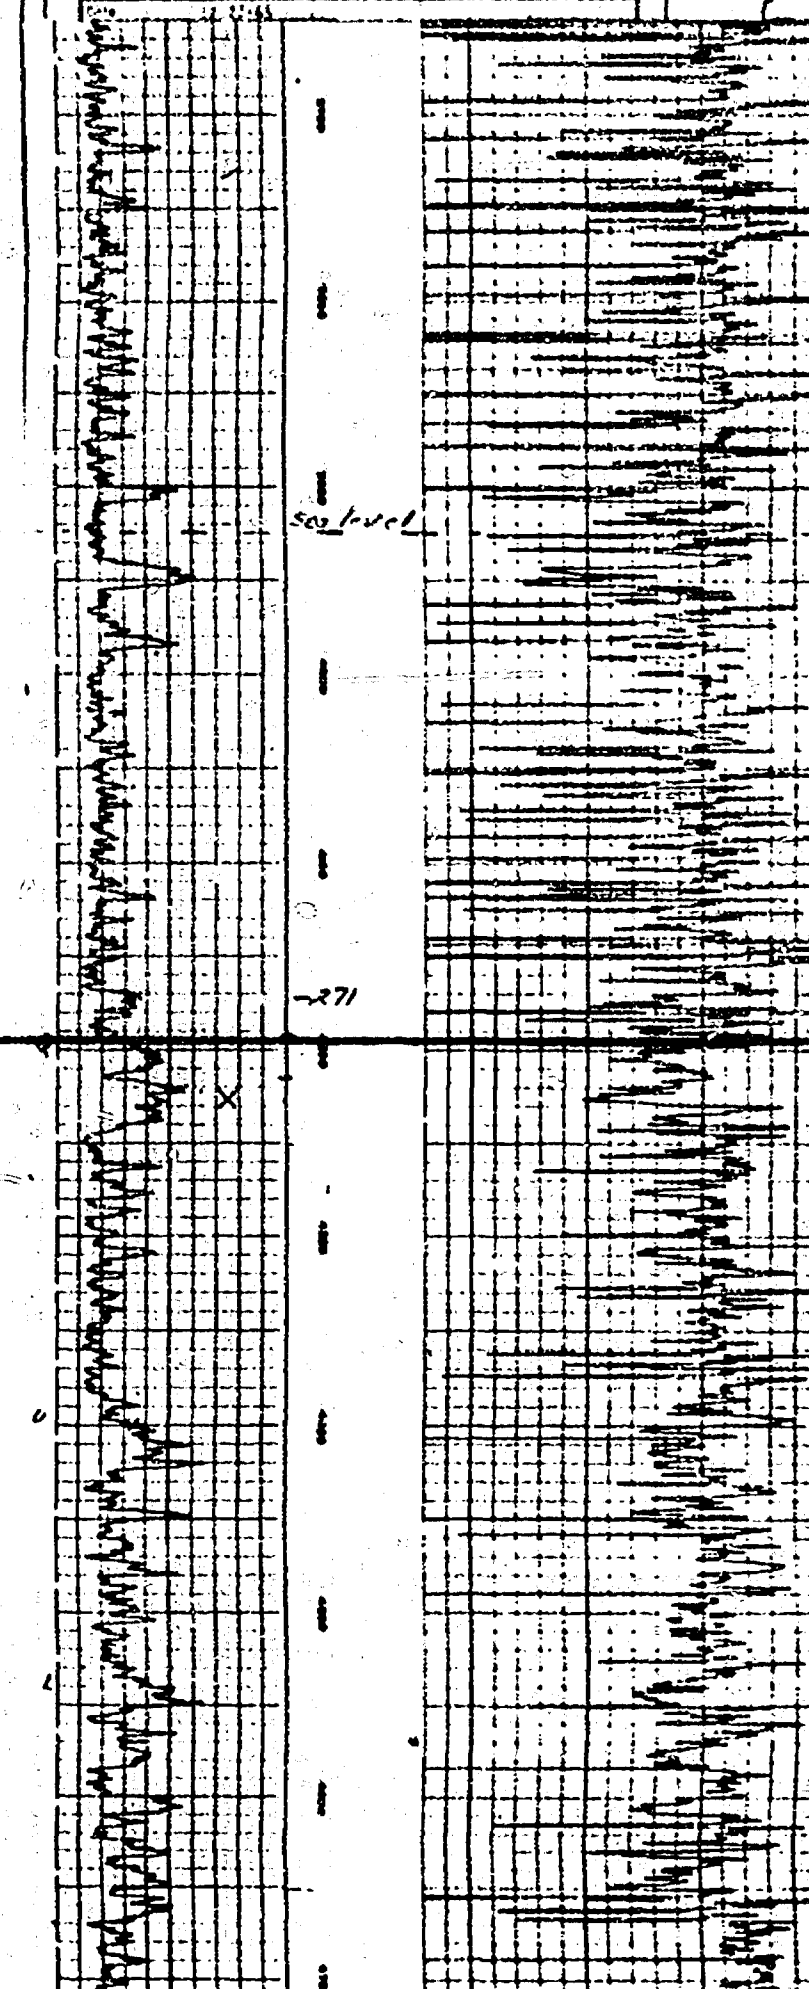
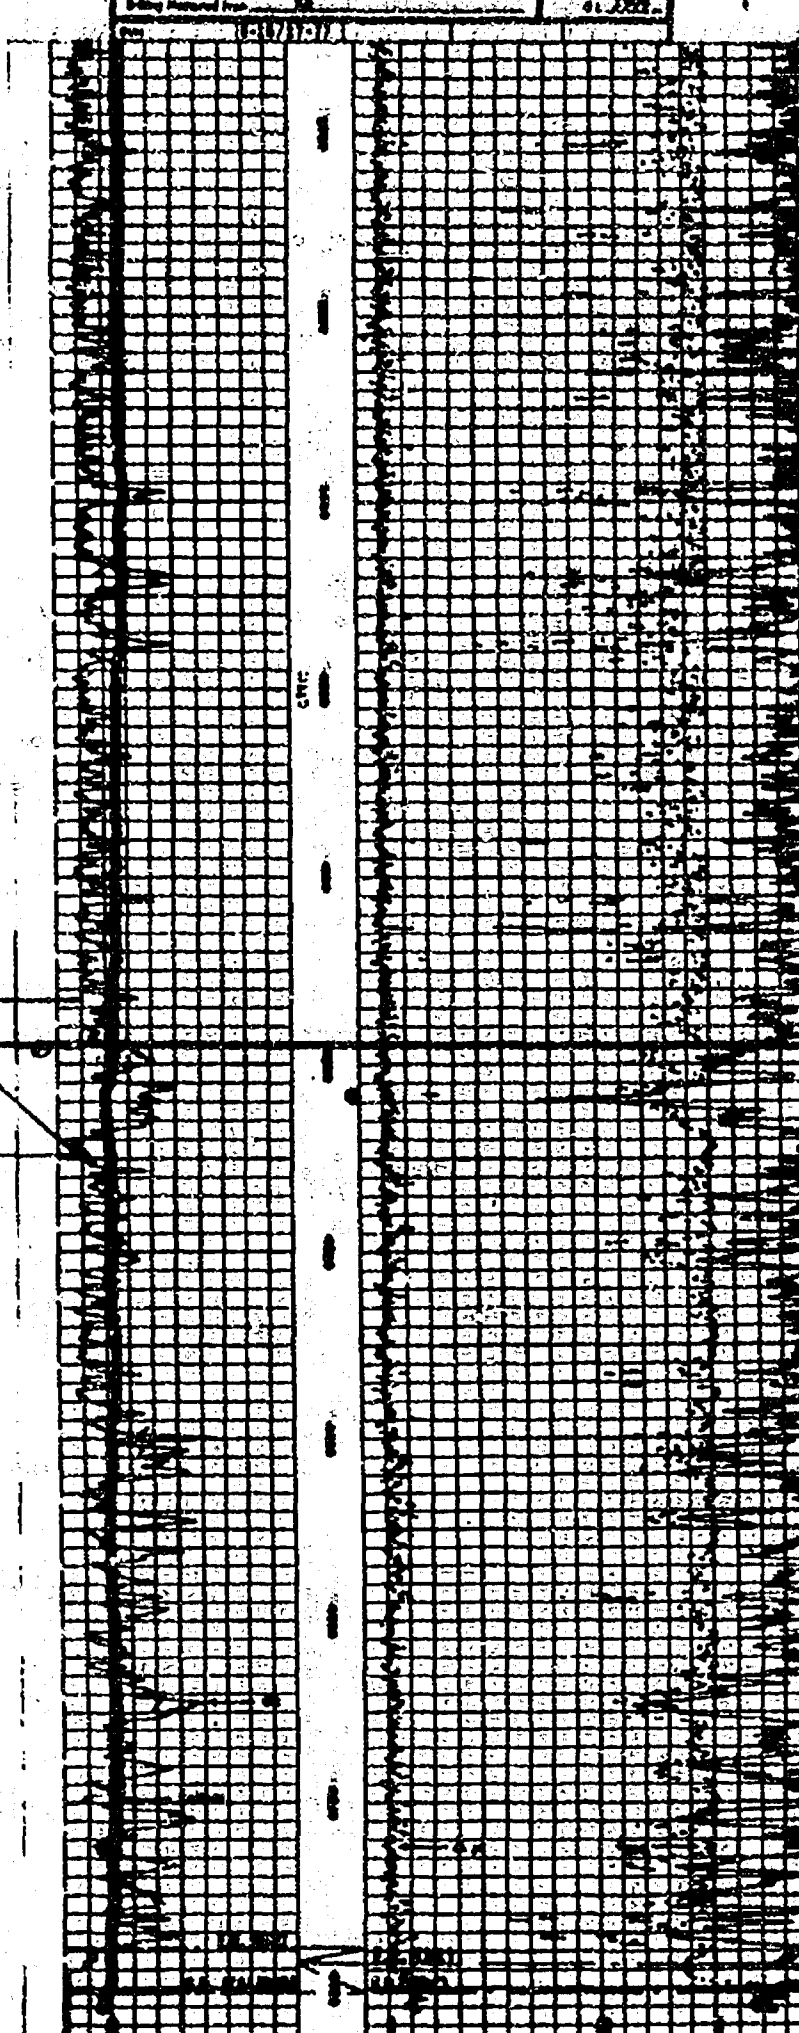
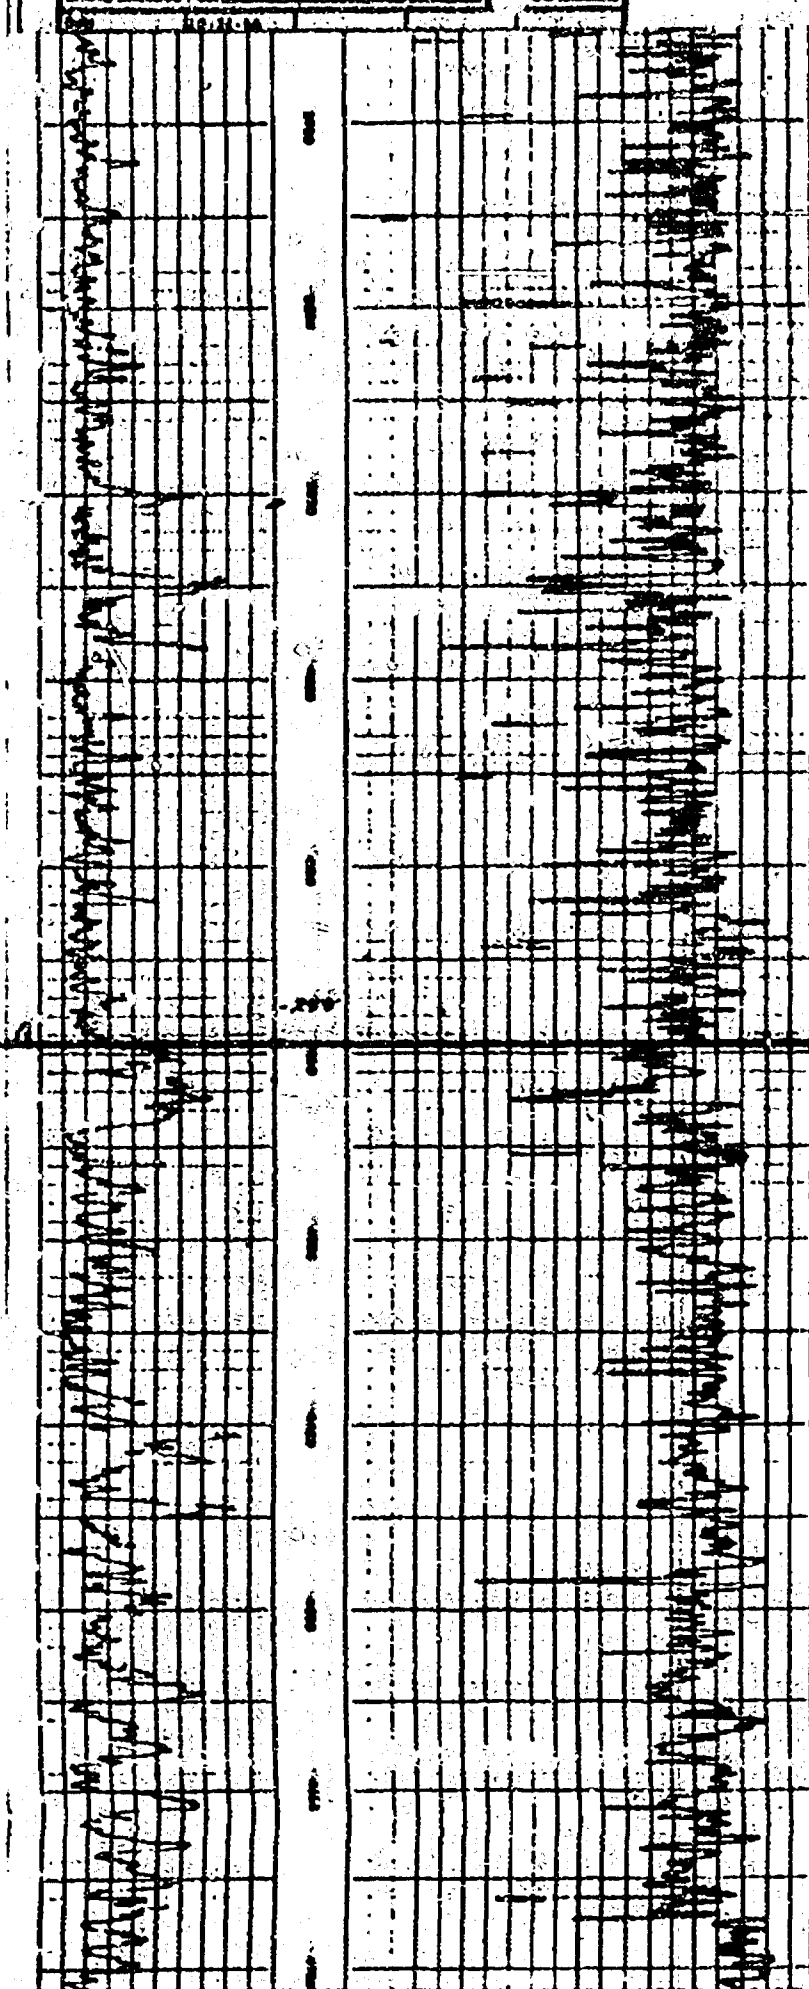
SPUD: 5-7-65 P&A: 1967

DRY 4105-4248' 00" 1/2" F  
5000 MCM/WT. 20000' 1/2"  
NO 322' 00" 1/2" 1/2" 1/2" 1/2"  
77 000' 00" 1/2" 1/2" 1/2" 1/2"  
HP 2270-2324'

SPUD: 8-15-77 COMP: 9-16-77  
IP: CAOF: 2415 MCF/GPD Prod. thru perfs  
4212-20'

SPUD: 9-9-66 COMP: 10-25-66

DATUM: TOP OF QUEEN

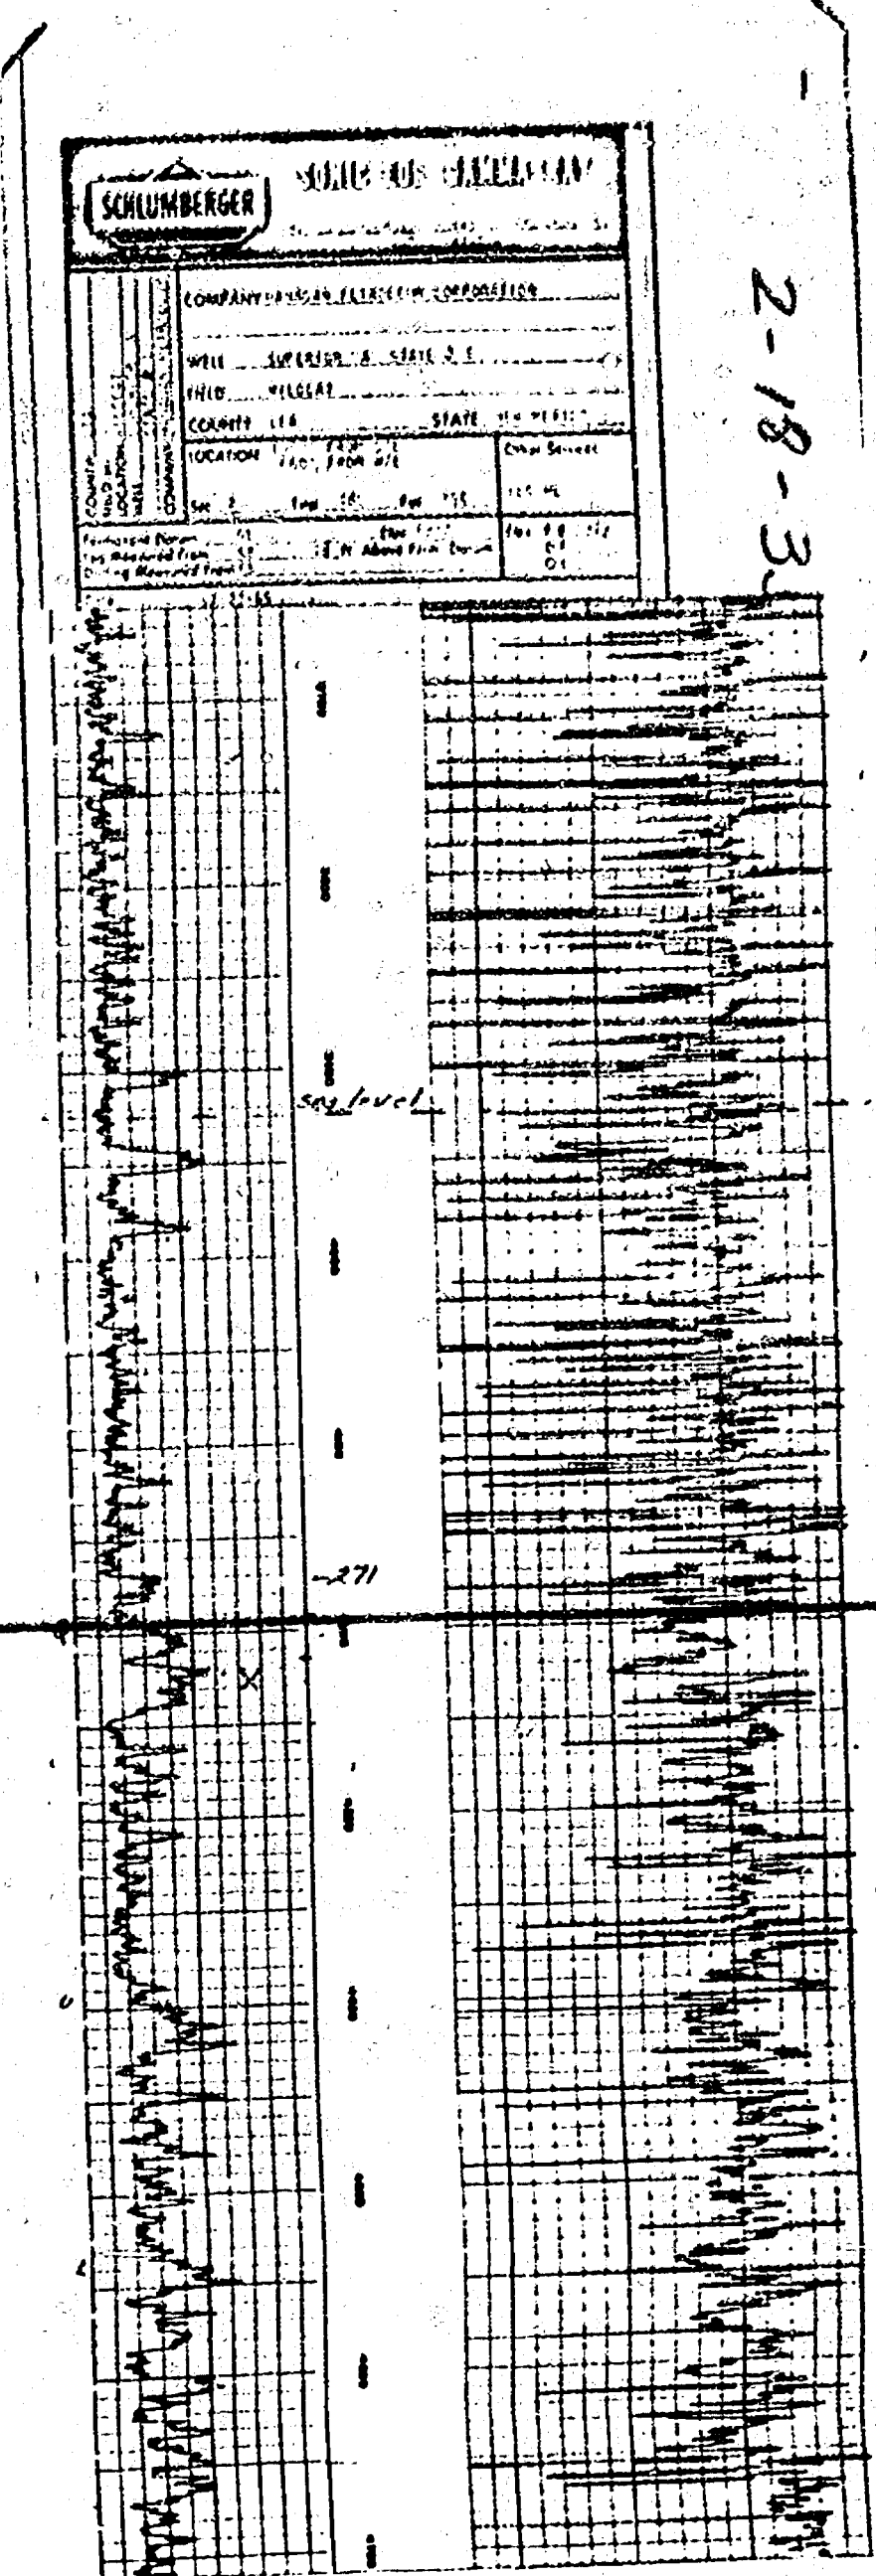
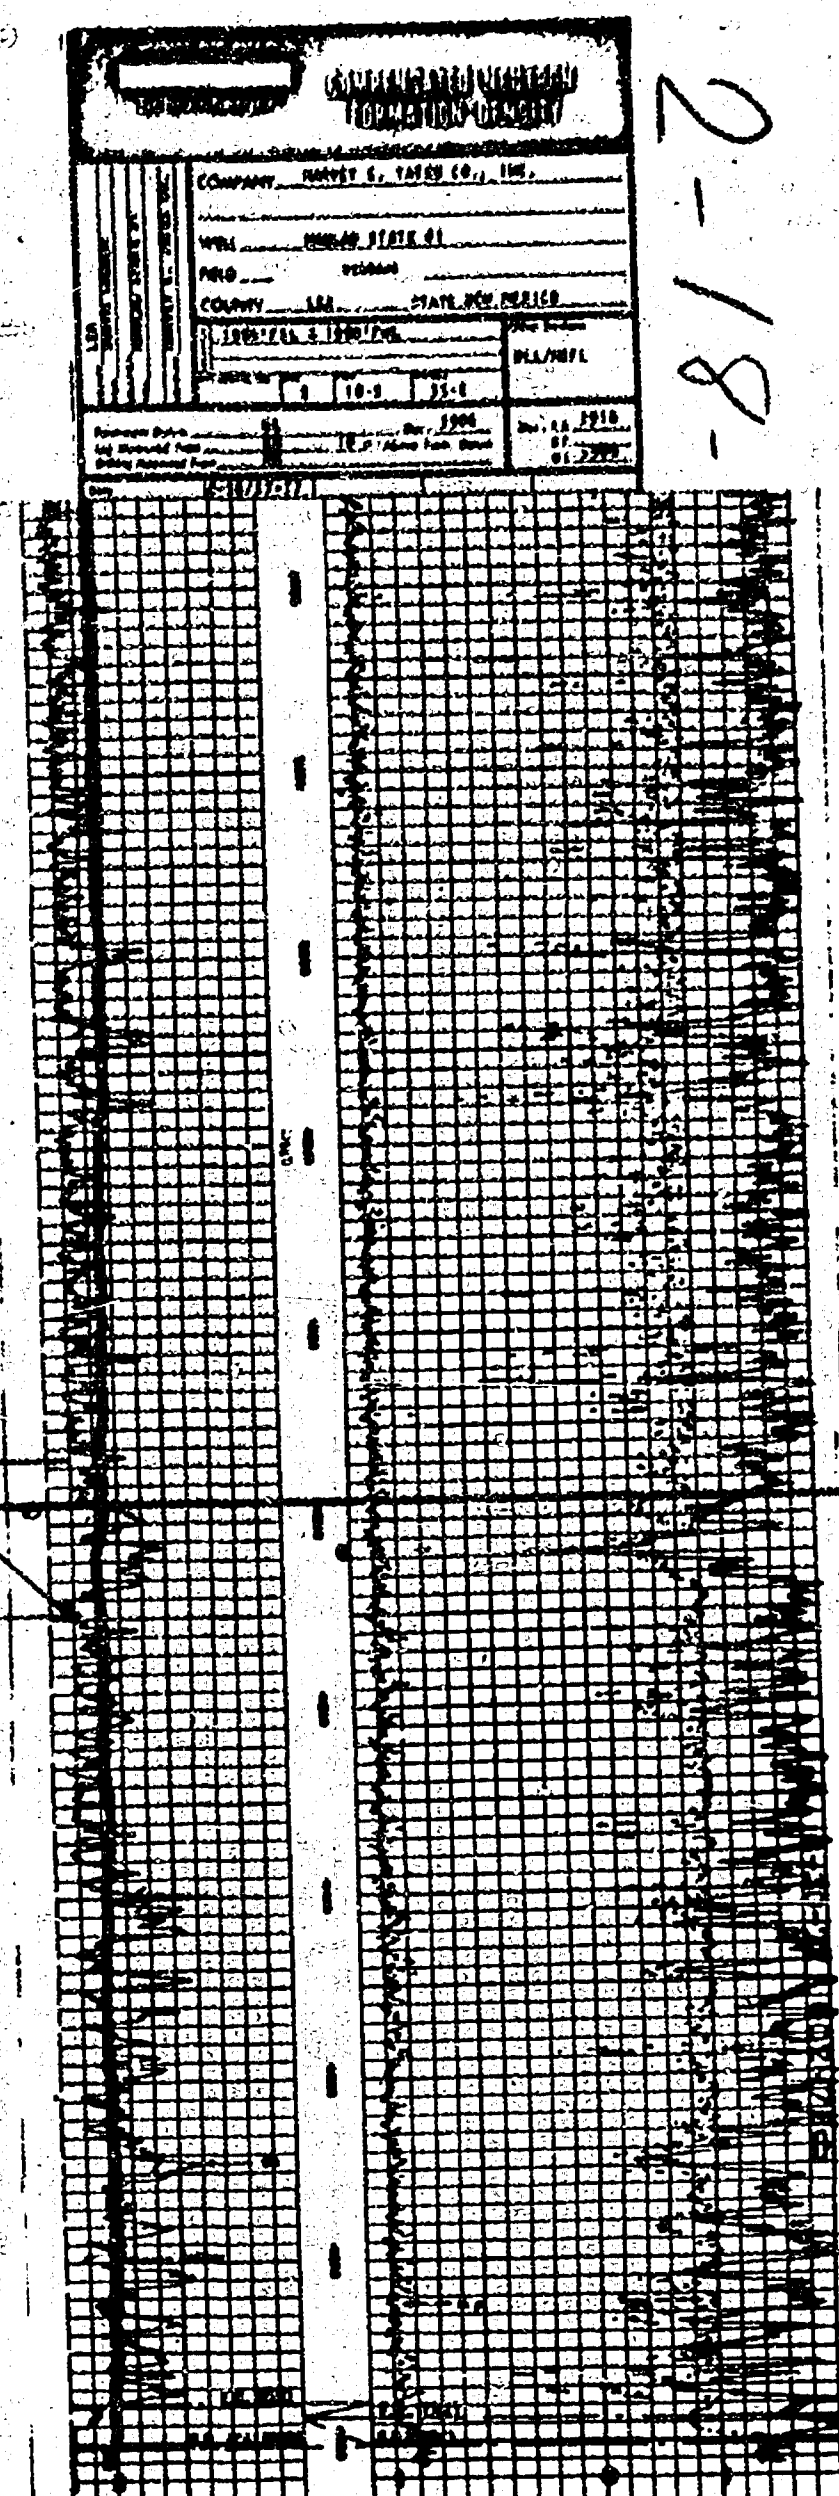
EXHIBIT NO. 3  
HARVEY E. YATES COMPANY  
STRATIGRAPHIC CROSS SECTION  
A-A'  
#1 HANLAD STATE  
LEA COUNTY, NEW MEXICO  
HORIZONTAL SCALE: 1"=100' VERTICAL SCALE: 1"=100'

SPUD: 5-7-65 PBA: 1967

SPUD: 8-15-77 COMP: 9-16-77  
IPCAOF: 2415 MCF/GPD Prod. thru perfs  
4212-20'

SPUD: 9-9-66 COMP: 10-25-66

DATUM: TOP OF QUEEN

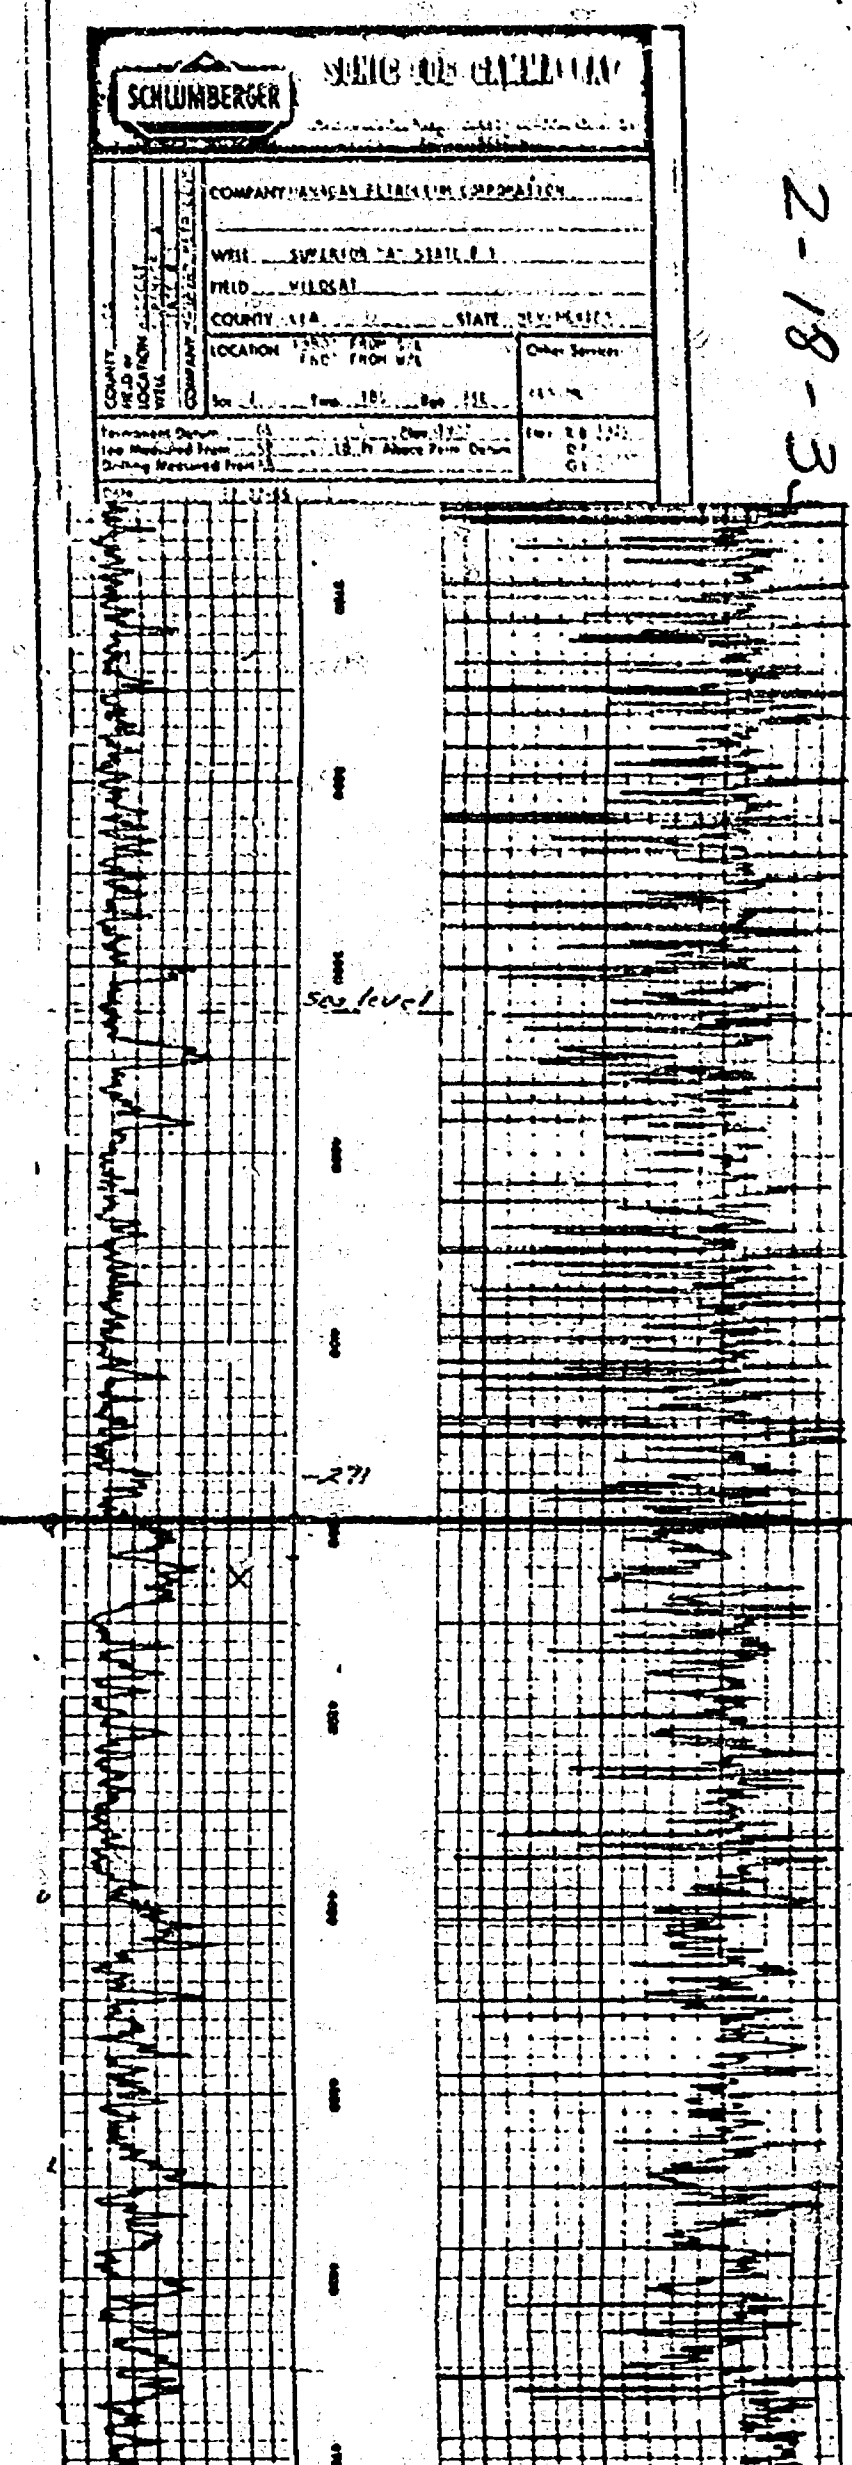
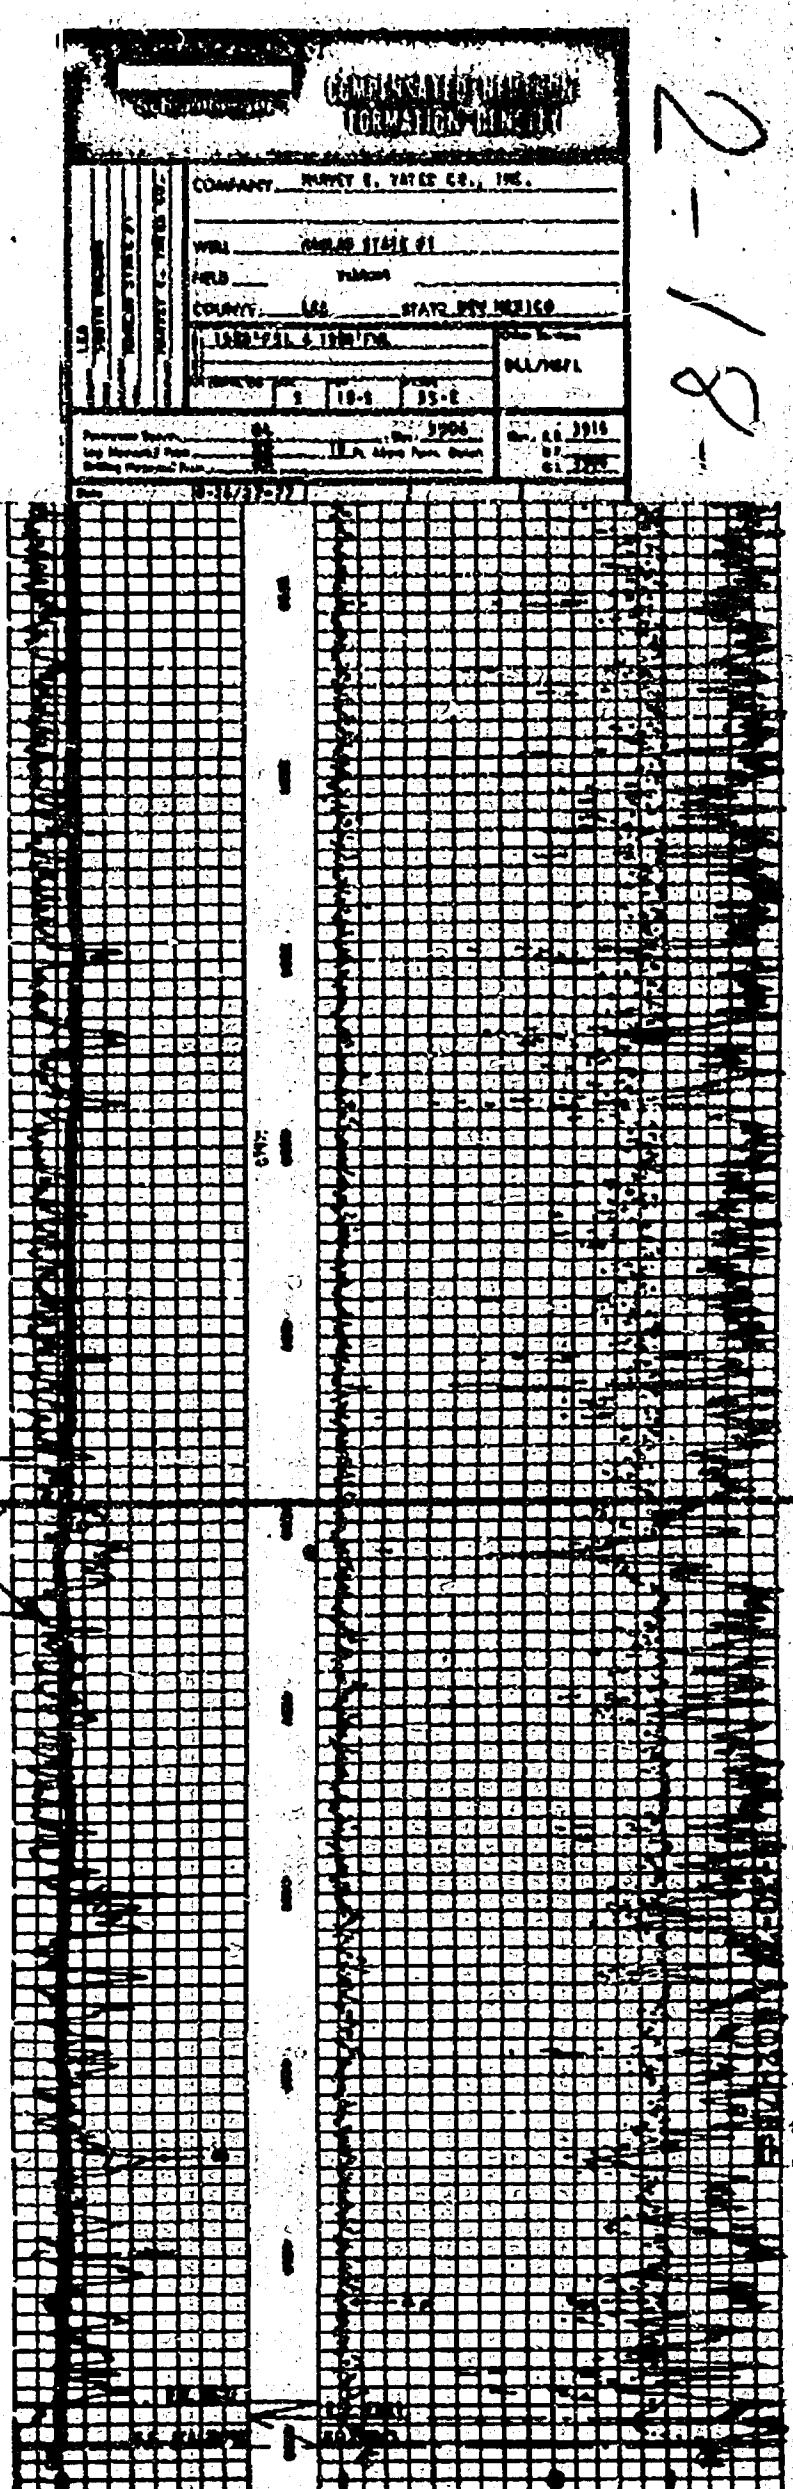
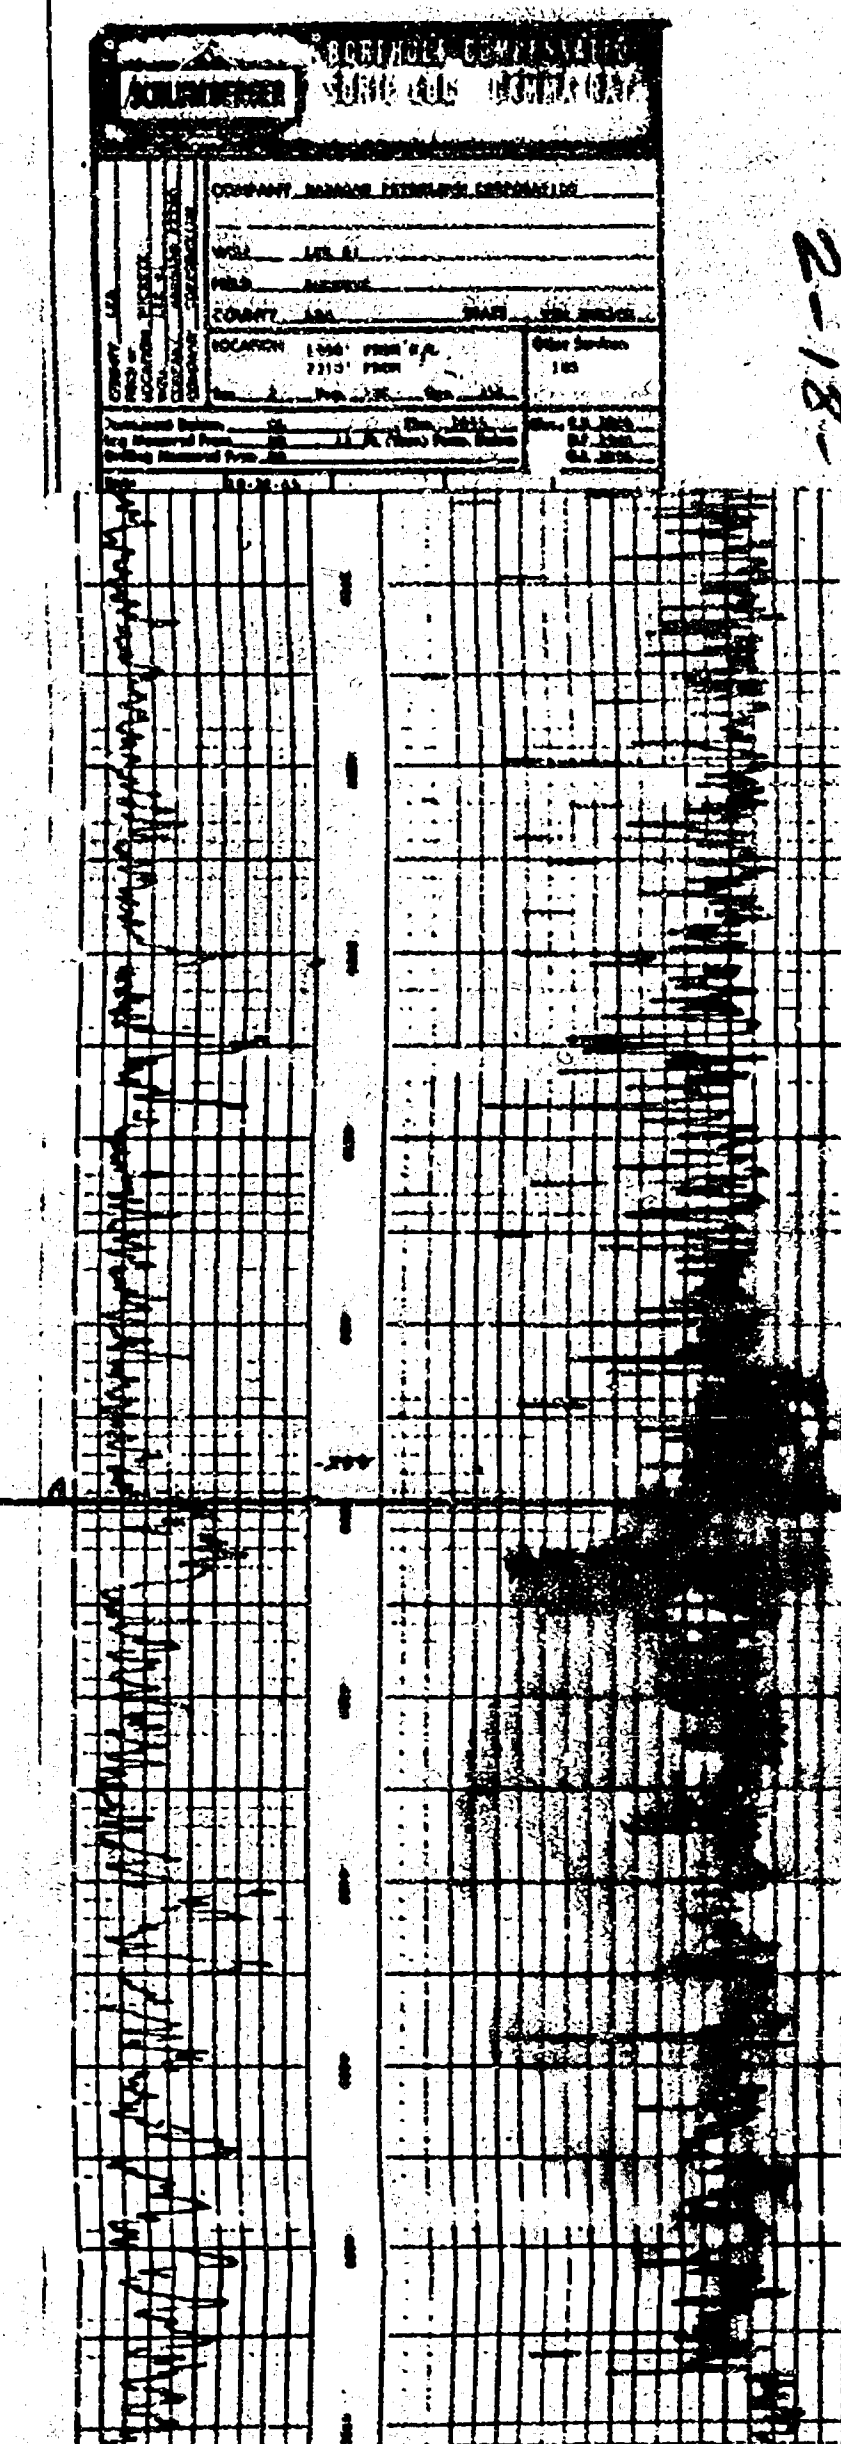
EXHIBIT NO. 3  
HARVEY E. YATES COMPANY  
STRATIGRAPHIC CROSS SECTION  
A-A'  
#1 HANLAD STATE  
LEA COUNTY, NEW MEXICO  
HORIZONTAL SCALE: NONE VERTICAL SCALE: 1"=100'

SPUD: 5-7-65 PBA: 1967

SPUD: 9-15-77 COMP: 9-16-77  
IPCAOP: 2415 MCFPD Prod. thru perf  
4212-20

SPUD: 9-9-66 COMP: 10-25-66

DATUM: TOP OF QUEEN
