Case No  
6507

EXHIBIT NO. 3  
HARVEY E. YATES COMPANY  
STRATIGRAPHIC CROSS SECTION  
A-A'  
#1 HANLAD STATE  
LEA COUNTY, NEW MEXICO  
HORIZONTAL SCALE: 1"=100' VERTICAL SCALE: 1"=100'

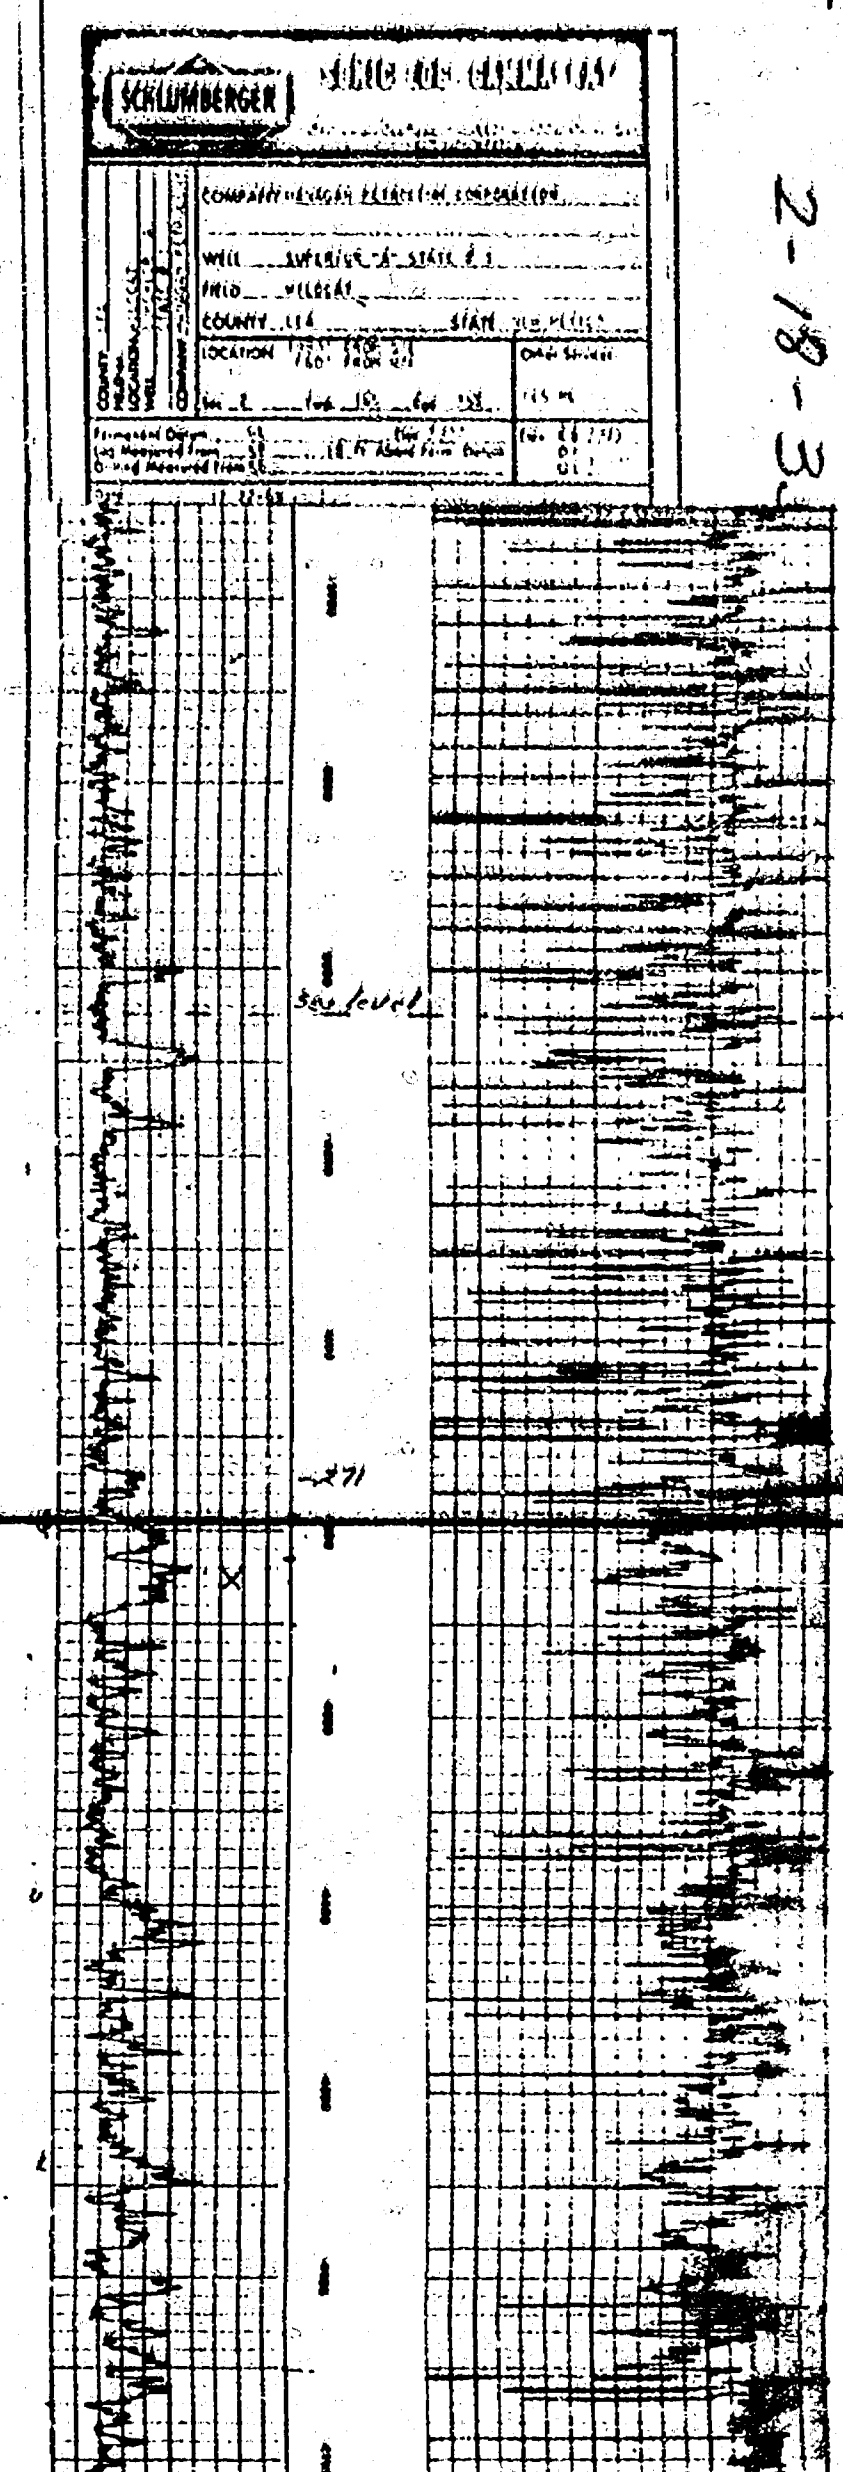
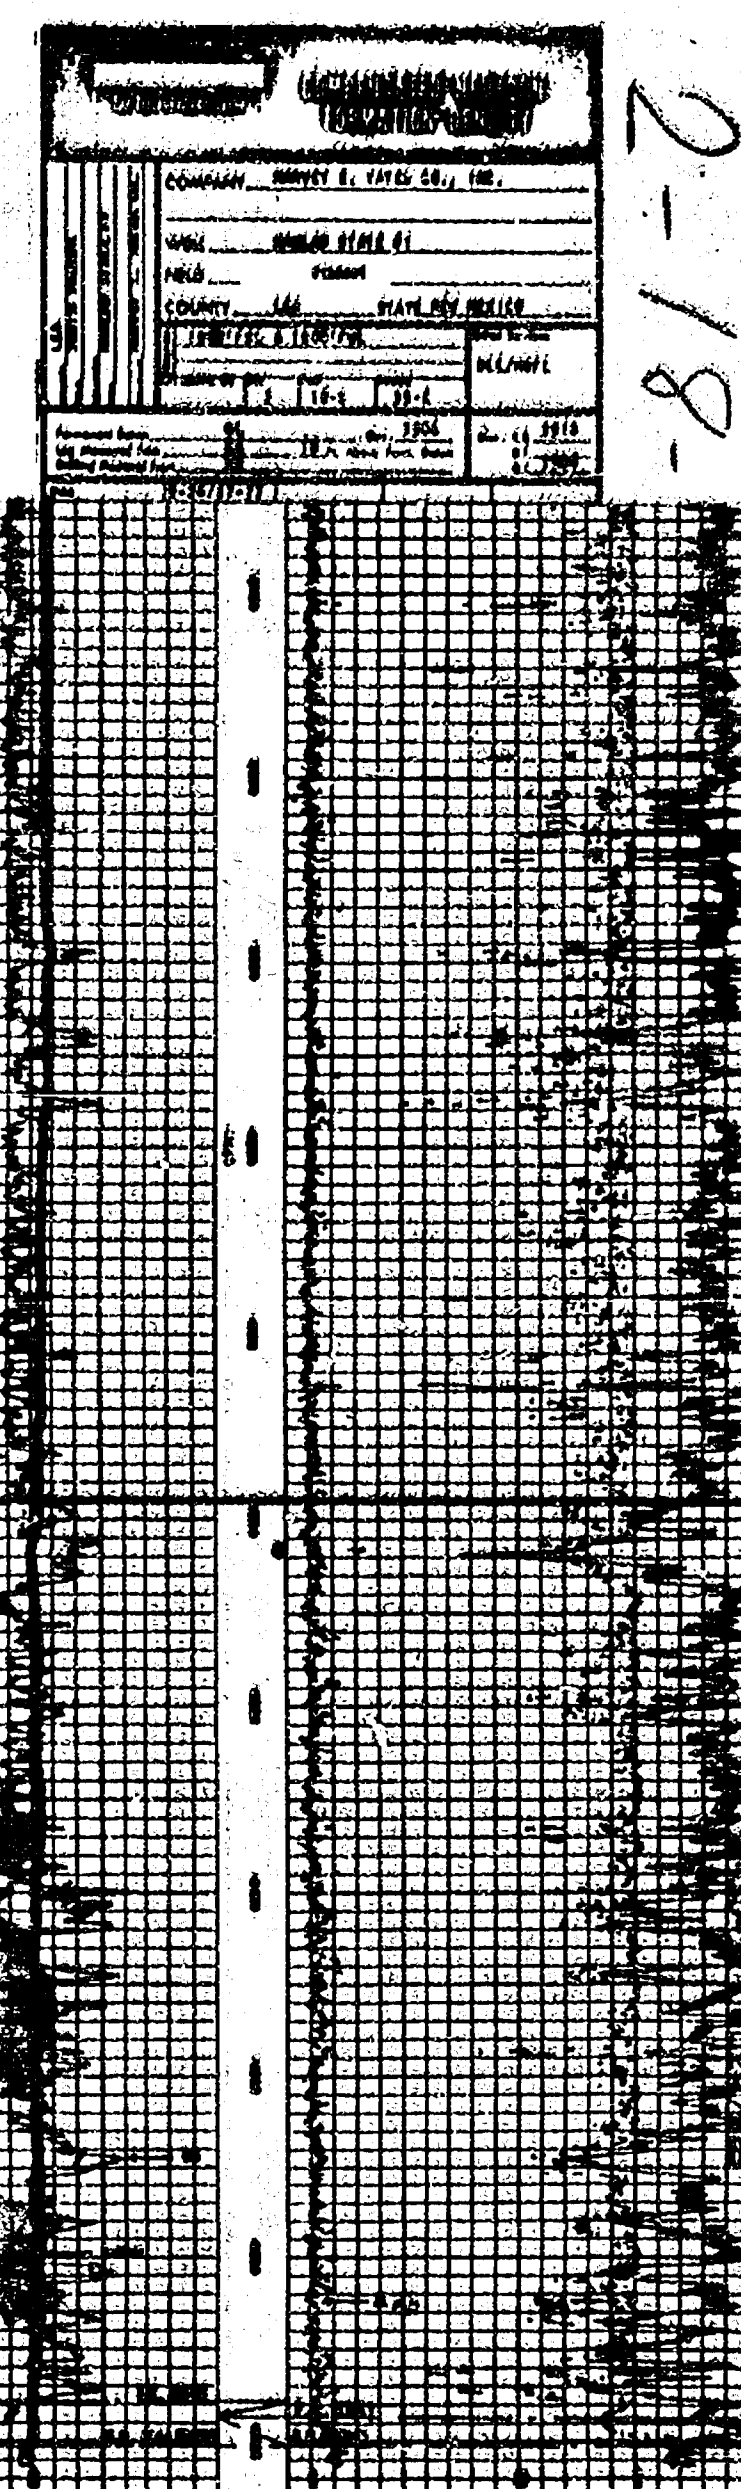
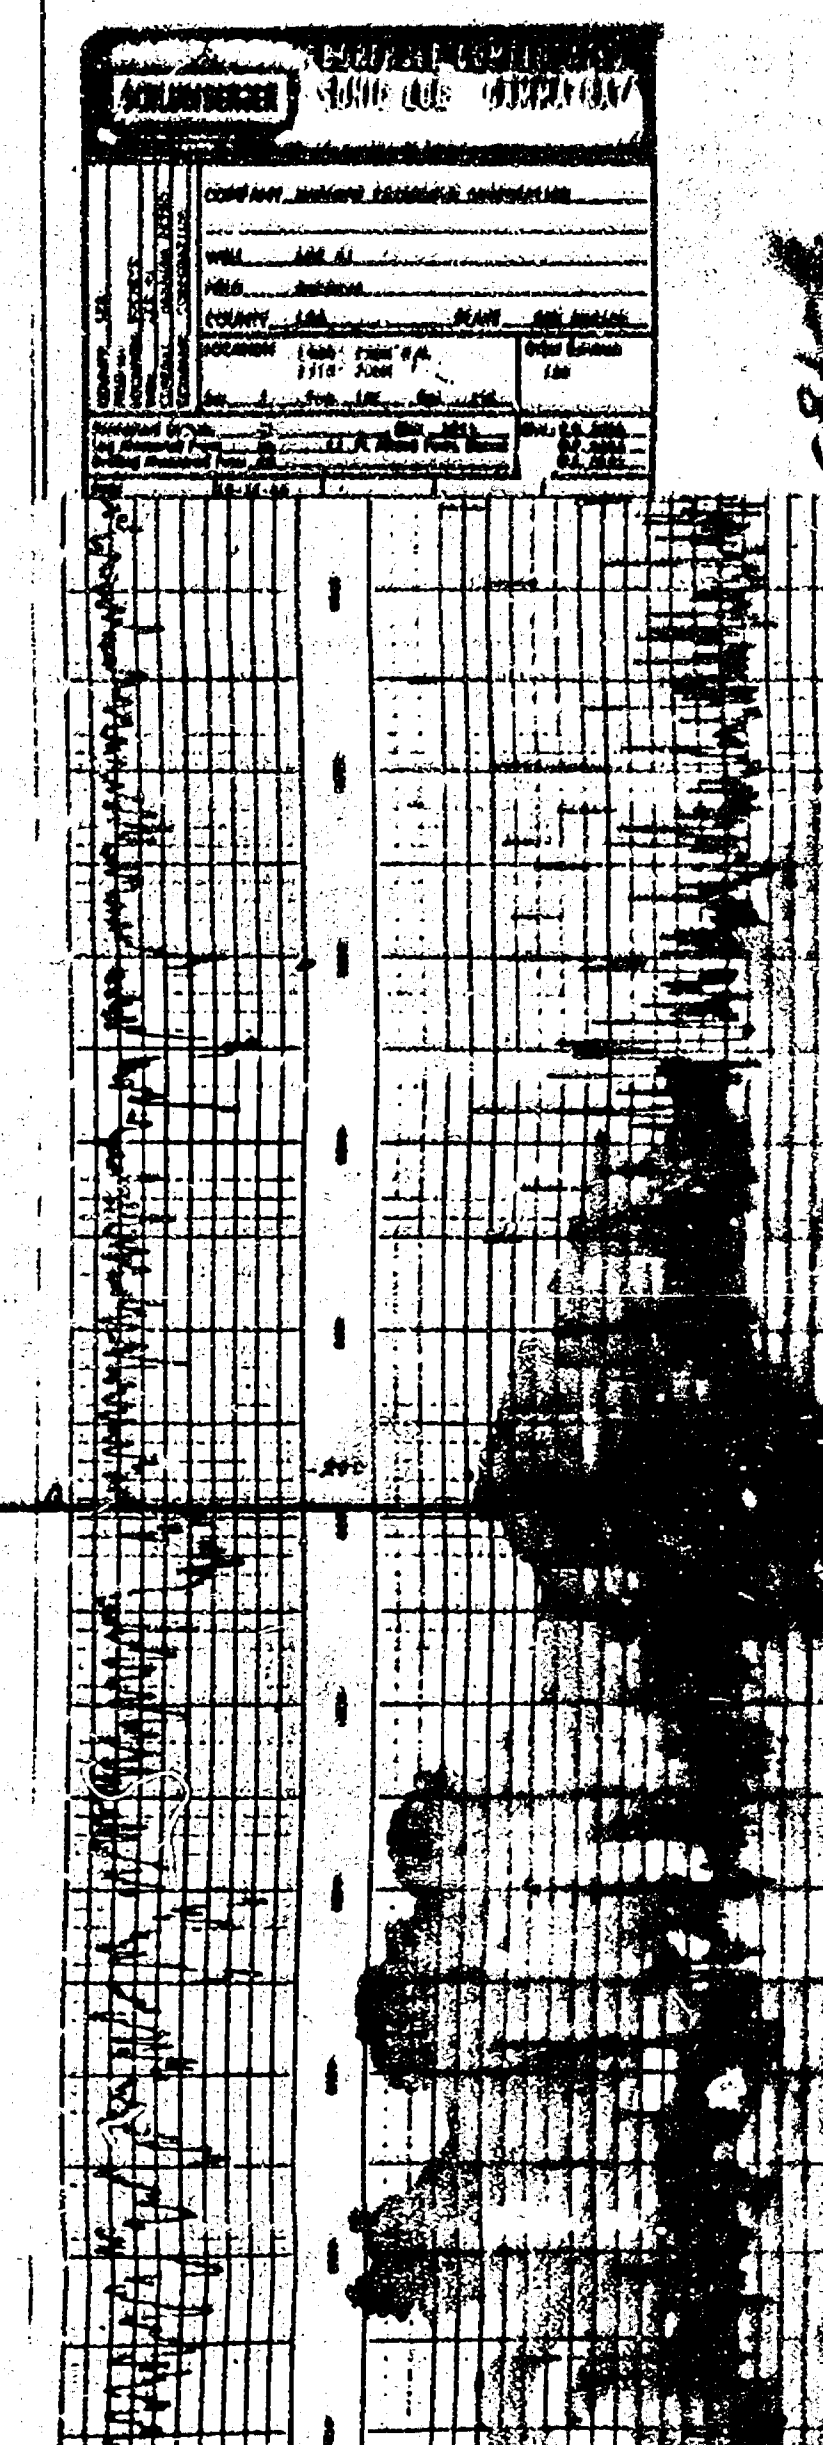
EXHIBIT NO. 3  
HARVEY E. YATES COMPANY  
STRATIGRAPHIC CROSS SECTION  
A-A'  
LEA COUNTY, NEW MEXICO  
HORIZONTAL SCALE: NONE VERTICAL SCALE: 1"=100'

SPUD: 5-7-65 P&A: 1967

SPUD: 8-15-77 COMP: 9-16-77  
IPCAOF: 2415 MCGRD Prod. thru perfs  
4212-20

SPUD: 9-9-66 COMP: 10-25-66

DATUM: TOP OF QUEEN

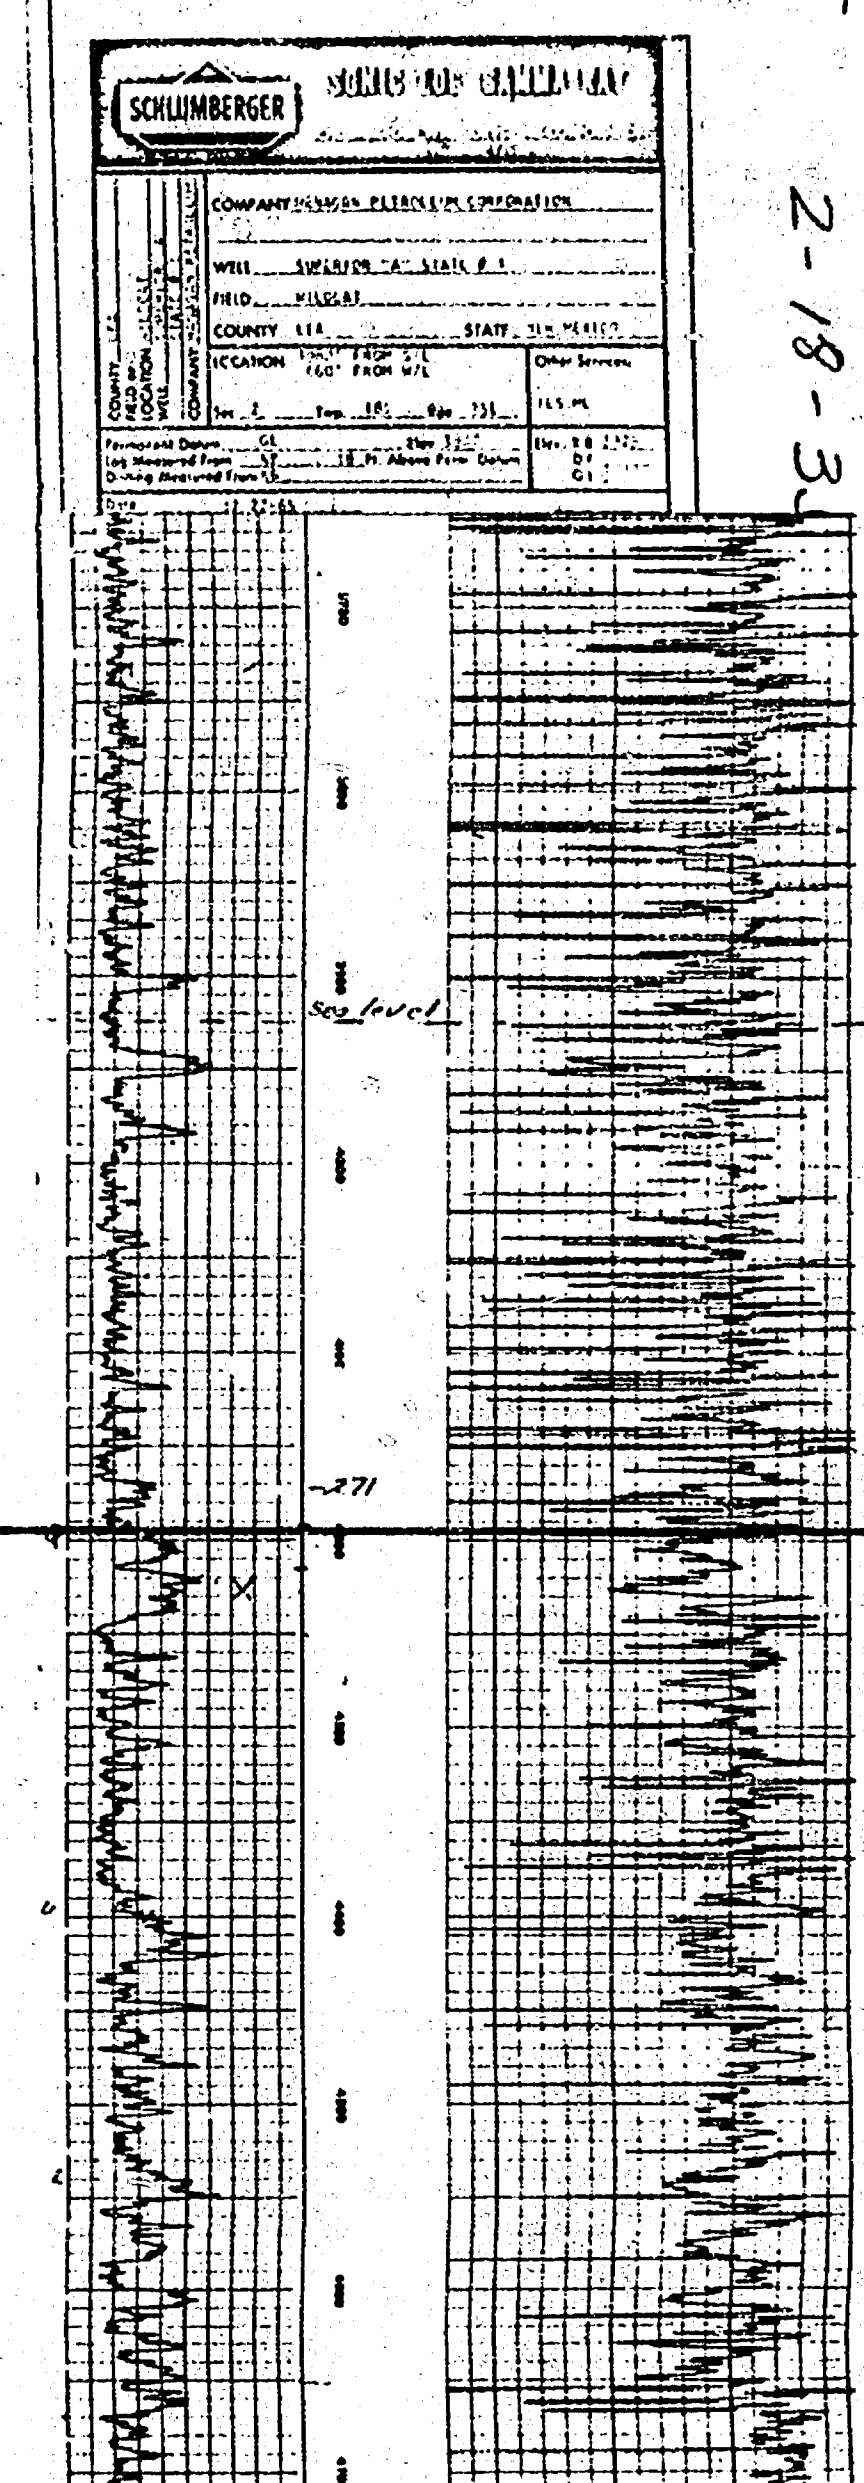
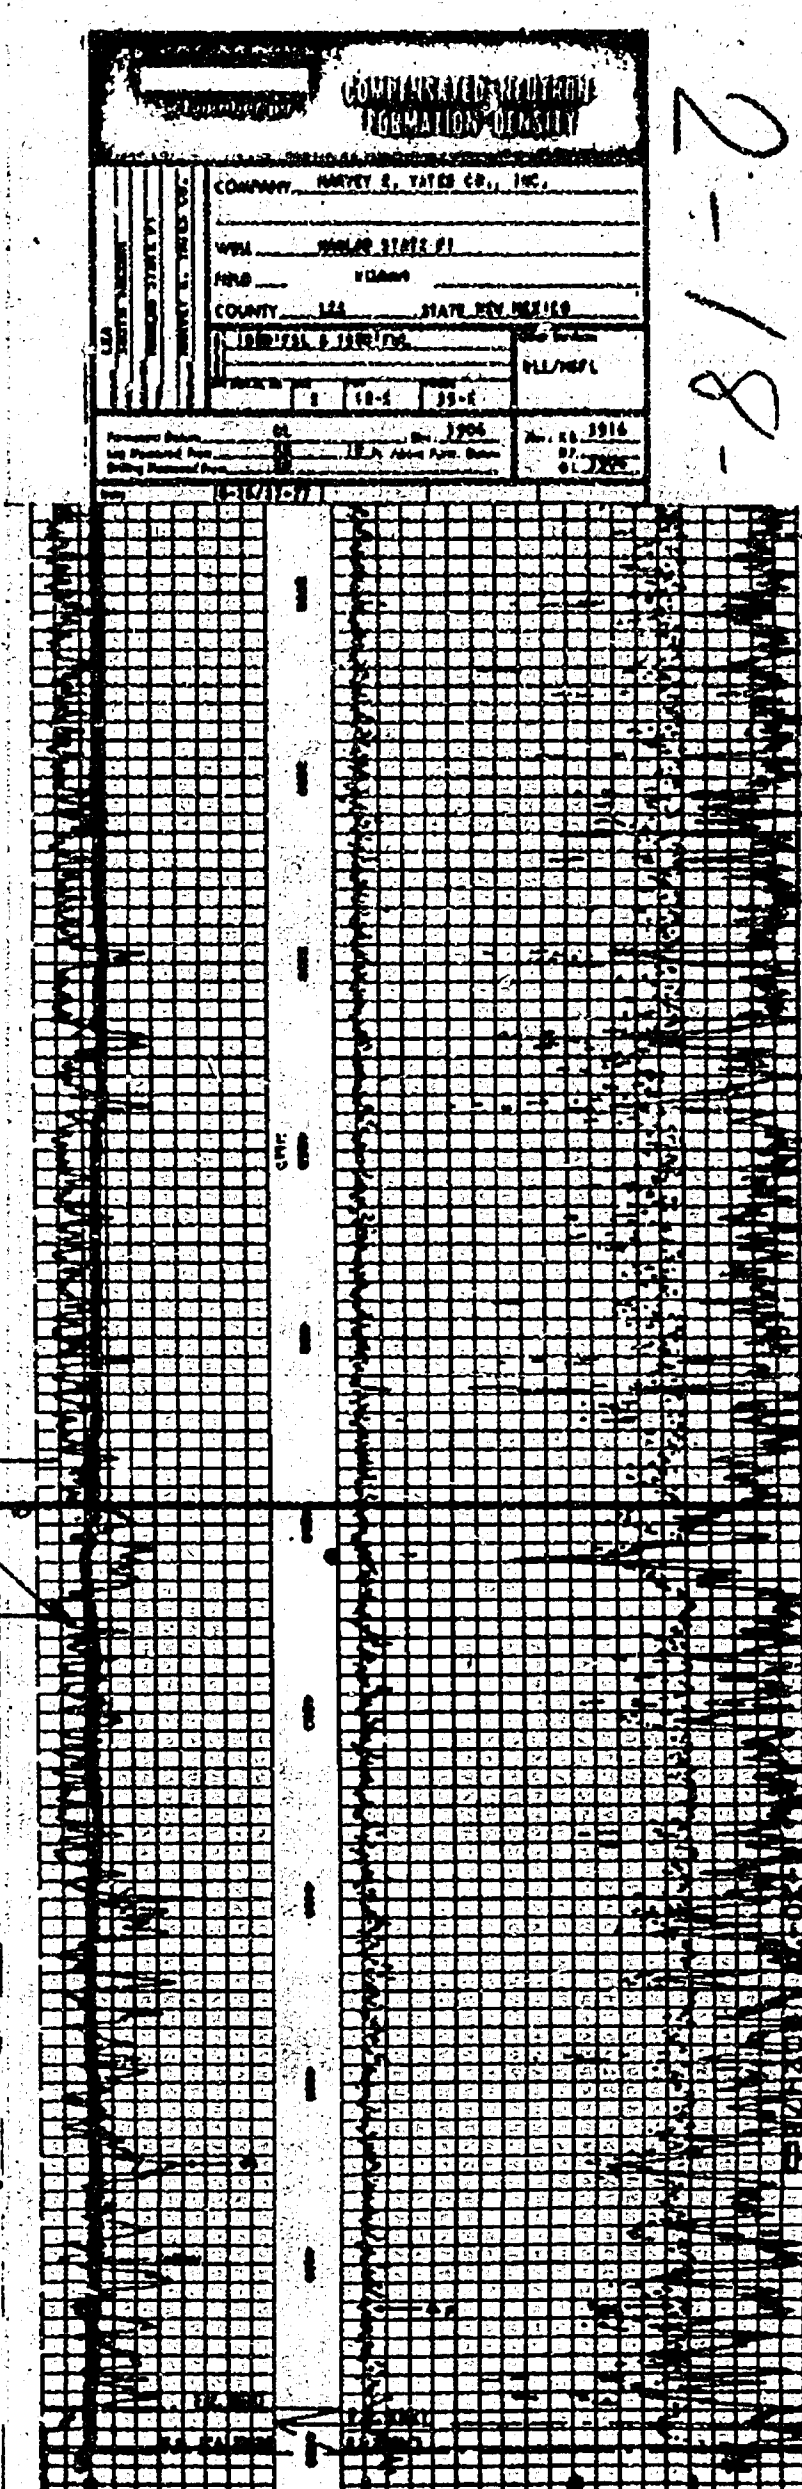
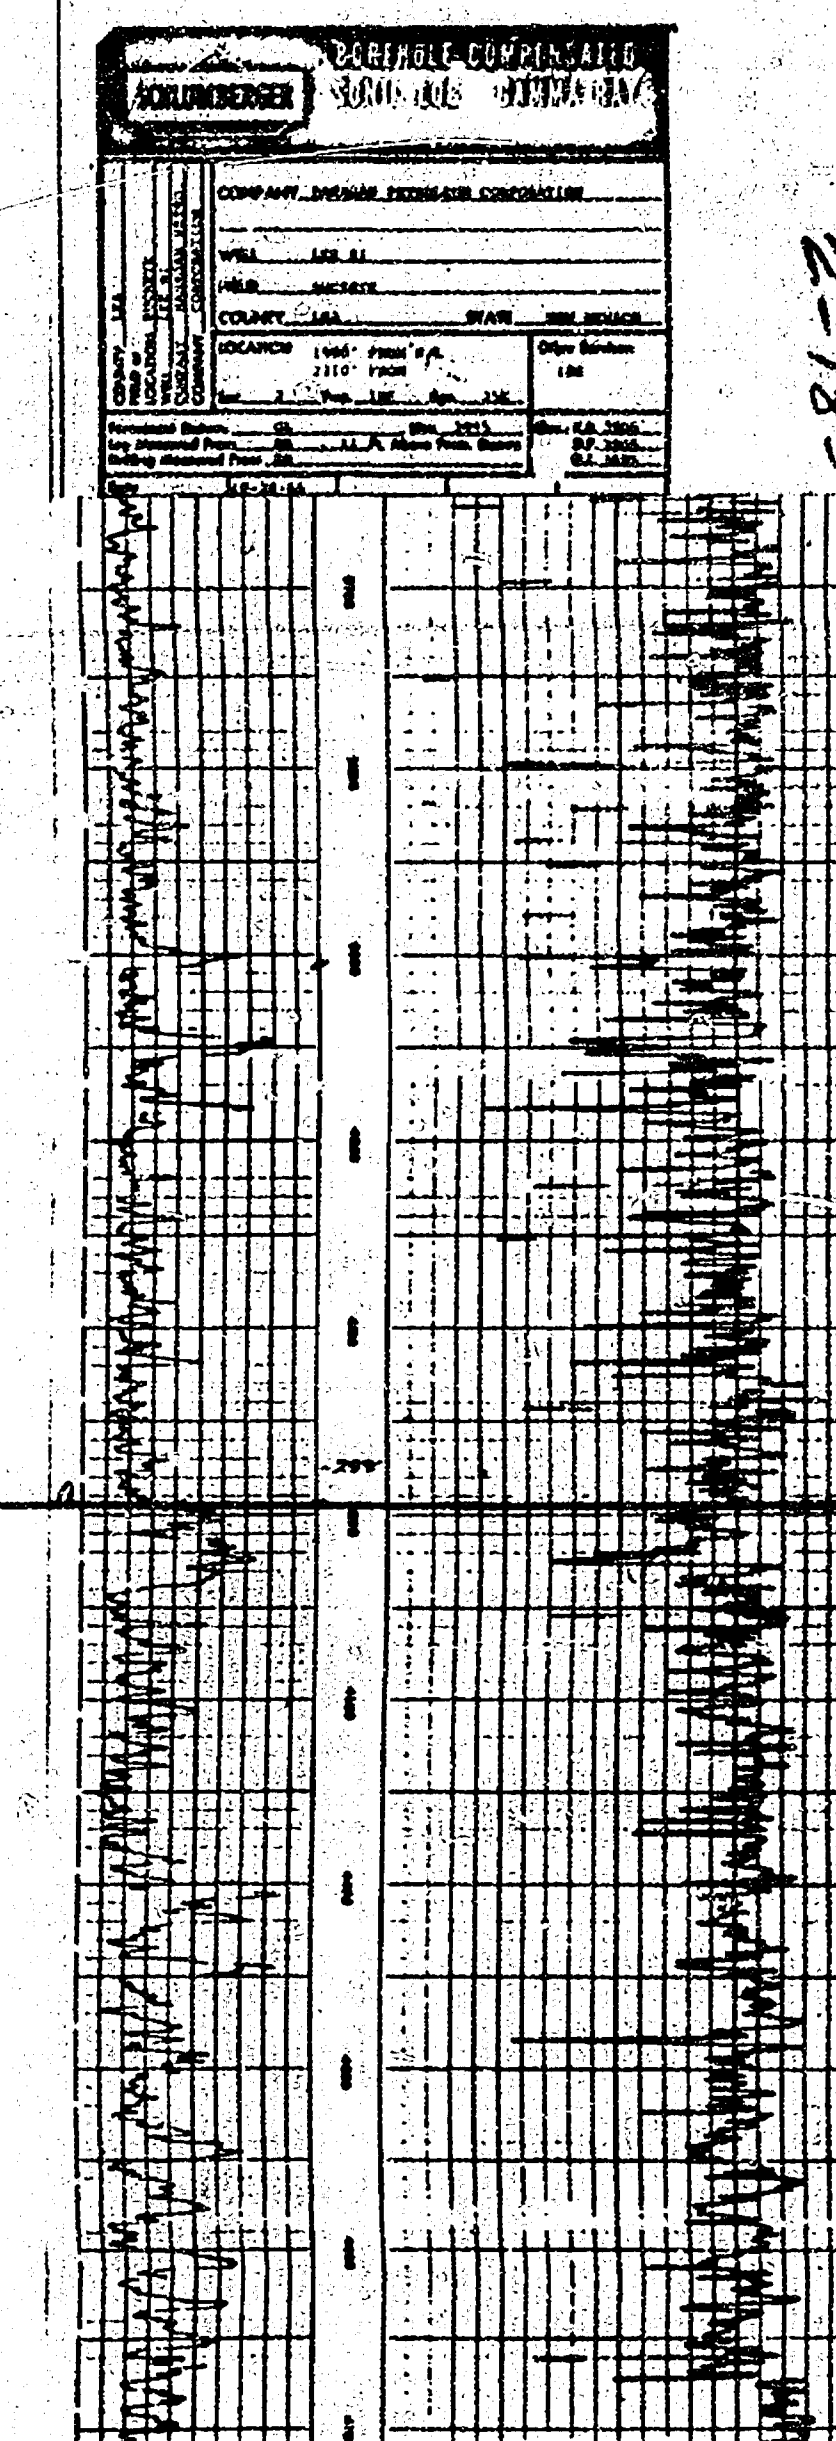
EXHIBIT NO. 3  
HARVEY E. YATES COMPANY  
STRATIGRAPHIC CROSS SECTION  
A-A'  
#1 HANLAD STATE  
LEA COUNTY, NEW MEXICO  
HORIZONTAL SCALE: NONE VERTICAL SCALE: 1"=100'

SPUD: 5-7-65 PSA: 1967

SPUD: 8-15-77 COMP: 9-16-77  
IPCAOF: 2415 MCFSPD Prod. thru perfs  
4212-20

SPUD: 9-9-66 COMP: 10-25-66

DATUM: TOP OF QUEEN
