## Recycling Facility and/or Recycling Containment

Operator: Enduring Resources, LLC (For multiple operators attach page with information) OGRID #: 372286  
Address: 200 Energy Court, Farmington, NM 87401  
Facility or well name (include API# if associated with a well): KWU 2309 19K Water Recycle Facility  
OCD Permit Number: 3RF-43 (For new facilities the permit number will be assigned by the district office)  
U/L or Qtr/Qtr NE/4 SW/4 Section 19 Township 23N Range 9W County: San Juan  
Surface Owner: ☒ Federal ☐ State ☐ Private ☐ Tribal Trust or Indian Allotment

**11/18/2021****Enduring Resources KWU 2309-19K 3RF-43 Primary Liner Compromise Repair Report**

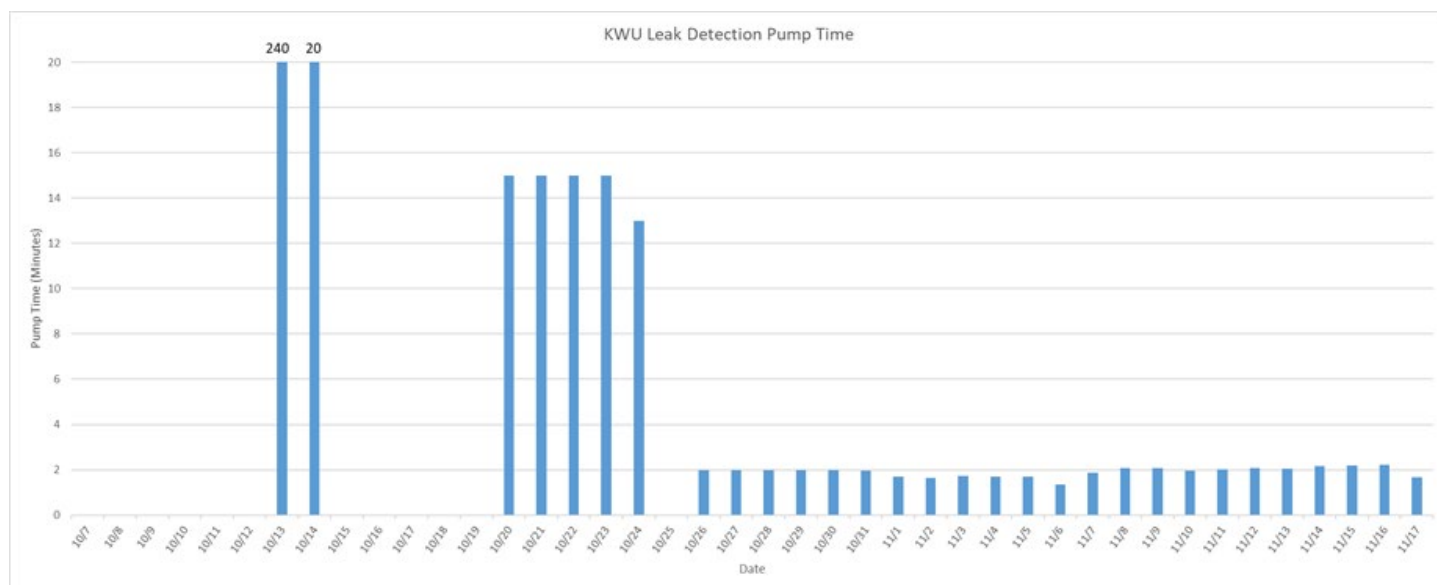
**Current data**

Enduring reached the 60% incremental volume at KWU 2309-19K 3RF-43 on 11/16/2021. Enduring commenced the 24-hour test on 11/17/2021. After 24 hours, with the continuation of similar leak detection pump times and similar water quality, the data indicates small amounts of water continue to migrate to the leak detection system as filling operations continue. We also continue to observe ice buildup between the two pond layers. This is likely caused by condensation being created during the day and freezing at night; therefore, we are likely to continue to see some liquid migration throughout the pond fill. Enduring Resources concludes that the primary liner continues to be leak free and filling operations have commenced to the next 10% milestone.
