Pit, Below-Grade Tank, or
Proposed Alternative Method Permit or Closure Plan Application

1.
Operator: Harvest Four Corners, LLC OGRID #: 37388
Address: 1755 Arroyo Dr., Bloomfield, NM 87413
Facility or well name: Jacques #1A
API Number: 30-045-22250 OCD Permit Number: Facility ID: fAB00000000607
U/L or Qtr/Qtr P Section 25 Township 30N Range 9W County: San Juan
Center of Proposed Design: Latitude 36.777549 Longitude -107.724558 NAD83
Surface Owner: ☒ Federal ☐ State ☐ Private ☐ Tribal Trust or Indian Allotment

JACQUES 1A
BELOW GRADE TANK
N36.777549, W107.724558

HARVEST MIDSTREAM
JACQUES 1A
API: 30-045-22250
SE¼ SE¼, SECTION 25, T30N, R9W
SAN JUAN COUNTY, NEW MEXICO
N36.777549, W107.724558

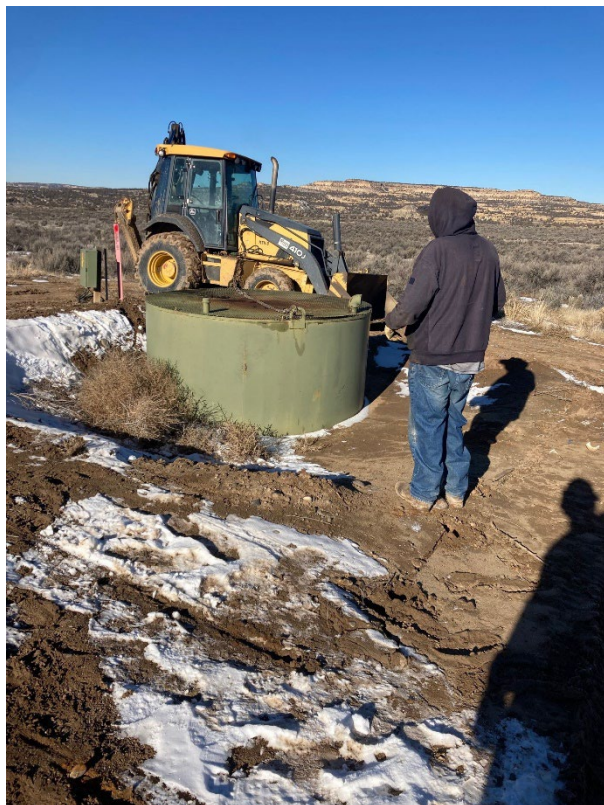
Photo 1: Jacques #1A BGT.

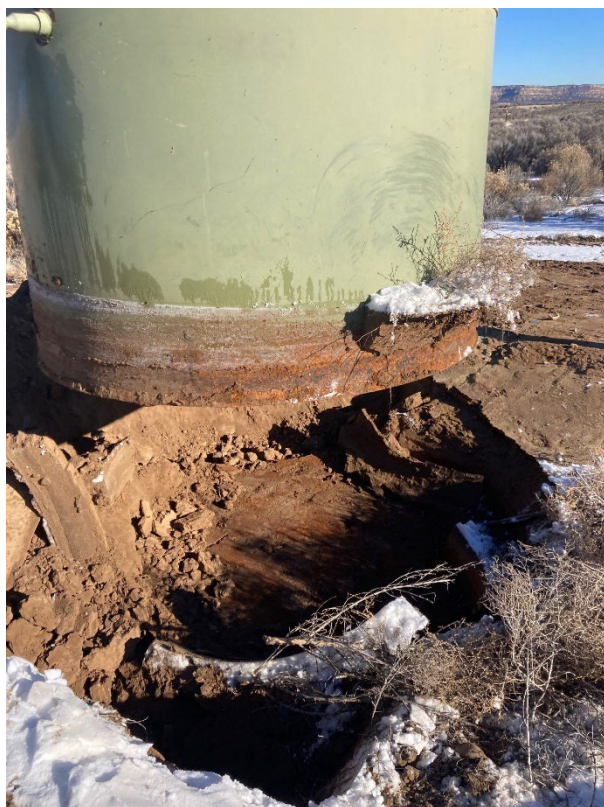
Photo 2: Jacques #1A BGT location following removal.

In accordance with standard procedures as outlined in the tank closure plans, Harvest removed any liquids and sludge found within the BGTs within 60 days of their ceasing operations. Liquids and sludge were disposed of only at the NMOCD-approved facilities named in the closure plans. Subsequently, Harvest removed the BGTs. All removed Harvest BGTs are properly disposed of, recycled, or reused in an approved manner. All associated equipment was also removed from the location.

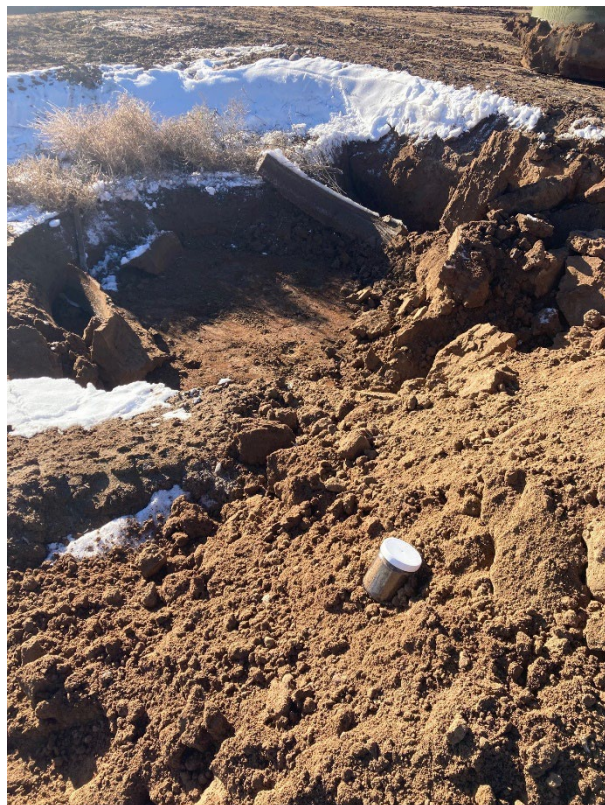
Photo 3: Jacques #1A composite soil sample.

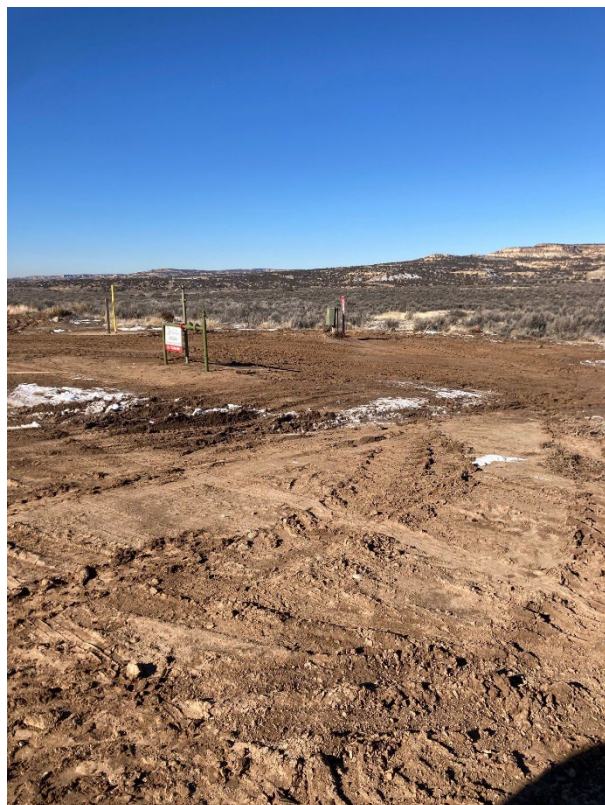
Photo 4: Jacques #1A BGT location following backfill.

Based on BGT laboratory analytical results for benzene, total BTEX, TPH, and chloride at the location of the removed Harvest BGT, the site was backfilled with clean soil obtained from on-site. No further work is recommended at the Jacques #1A for this Harvest BGT Closure.

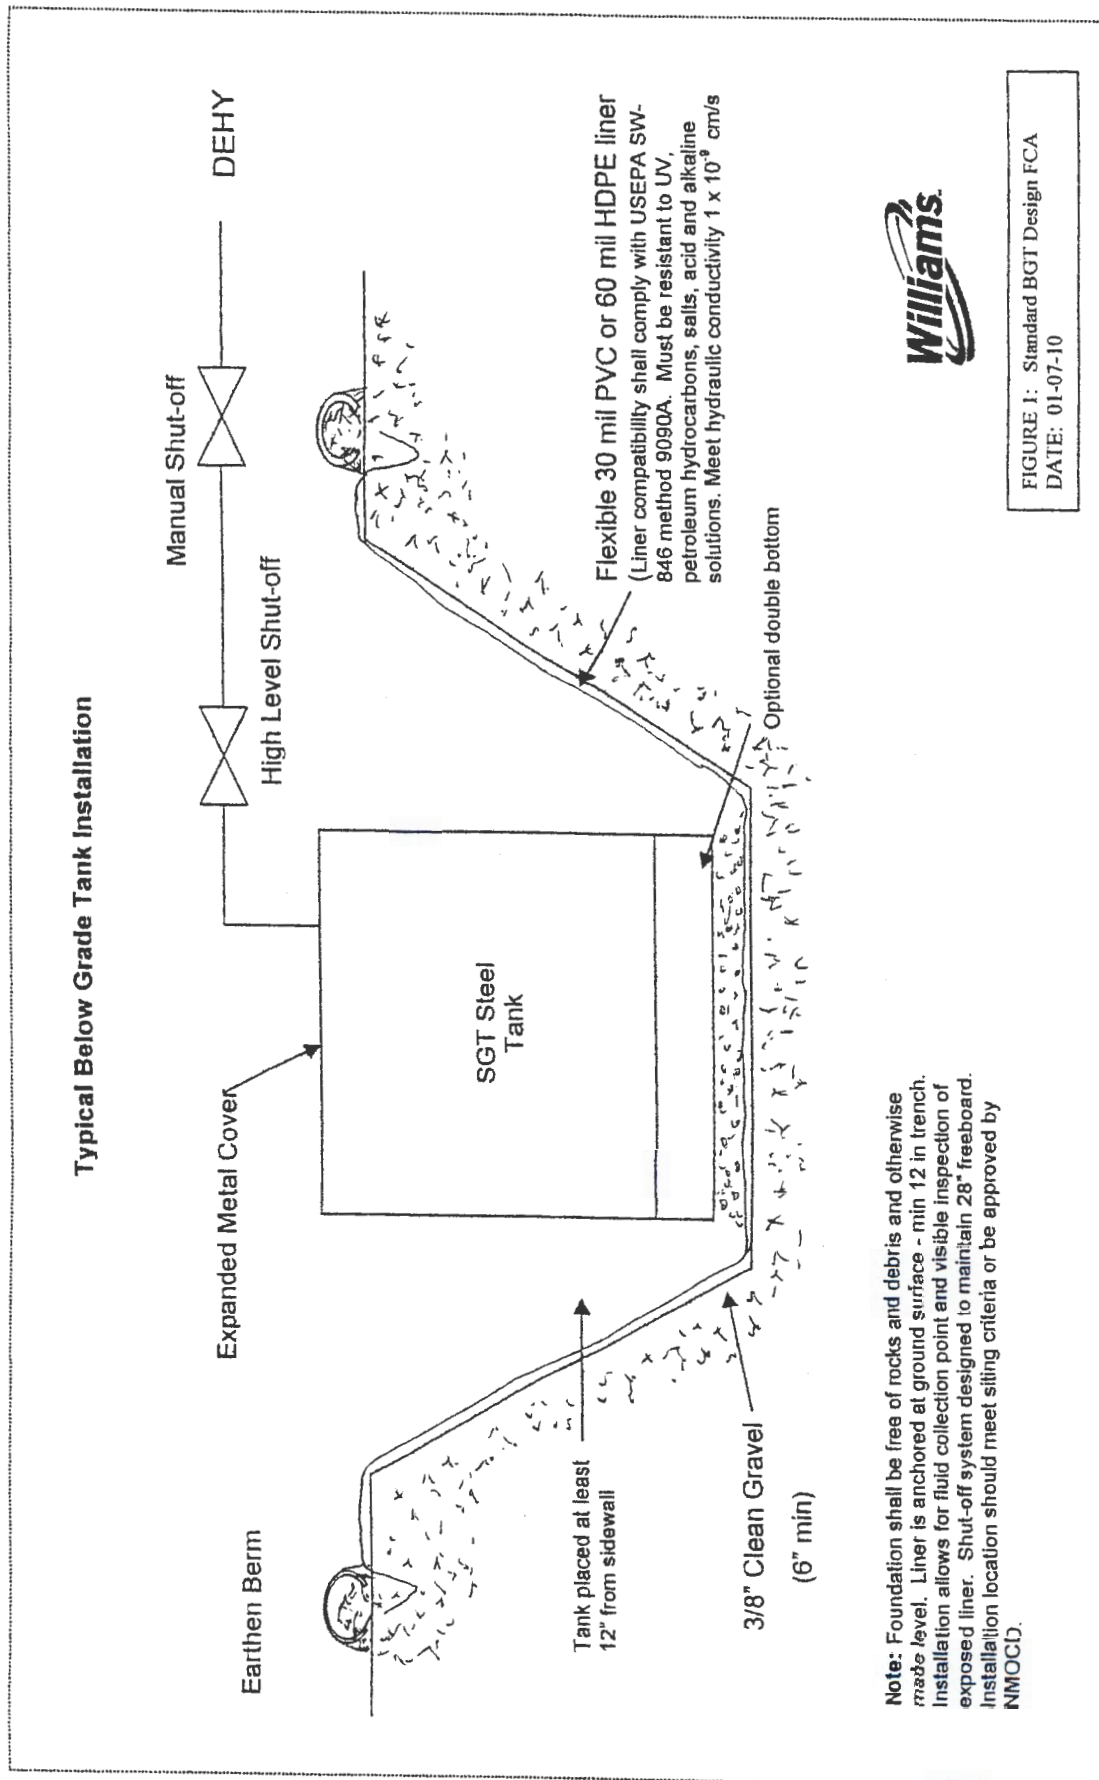
14. An existing single walled tank (installed prior to June 16, 2008) which has completely open sidewalls for visible inspection and which may or may not have a geomembrane liner, need not meet the above design and construction standards unless and until integrity fails, or there is a change of Operator, or the tank or facility is sold. The tank will then be closed pursuant to the Closure Plan or be retrofitted in accordance with the design drawing (see Figure 1) or NMOCD approved modification.

Any modifications to, or retrofitting of existing tanks shall necessitate that all of the aforementioned design elements be included and as provided in the design drawing (see Figure 1). If modifications cannot reasonably include the same design standards for new tanks, the existing tank shall be retired and removed from service. In this event, the Williams Closure Plan for Below Grade Tanks shall be implemented.

- A below-grade tank constructed and installed prior to June 16, 2008 that does not meet current design standards and that does not otherwise demonstrate integrity (i.e. leaks), or when there is any penetration of liner material below the liquid surface, shall be closed pursuant to the Closure Plan. *Installation of any new tank meeting the current design criteria (see Figure 1 Design Drawing) shall commence only after closing the defective BGT.*

- Ensure that any BGT modification, replacement, or retrofit conforms with current and applicable design and construction specifications (see Design and Construction Plan Figure 1).
