## Site Assessment/Characterization

State of New Mexico  
Oil Conservation Division

## Remediation Plan

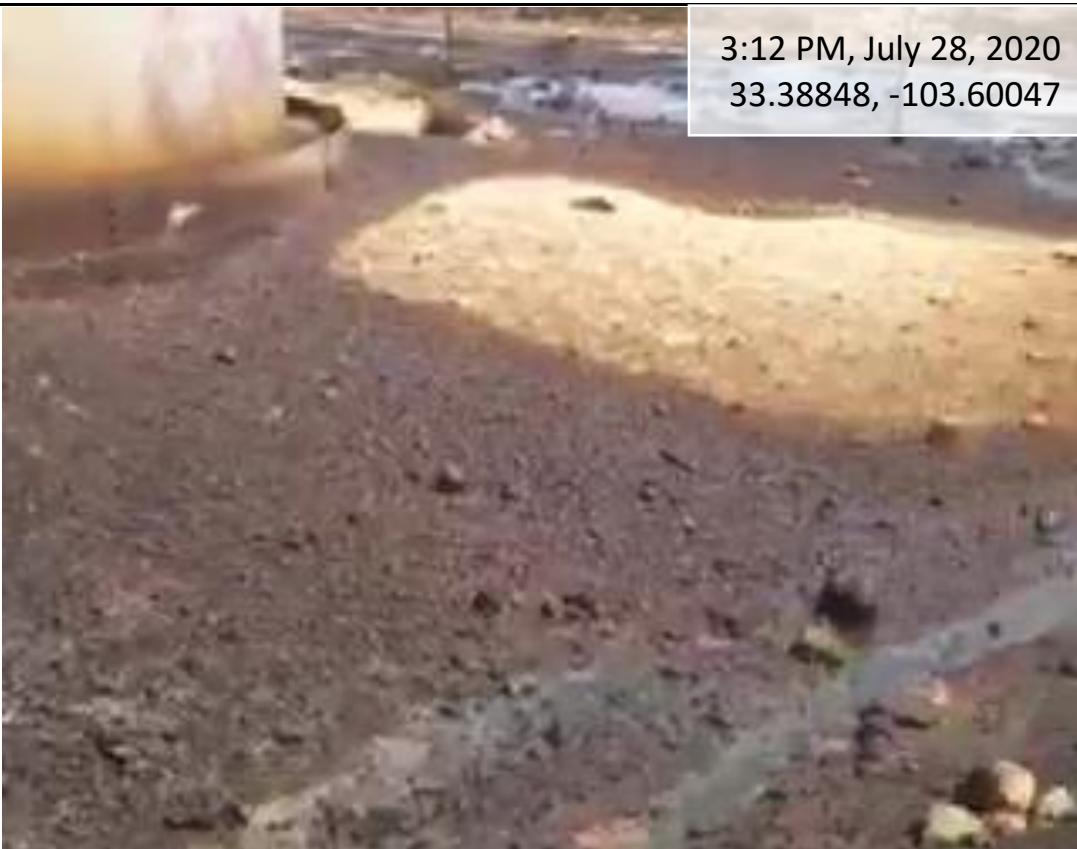
| <b>Photo Number:</b><br>3 | <p>3:12 PM, July 28, 2020<br/>33.38848, -103.60047</p> |

| <b>Photo Direction:</b><br>Southeast | |
| <b>Photo Description:</b><br><br>Initial spill in tank battery and spillover to the south. | |

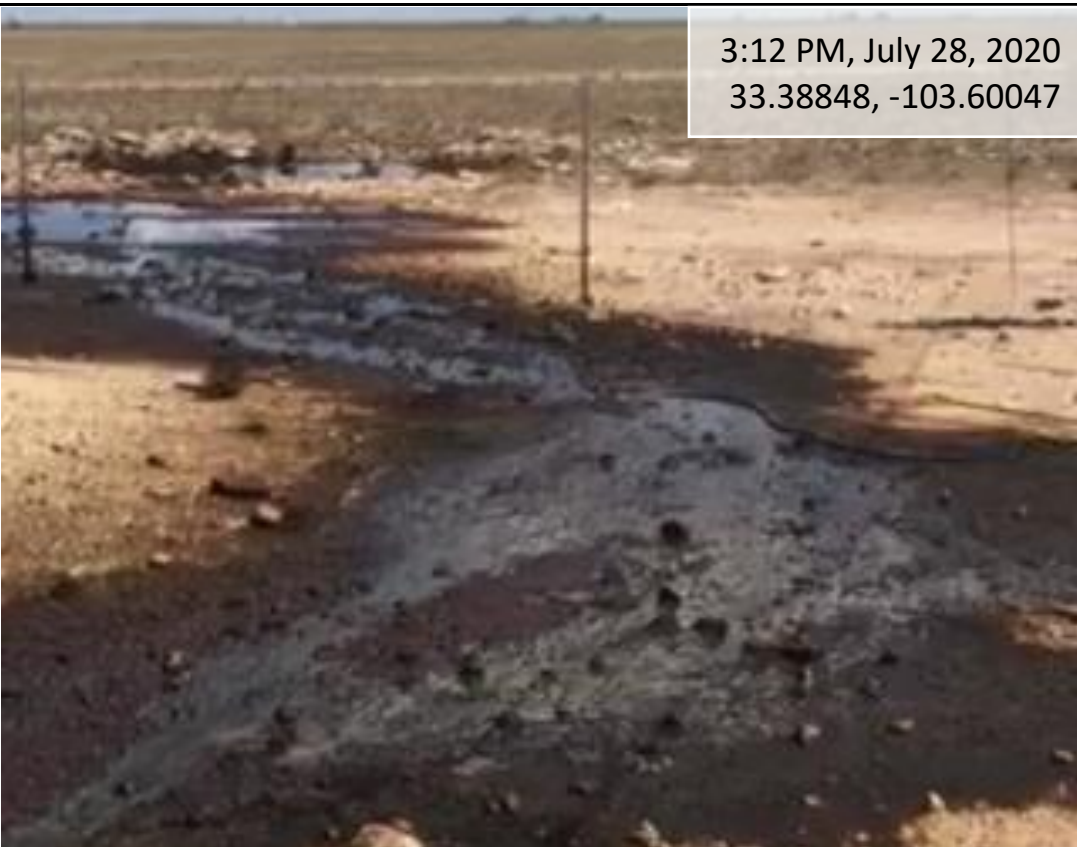
| <b>Photo Number:</b><br>4 | <p>3:12 PM, July 28, 2020<br/>33.38848, -103.60047</p> |

| <b>Photo Direction:</b><br>South | |
| <b>Photo Description:</b><br><br>Initial spill in tank battery and spillover to the south. | |

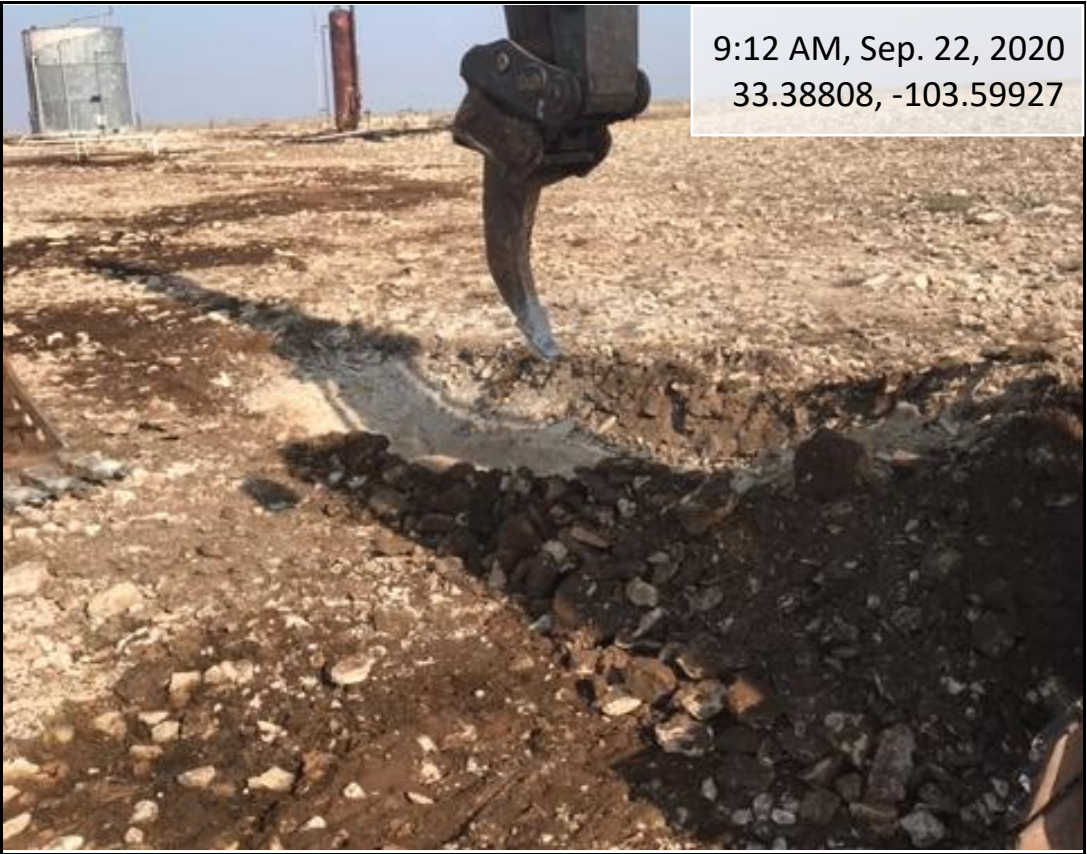
| <b>Photo Number:</b><br>5 | <p>9:12 AM, Sep. 22, 2020<br/>33.38808, -103.59927</p> |

| <b>Photo Direction:</b><br>Northwest | |
| <b>Photo Description:</b><br><br>Initial spill in southeast pasture during test trench excavation. | |
